## **Merced River Corridor Restoration Plan Baseline Studies**

# **Volume II: Geomorphic and Riparian Vegetation Investigations Report**

**VOLUME II  
GEOMORPHIC AND RIPARIAN VEGETATION  
INVESTIGATIONS REPORT**

Stillwater Sciences  
2532 Durant Avenue  
Berkeley, CA 94704

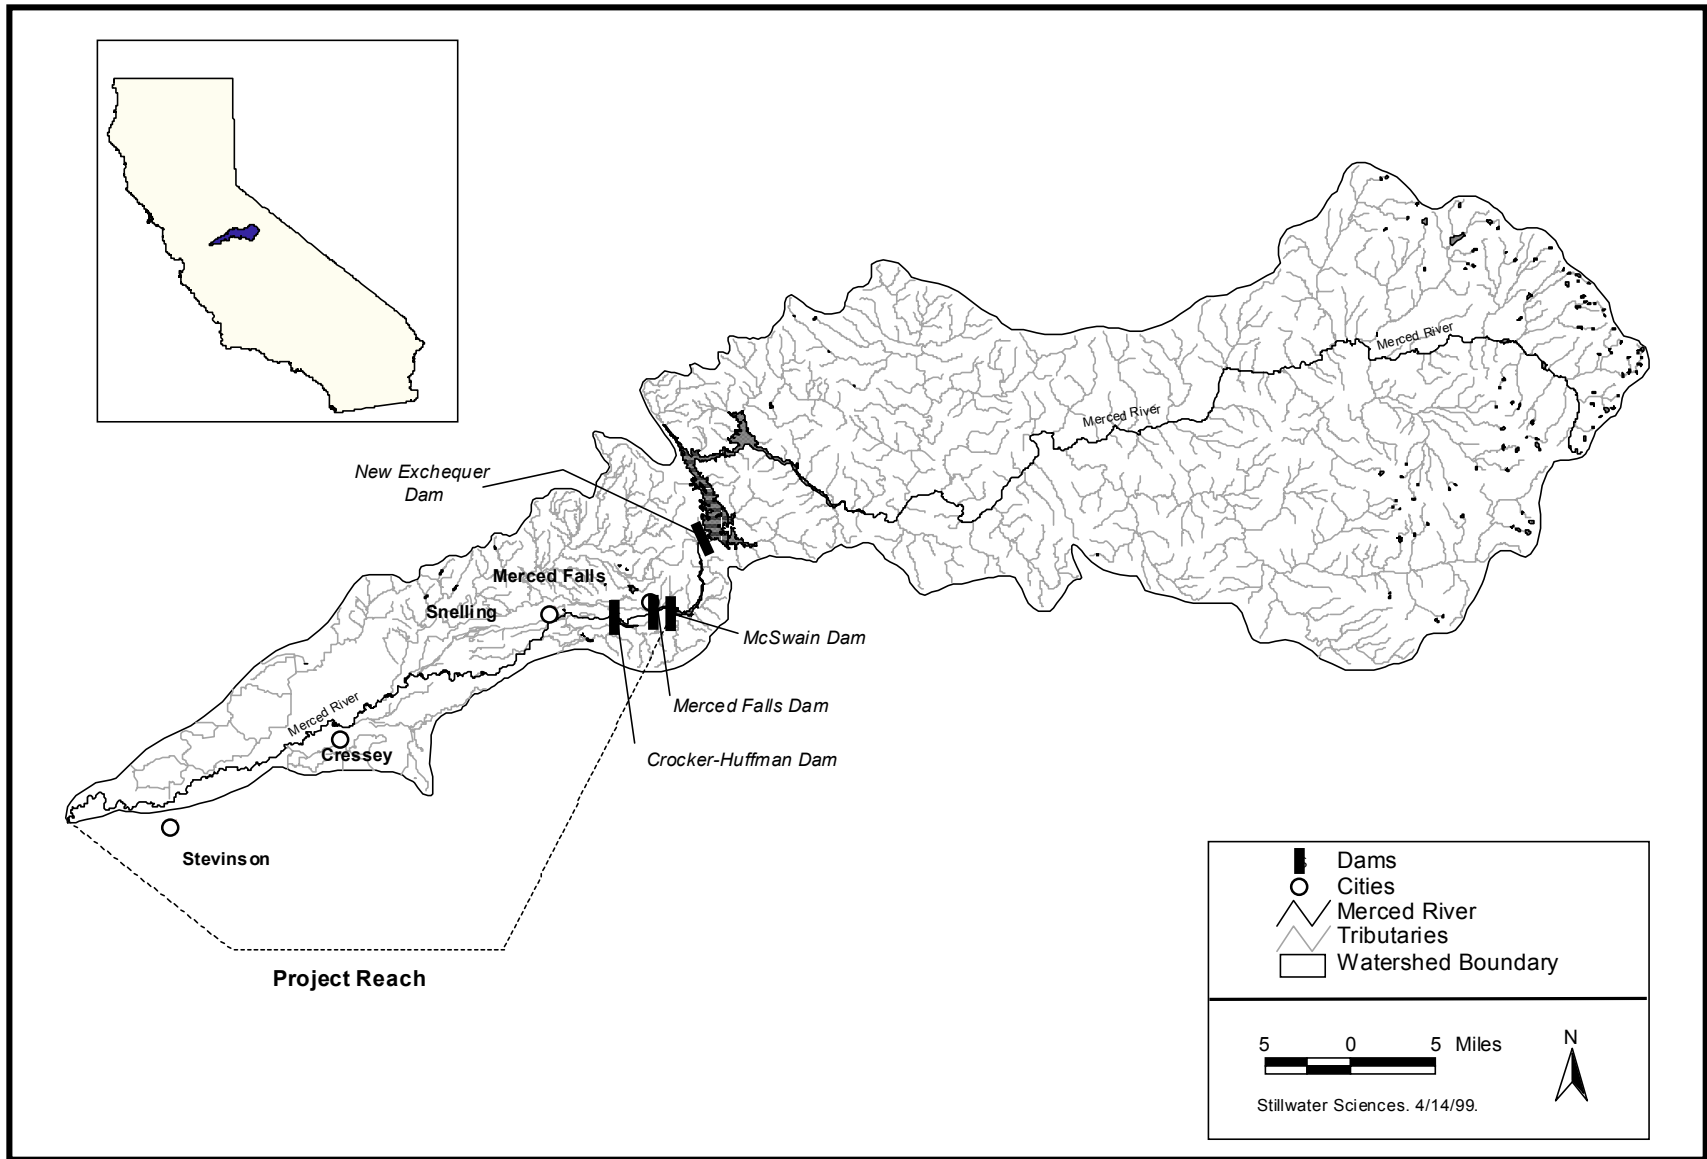
**Figure 1.1-1. The Merced River watershed and project reach.**

Four mainstem dams affect flow conditions in the lower Merced River (Figure 1.1–1 and Table 2). The two largest dams are New Exchequer Dam (which impounds Lake McClure) and McSwain Dam (which impounds Lake McSwain). These dams, which are known collectively as the Merced River Development Project, are owned by Merced ID and are licensed by the Federal Energy Regulatory Commission (FERC). Merced Falls Dam and Crocker-Huffman Dam are low diversion dams which divert flow into the Merced ID Northside Canal and Main Canal, respectively. Merced Falls Dam is owned by Pacific Gas and Electric; Crocker-Huffman Dam is owned by Merced ID. Three additional small dams—MacMahon, Green Valley, and Metzger dams—are located on tributaries upstream of the New Exchequer Dam. These dams have a combined reservoir capacity of 835 acre-feet<sup>c</sup>. Also, Kelsey Dam impounds a small (972 acre-feet) reservoir on Dry Creek, the only major tributary to the Merced River downstream of the mainstem dams.

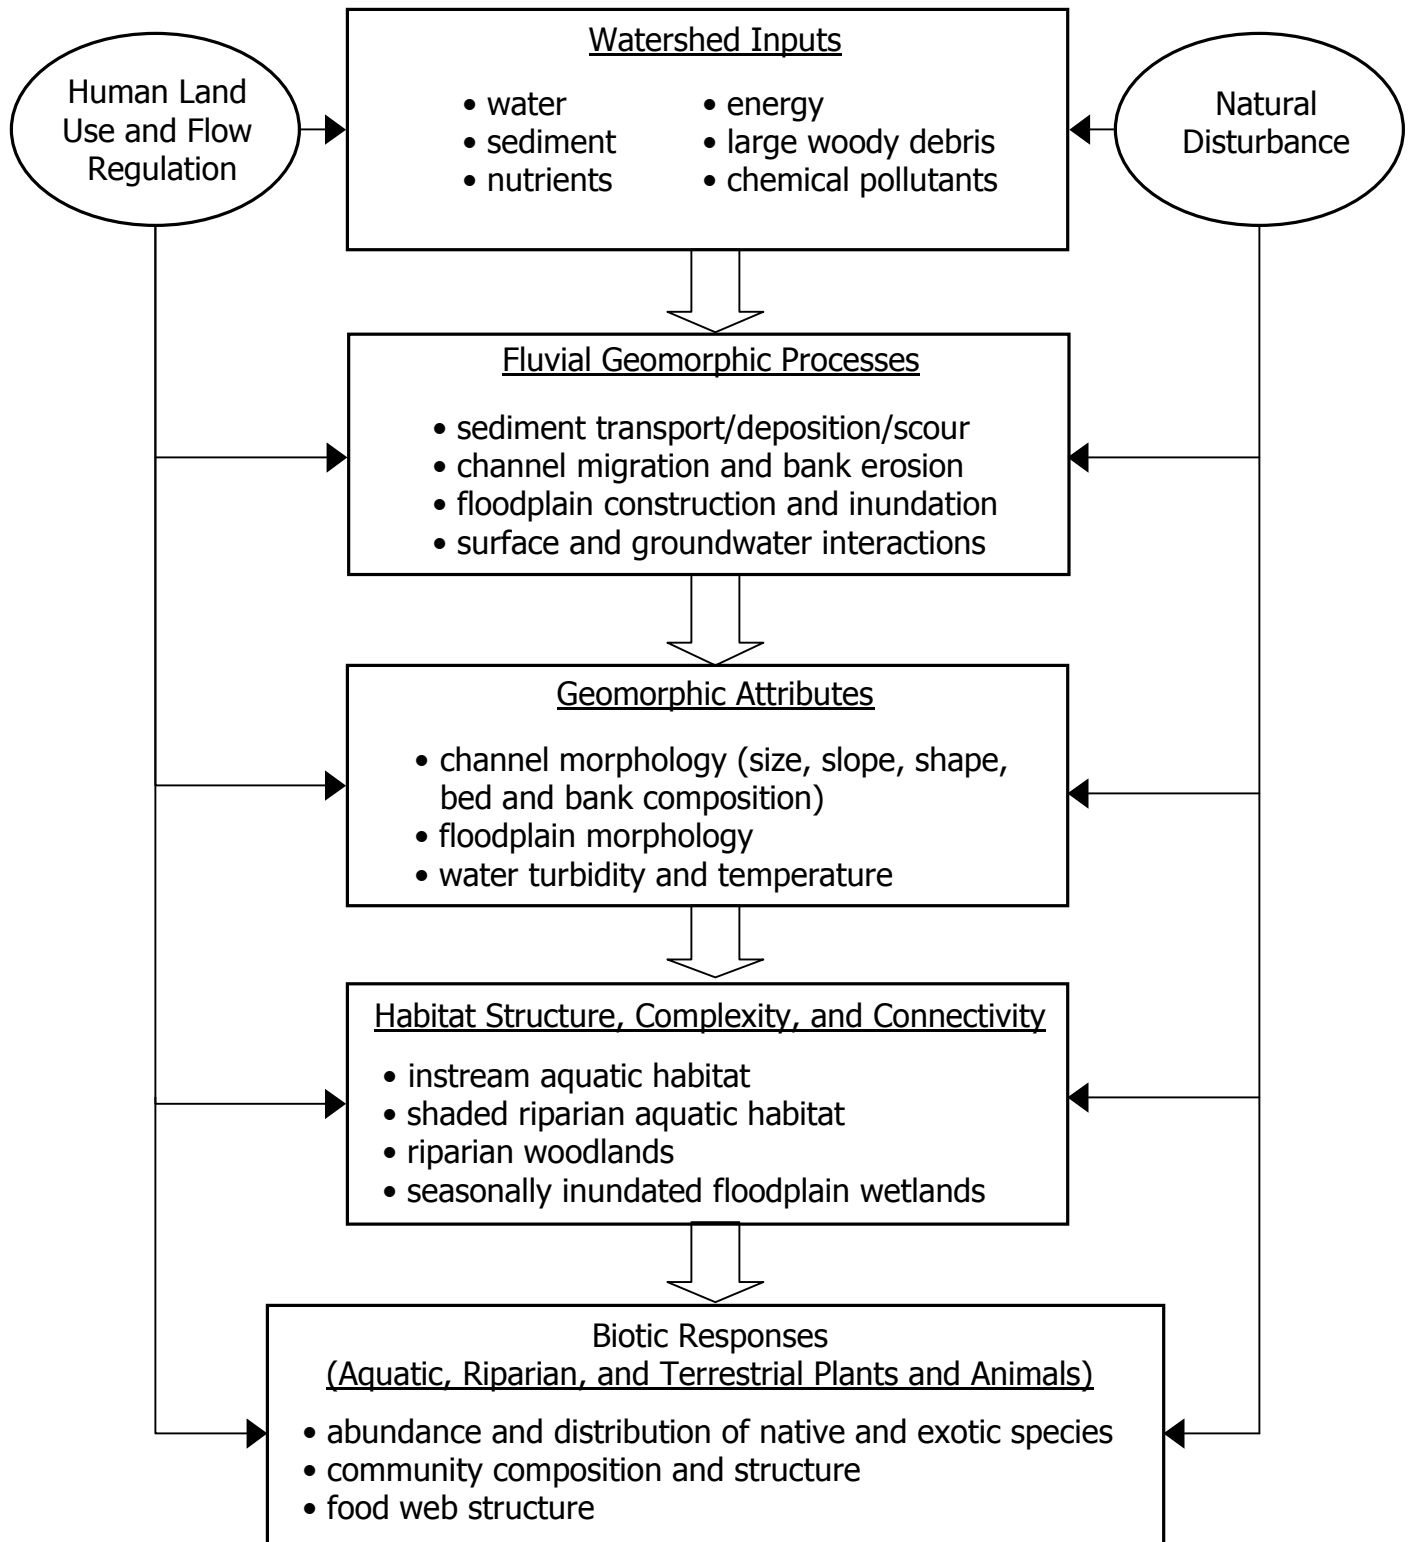
**Figure 2-1. A simplified conceptual model of the physical and ecological linkages in alluvial river-floodplain systems.**

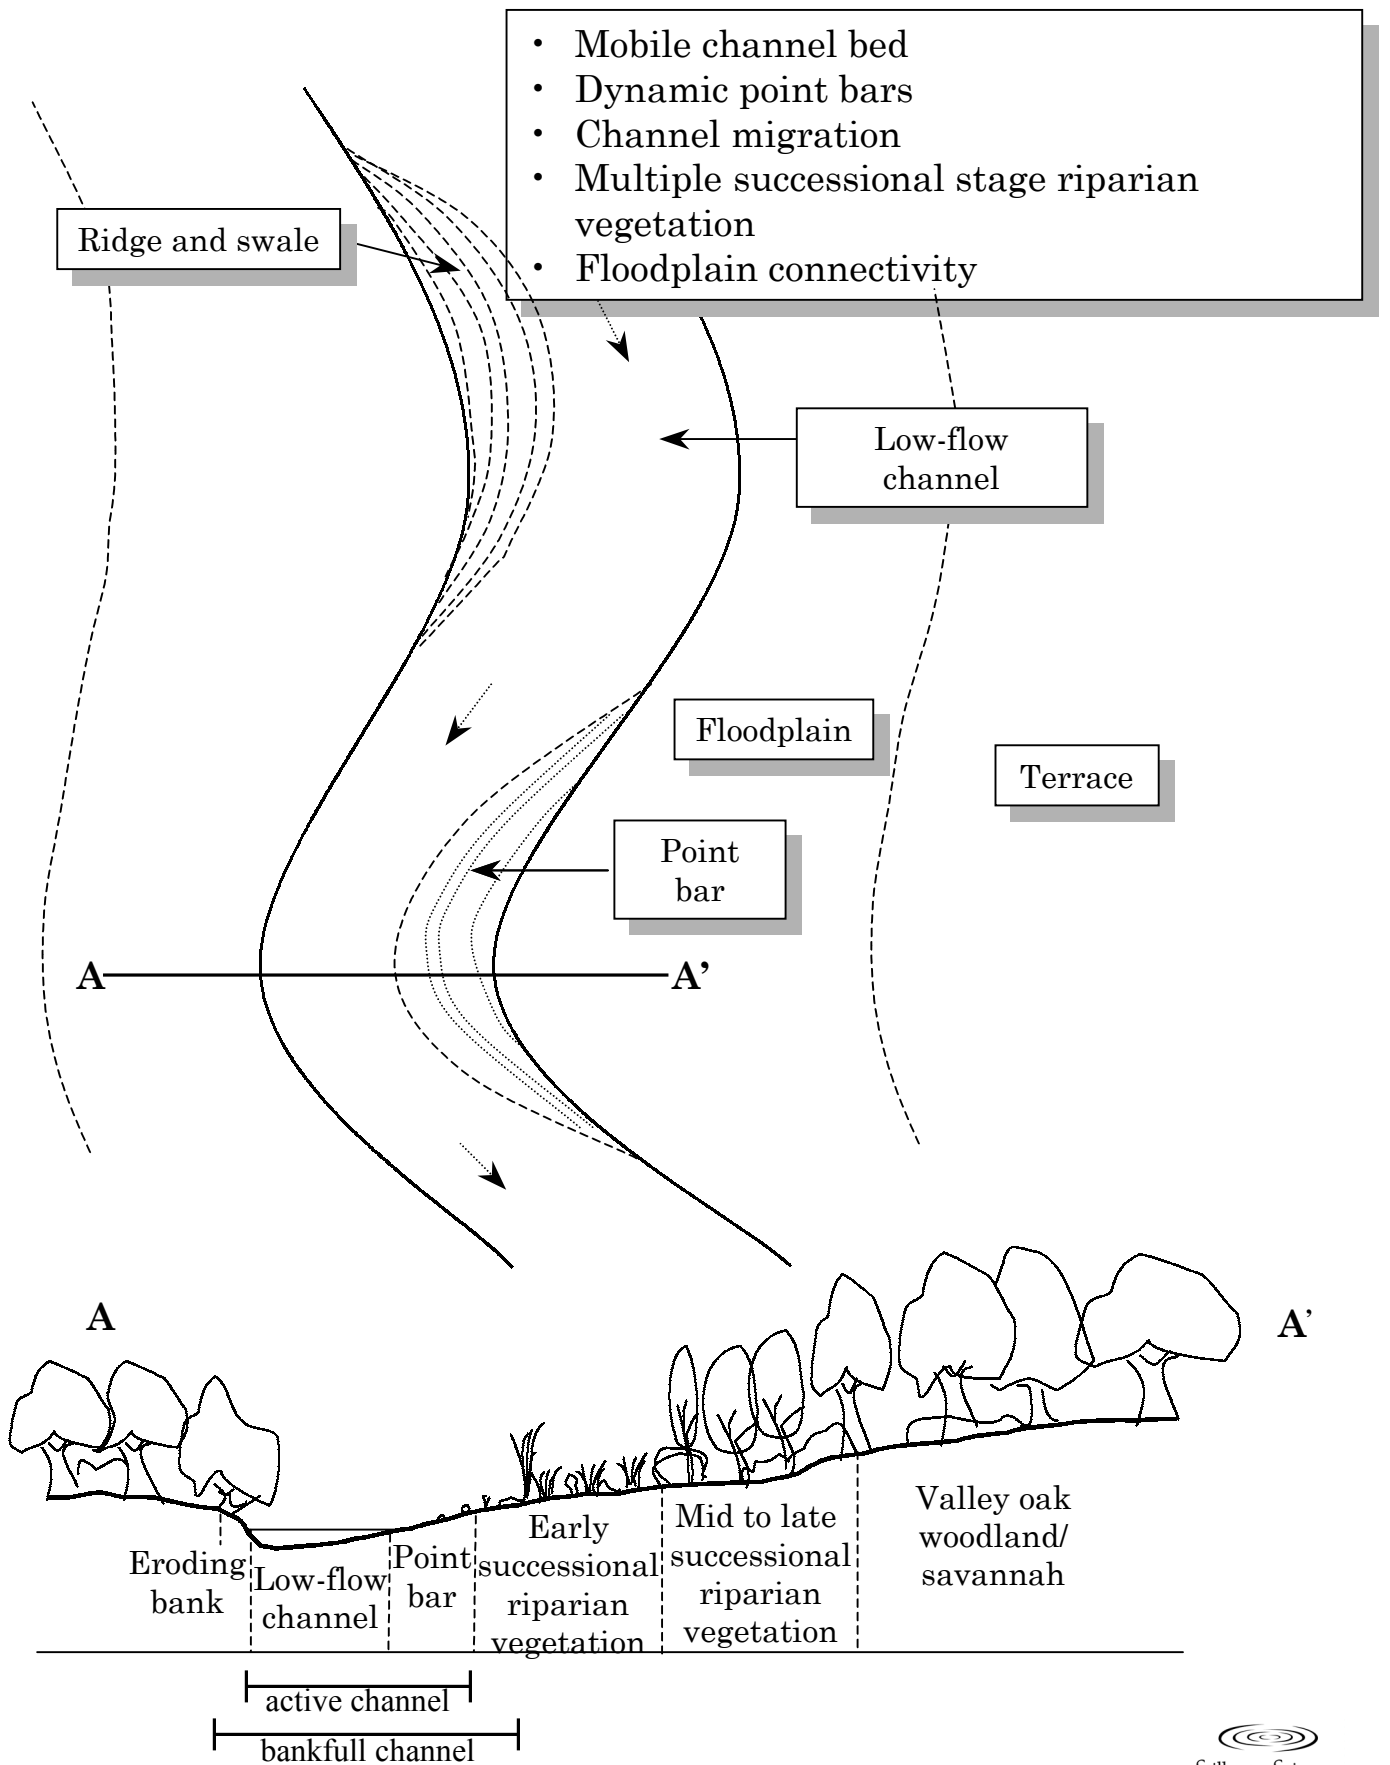
**Figure 2-2. Conceptual diagram of a "healthy" alluvial river system.**

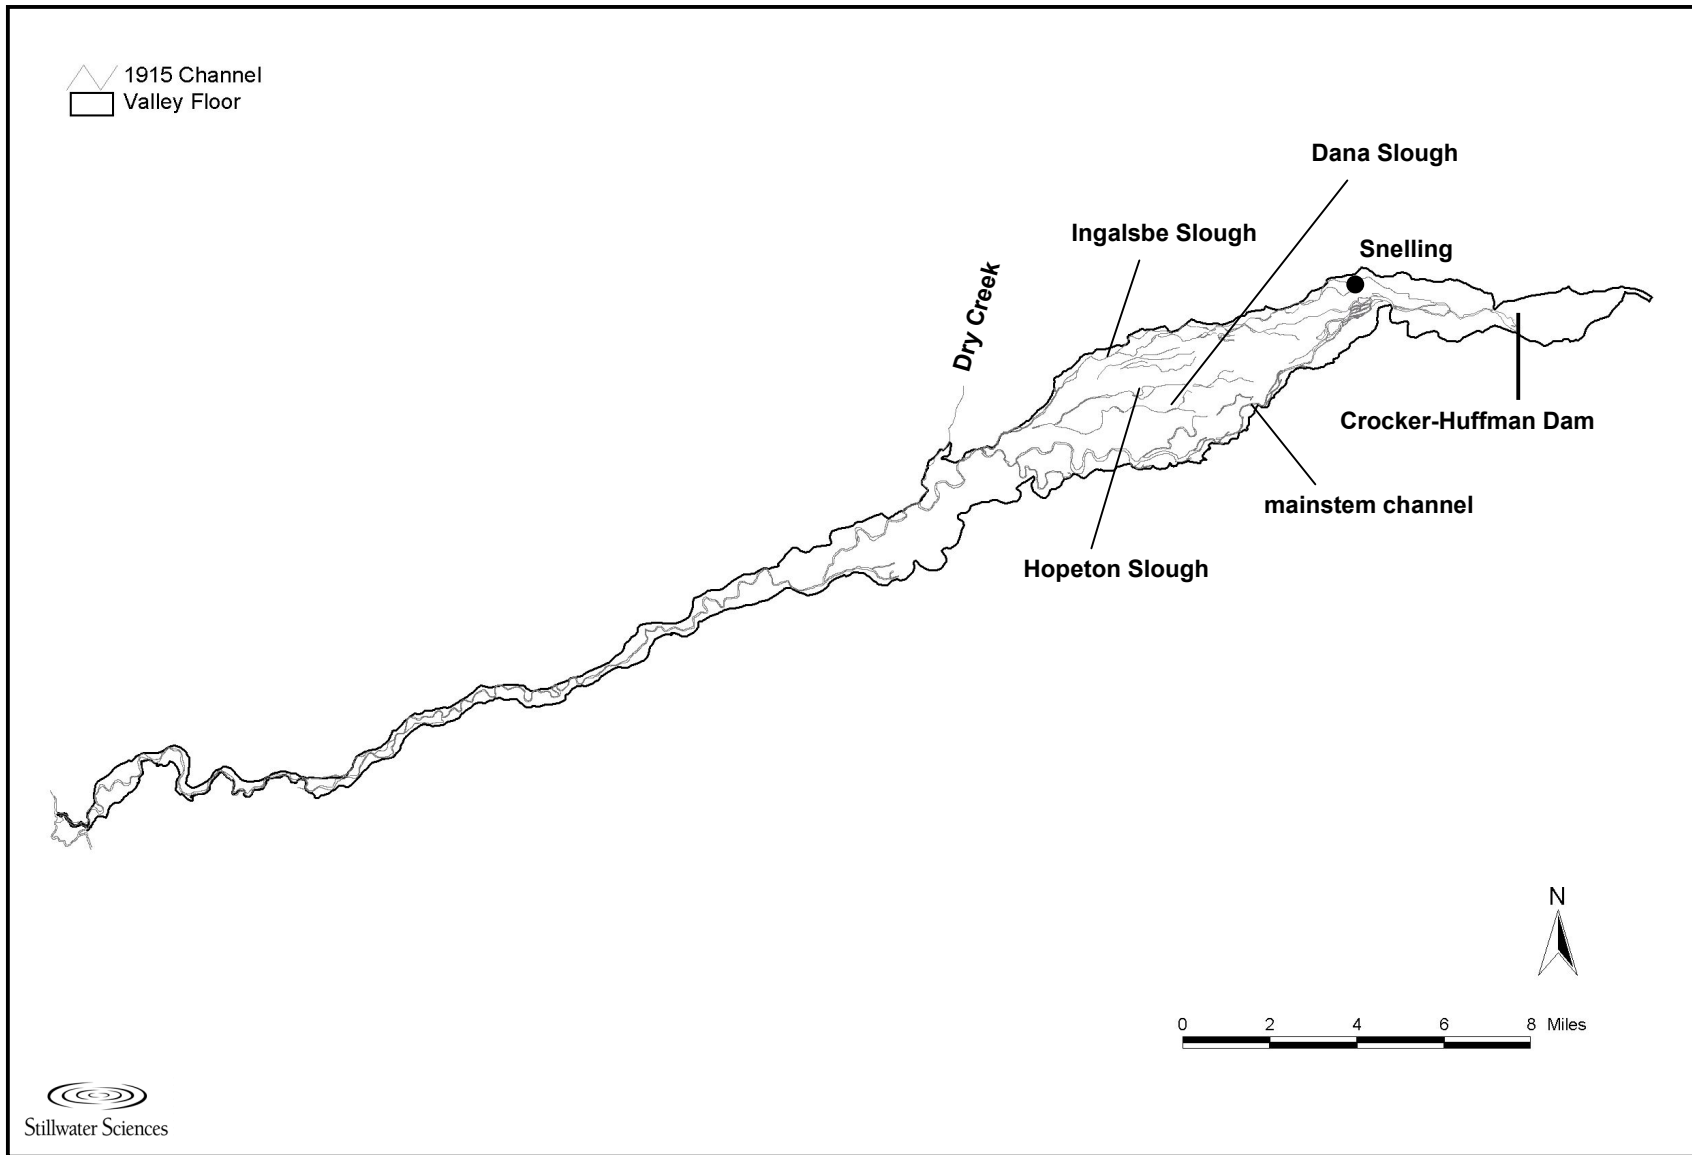
**Figure 3.1-2. Merced River alluvial valley floor boundary and 1915 channel alignment.**

(The alluvial valley floor was identified and digitized using geologic maps and 1:24,000-scale topographic maps. The 1915 channel alignment was digitized from historical 1:31,680-scale topographic maps.)

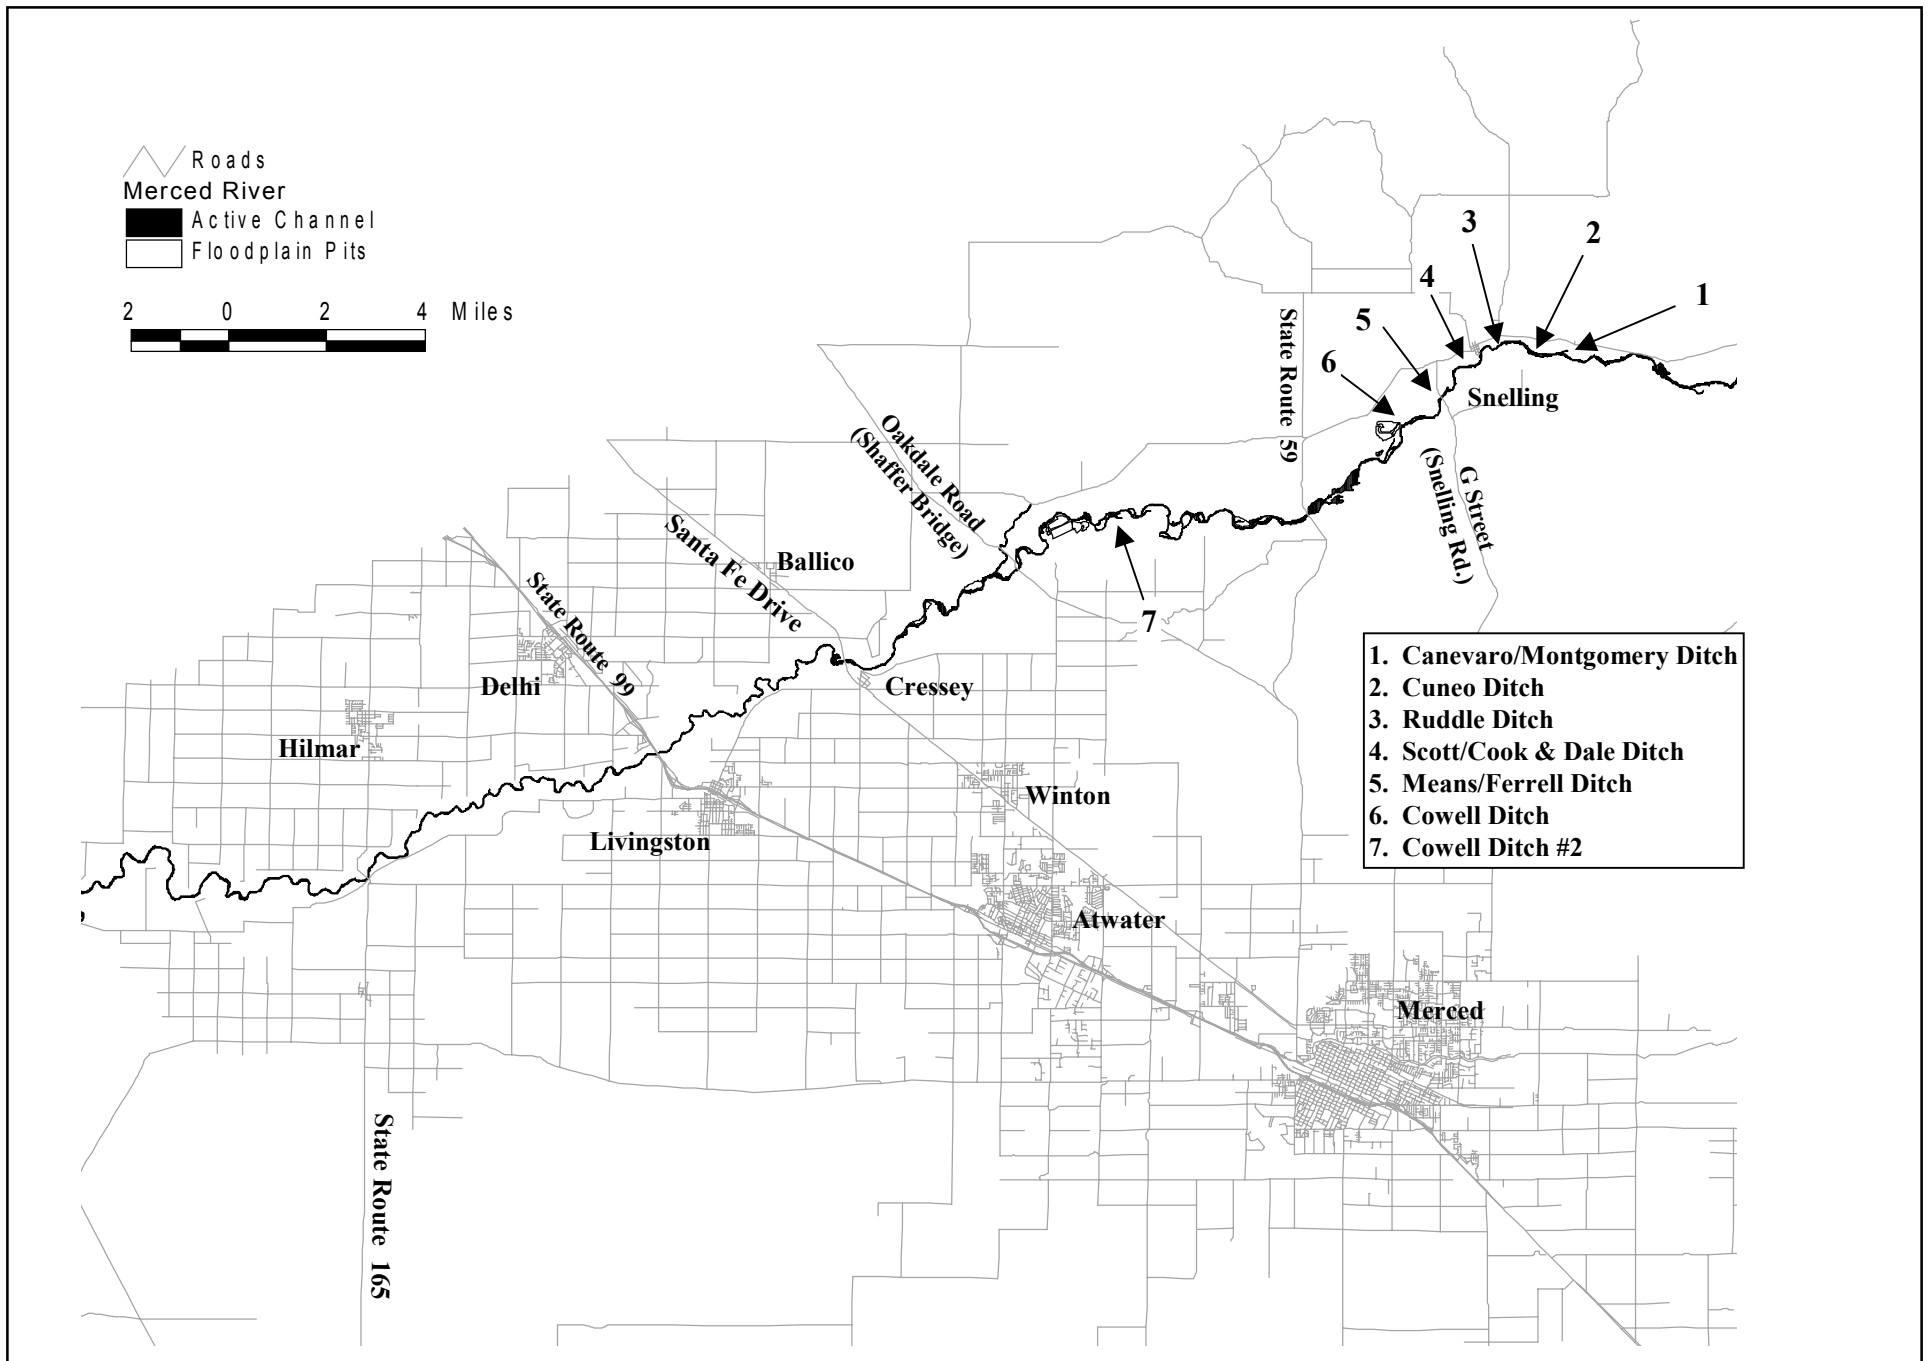
**Figure 3.1-3. Merced River riparian water diversions.**

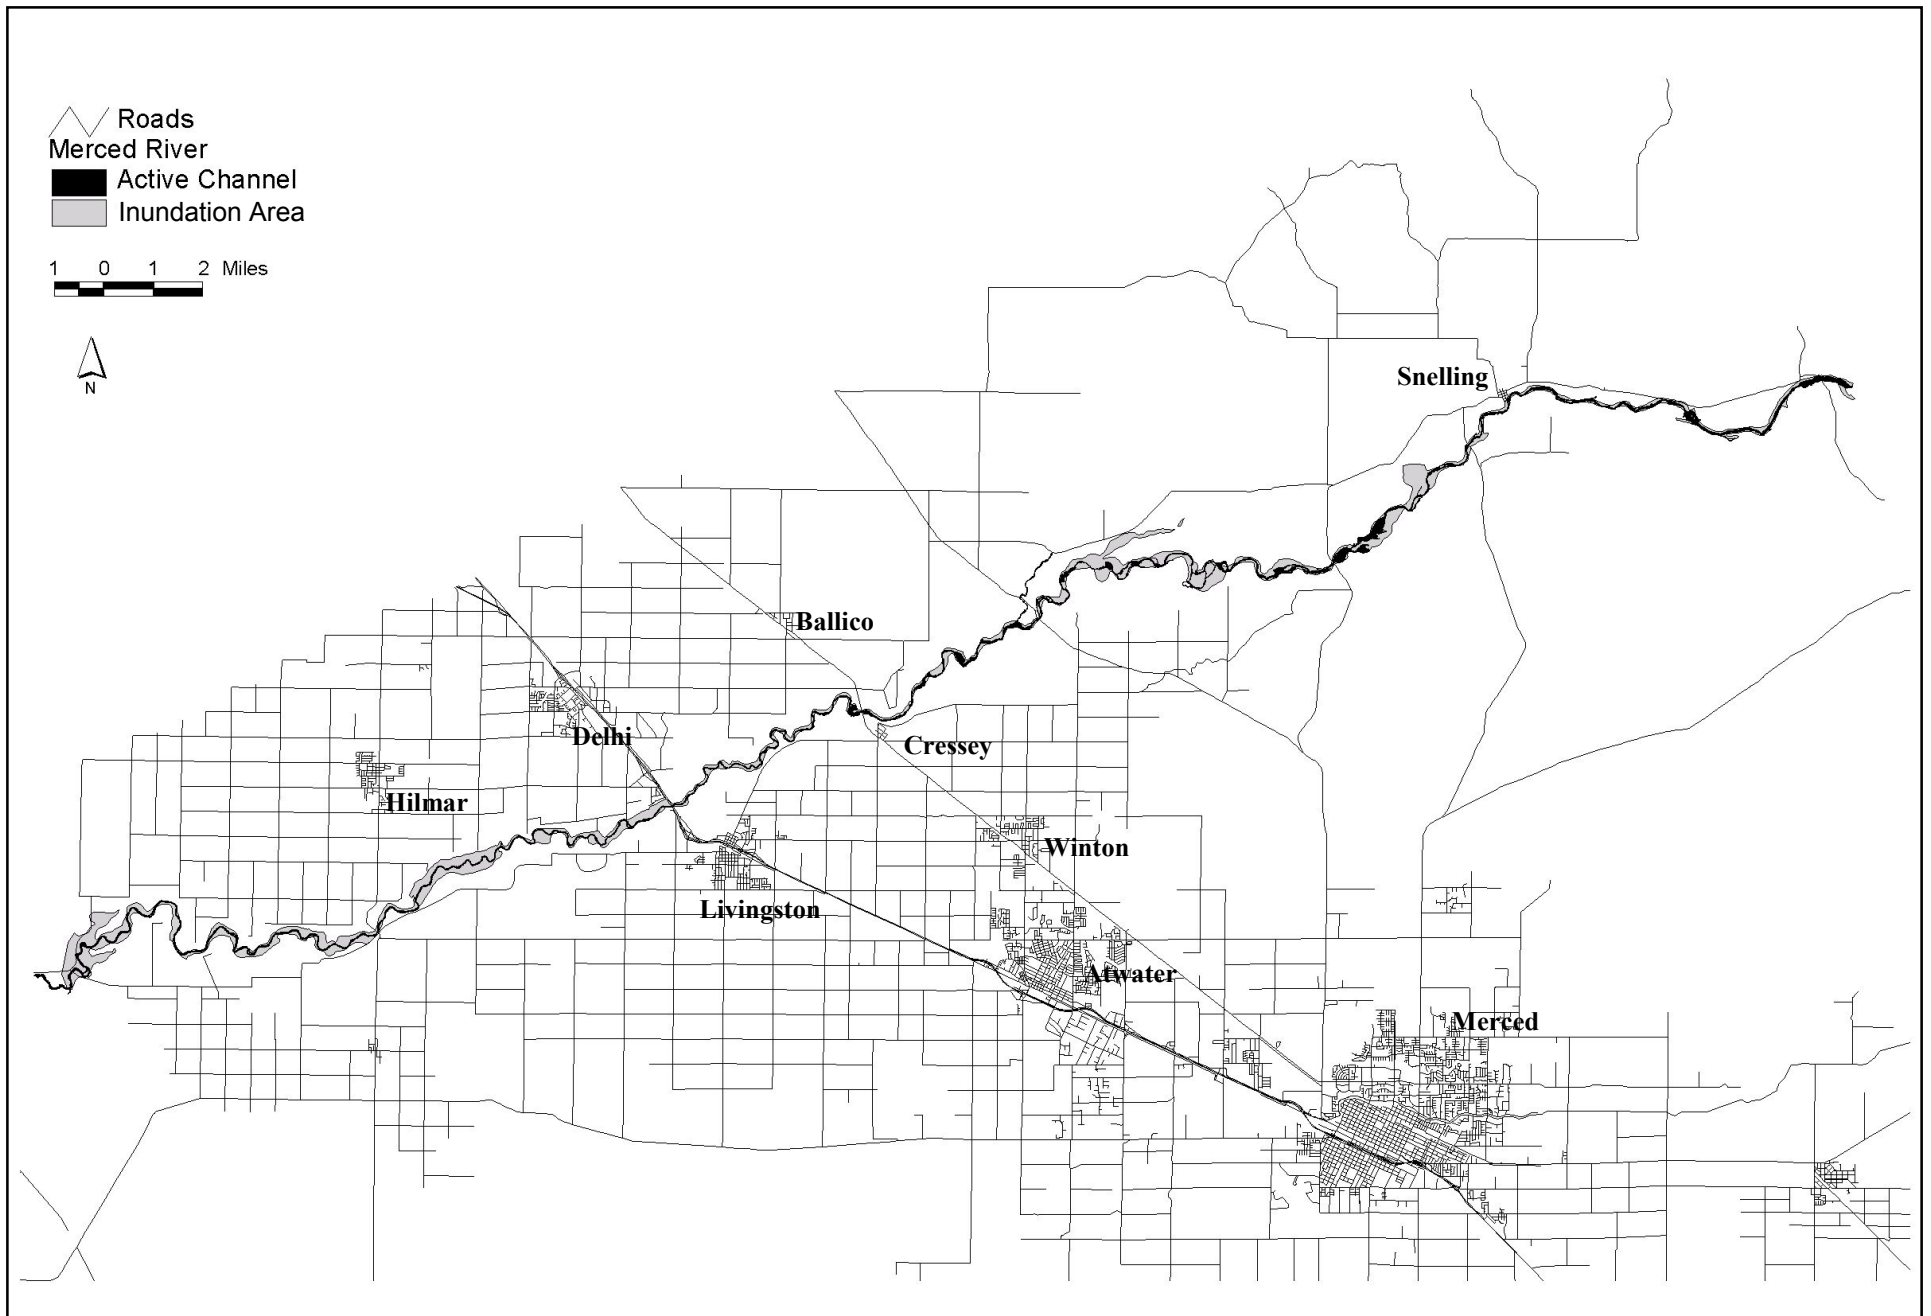
**Figure 3.2-1. Area inundated by January 1997 flood.**

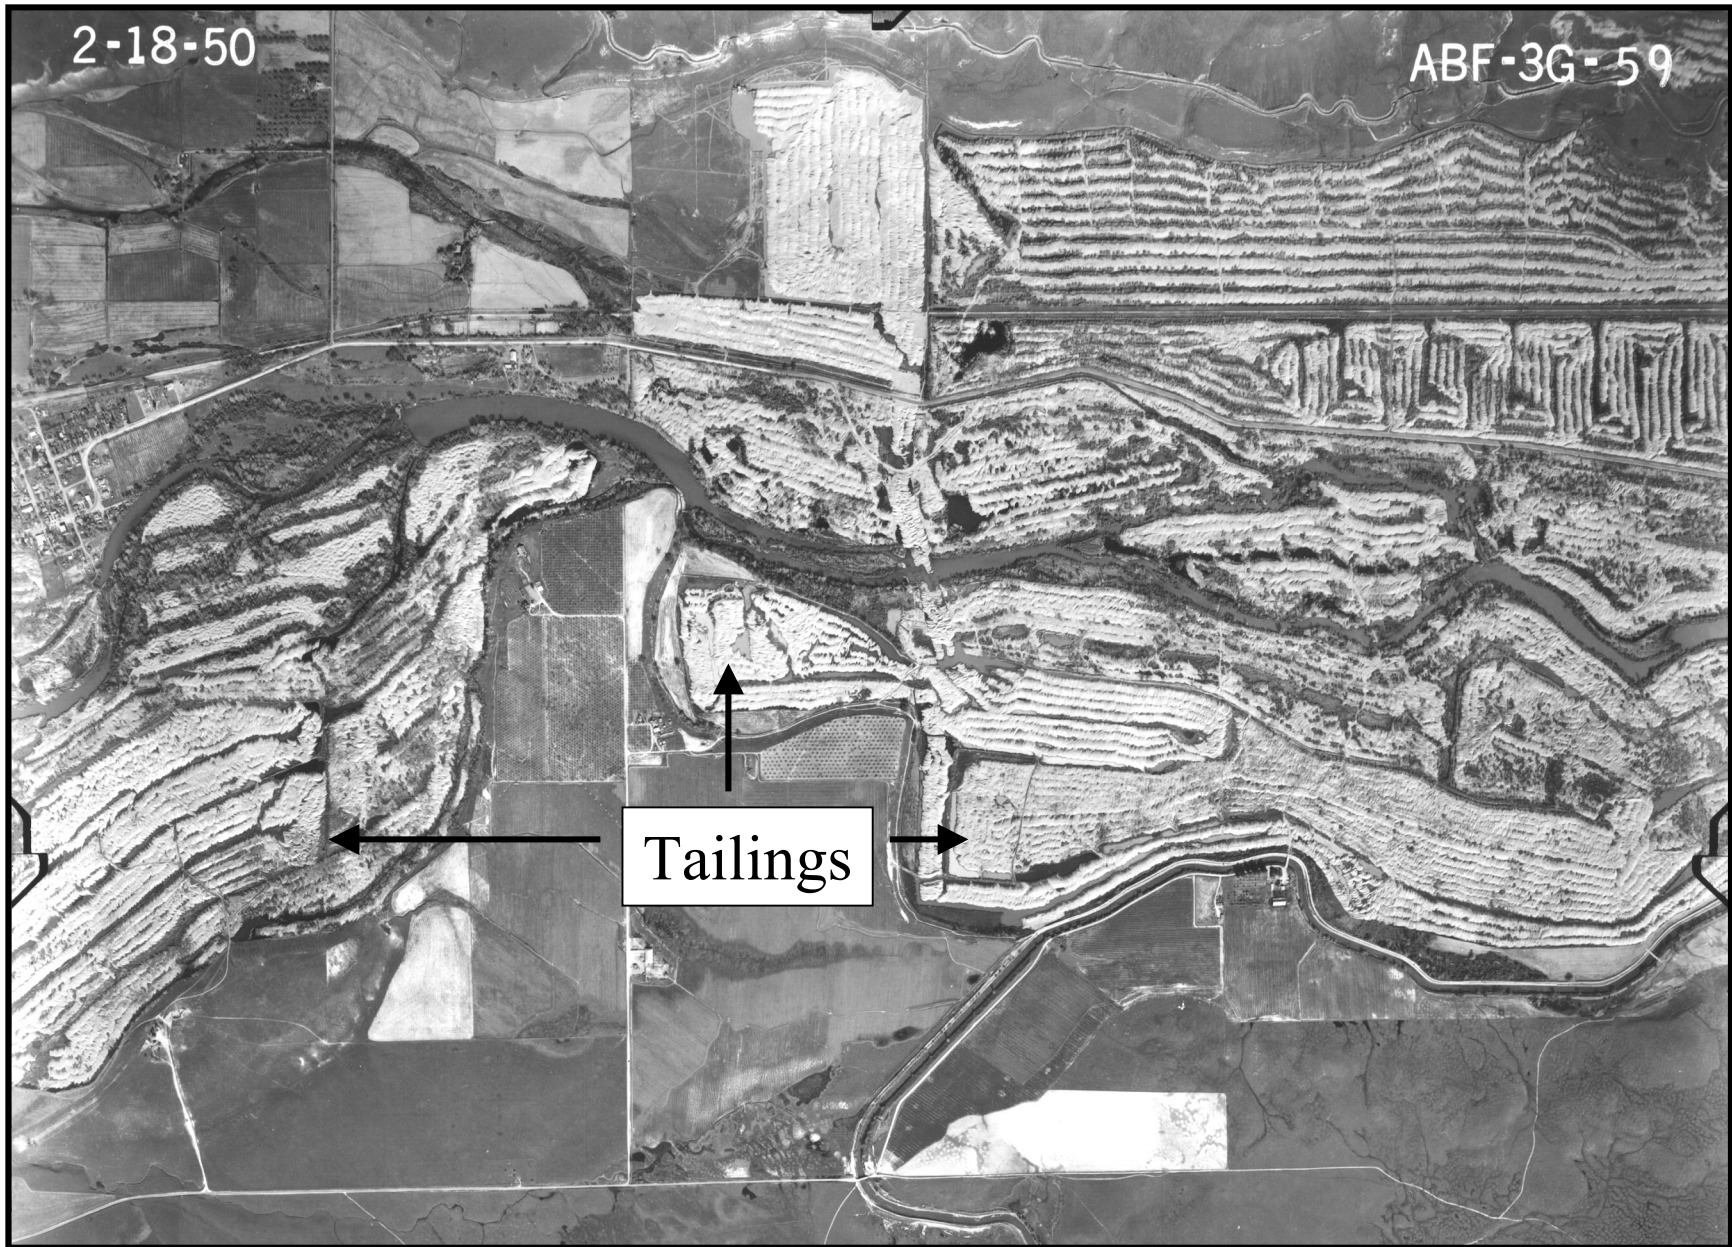
**Figure 3.2-2. Dredger tailings in the Snelling vicinity.**

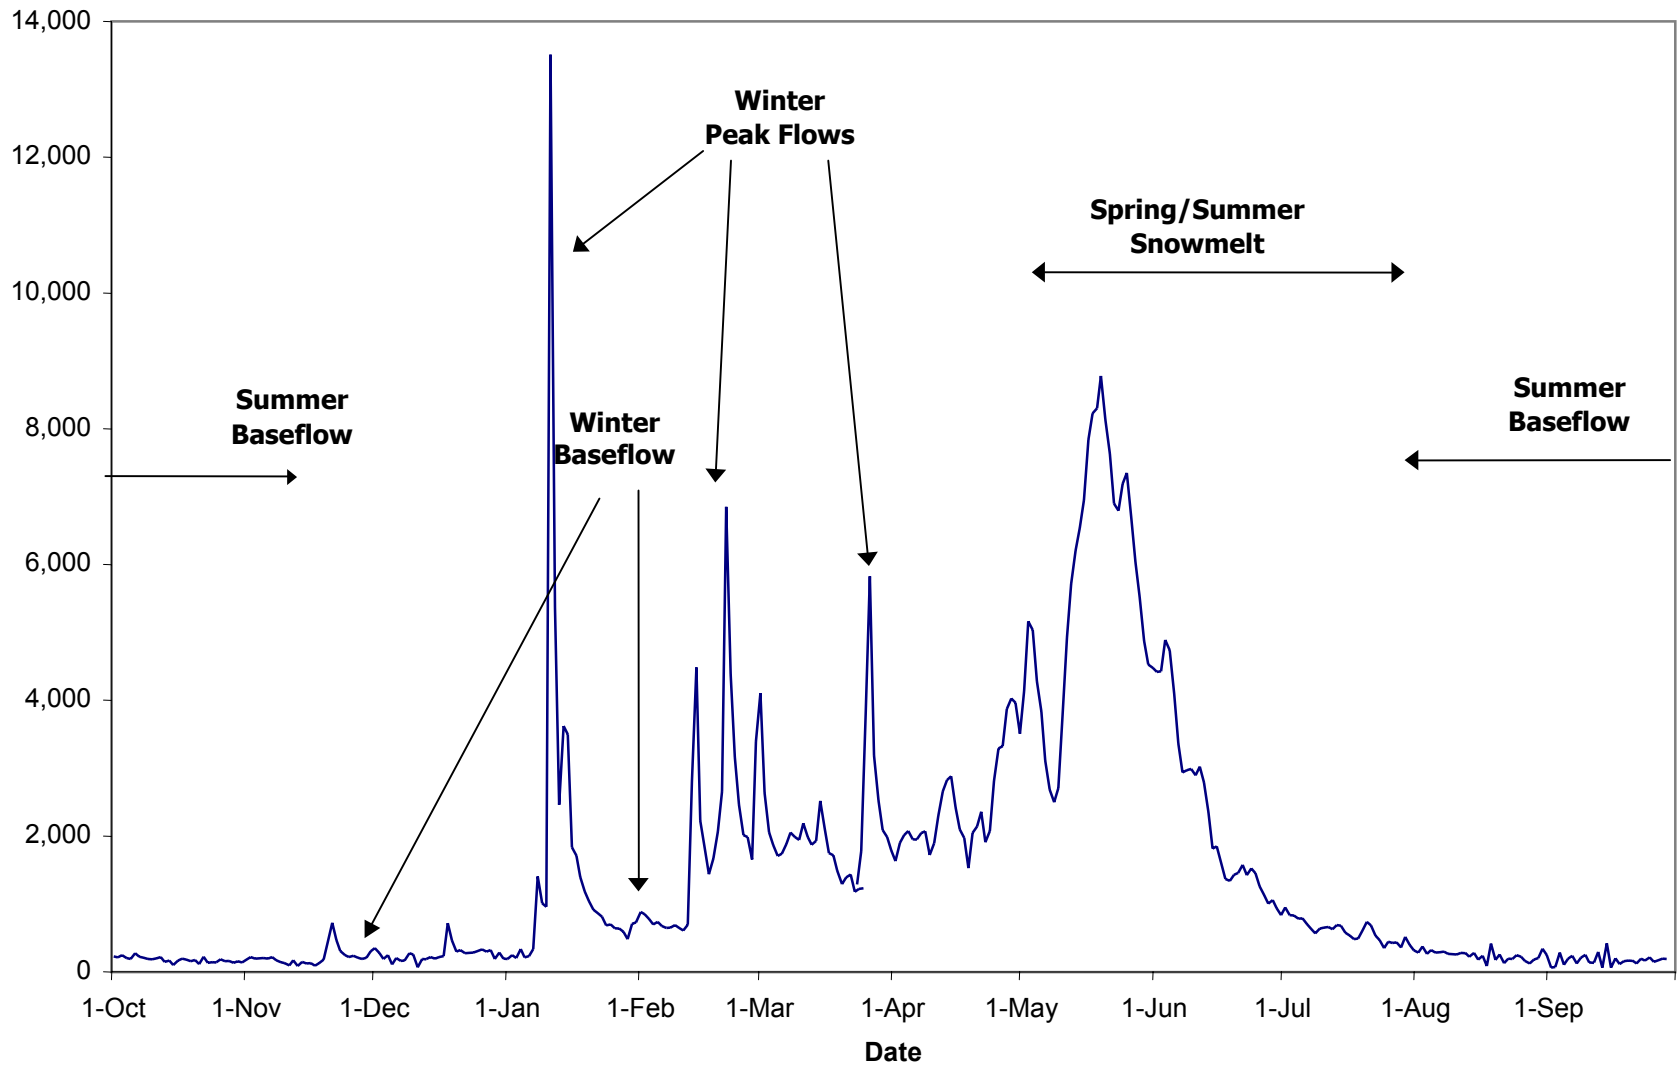
**Figure 4.1-1. Hydrograph components for unregulated flow conditions in the Merced River.**  
 (Hydrograph shown is estimated inflow to Lake McClure for water year 1979, representative of a median water year.)  
 (source: Merced Irrigation District)

The Merced River's natural hydrograph can be broken into four components: summer baseflows, fall and winter peak flows, winter baseflows, and spring and summer snowmelt (Figure 4.1-1). Summer baseflows begin at the end of the snowmelt recession and end with the first storm in late fall. Under pre-dam conditions, summer baseflows typically began between late June and August and ranged from 100 to 300 cfs, with monthly flows averaging 304 cfs, 123 cfs, and 224 cfs for August, September, and October respectively (based on flow at the Merced River near Exchequer gauge for the period 1902–1913, 1915–1920). Through the fall and winter, rainstorms and rain-on-snow events generated brief, sharp peaks in flow. Large-magnitude, short-duration floods caused by rain-on-snow events typically occurred in late December through February; moderate-magnitude events extended through March. Winter baseflows, which occur over the same time period as fall and winter peak flows, are the stable flows that occur between fall and winter storm events. These baseflows are fed by shallow groundwater return and generally increase in magnitude throughout the winter as soils become saturated. Prior to flow regulation, winter baseflows in the Merced River generally ranged from approximately 200 to 1,700 cfs (measured at Merced River near Exchequer gauge) depending on water-year-type. During dry and critically dry years, winter baseflows were about the same magnitude as summer baseflows. The spring and summer snowmelt period was the wettest period of the natural annual hydrograph. During this period, snowmelt from the upper watershed produced high flows that spanned several weeks or months and receded slowly beginning in late spring or early summer. Prior to flow regulation, spring and summer snowmelt on the Merced River typically began in mid-March and ended between late June and August, when flows returned to summer baseflow levels. The peak of the snowmelt typically occurred between late March and June, and the recession limb generally lasted until mid-to-late July but extended later during wetter years. Under natural conditions, these spring snowmelt flows and the slow recession limb drove many processes that characterize a healthy alluvial river system. For instance, high spring flows inundated floodplains and delivered fine sediment to floodplains and riparian zones. In some years, the slow recession limb coincided with the timing of seed release of cottonwoods and other riparian trees and supported seed germination and seedling establishment. In addition, these spring high flows supported chinook salmon juvenile and outmigrant life stages.

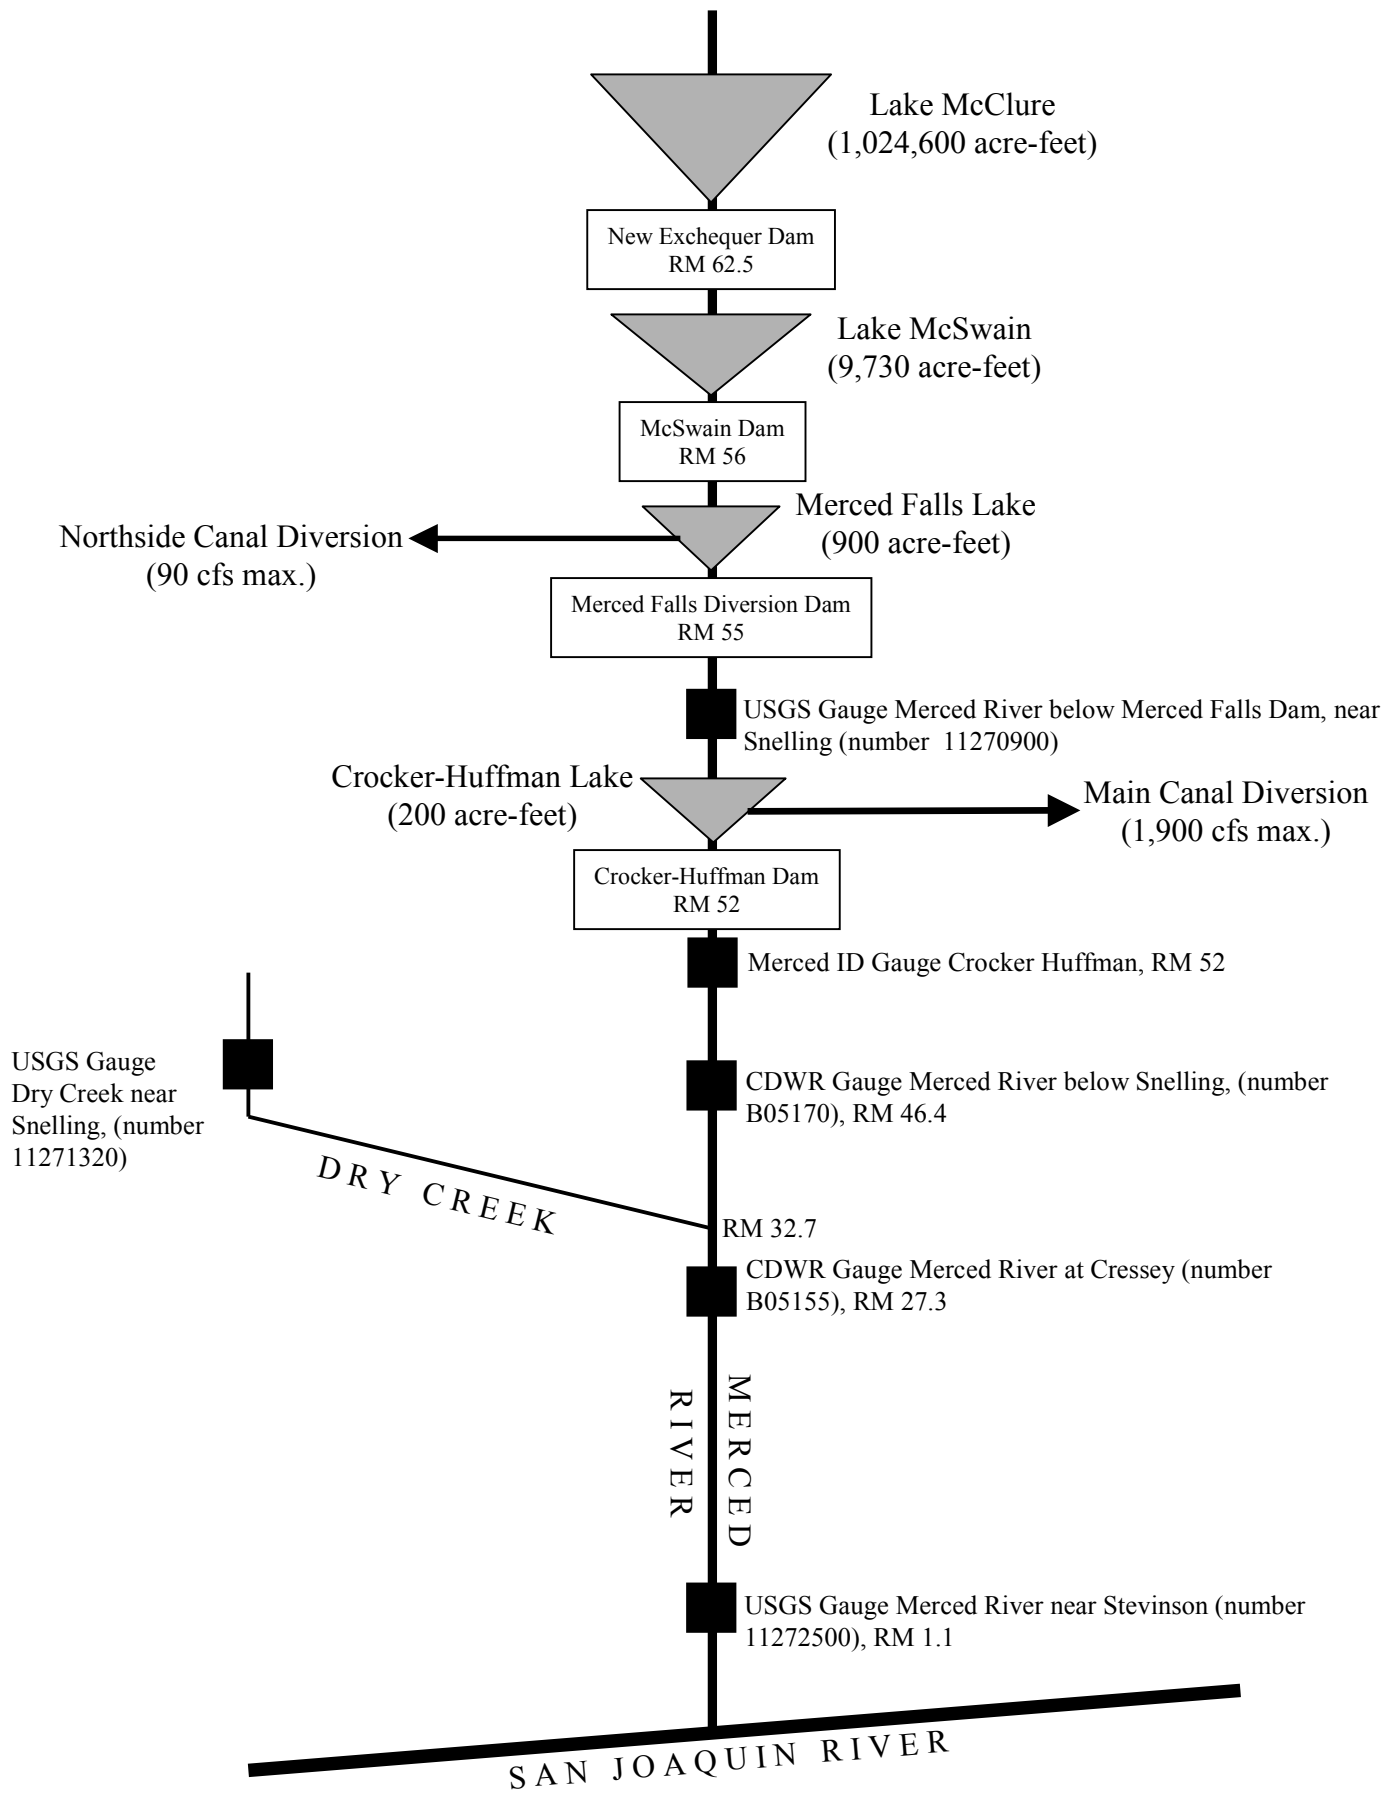
**Figure 4.2-1. Schematic diagram of Merced River dams, reservoirs, diversions and flow gauges.**
