## **Merced River Corridor Restoration Plan Baseline Studies**

# **Volume II: Geomorphic and Riparian Vegetation Investigations Report**

**VOLUME II  
GEOMORPHIC AND RIPARIAN VEGETATION  
INVESTIGATIONS REPORT**

Stillwater Sciences  
2532 Durant Avenue  
Berkeley, CA 94704

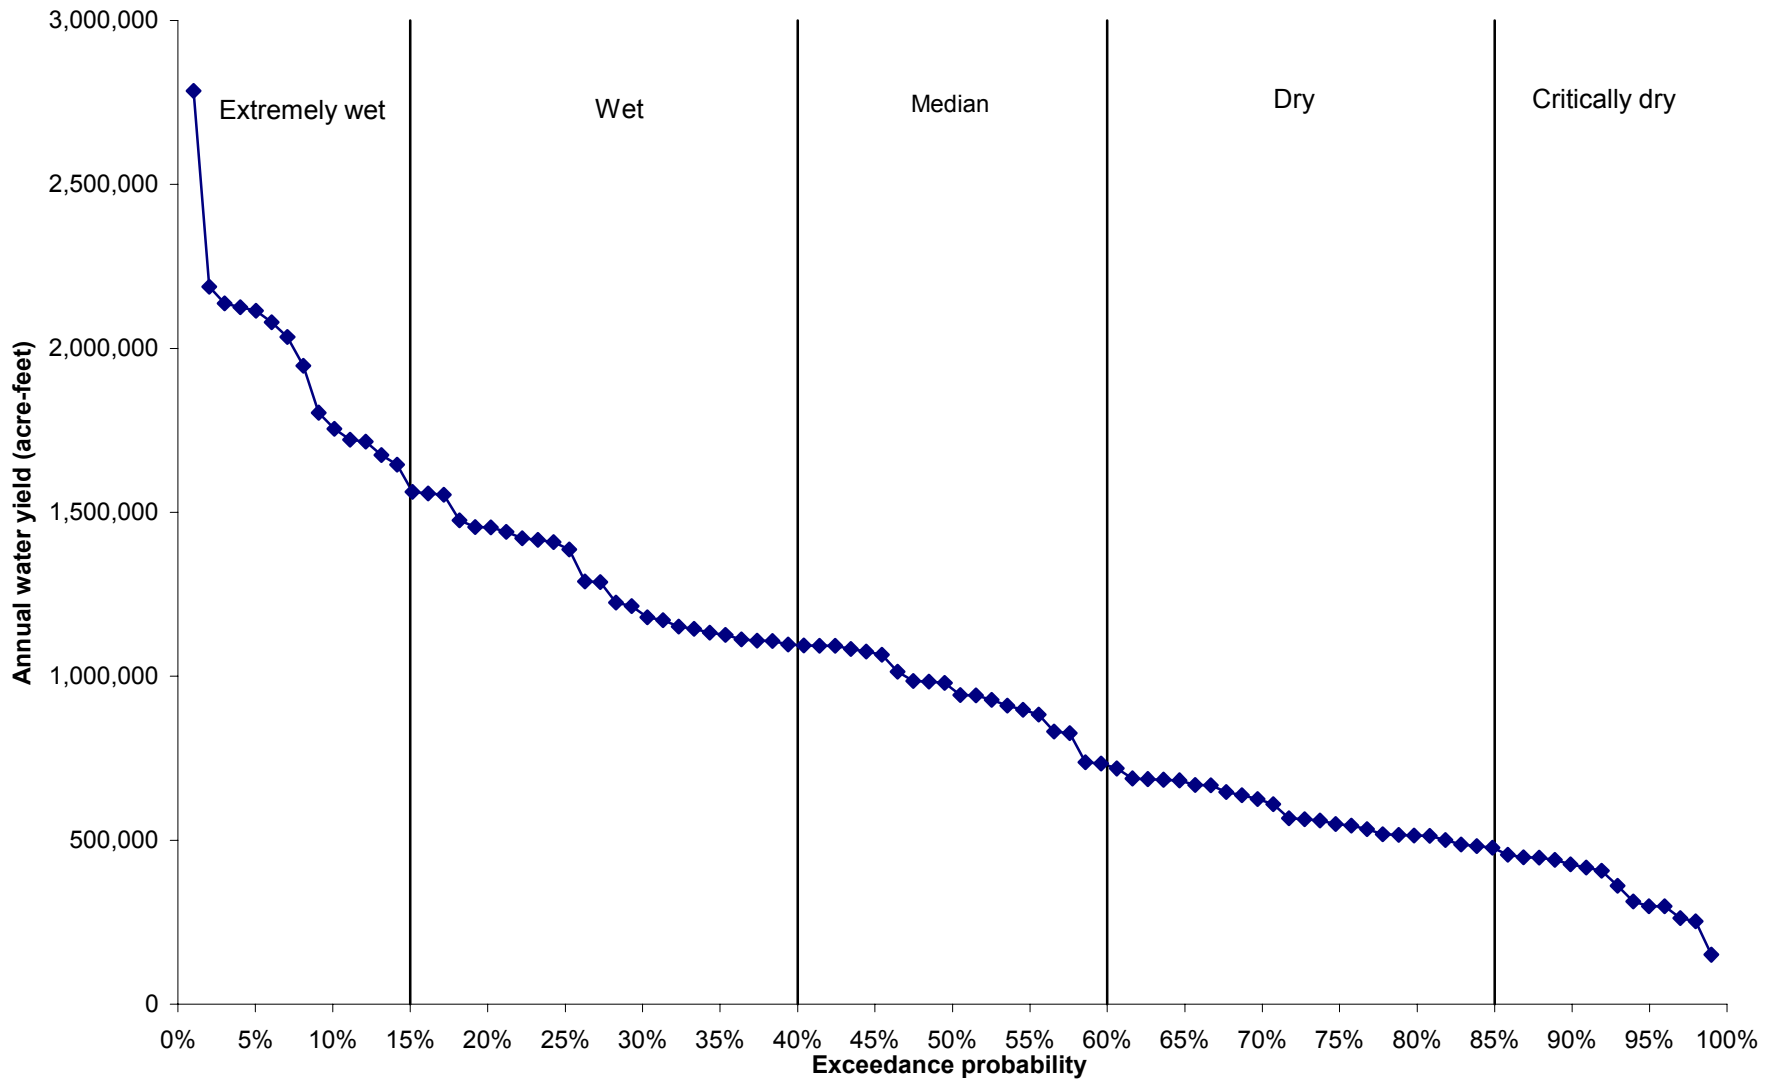
**Figure 4.2-3. Cumulative plot of ranked annual water yields from the Merced River (1902–1998).**

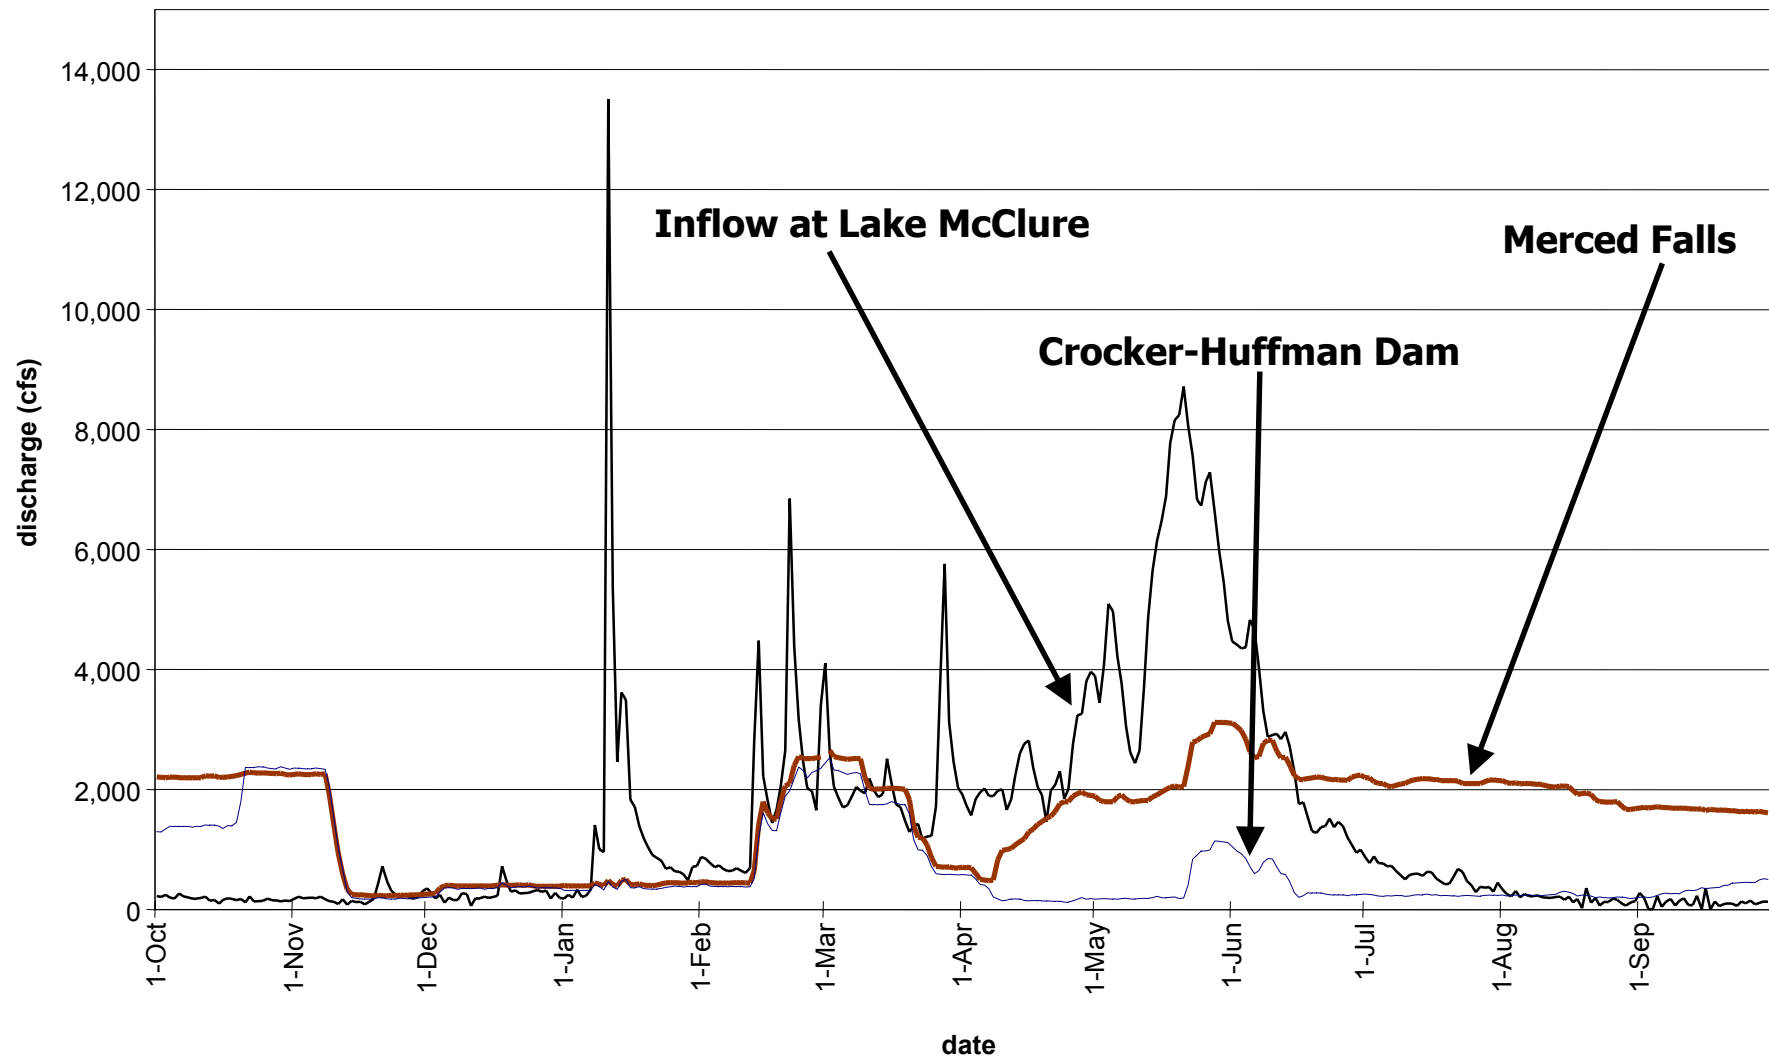
**Figure 4.2-4C. Annual hydrographs of inflow to Lake McClure and flow at Merced Falls and Crocker-Huffman Dam for a median year (water year 1979).**

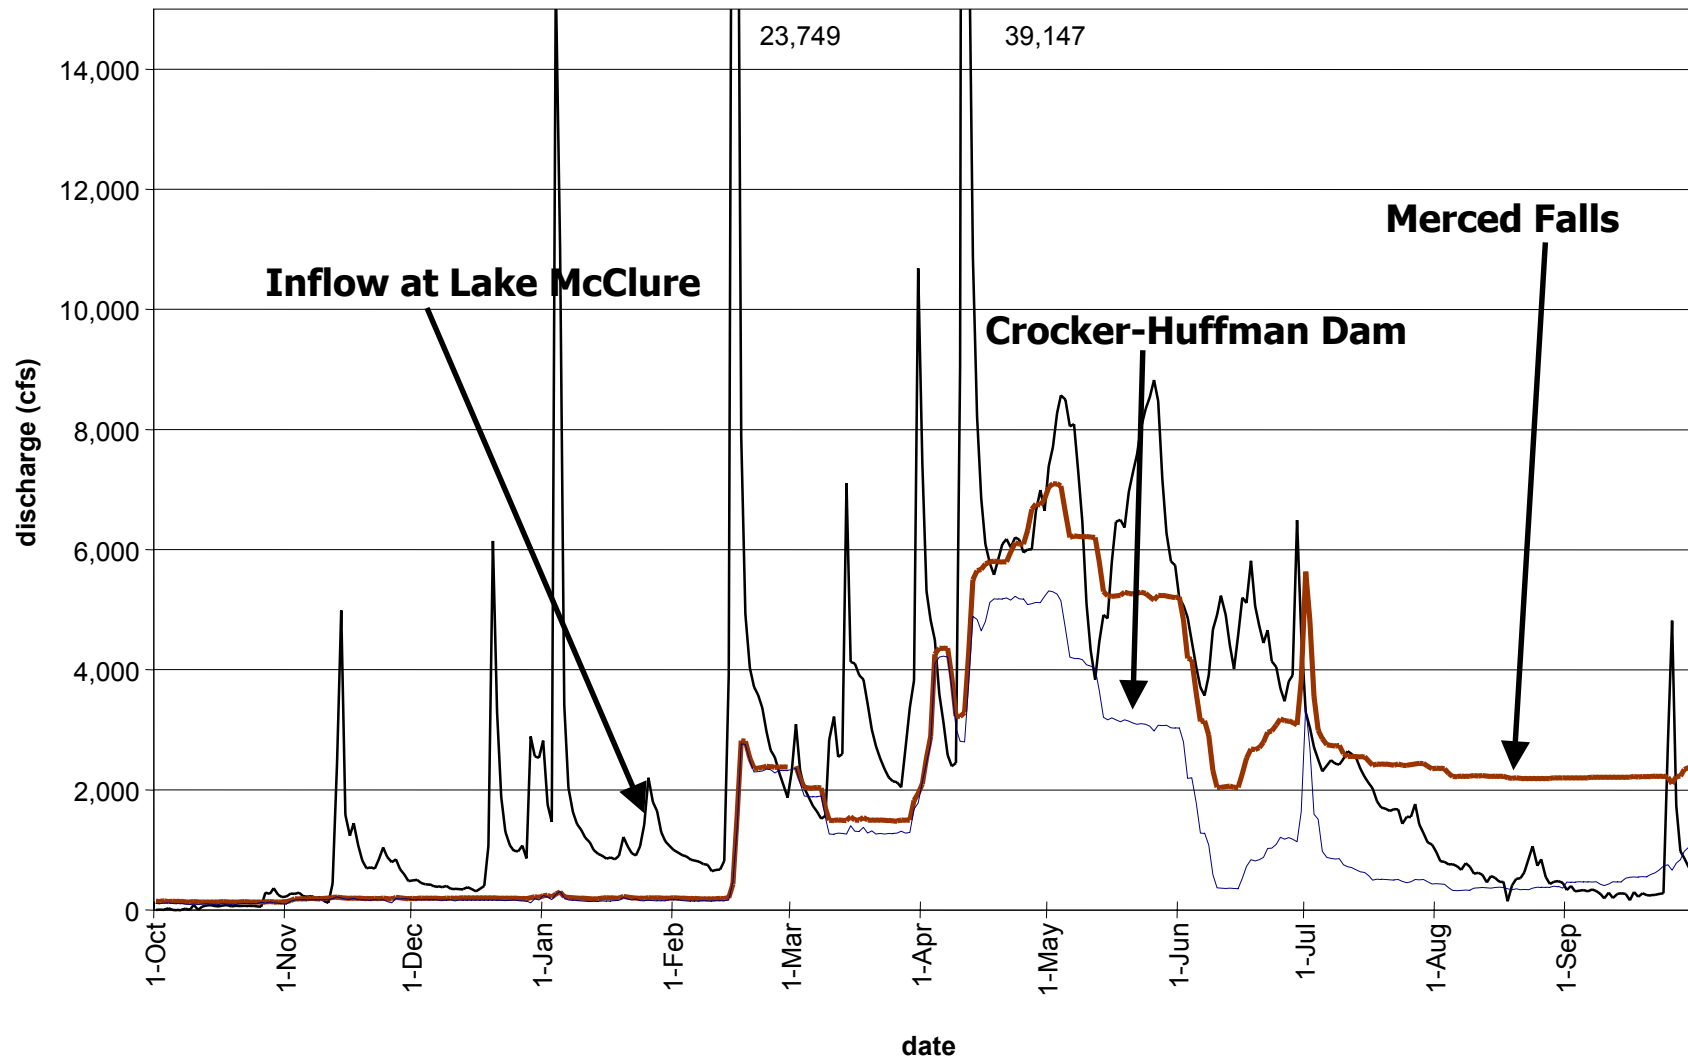
**Figure 4.2-4E. Annual hydrographs of inflow to Lake McClure and flow at Merced Falls and Crocker-Huffman Dam for an extremely wet year (water year 1982).**

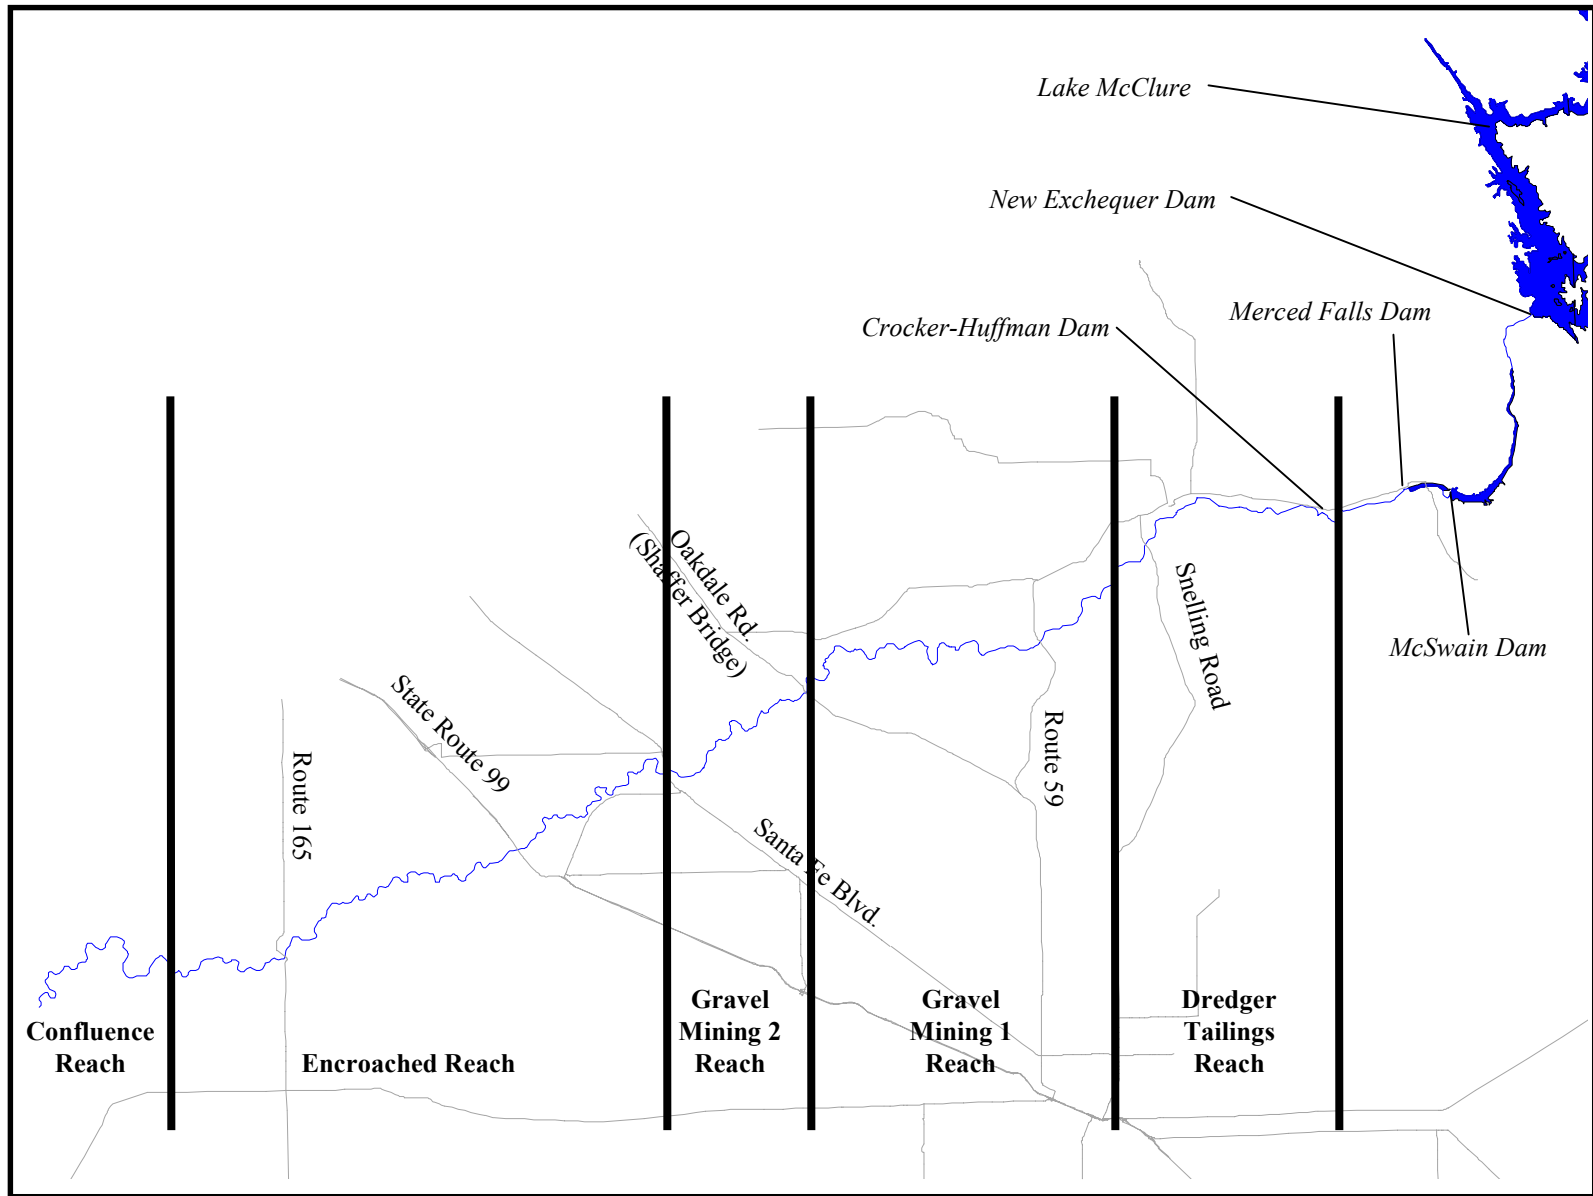
**Figure 5.1-1. Merced River reaches delineation.**

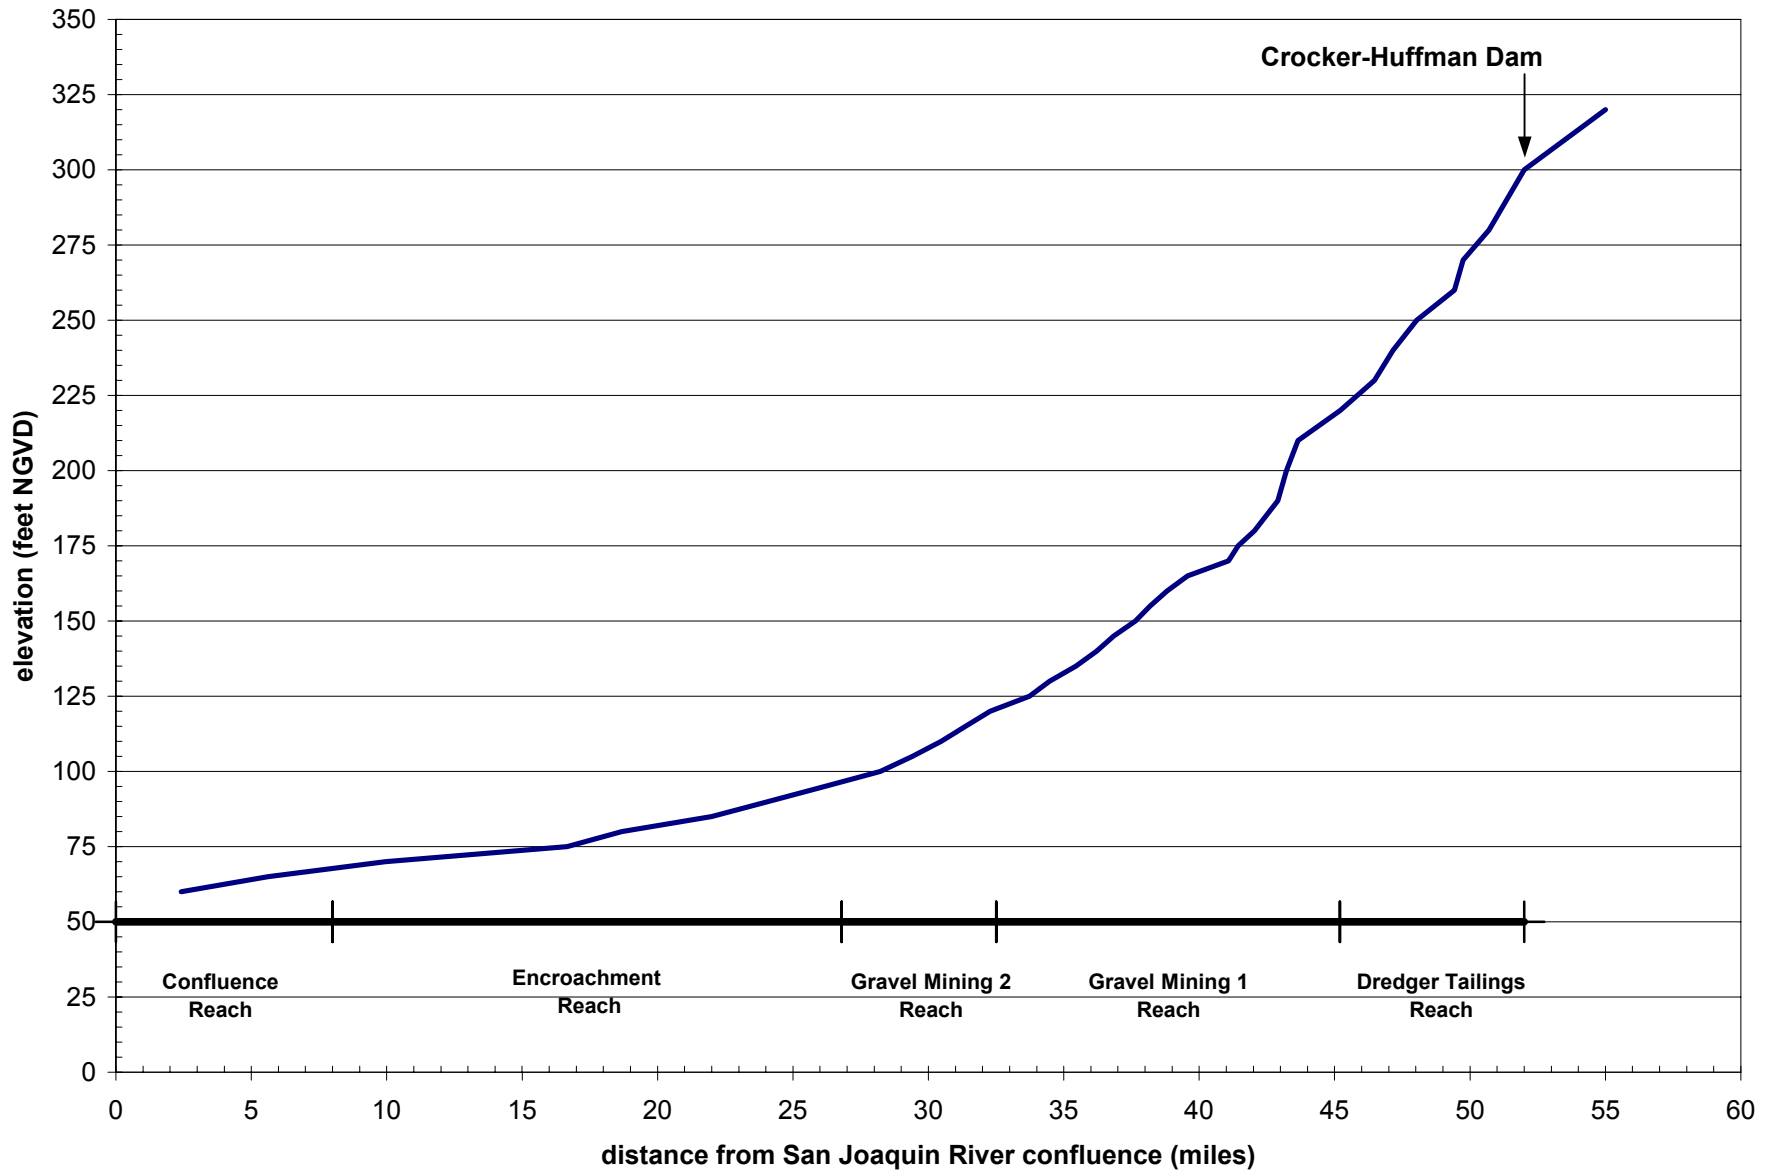
**Figure 5.1-2. Merced River longitudinal profile.**  
 (from U. S. Geological Survey 1:24,000-scale topographic maps)

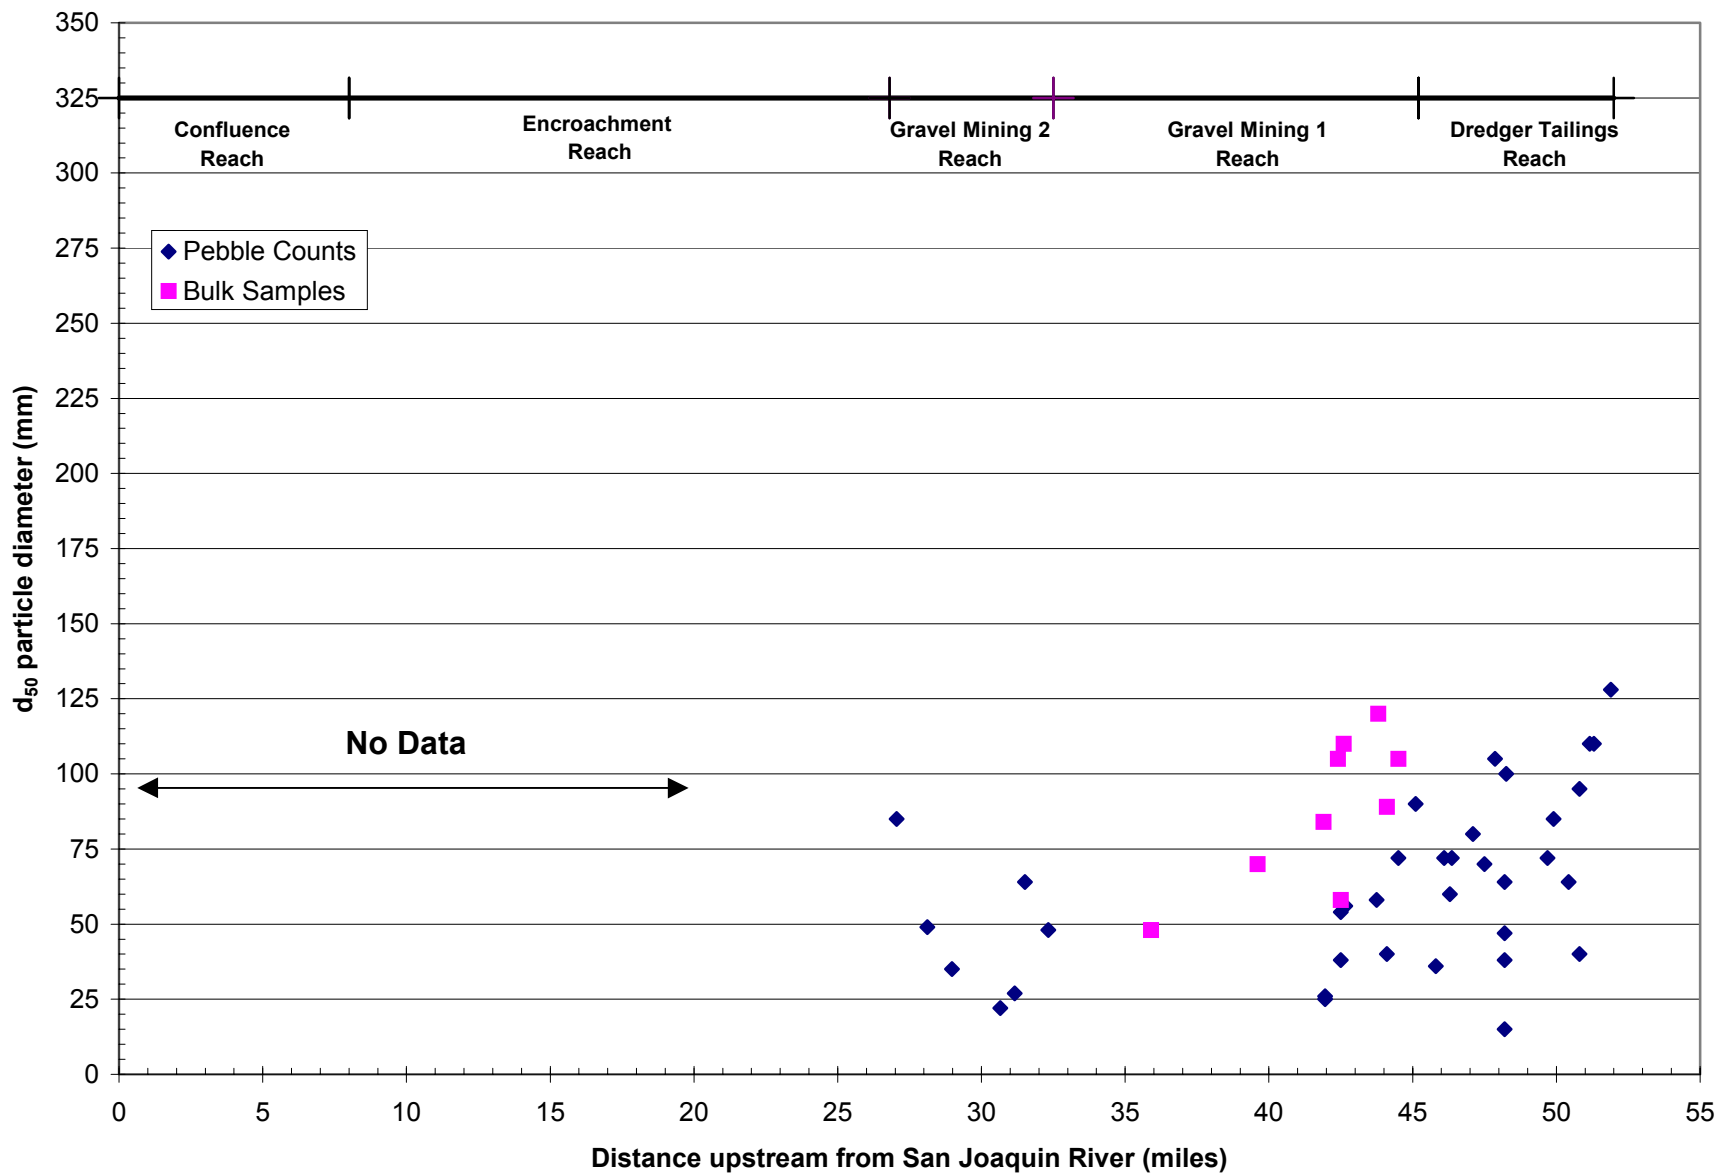
**Figure 5.1-3. Merced River surface particle size -  $D_{50}$ .**  
 (sources: CDWR 1994b, Vick 1995)

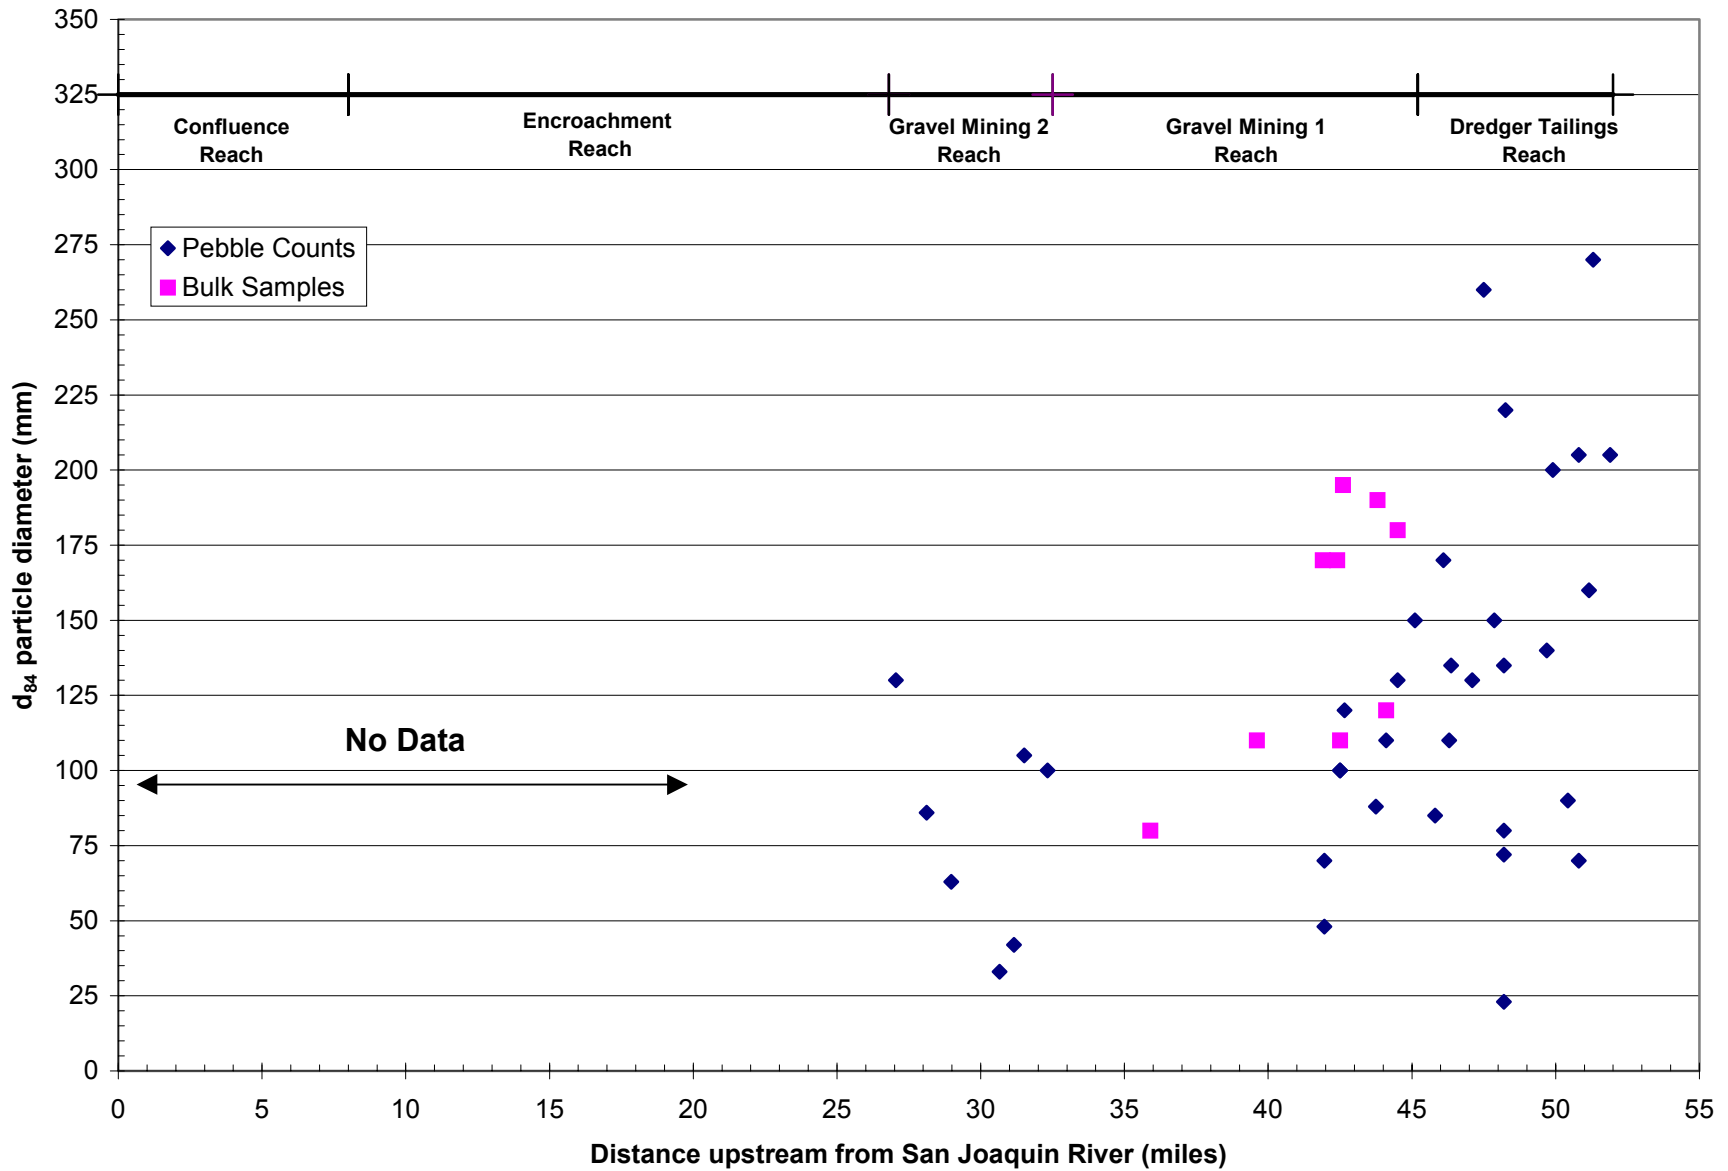
**Figure 5.1-4. Merced River surface particle size -  $D_{84}$ .**  
 (sources: CDWR 1994b, Vick 1995)

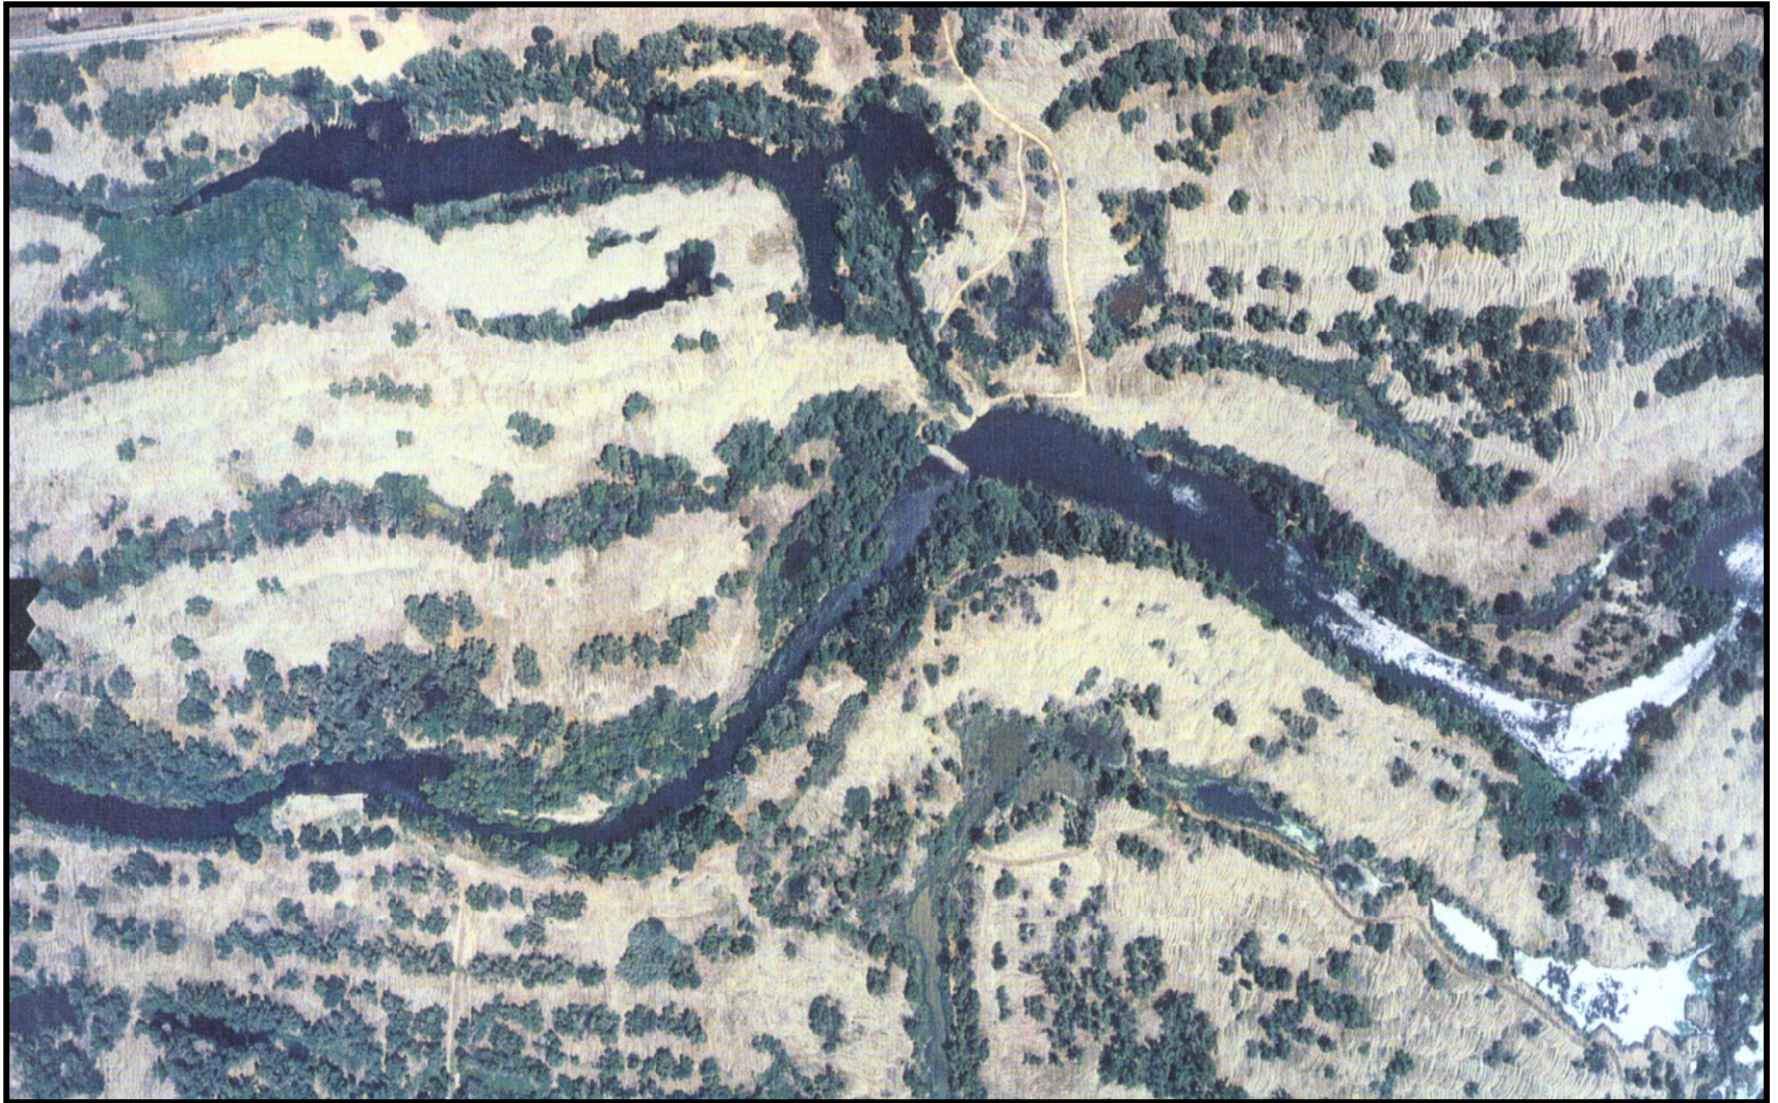
**Figure 5.1-5. Aerial photograph showing conditions in the Merced River Dredger Tailings Reach.**

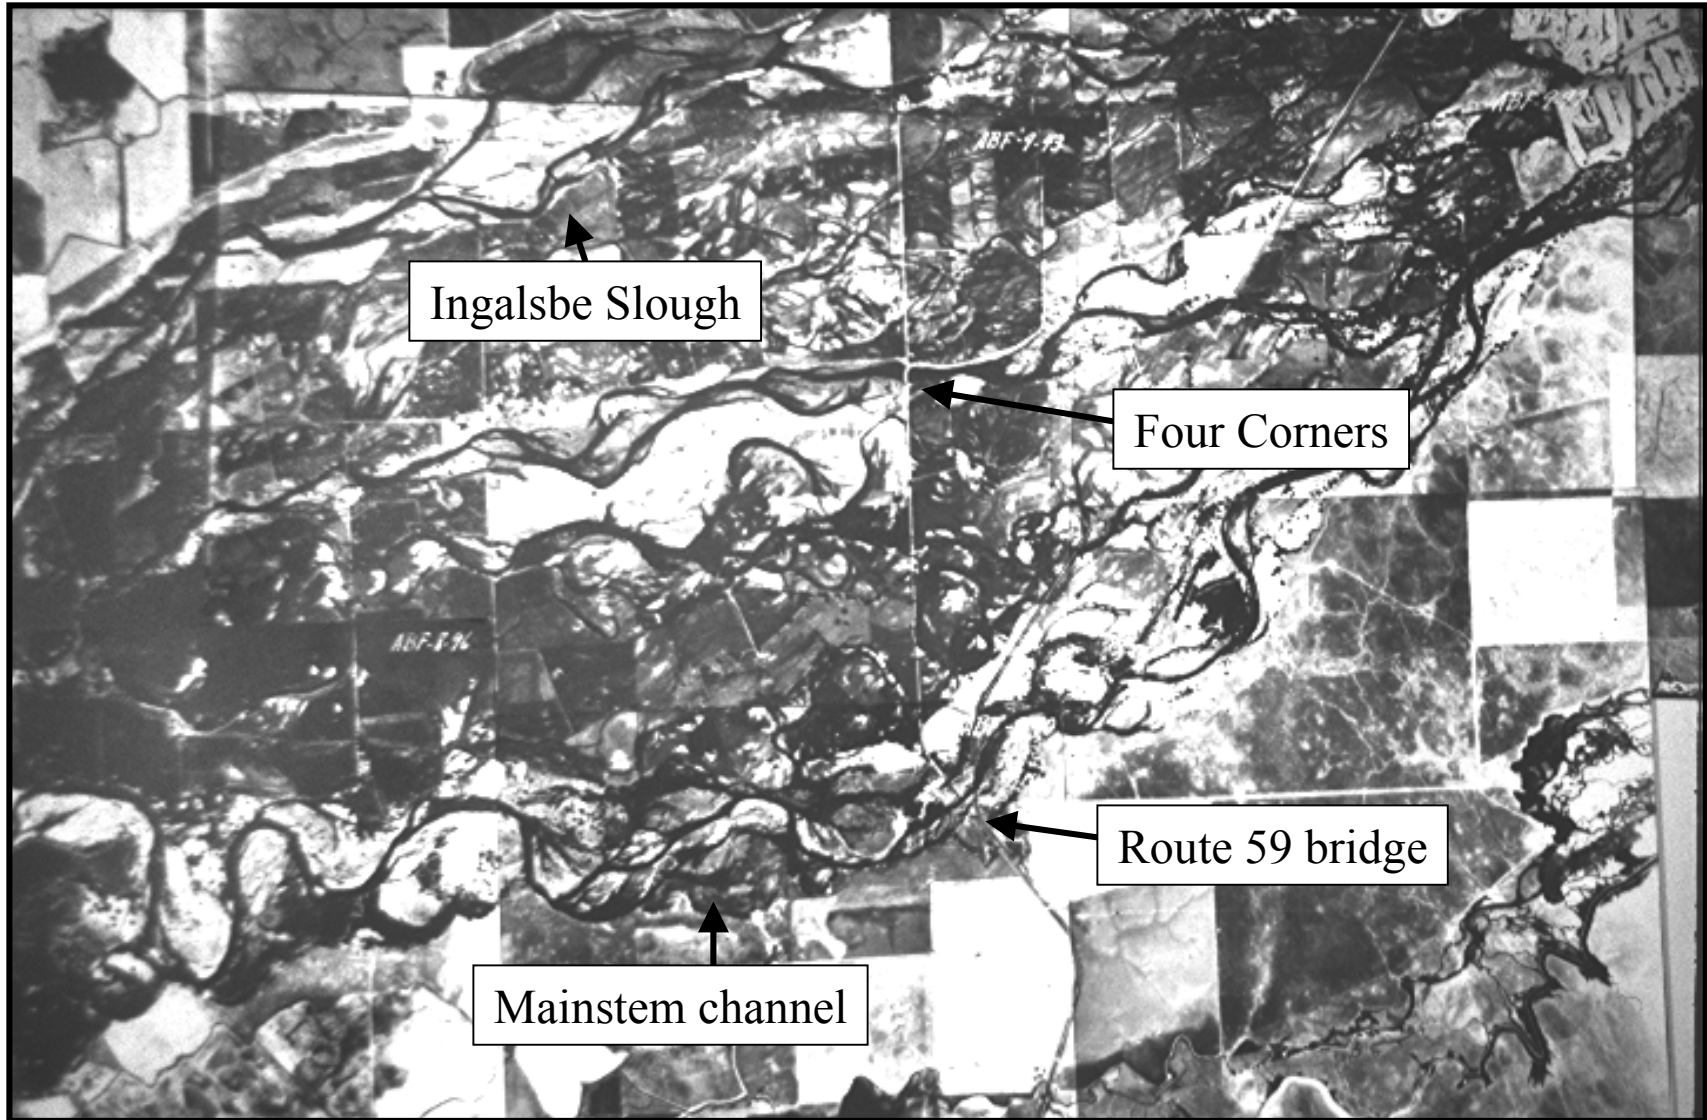
**Figure 5.1-6. Merced River multiple-channel system as shown in 1937 aerial photographs.**  
(photo: Agricultural Stabilization and Conservation Service 1937)

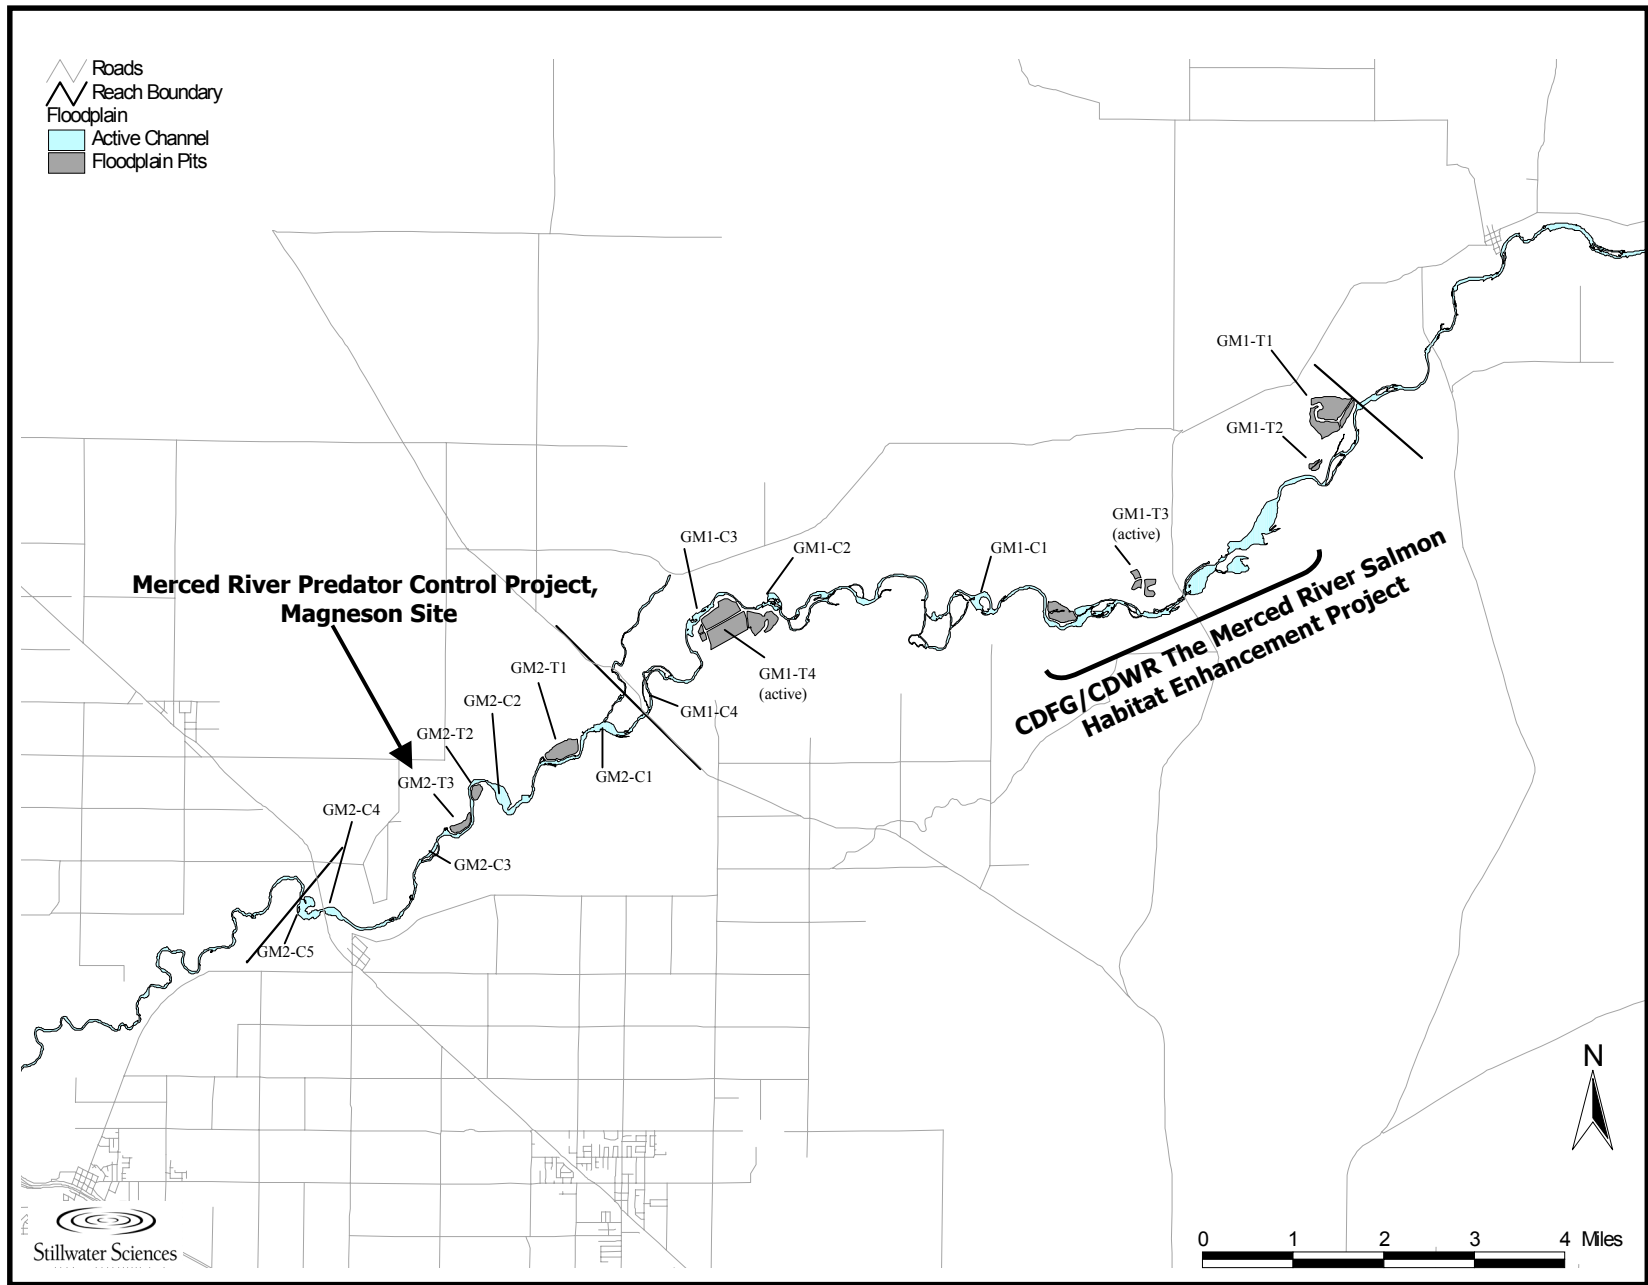
**Figure 5.1-8. Terrace and in-channel aggregate mines in the Gravel Mining 1 and Gravel Mining 2 reaches.**

In 1996, the CDFG, working with the CDWR and with funding from the Four Pumps Agreement, completed the Merced River Predator Control Project, Magneson Site Project (Figure 5.1–8). This project isolated a pit (referred to as GM2-T3 in Table 11) that had captured the river channel. The pond was left in place behind the repaired berm to retain recreational fishing opportunities important to the landowner. (Figure 5.1–9).

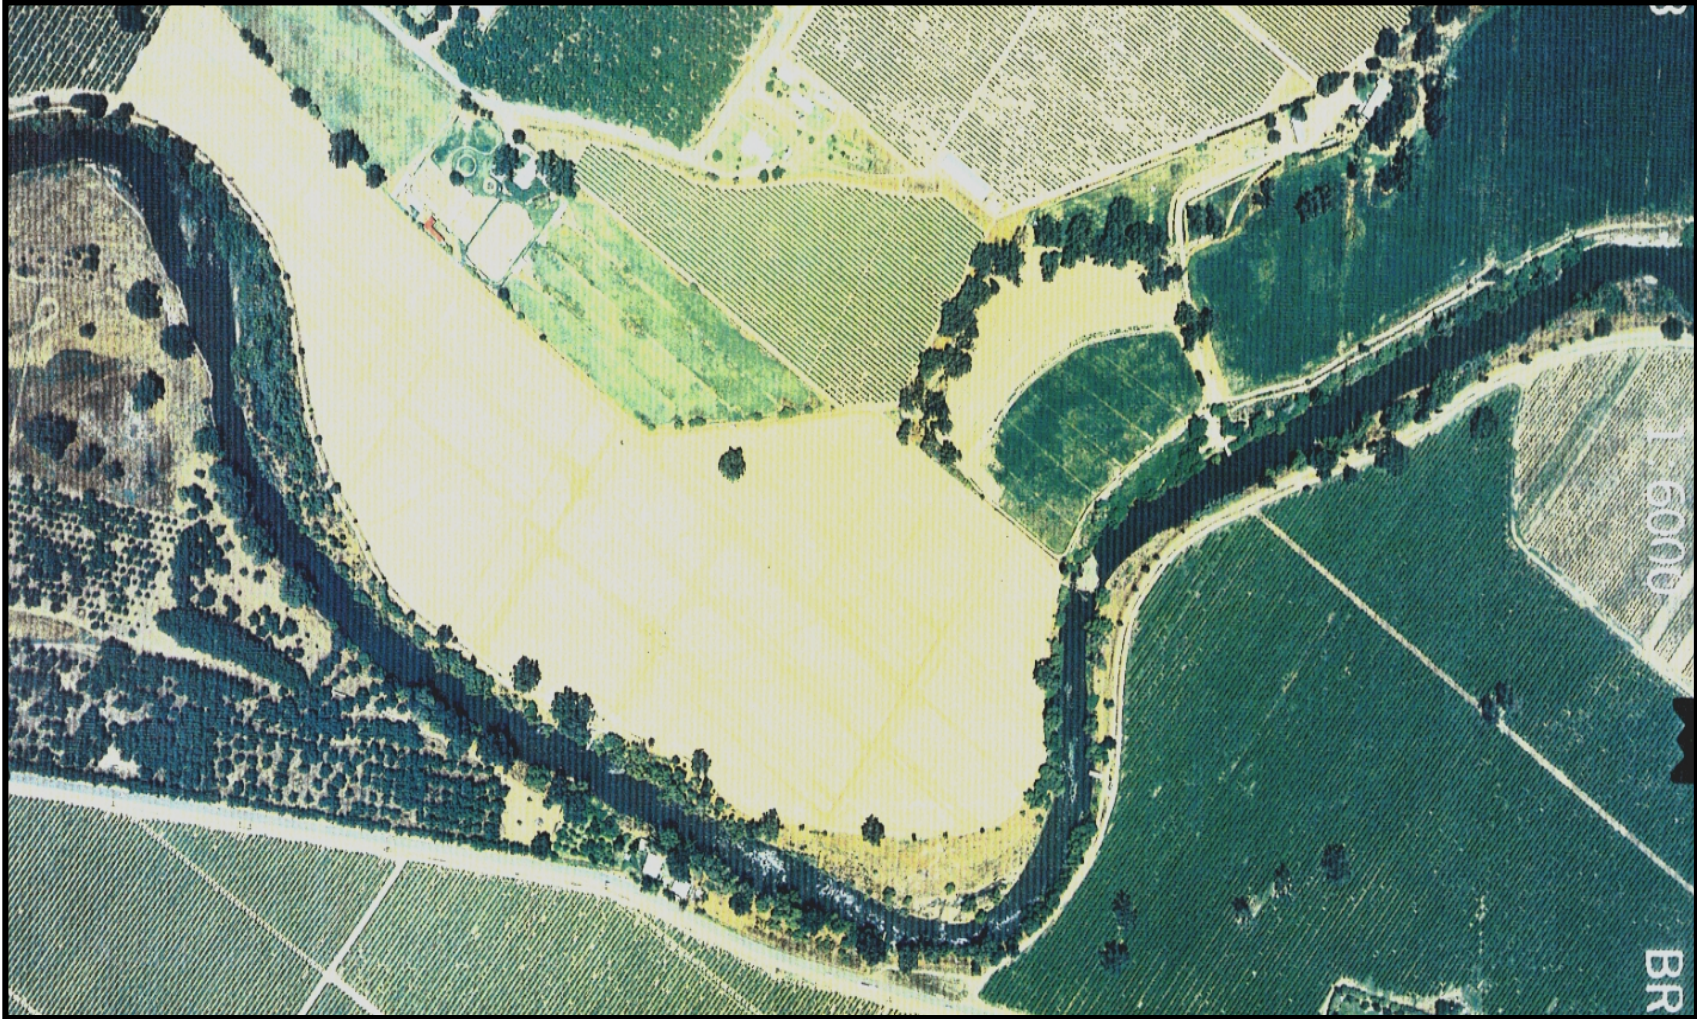
**Figure 5.1-10. Aerial photograph showing conditions in the Encroachment Reach.**  
(photo: U. S. Bureau of Reclamation 1993)
