## **Merced River Corridor Restoration Plan Baseline Studies**

# **Volume II: Geomorphic and Riparian Vegetation Investigations Report**

**VOLUME II  
GEOMORPHIC AND RIPARIAN VEGETATION  
INVESTIGATIONS REPORT**

Stillwater Sciences  
2532 Durant Avenue  
Berkeley, CA 94704

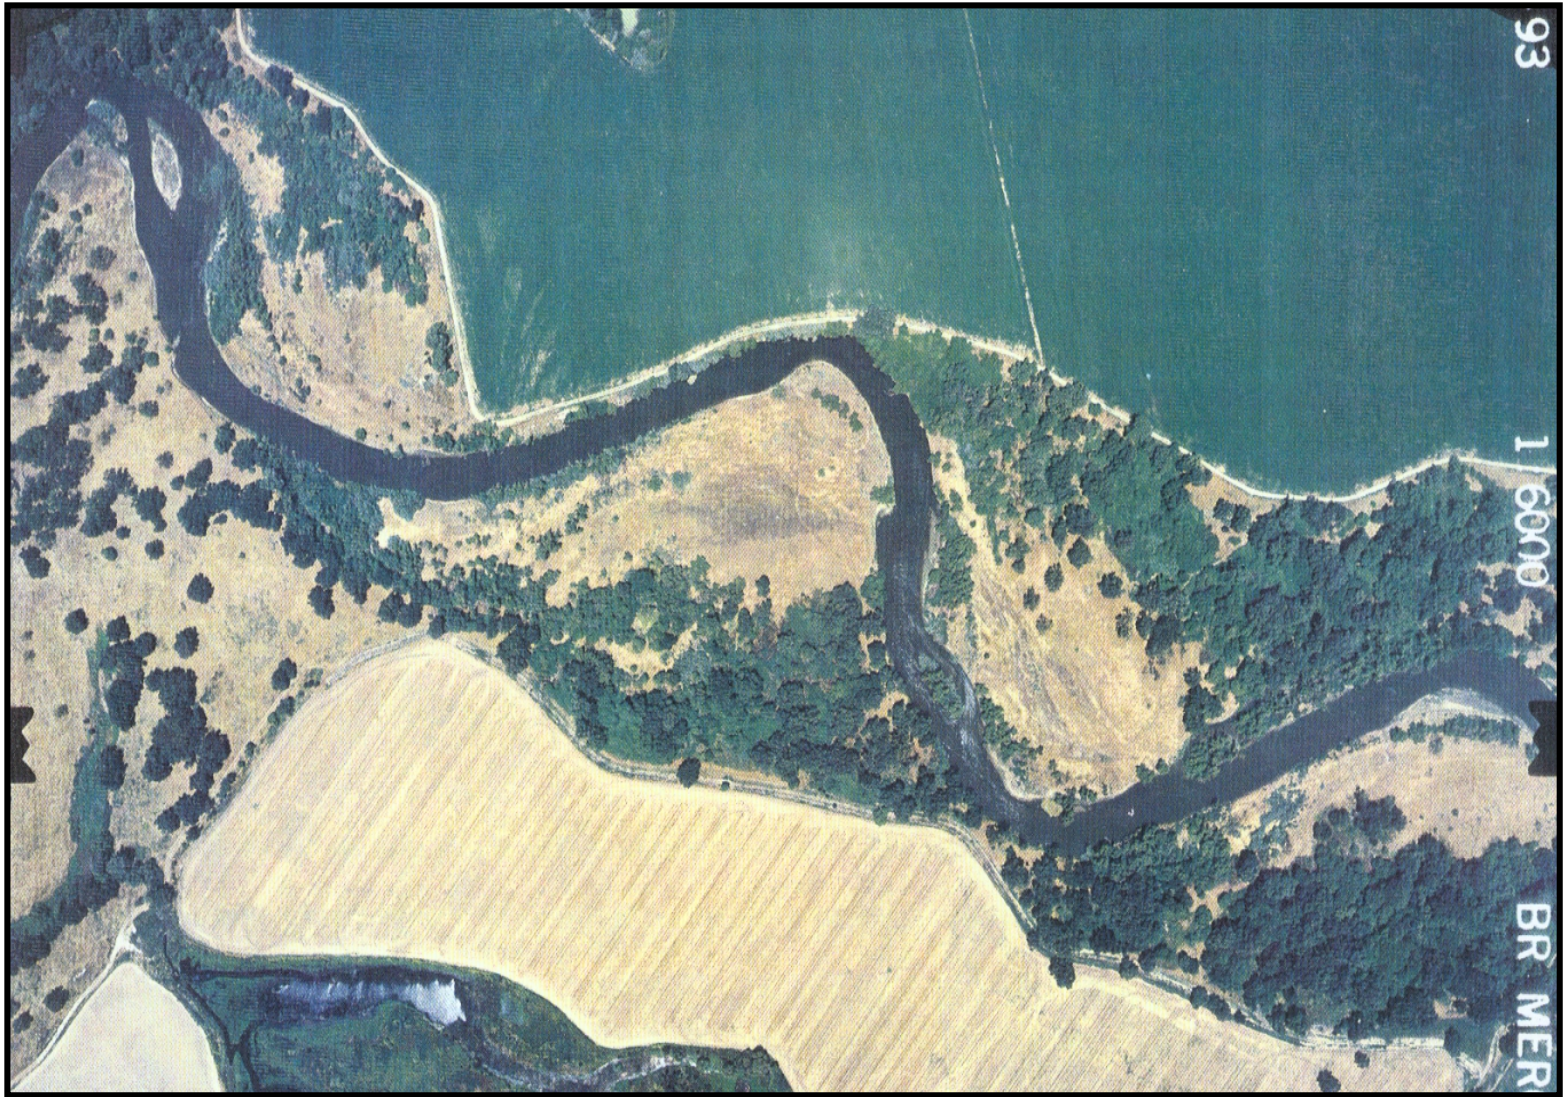
**Figure 5.1-11. Aerial photograph showing conditions in the Confluence Reach.**  
(photo: U. S. Bureau of Reclamation 1993)

The Confluence Reach extends from Hultberg Road (RM 8) to the San Joaquin River confluence (RM 0). An aerial photograph depicting typical conditions in this reach is shown in Figure 5.1–11. The reach-averaged channel slope is 0.0002 (Figure 5.1–2). This reach is entirely sand-bedded and is subject to backwater effects from the San Joaquin River. Where meanders are not armored, active sandbars and diverse riparian communities are present. The most extensive and continuous stands of native vegetation remaining along the Merced River corridor are located in this reach just upstream from the San Joaquin confluence (RM 0–3).

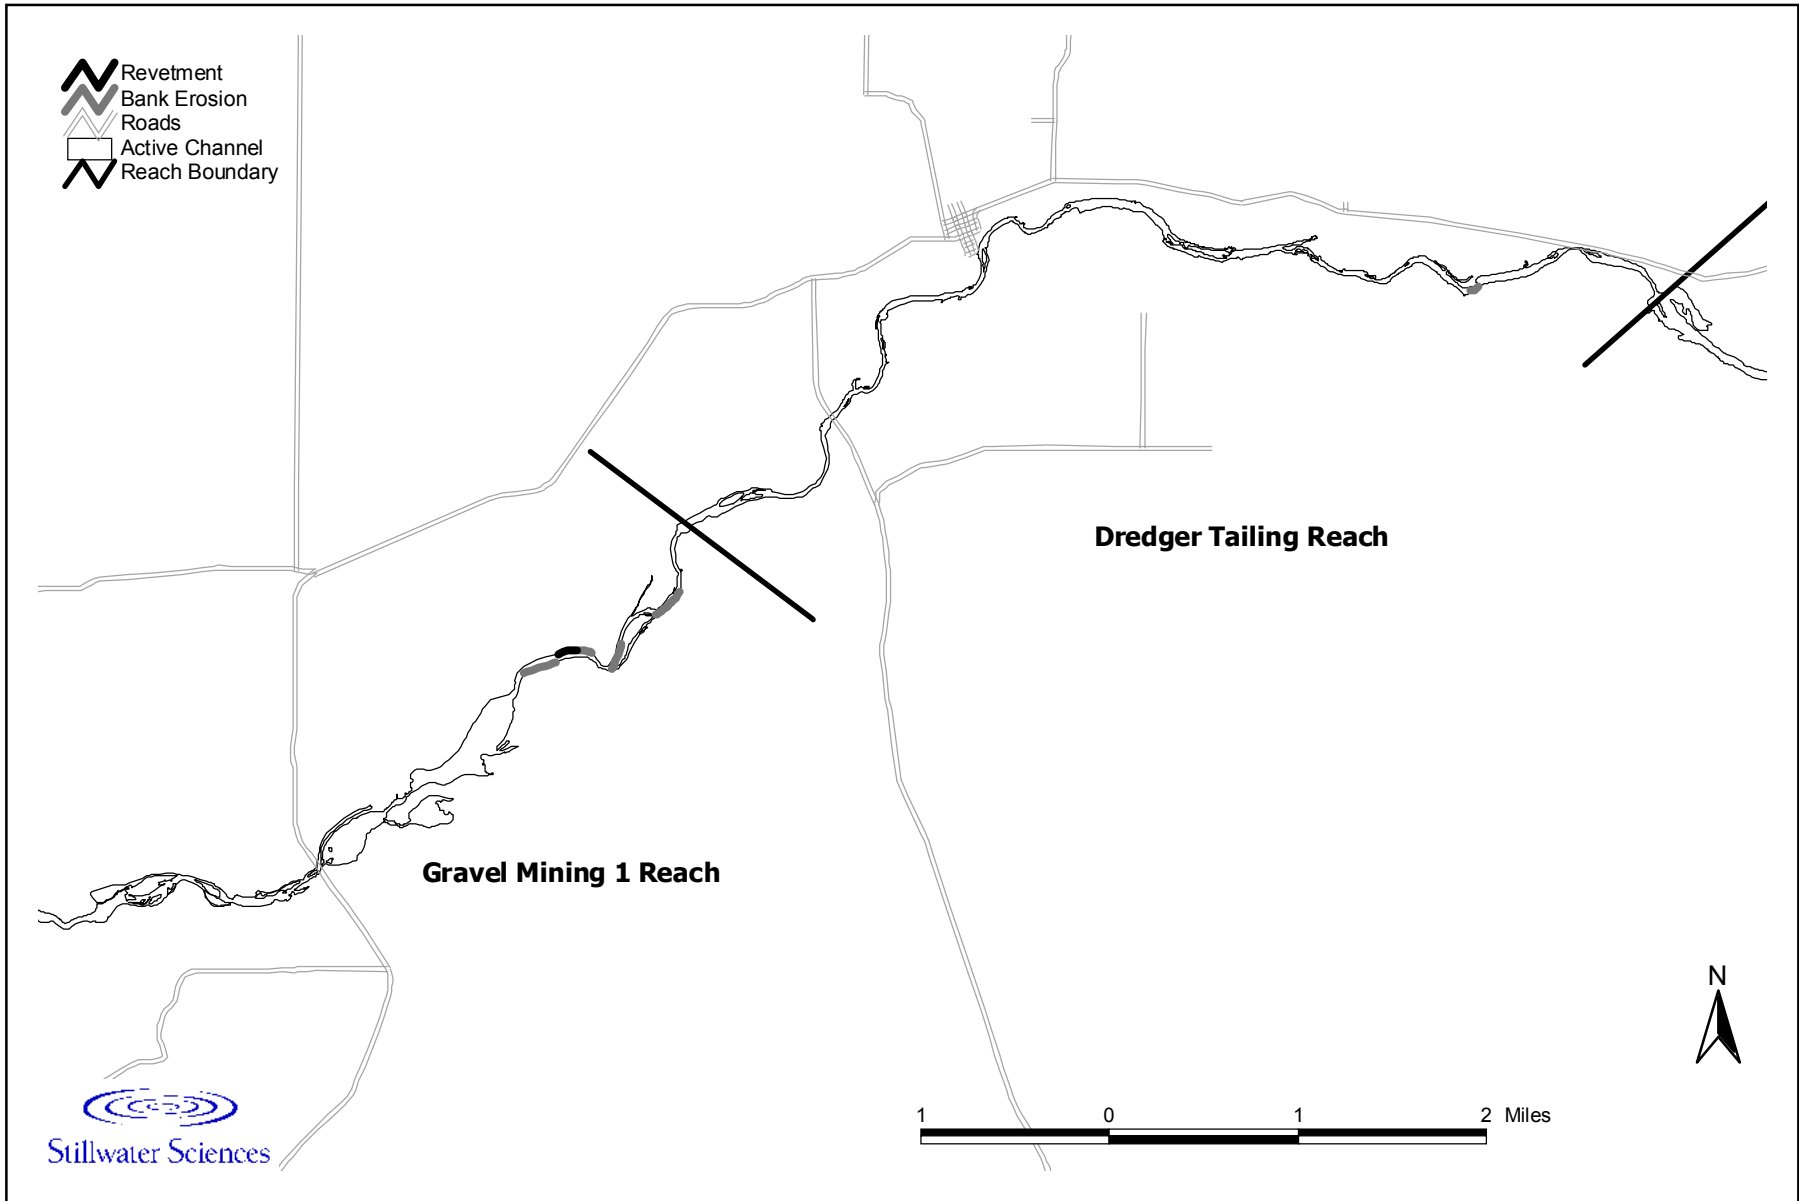
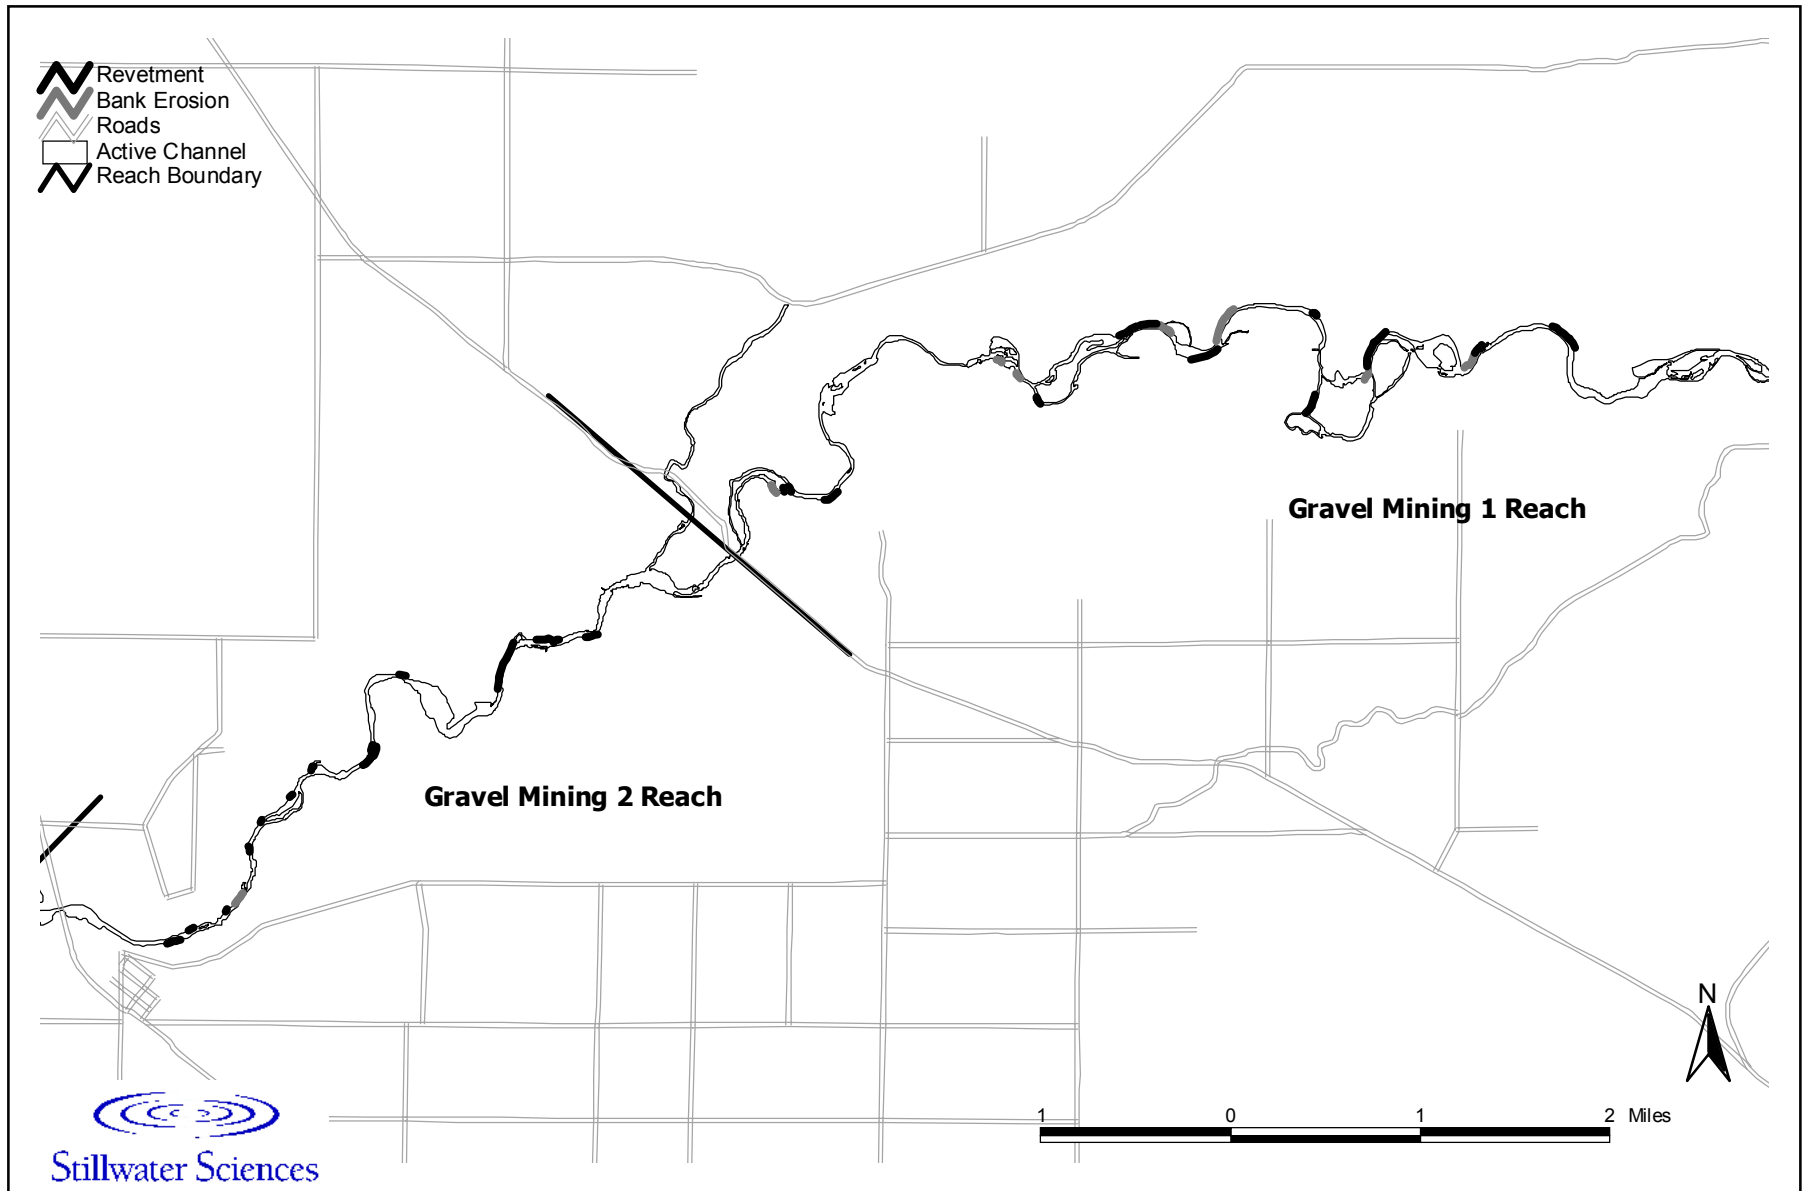
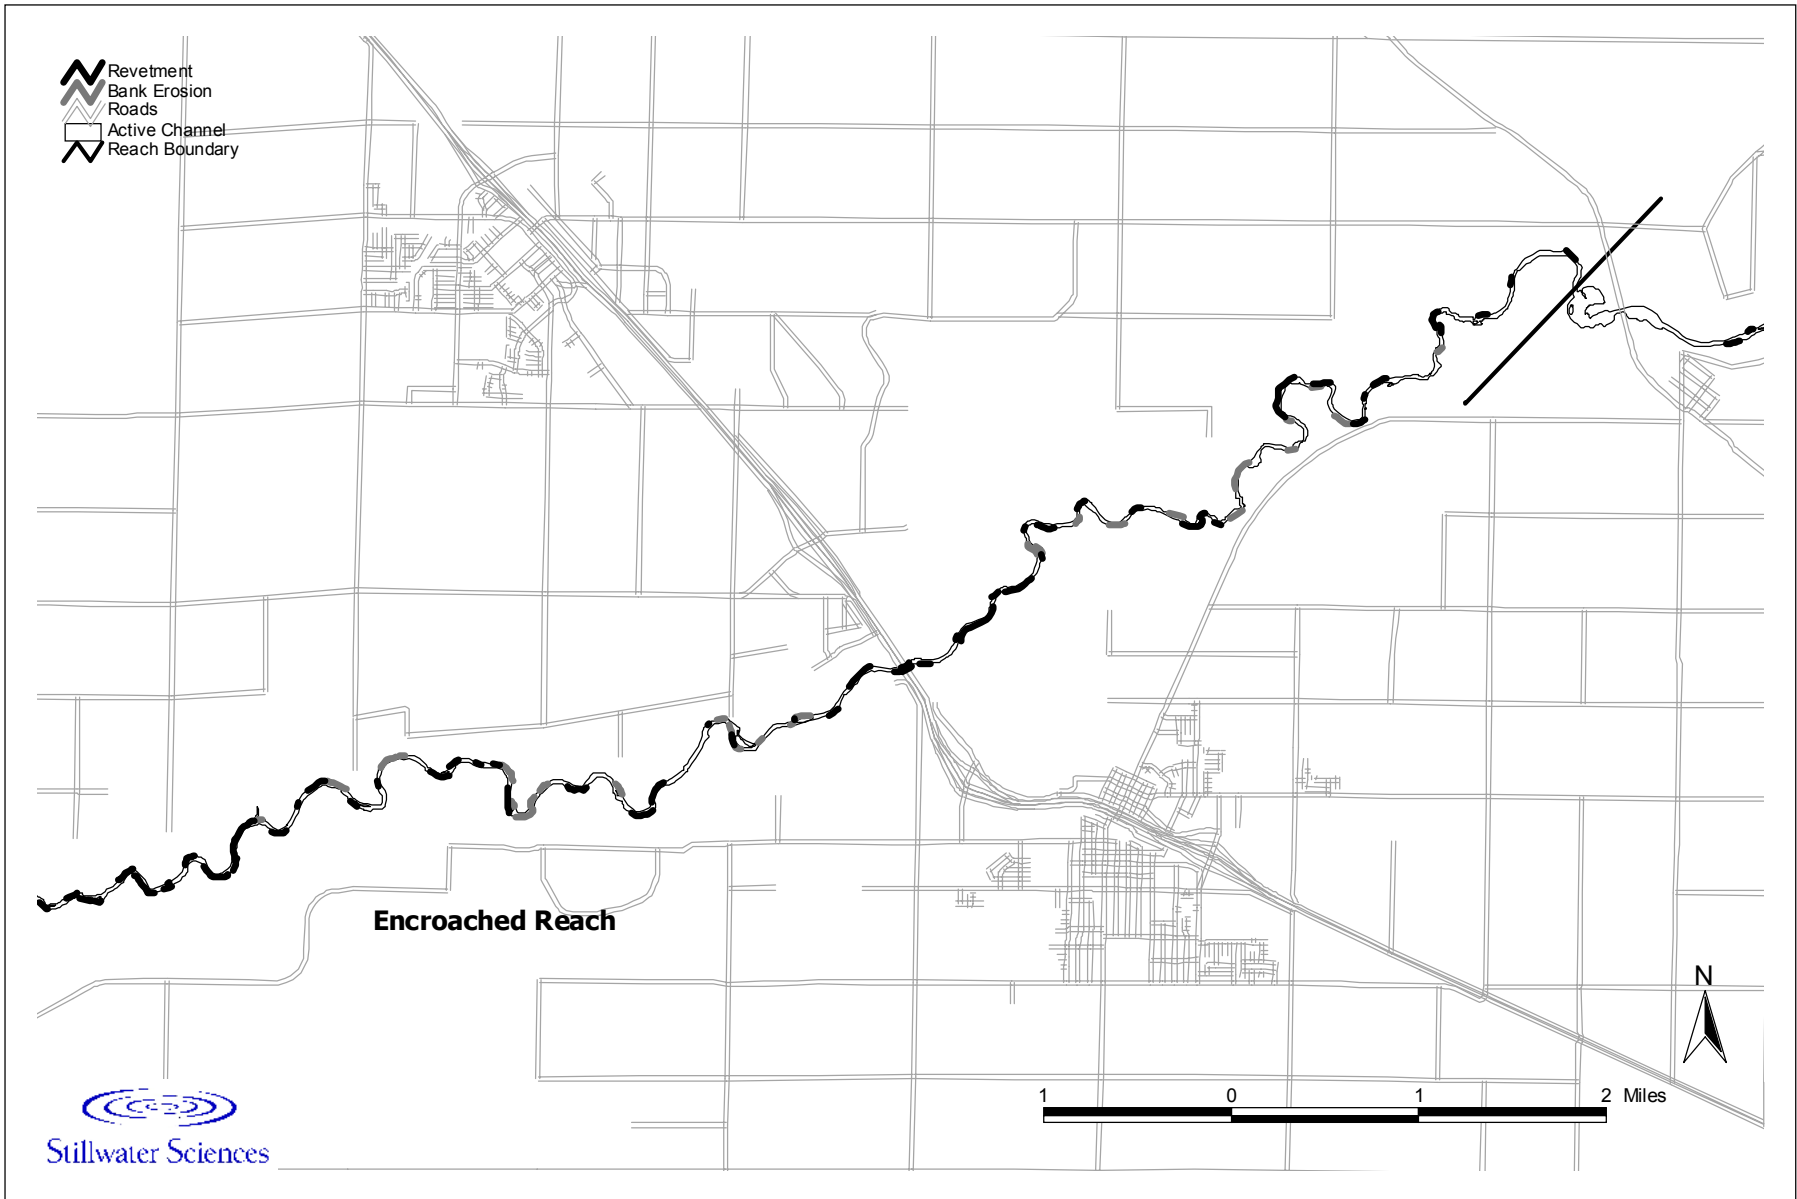
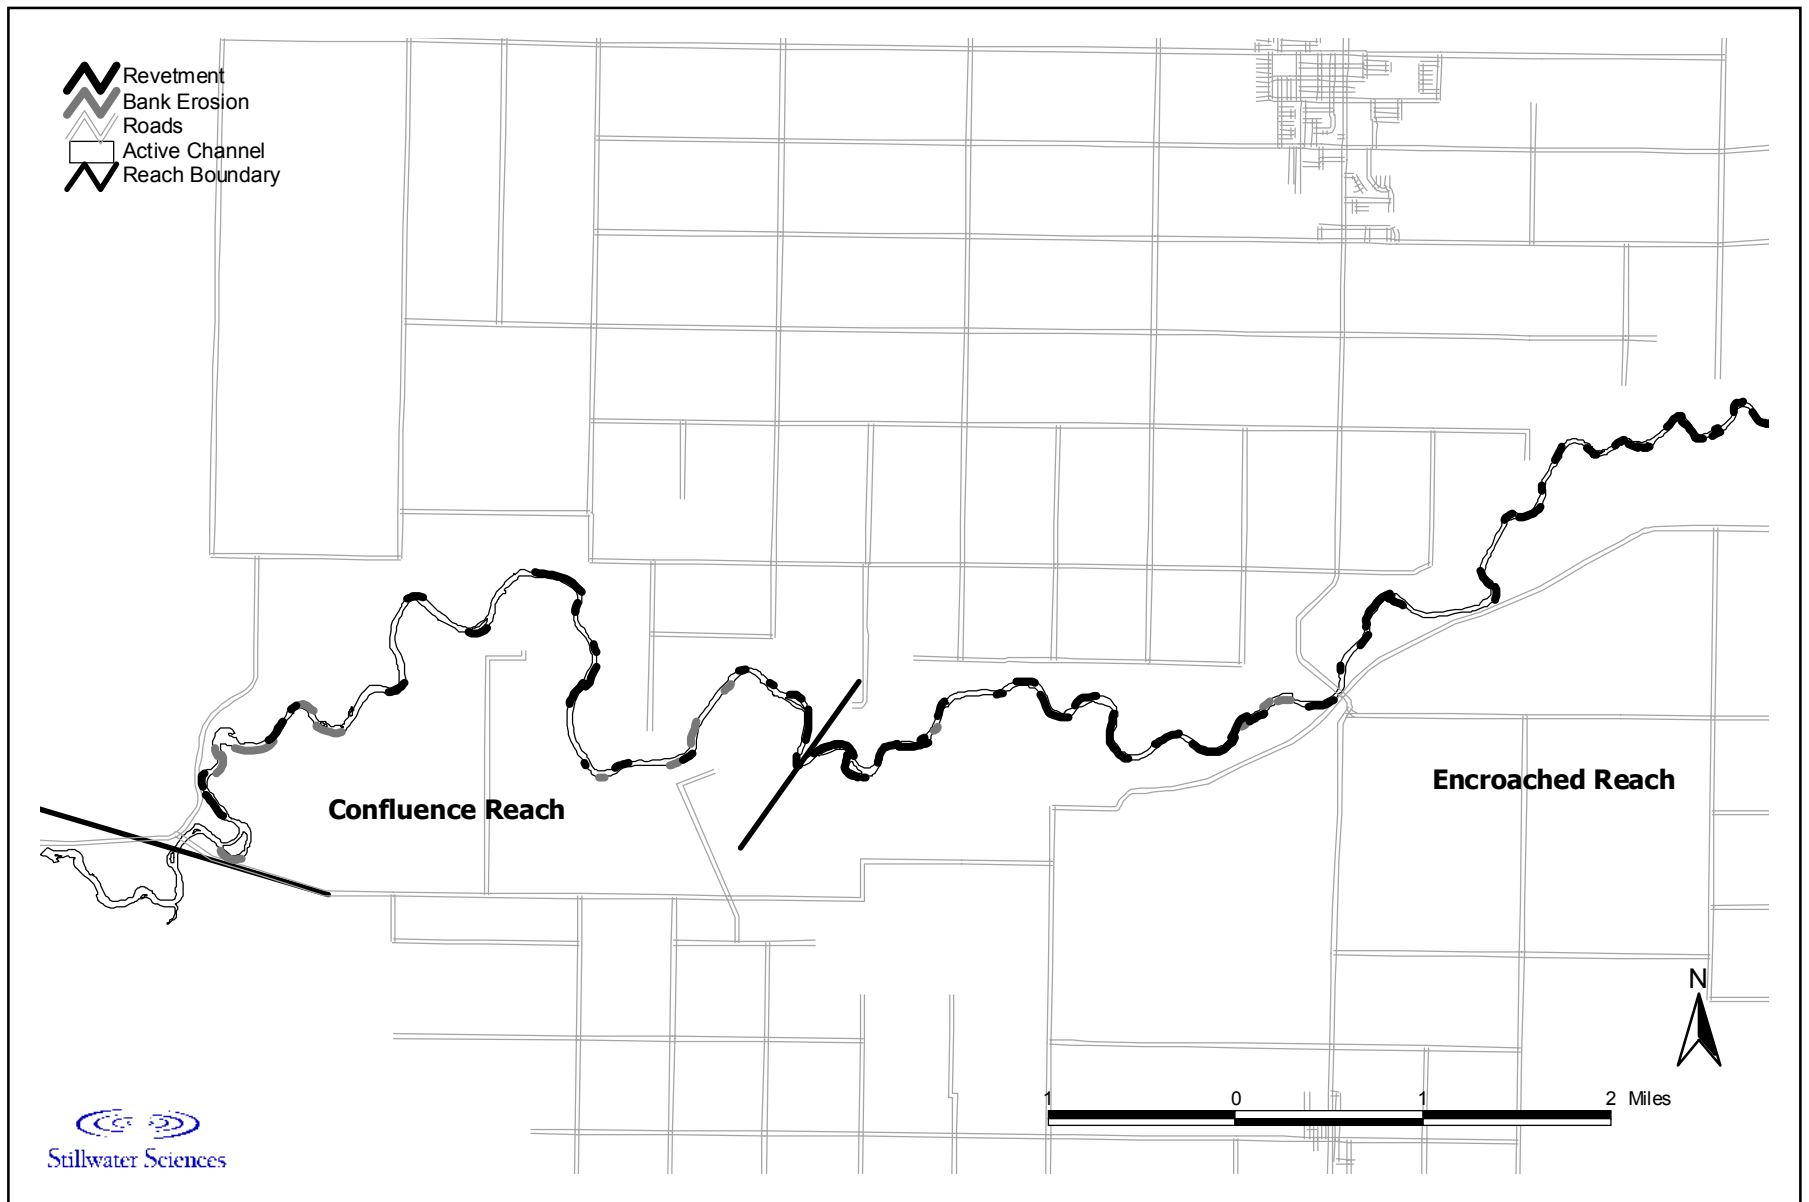
**Figure 5.2-1A. Bank erosion and revetment in the Merced River.**

**Figure 5.2-1B. Bank erosion and revetment in the Merced River.**

Figure 5.2-1C. Bank erosion and revetment in the Merced River

**Figure 5.2-1D. Bank Erosion and revetment in the Merced River.**

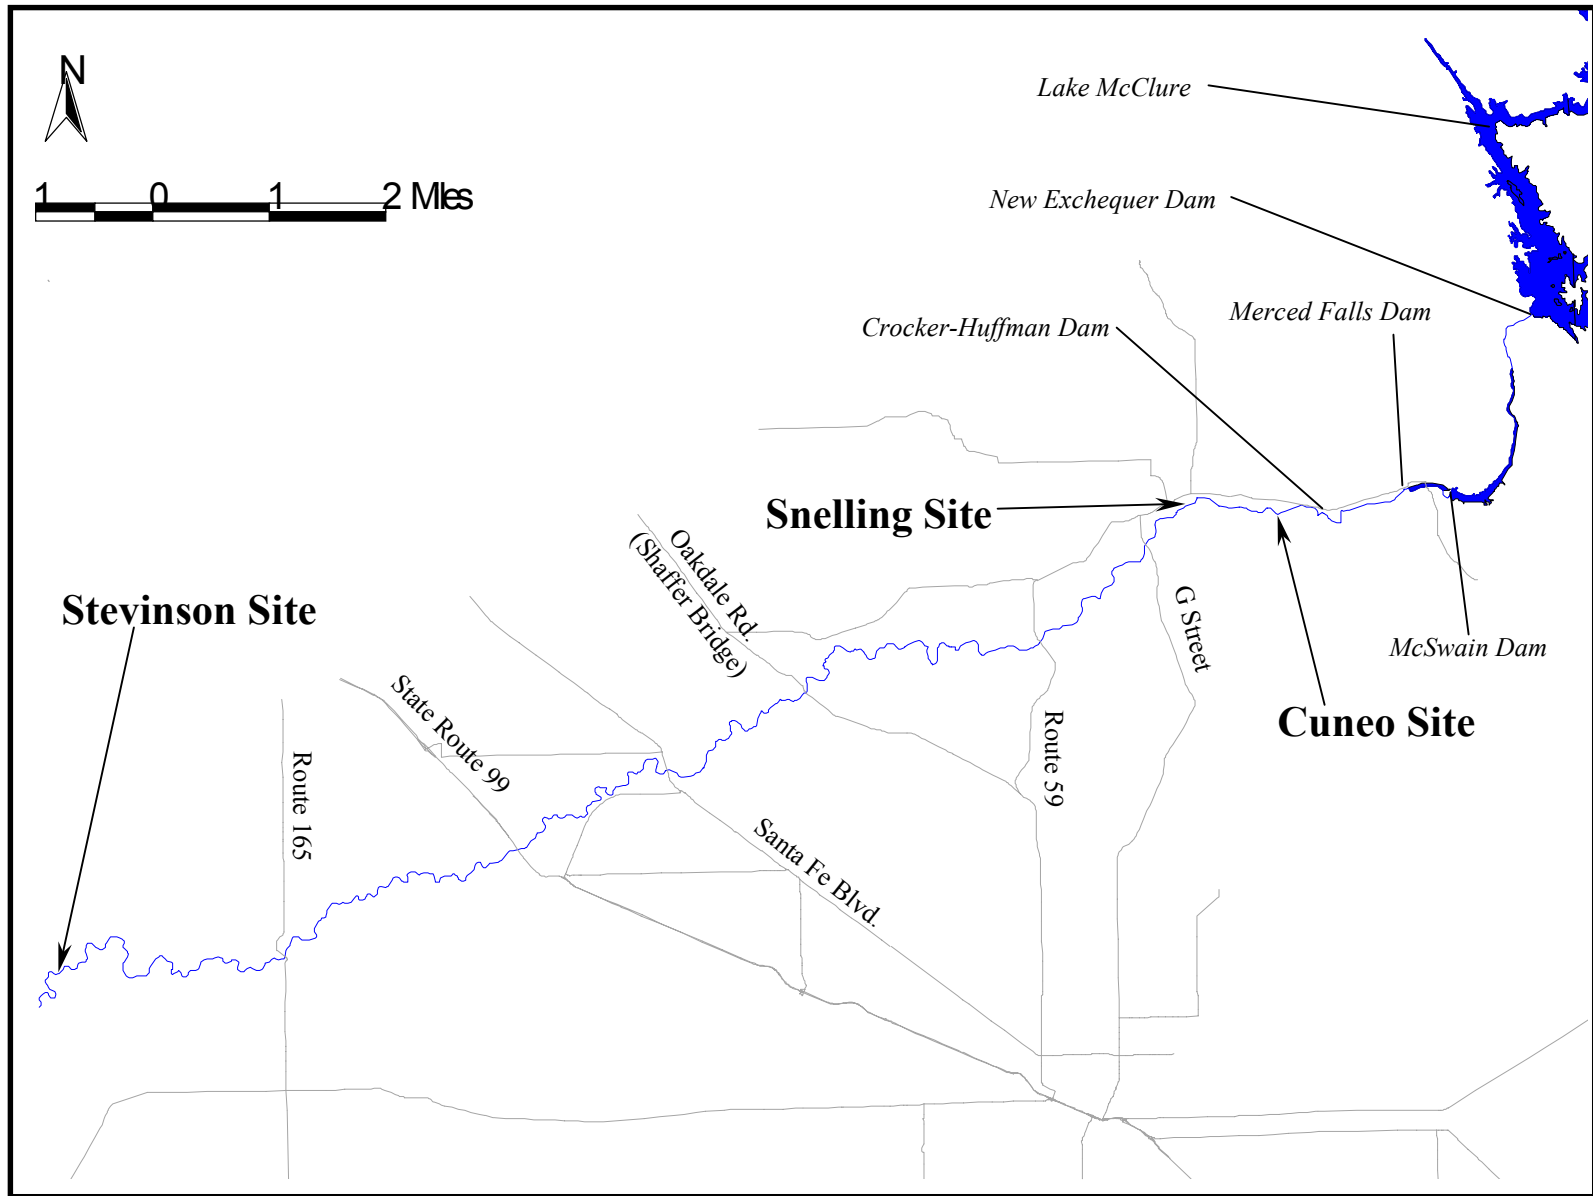
**Figure 5.3-1. Location of Phase II study sites on the Merced River.**

The Cuneo Site is located 1.2 river miles downstream of Crocker-Huffman Dam at the Merced ID's Cuneo Fishing Access (Figure 5.3-1). This site was used to assess historic and current sediment texture, as well as historic and current bedload transport conditions. The site consists of a formerly active bar that has been converted to a floodplain as a result of flow regulation. Because the bar was not dredged, the sediment texture on the bar is representative of sediment that was mobilized under pre-dam flow conditions. In addition, the site is located downstream of several CDFG/CDWR gravel augmentation sites and is one of the few depositional areas observed in the river channel. Recent in-channel sediment deposits at this site are indicative of sediment texture that is mobile under post-dam hydrologic conditions. At this site, one cross section was surveyed and two pebble counts were conducted—one on the fossilized bar and one in the channel—to document historical and current bed texture (Figure 5.3-4). The cross section was surveyed using the same equipment and methods described for the Snelling Site above. Permanent endpins were placed at each end of each cross section, and the location of the section and the pins was mapped onto an aerial photograph. Data from this site will be used for sediment transport modeling in Phase III of the project.

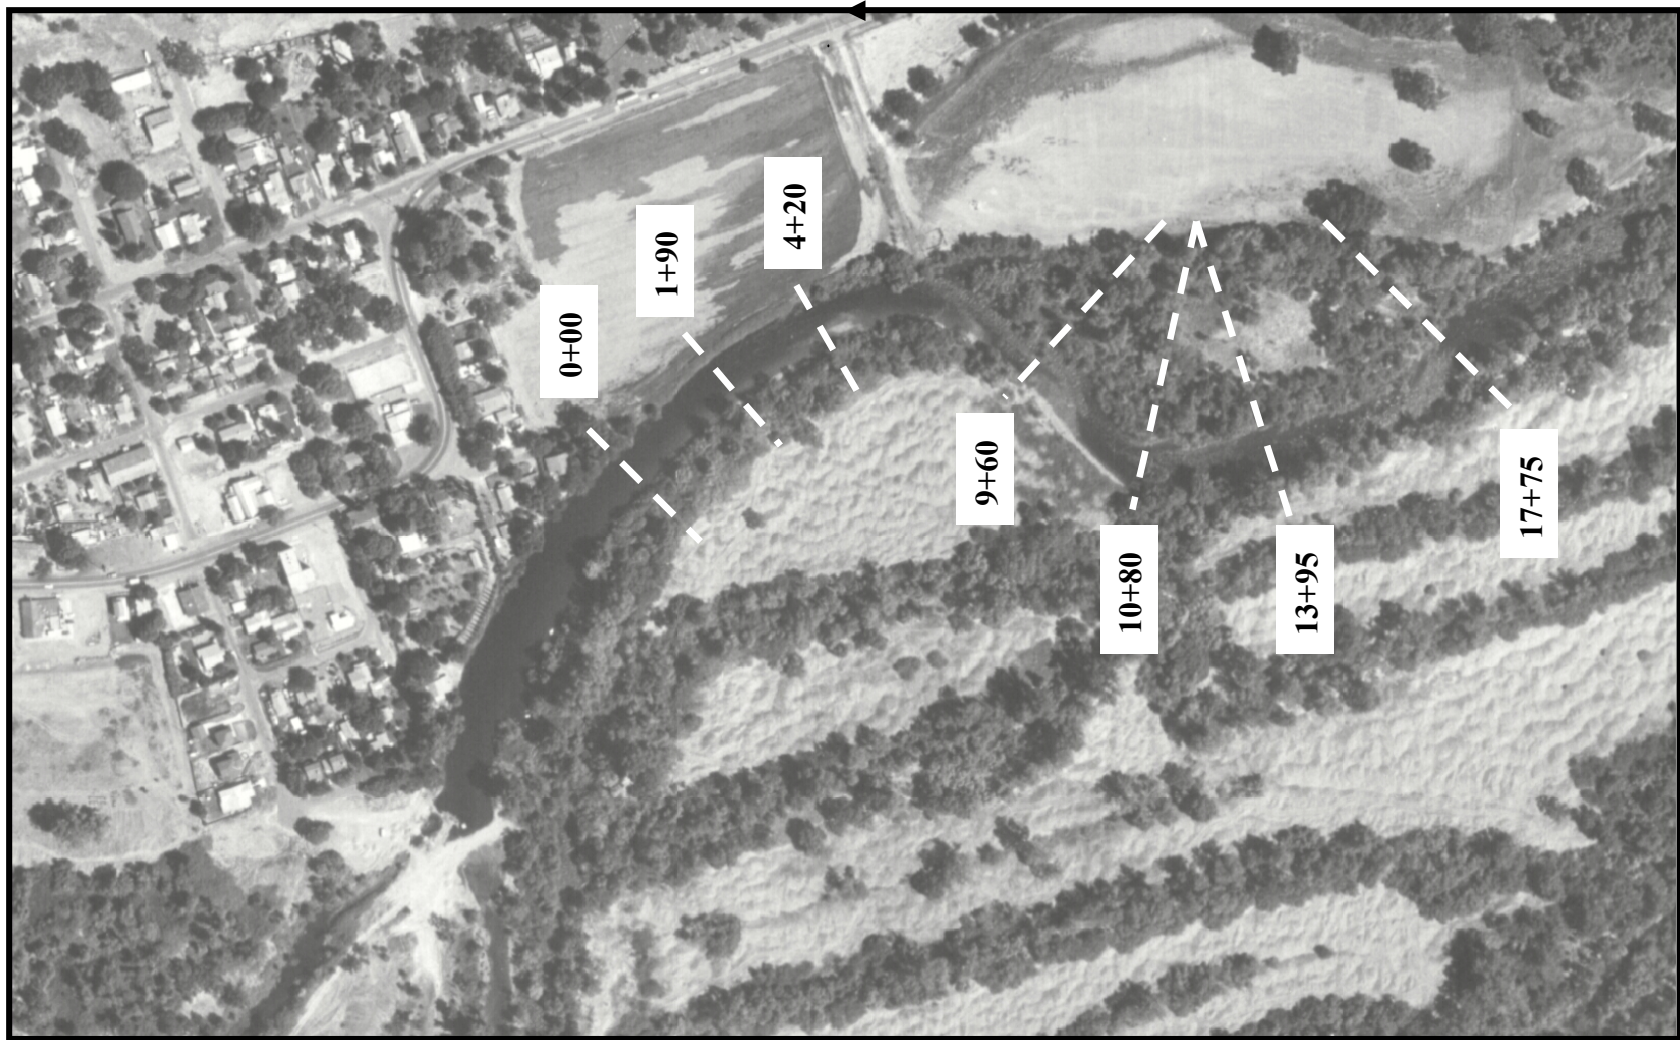
**Figure 5.3-2. Cross section survey locations at the Snelling Site.**  
(photo: Merced County Planning and Community Development Department 1998)

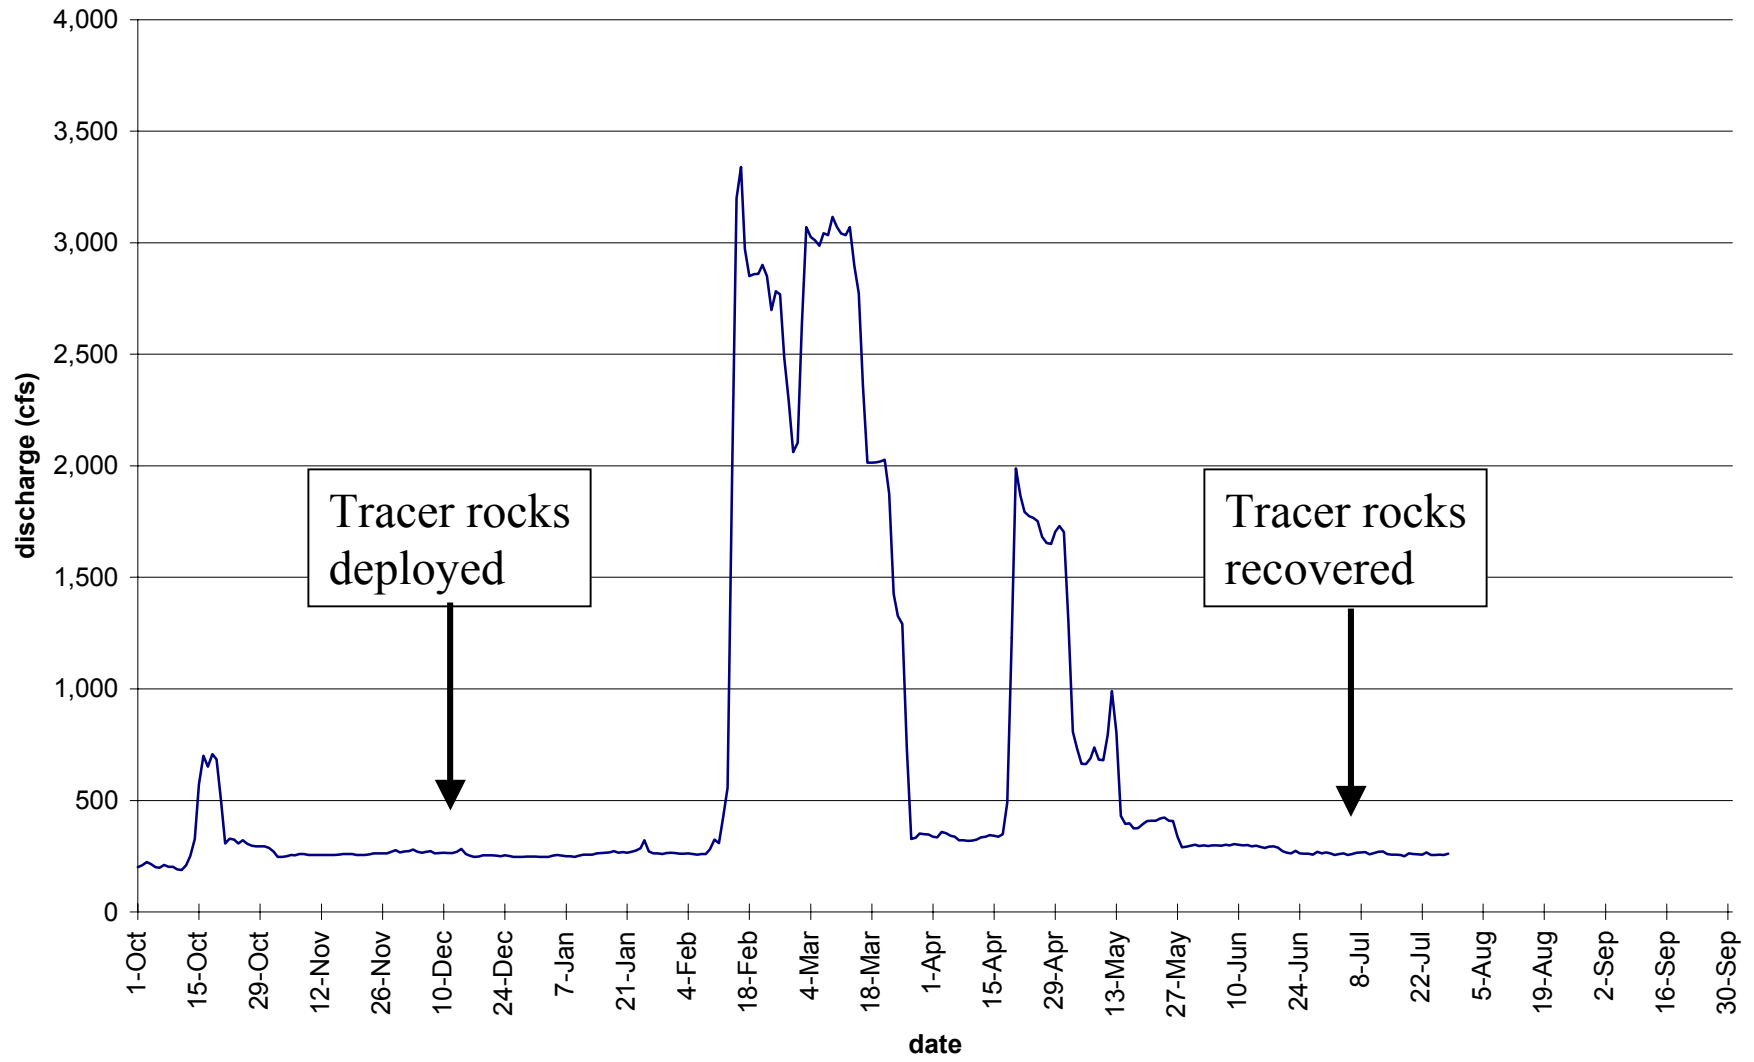
**Figure 5.3-3. Flows at the Snelling Site between tracer rock deployment and recovery.**  
 (source: Merced Irrigation District Crocker-Huffman gauge)

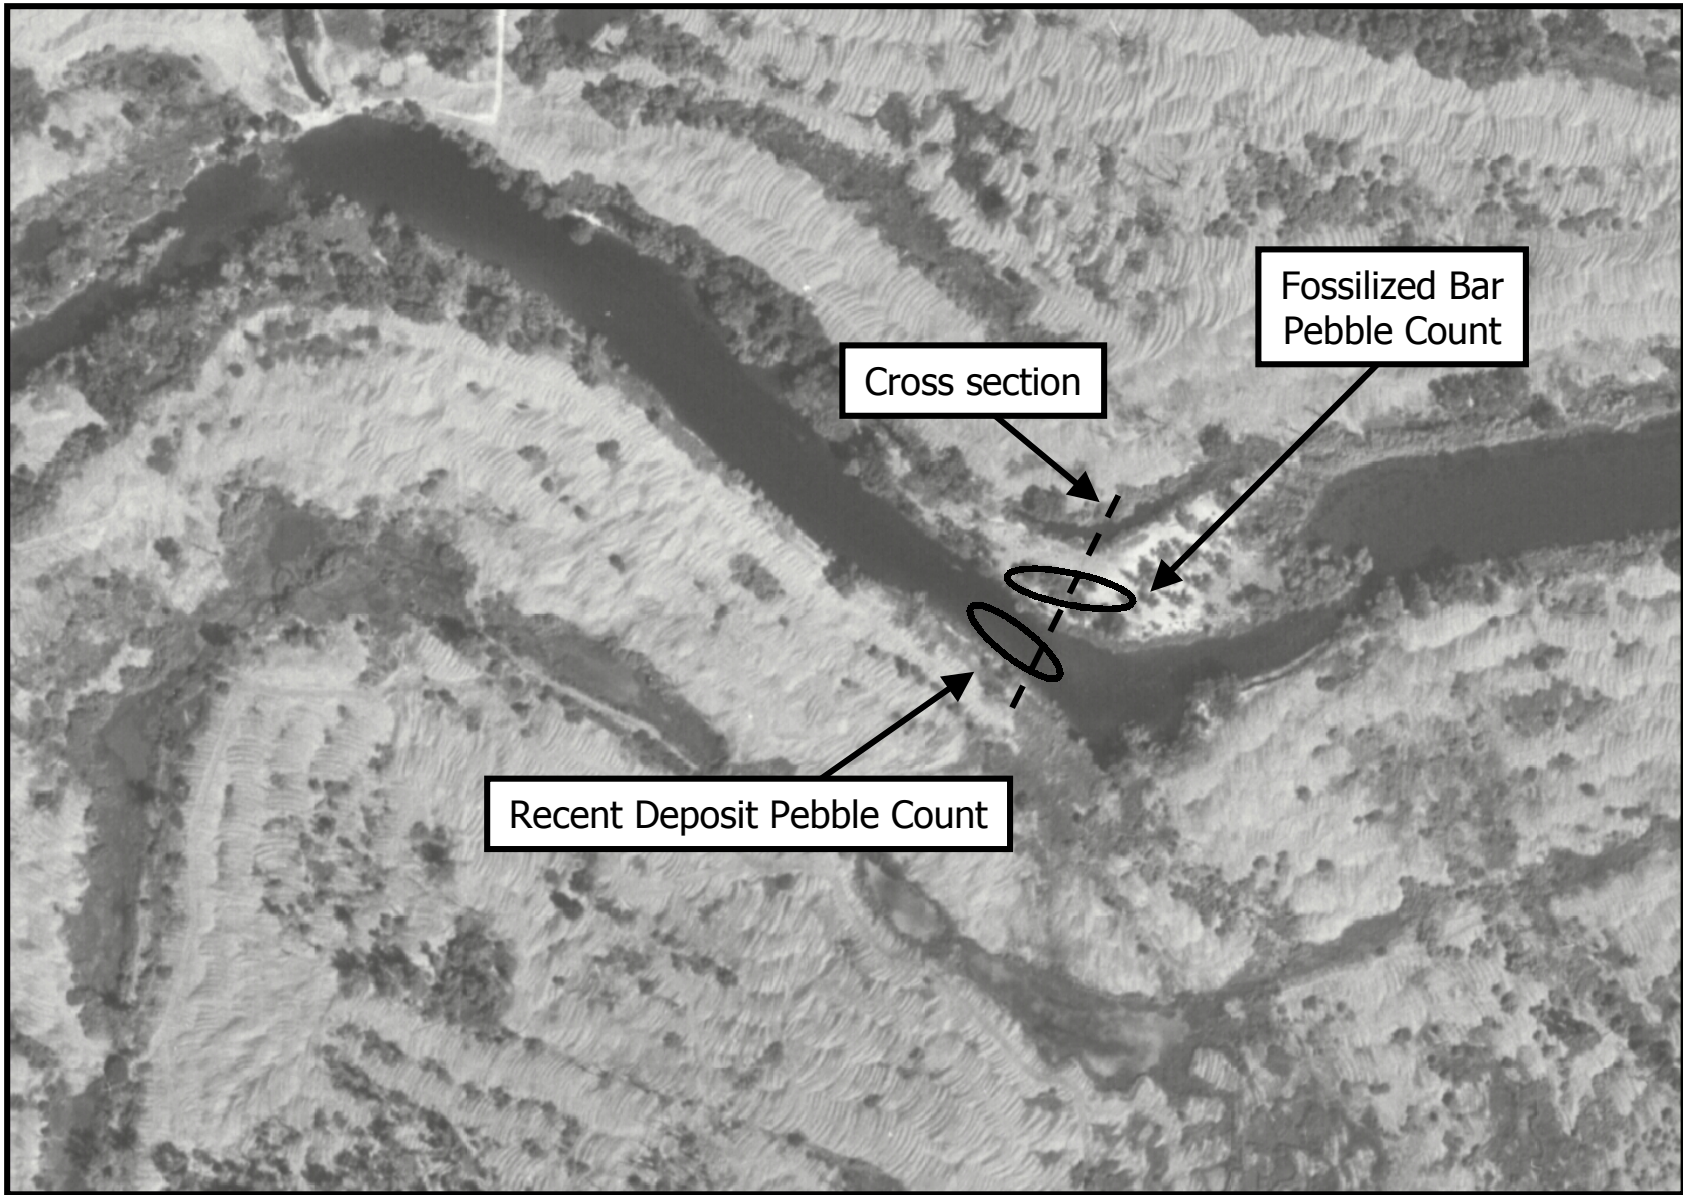
**Figure 5.3-4. Cross section and pebble count locations at the Cuneo Site.**  
(photo: Merced County Planning and Community Development Department 1998)

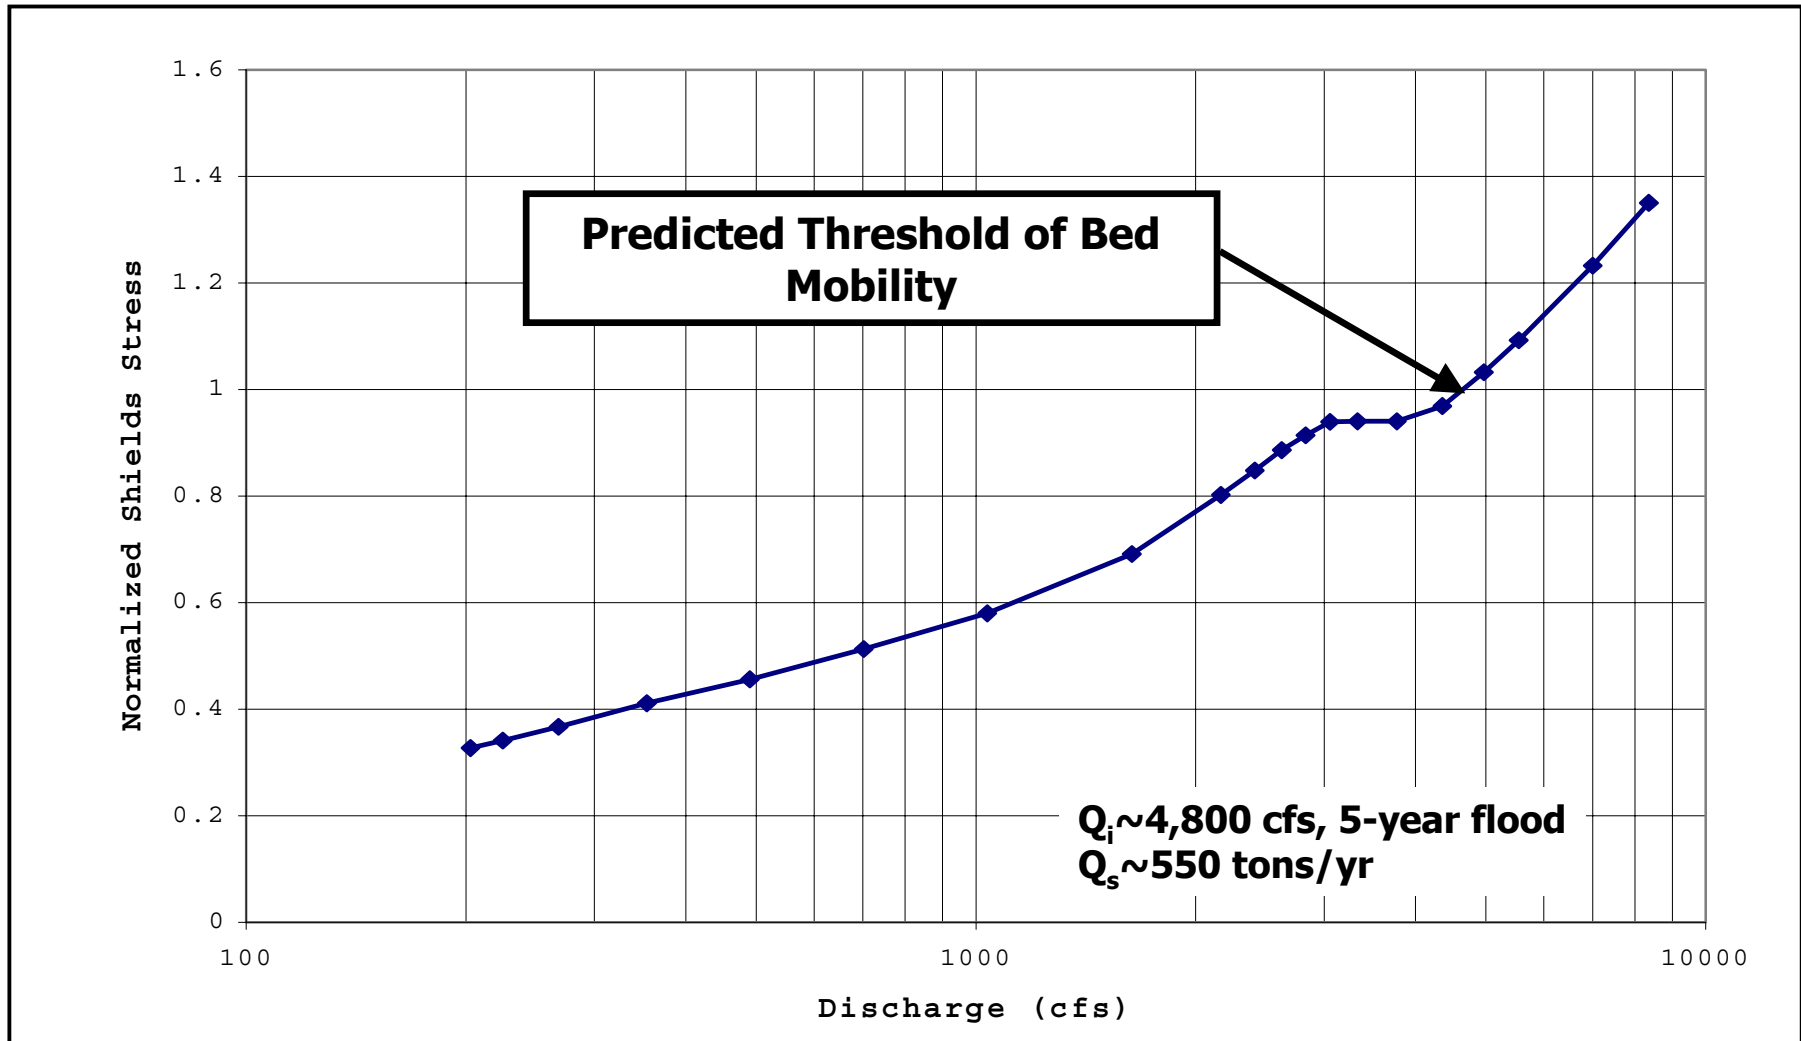
**Figure 5.3-5. Normalized Shields stress versus discharge for the Snelling Site.**

(The channel bed is predicted to be in motion when the normalized Shields stress is  $\geq 1.0$ .)
