## **Merced River Corridor Restoration Plan Baseline Studies**

# **Volume II: Geomorphic and Riparian Vegetation Investigations Report**

**VOLUME II  
GEOMORPHIC AND RIPARIAN VEGETATION  
INVESTIGATIONS REPORT**

Stillwater Sciences  
2532 Durant Avenue  
Berkeley, CA 94704

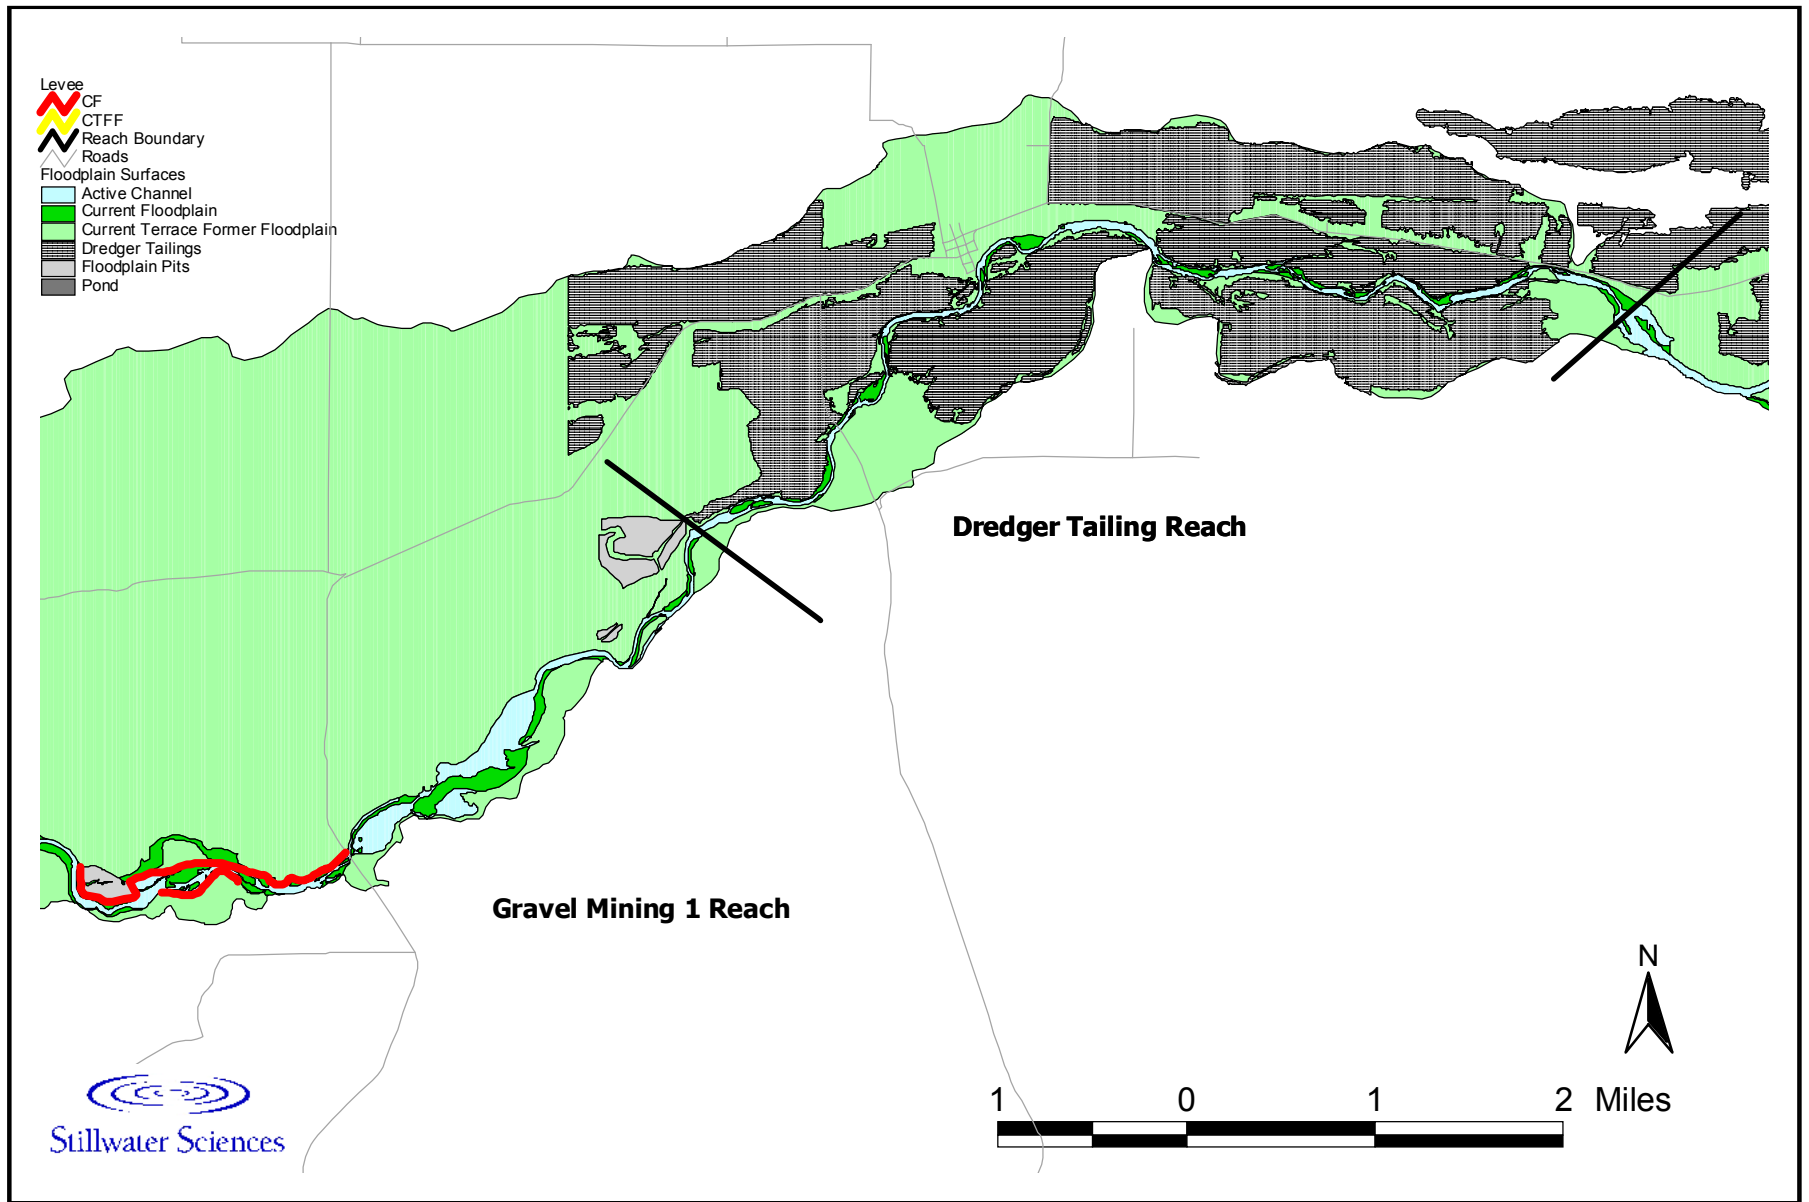
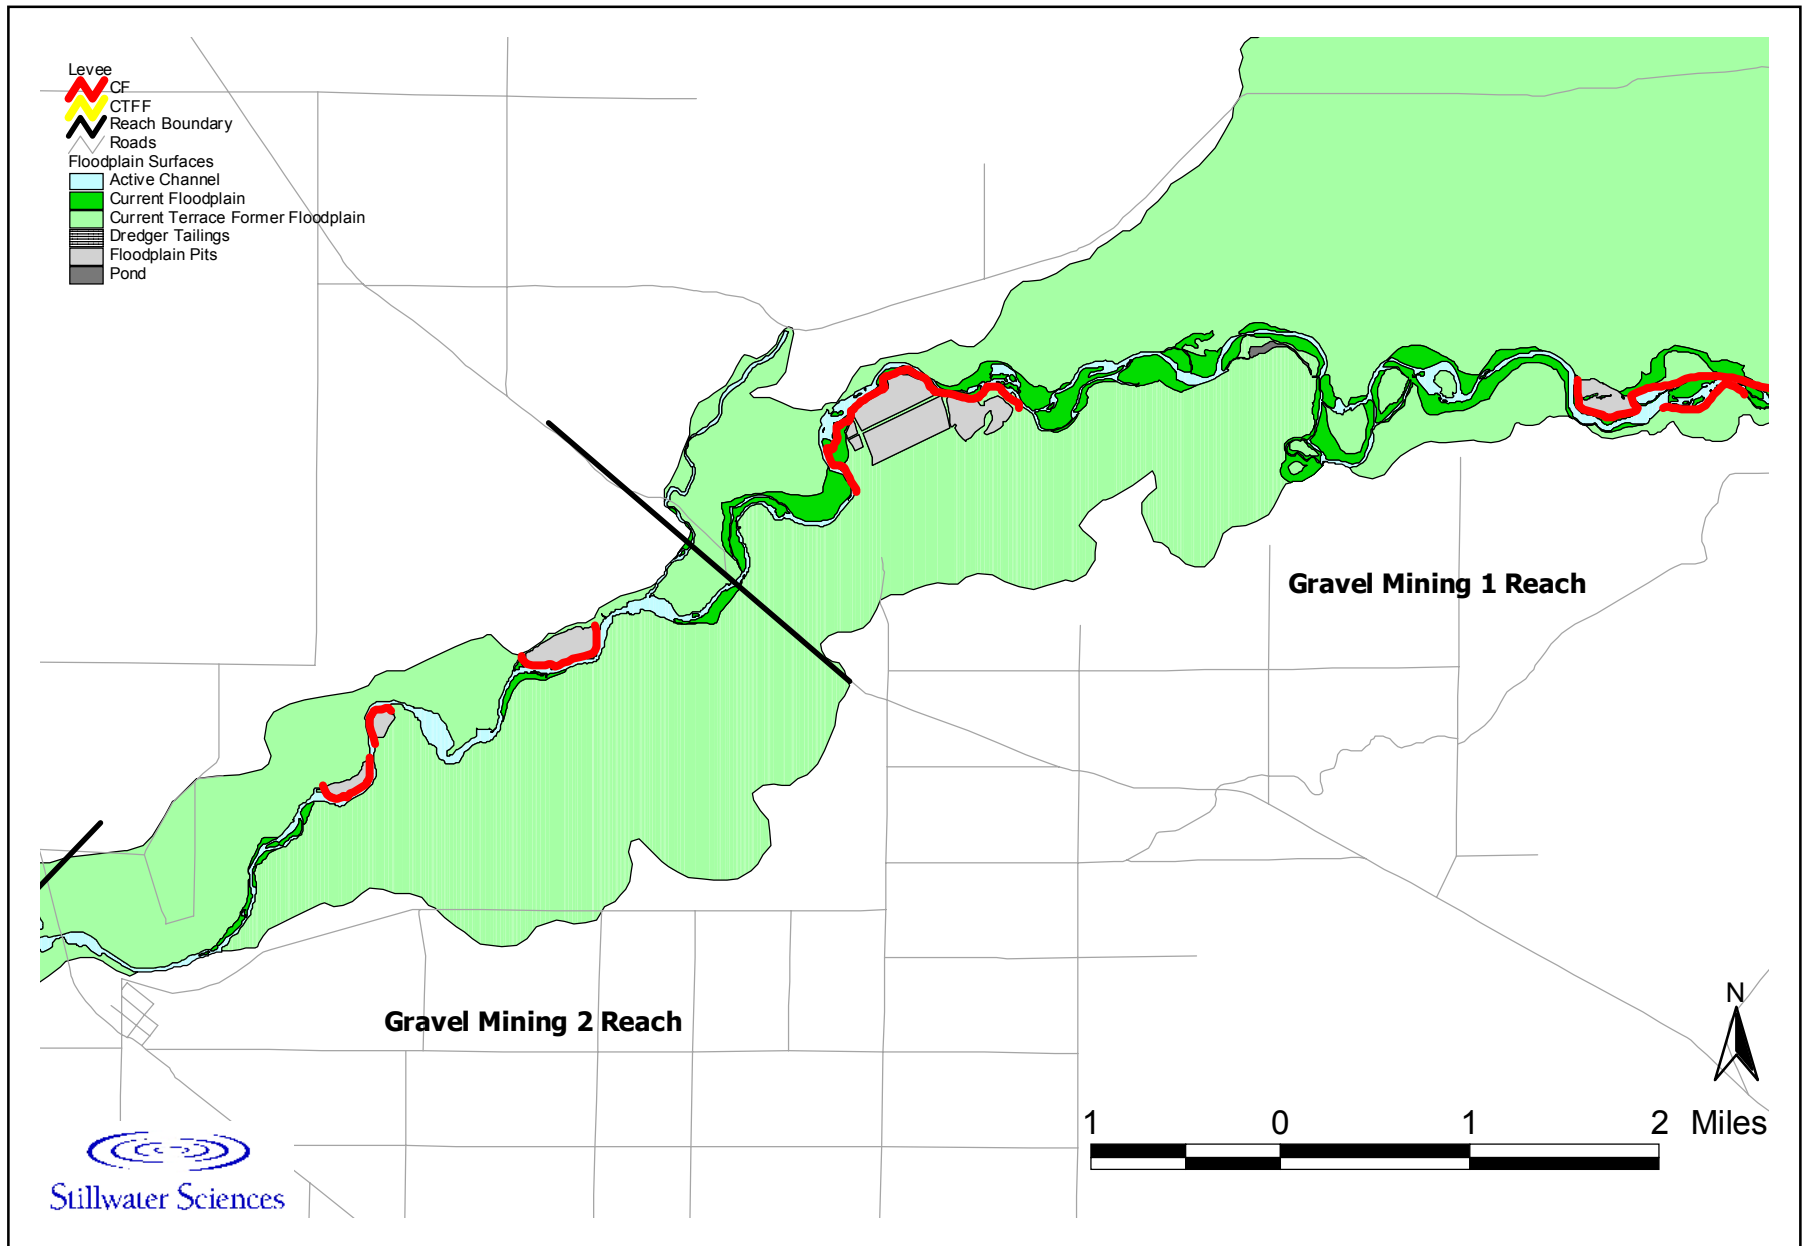
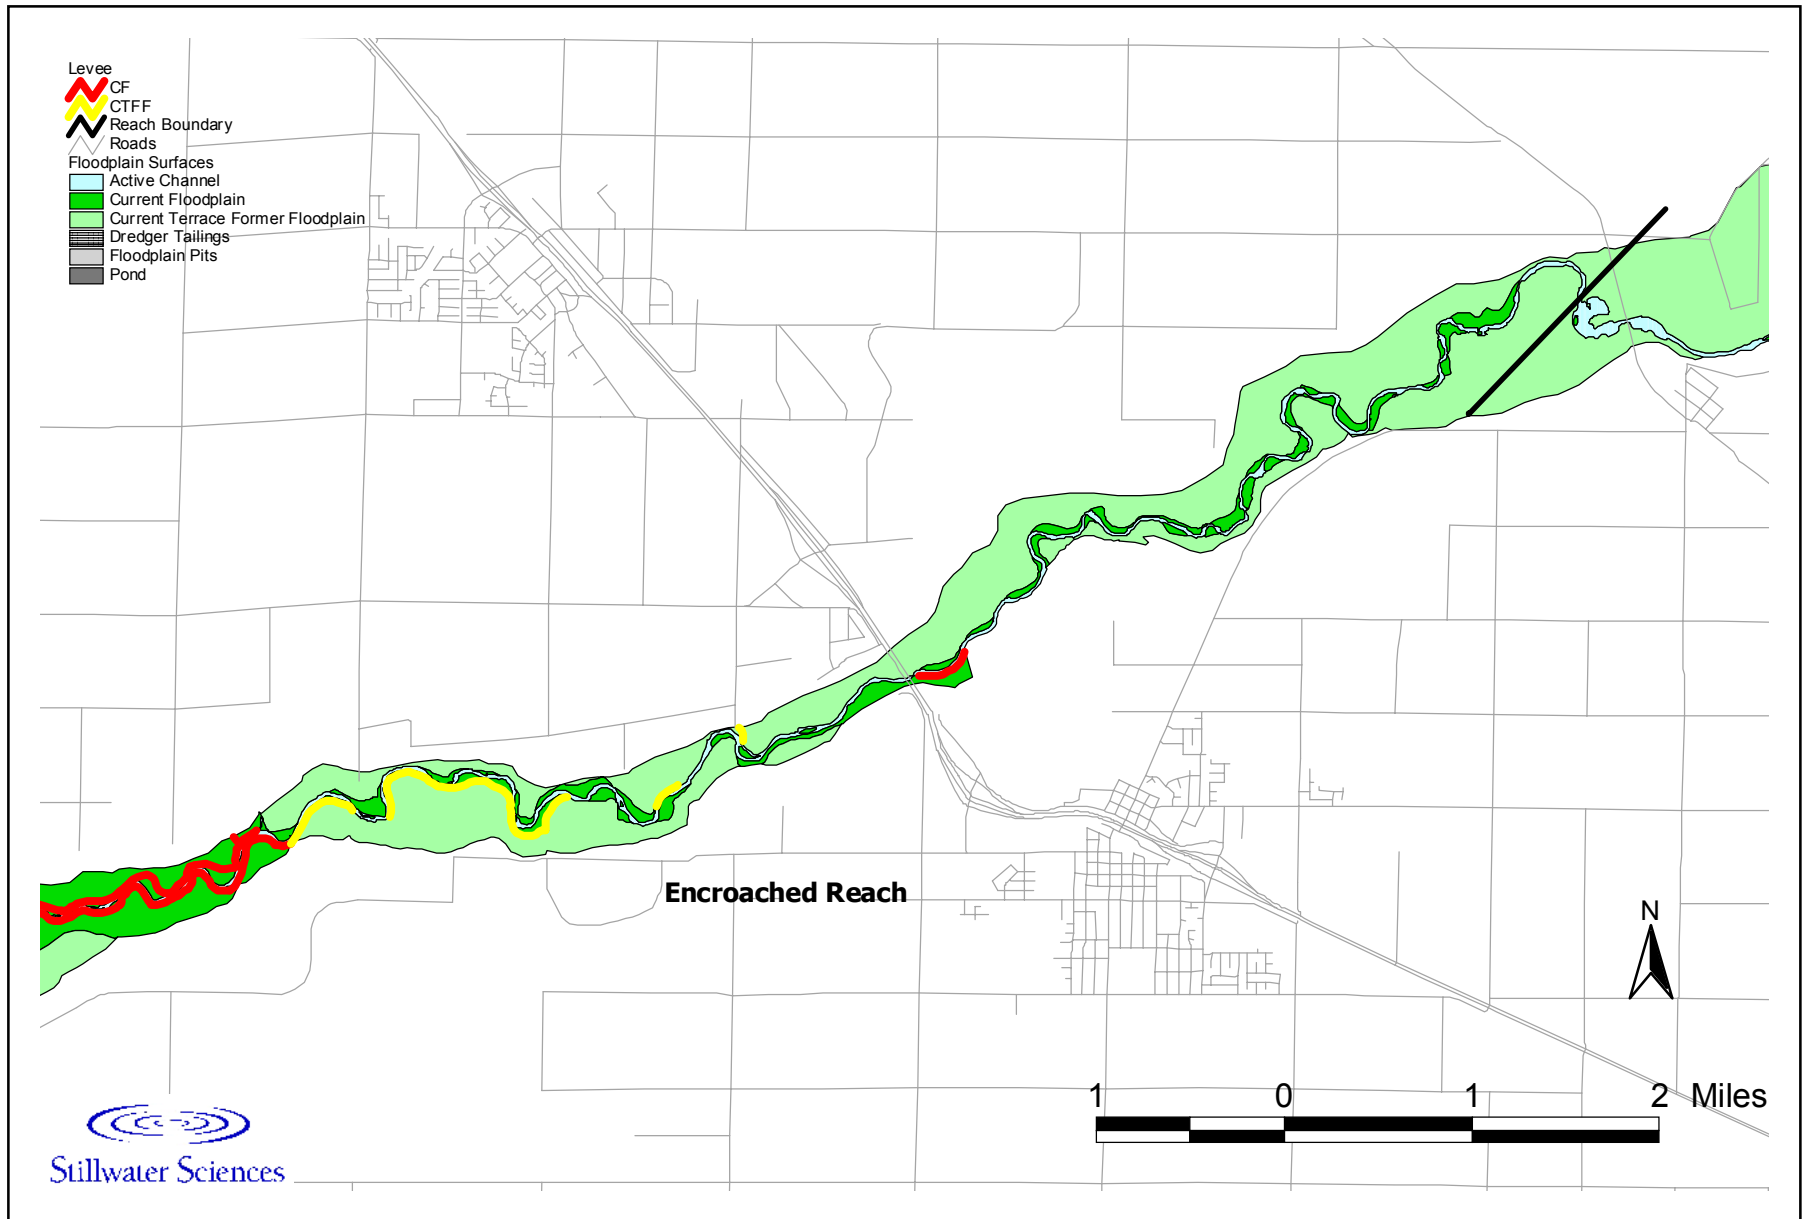
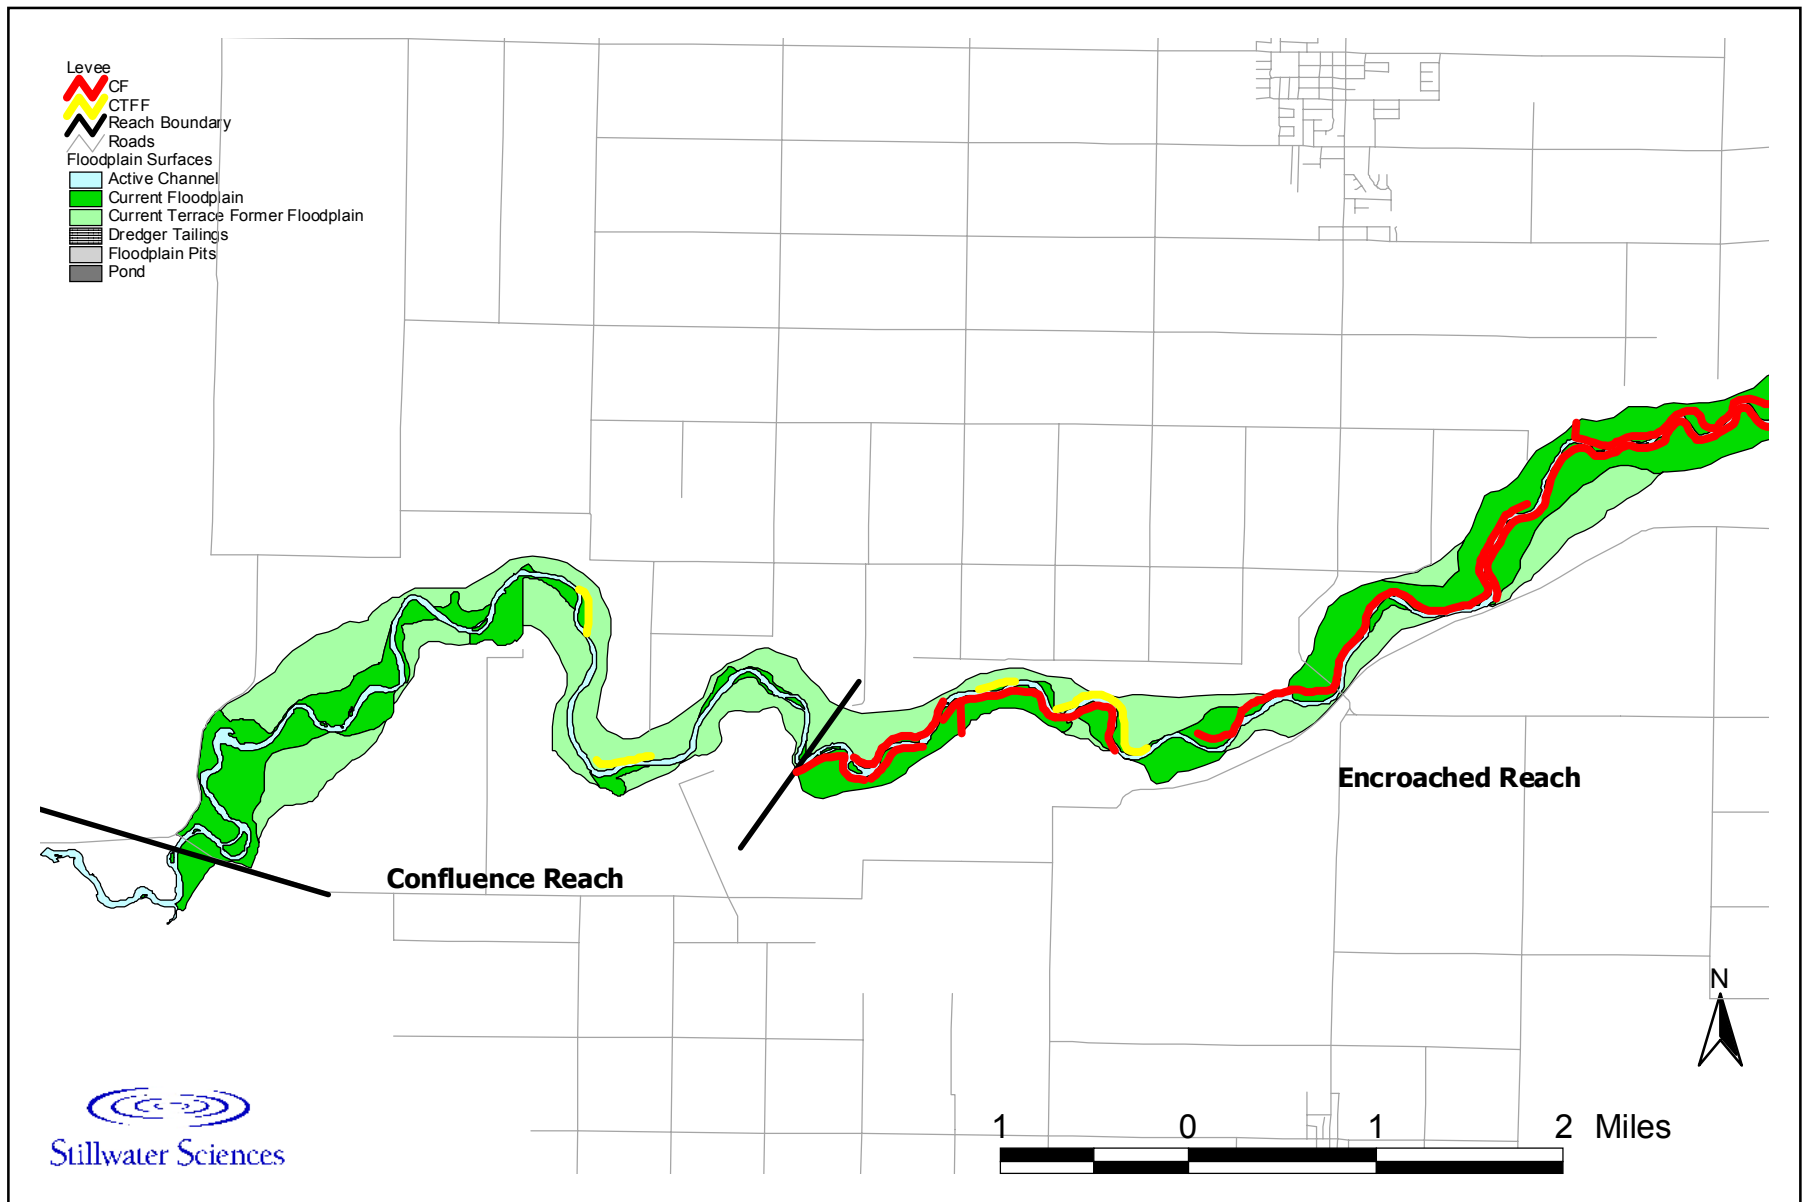
**Figure 5.5-1A. Merced River current and historic floodplain and levees**

**Figure 5.5-1B. Merced River current and historic floodplain and levees.**

**Figure 5.5-1C. Merced River current and historic floodplain and levees.**

Figure 5.5-1D. Merced River current historic floodplain and levees.

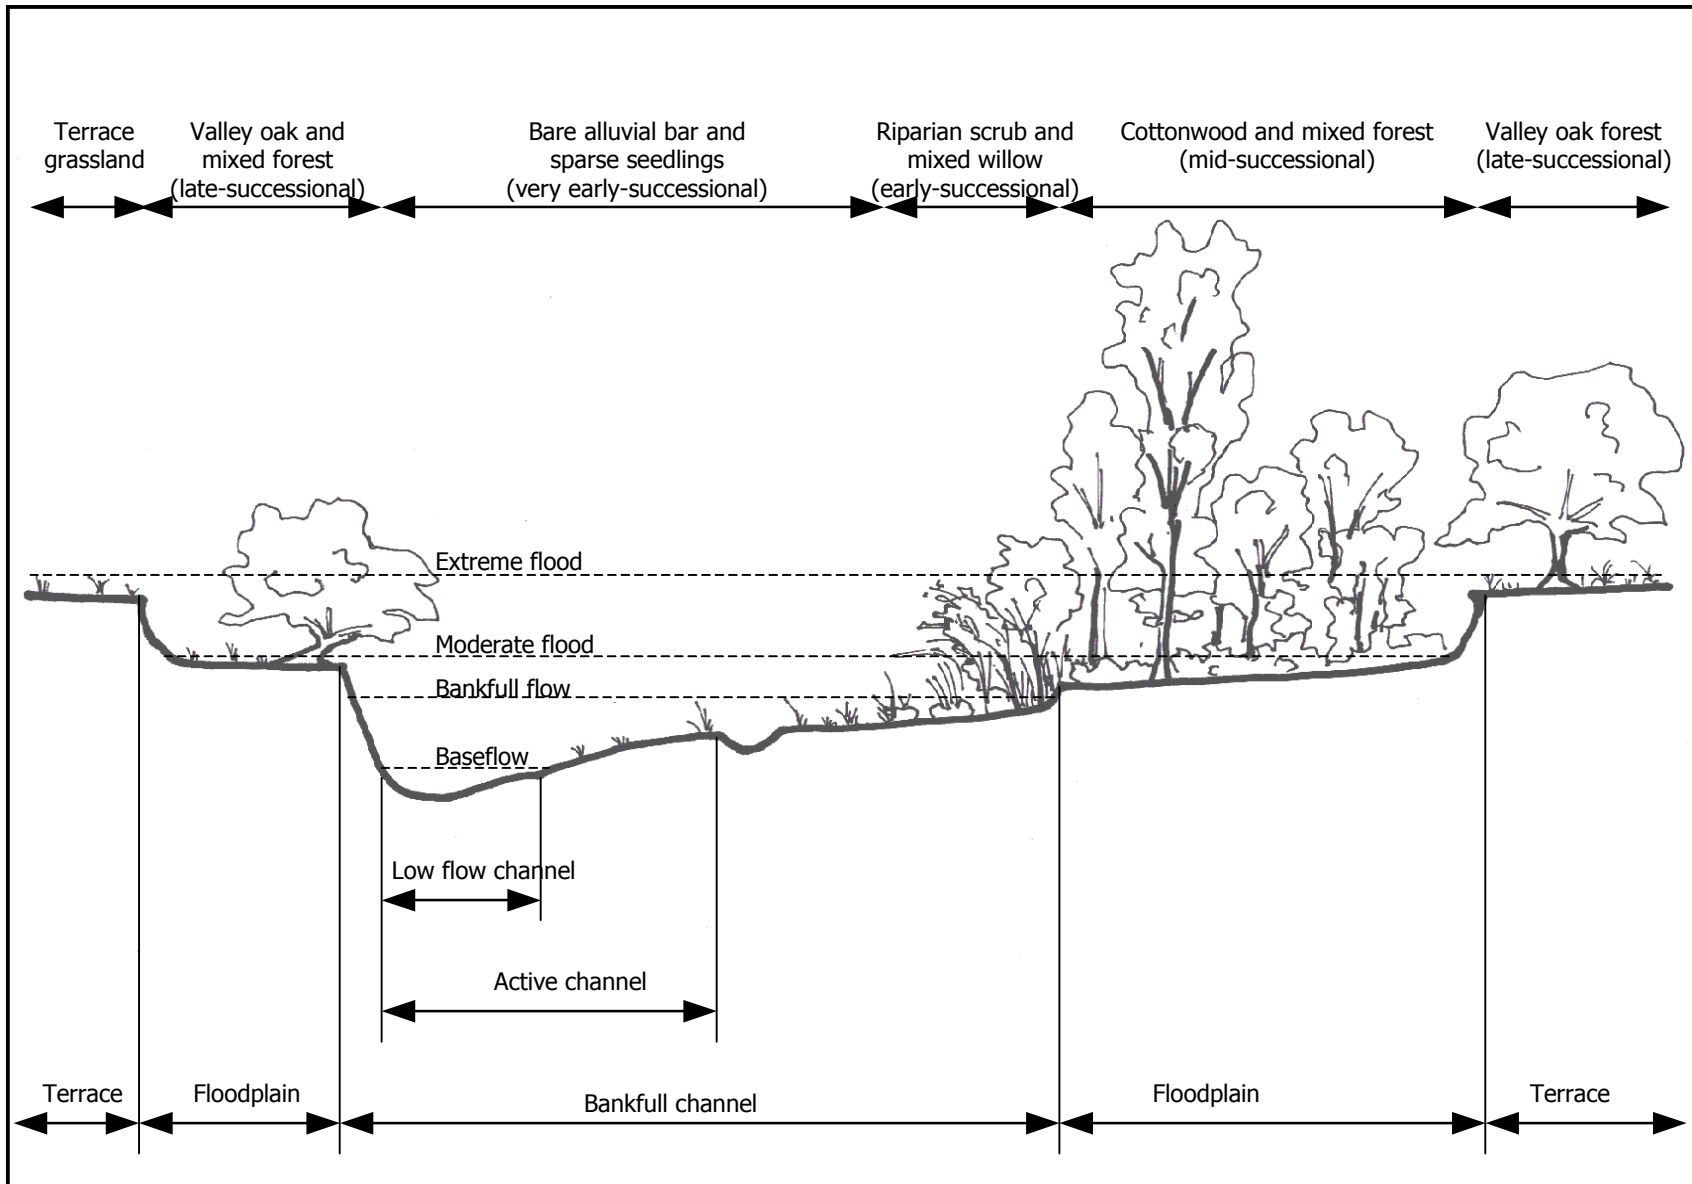
**Figure 5.6-1. Schematic cross section of the "healthy" alluvial river.**

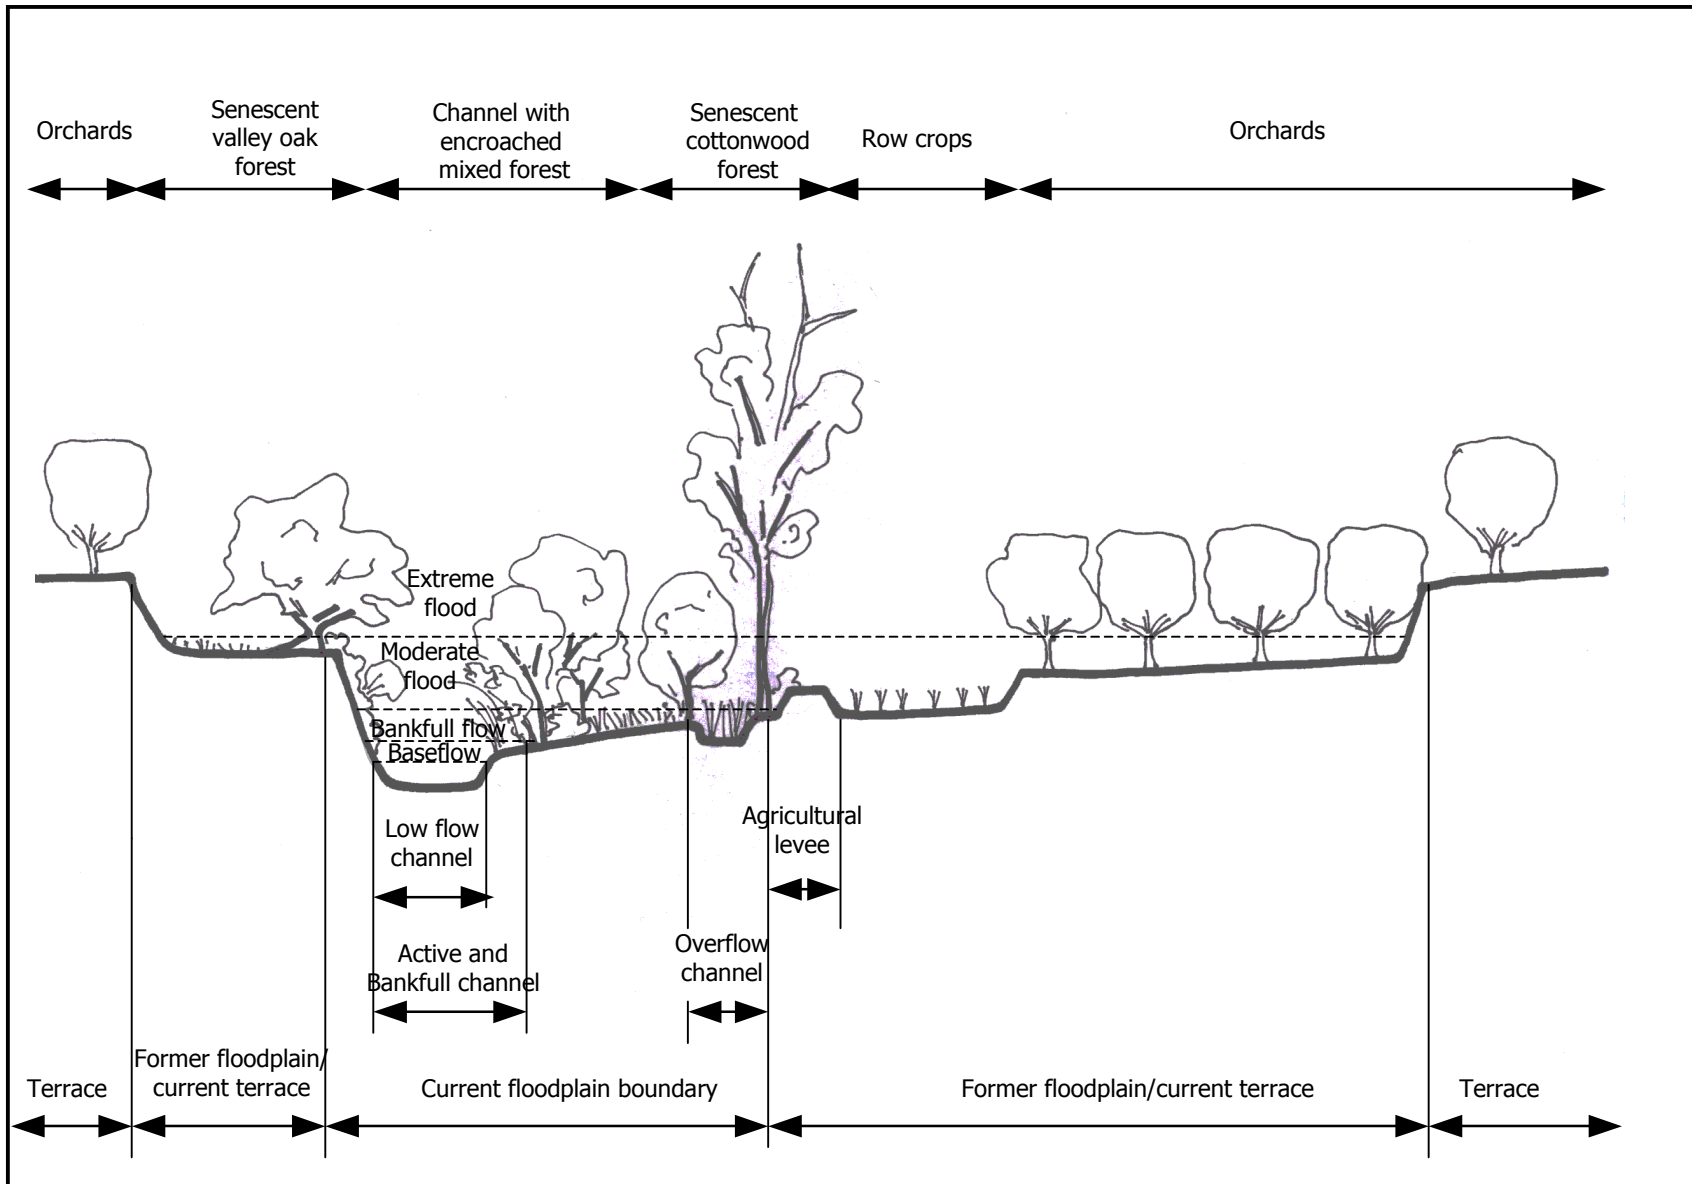
**Figure 5.6-2. Schematic cross section of a river channel with encroached riparian vegetation.**

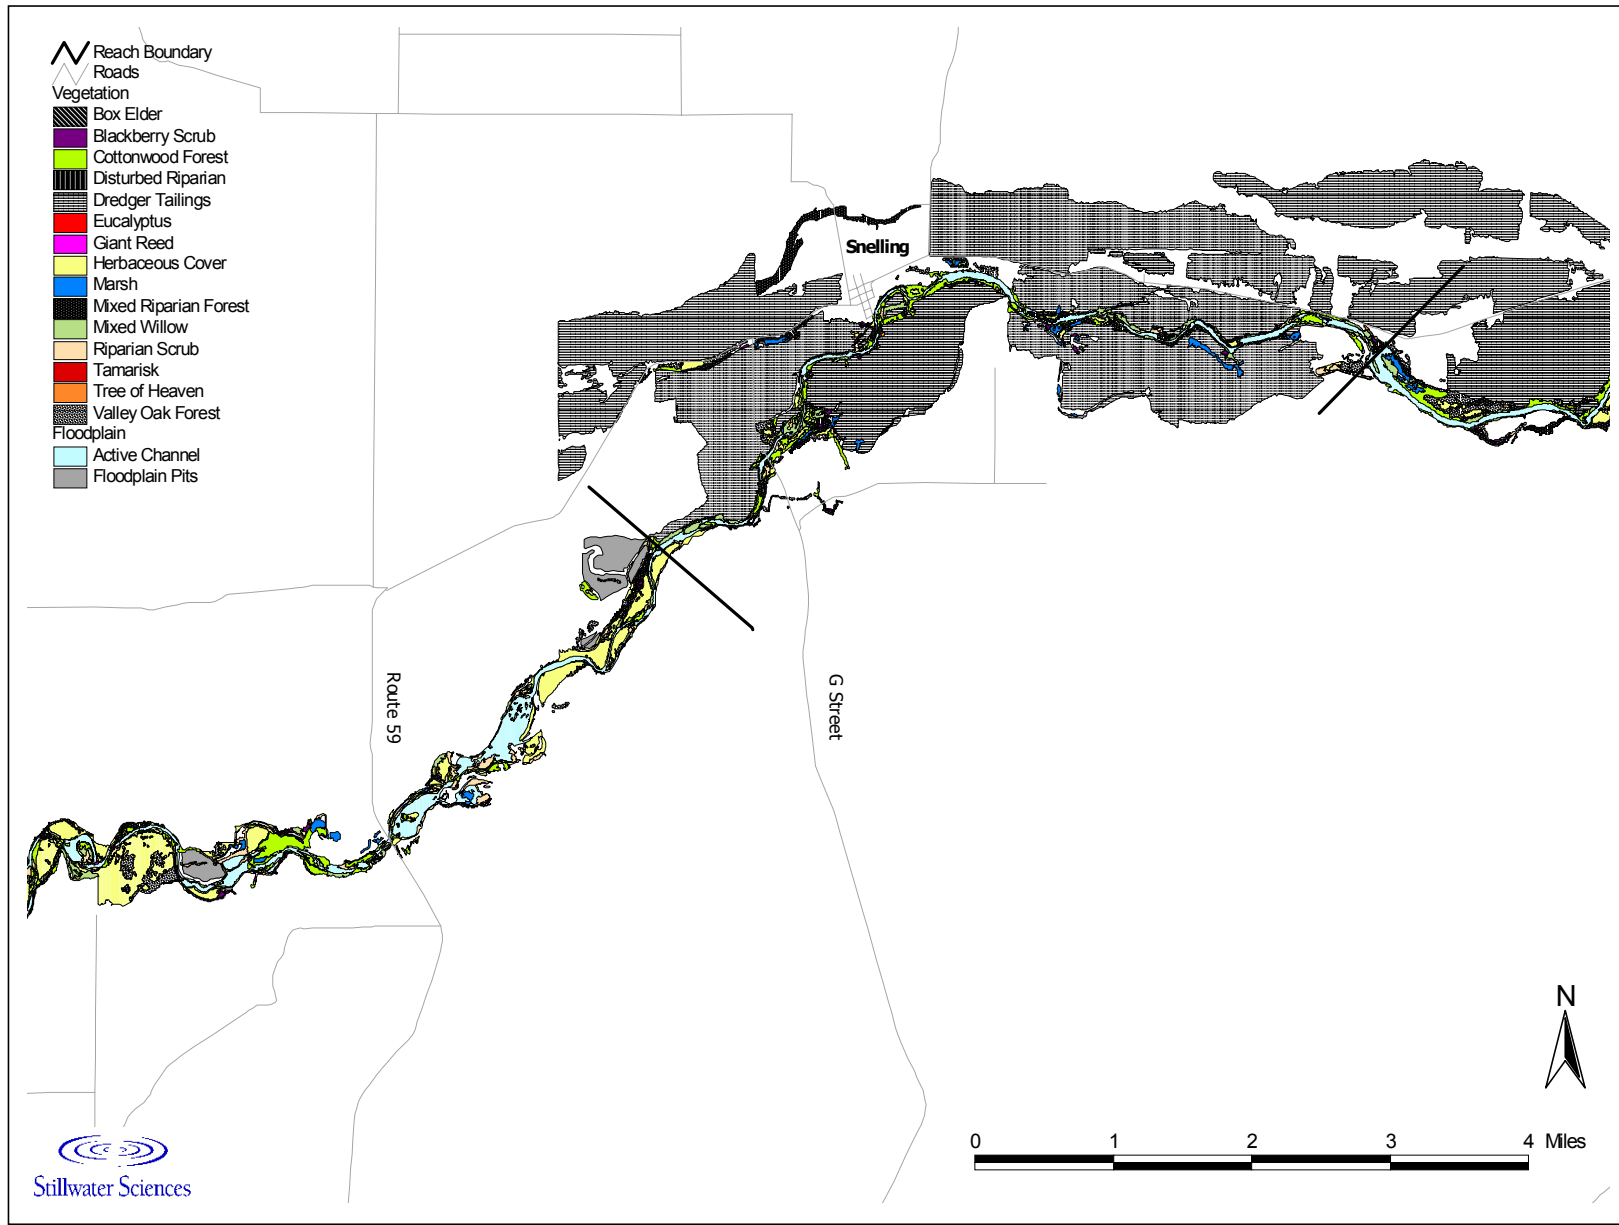
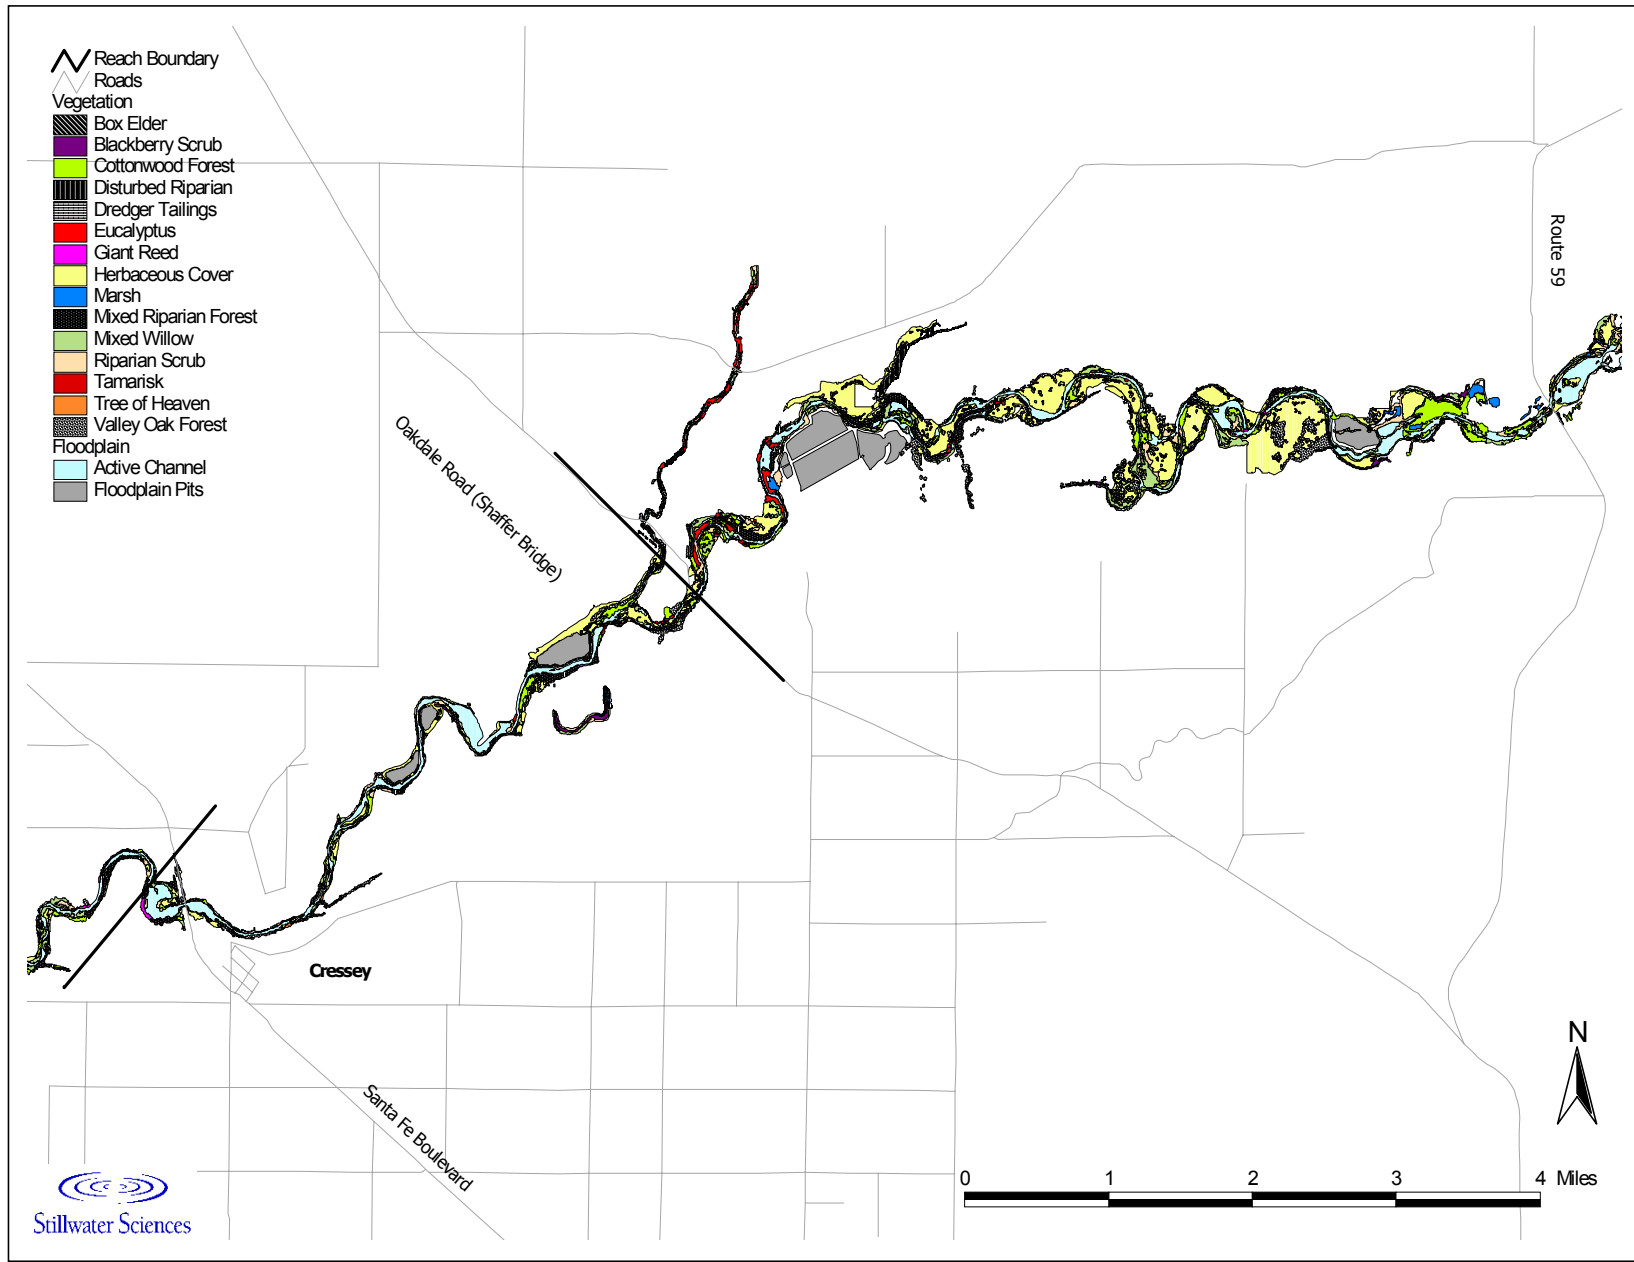
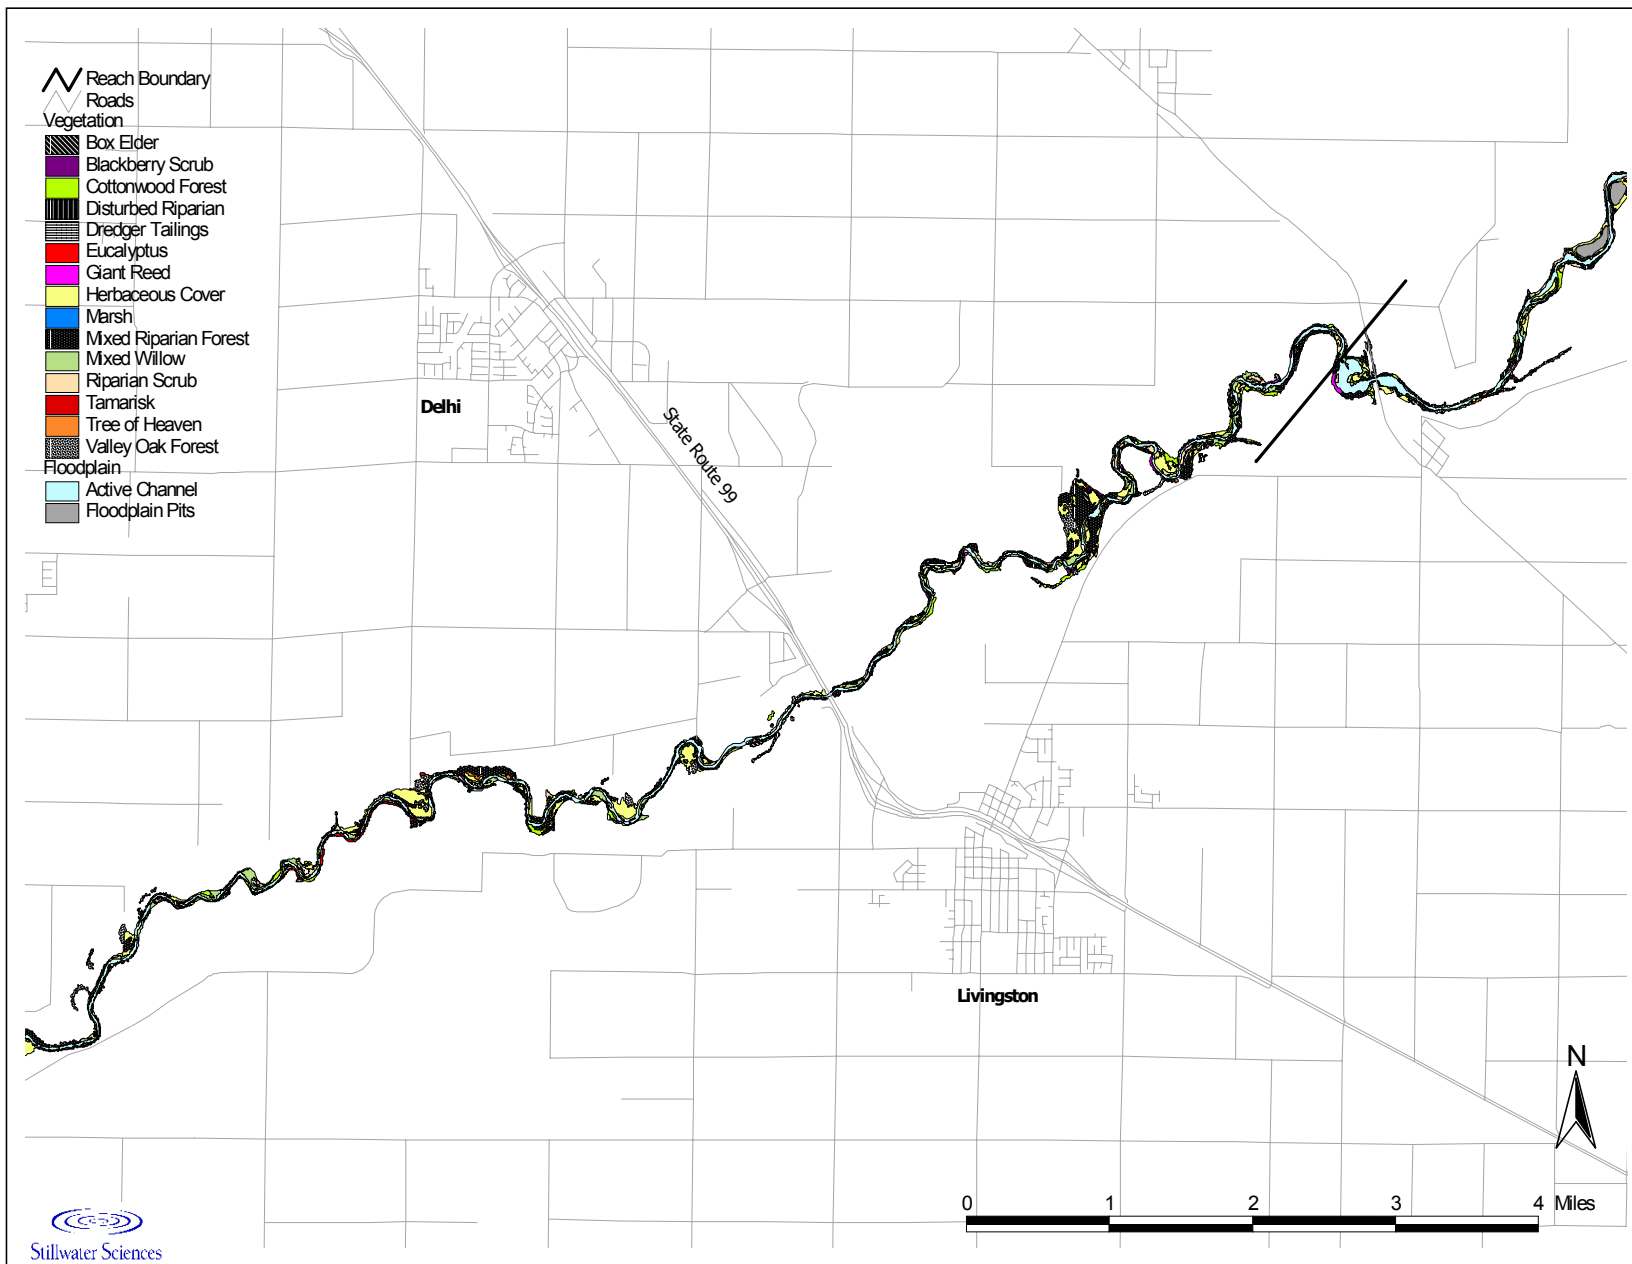
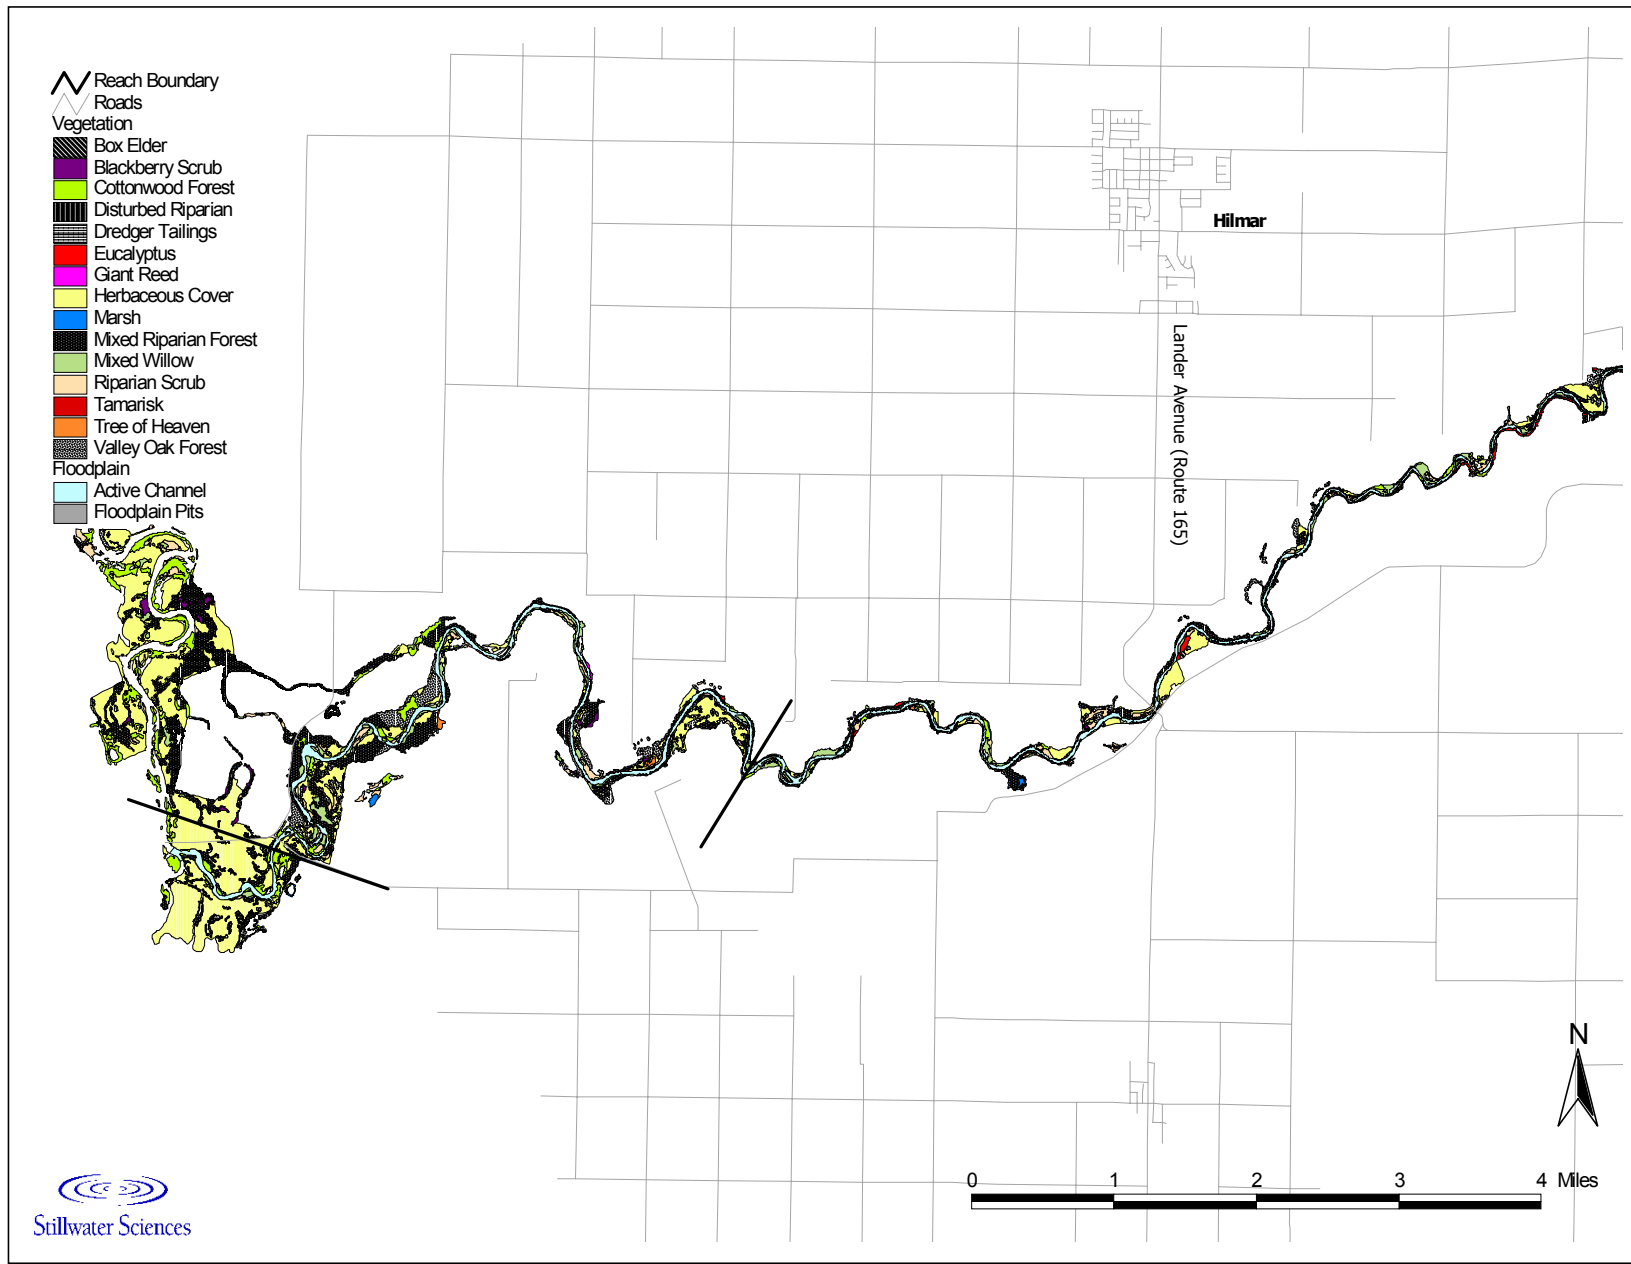
Figure 6.1-1A. Merced River vegetation distribution.

Figure 6.1-1B. Merced River vegetation distribution.

Figure 6.1-1C. Merced River vegetation distribution.

Figure 6.1-1D. Merced River vegetation distribution

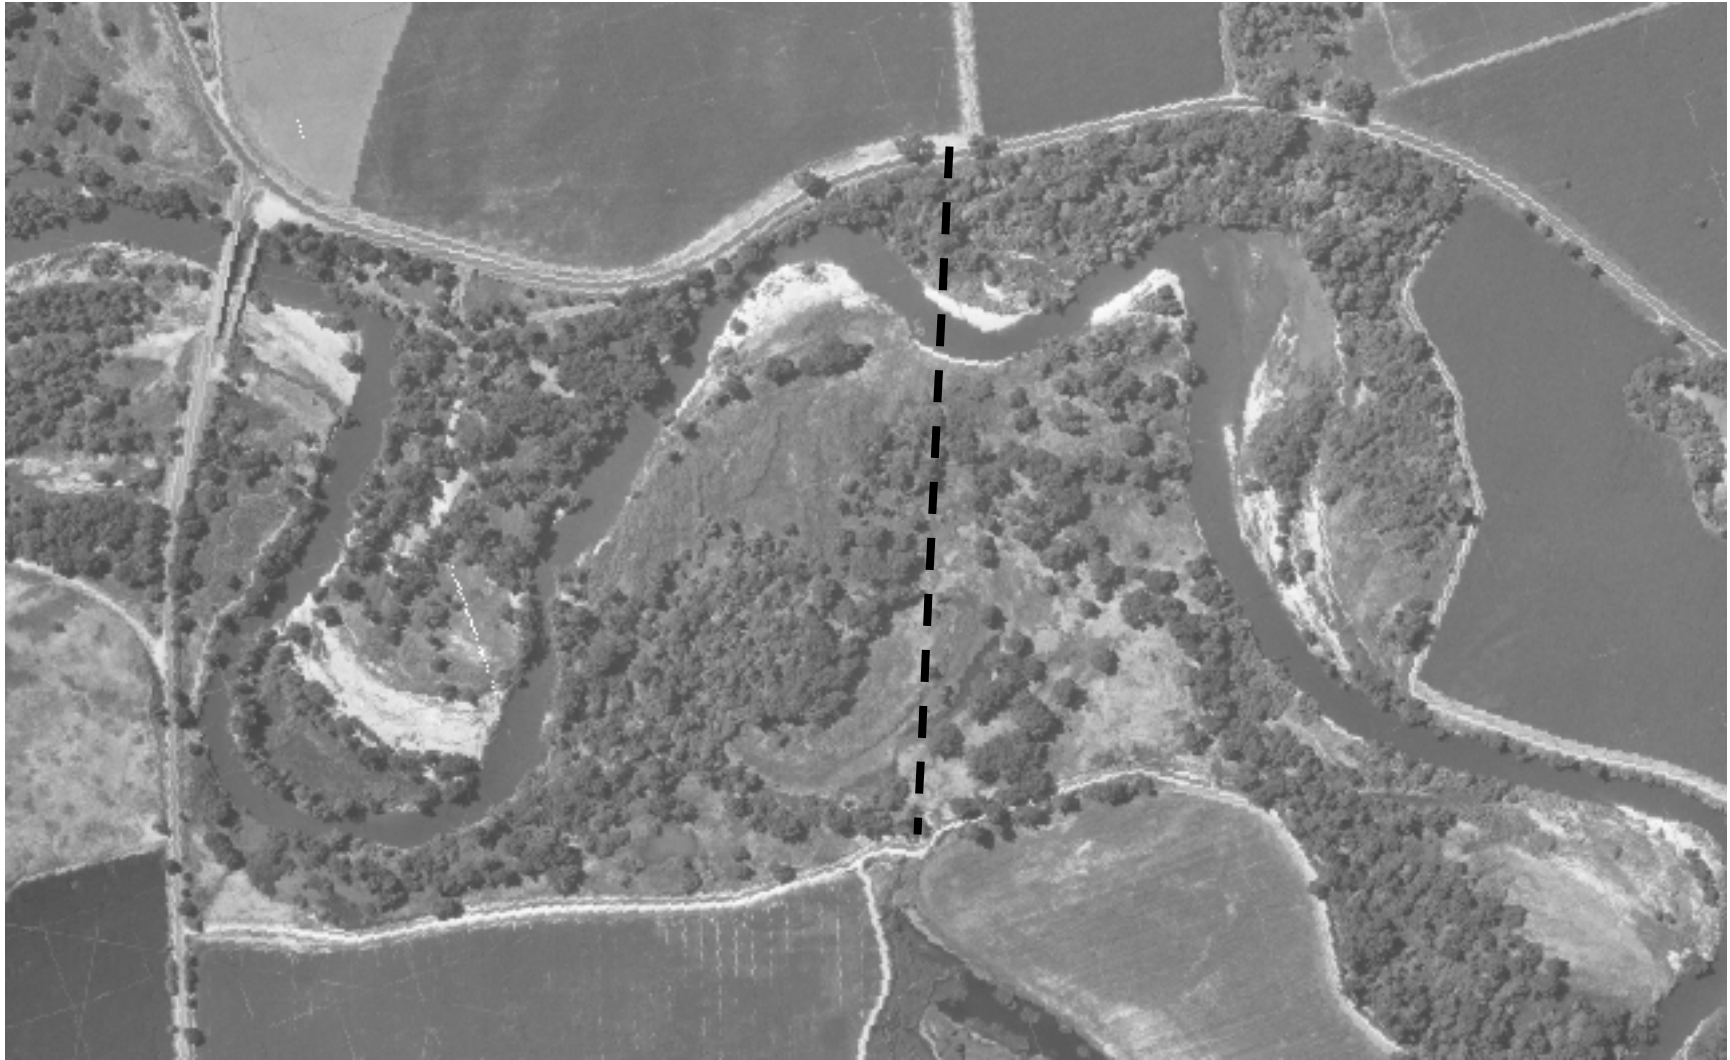
**Figure 6.2-1. Aerial photograph of the Stevinson Site showing vegetation transect location.**  
(photo: Merced County Planning and Community Development Department 1998)
