## **Merced River Corridor Restoration Plan Baseline Studies**

# **Volume II: Geomorphic and Riparian Vegetation Investigations Report**

**VOLUME II  
GEOMORPHIC AND RIPARIAN VEGETATION  
INVESTIGATIONS REPORT**

Stillwater Sciences  
2532 Durant Avenue  
Berkeley, CA 94704

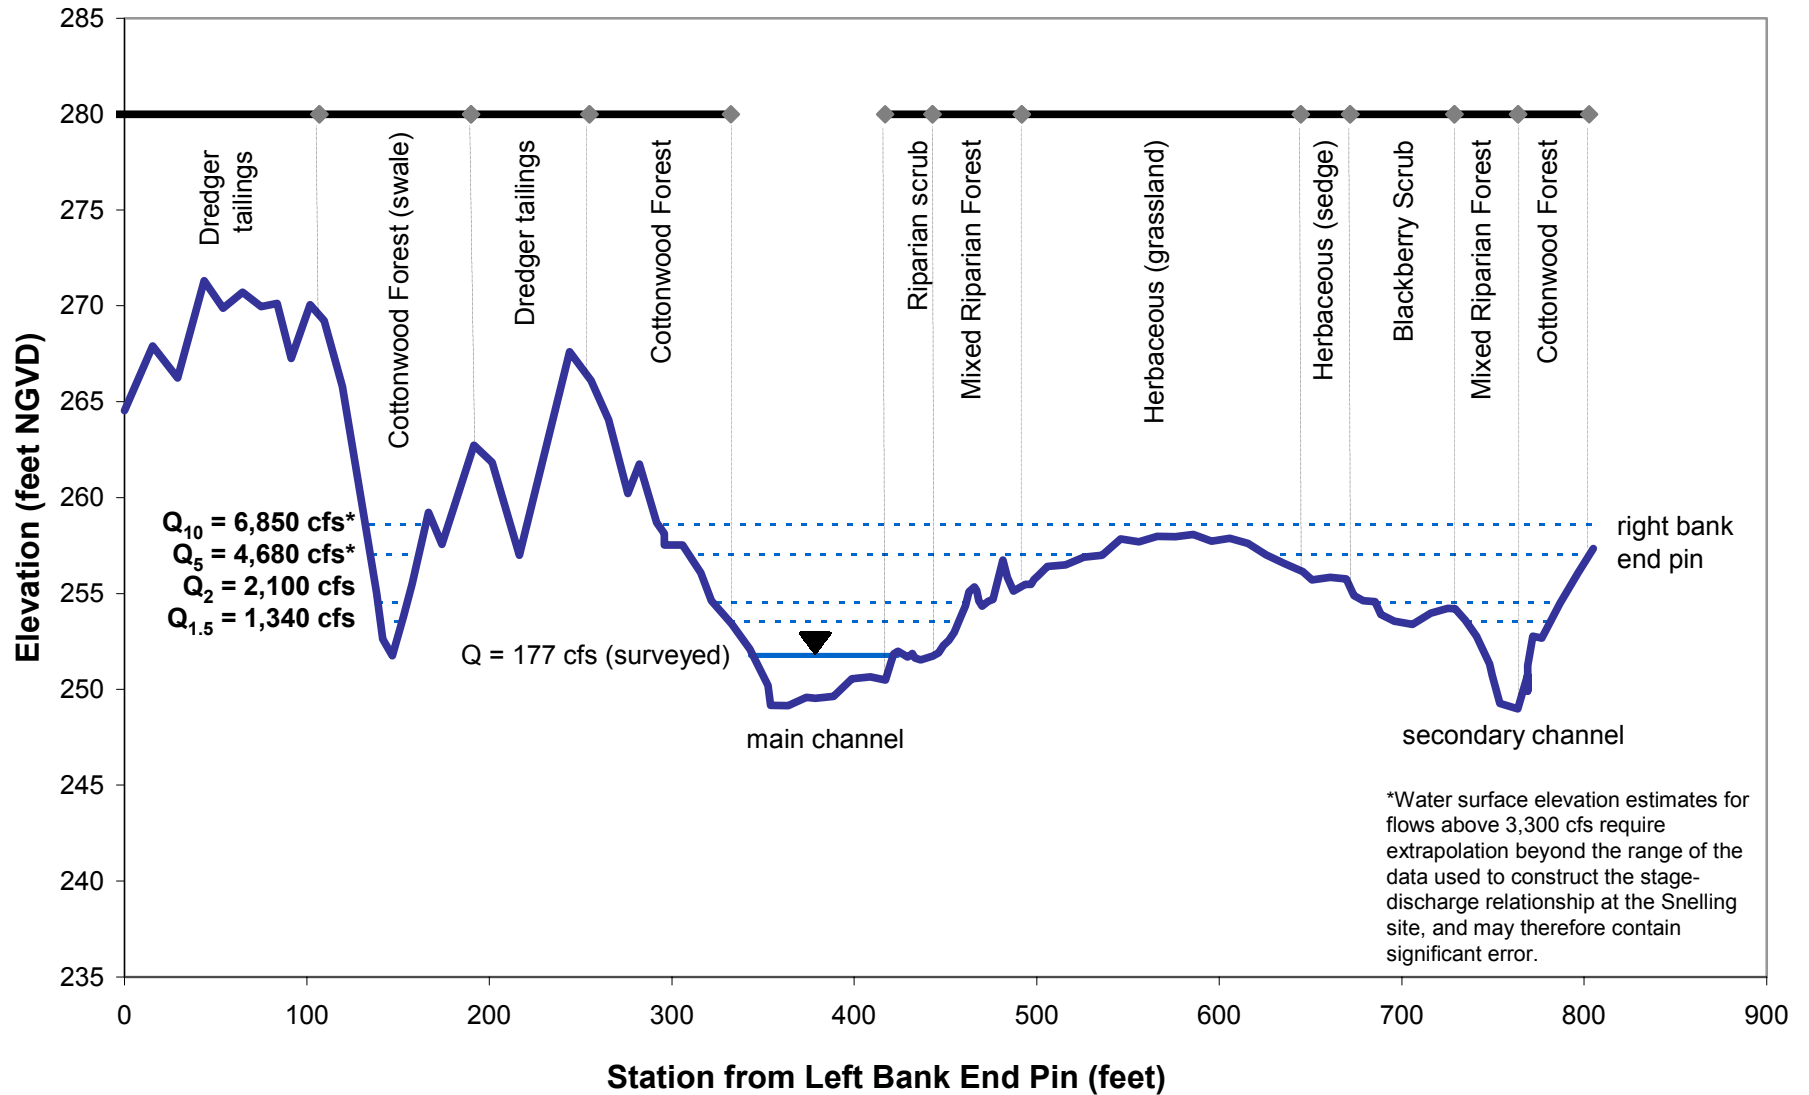
**Figure 6.3-2. Snelling Site vegetation cover and topographic cross section 13+95.**

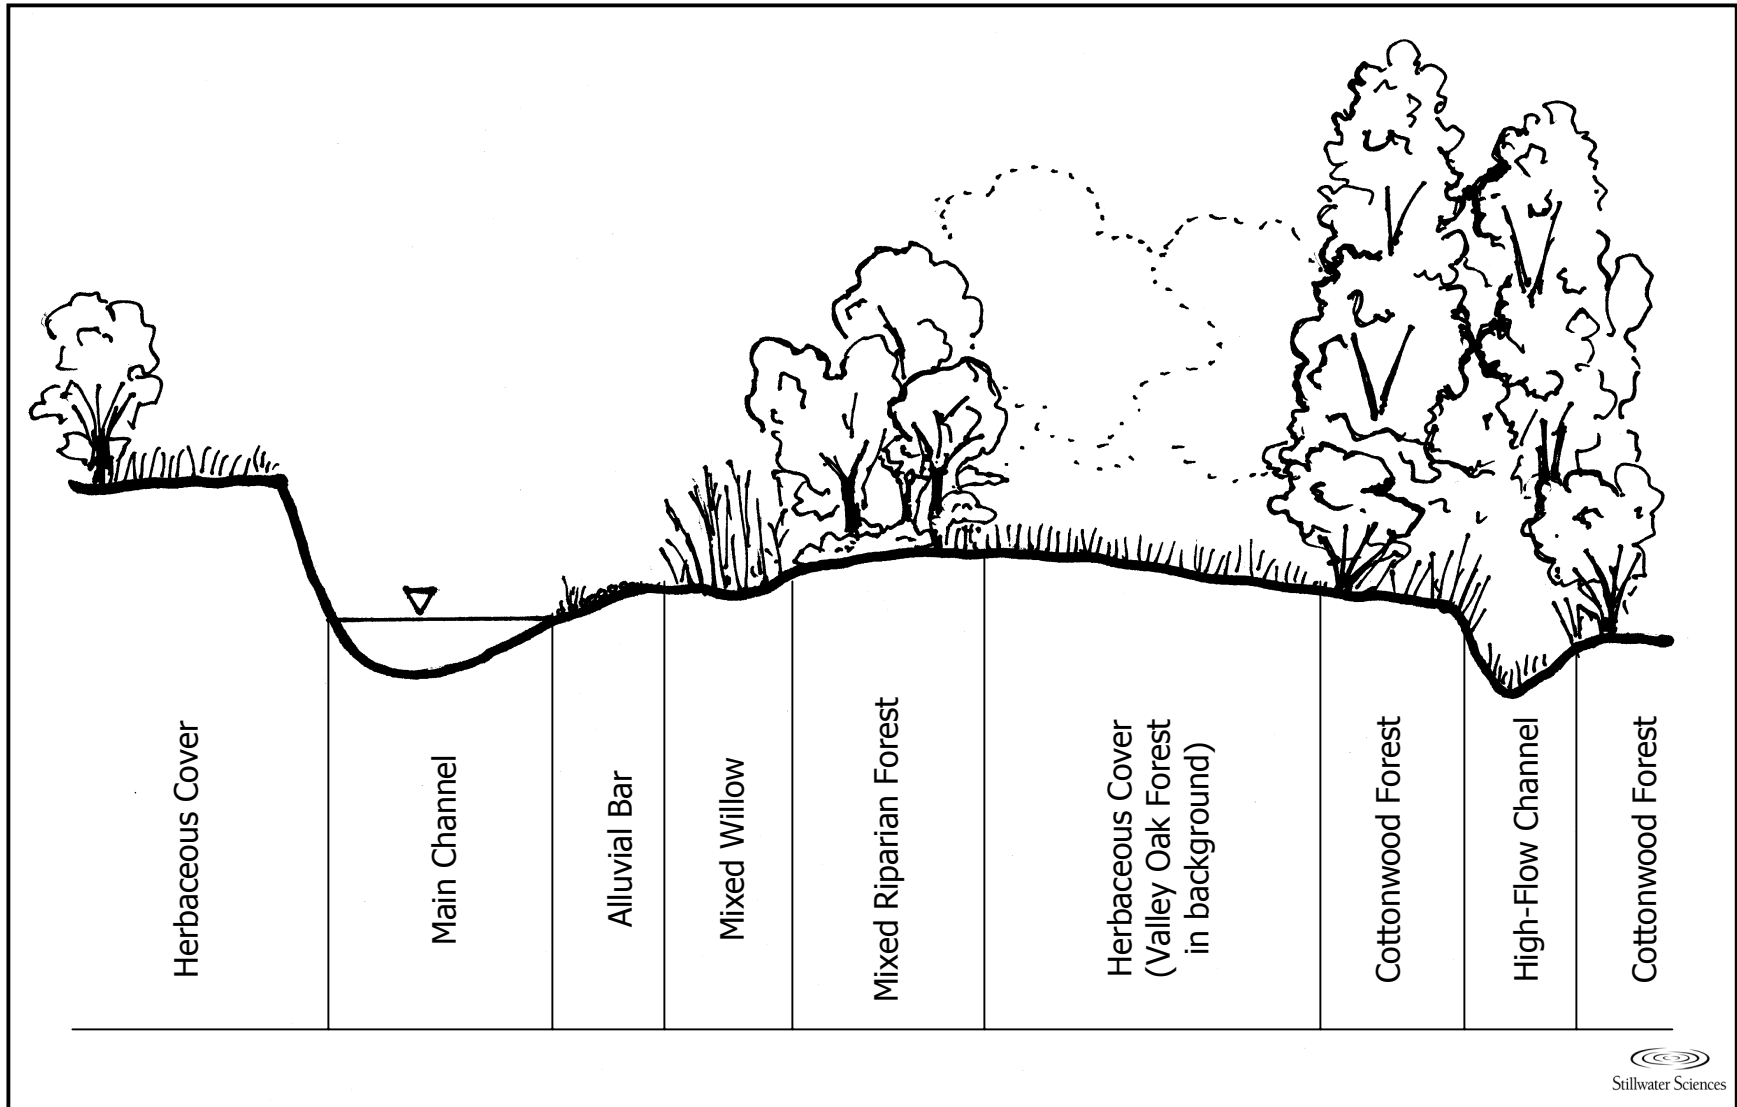
**Figure 6.4-1. Generalized vegetation toposequence for least disturbed sites on the Merced River.**

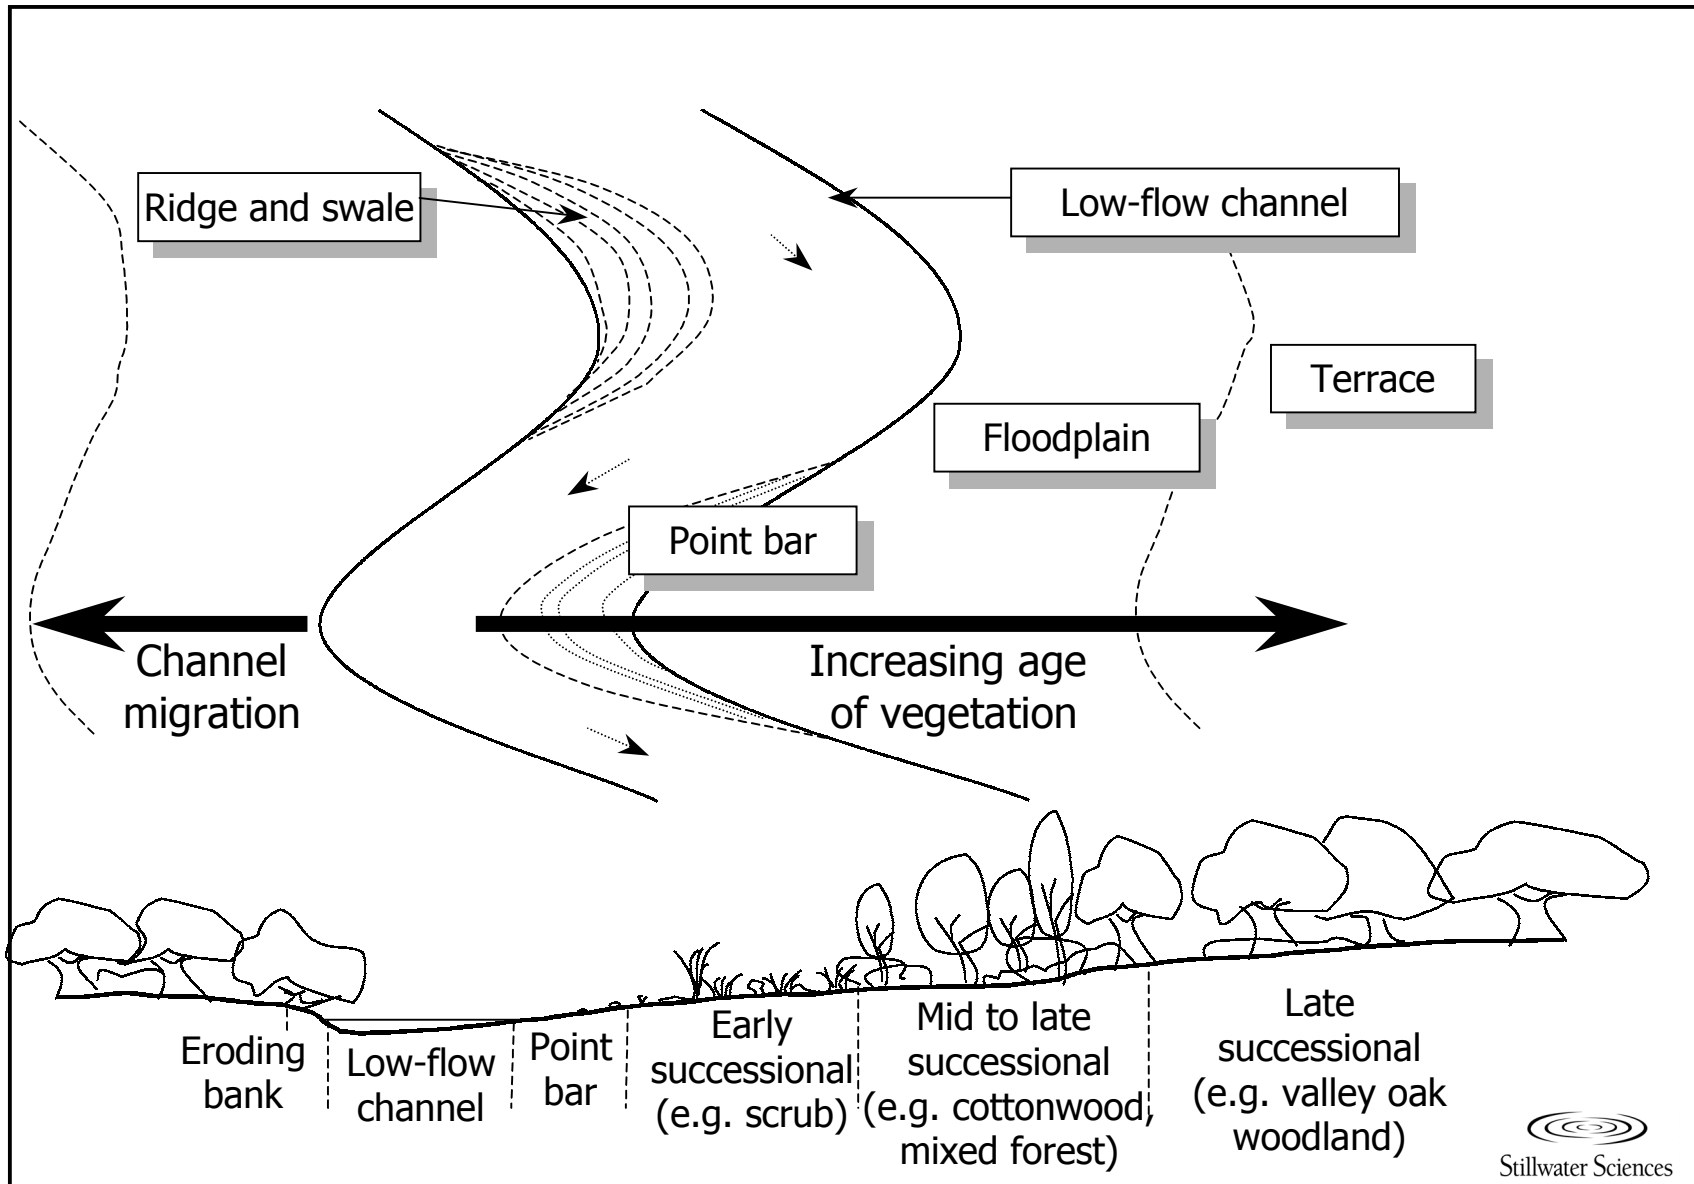
**Figure 6.5-2. Schematic diagram of riparian succession.**

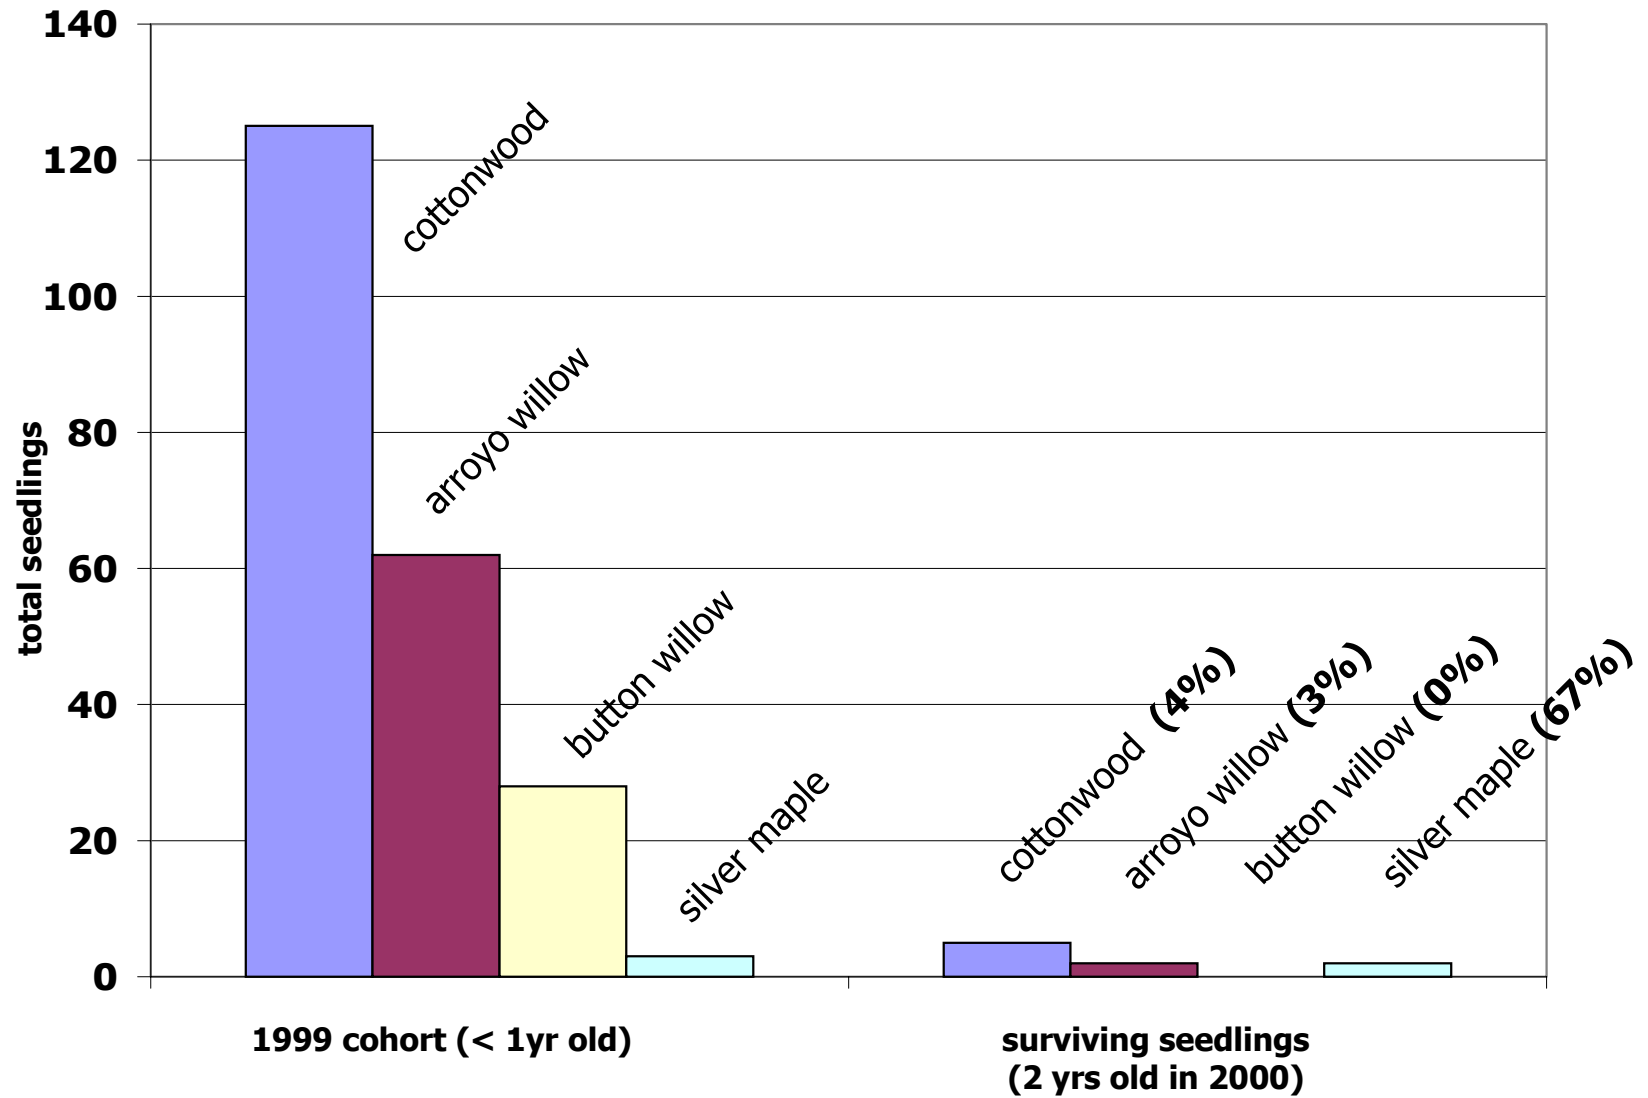
**Figure 6.5-3. Seedling survival between October 1999 and June 2000, Snelling cross section 13+95.**  
 Percent survival for each species is in parentheses.

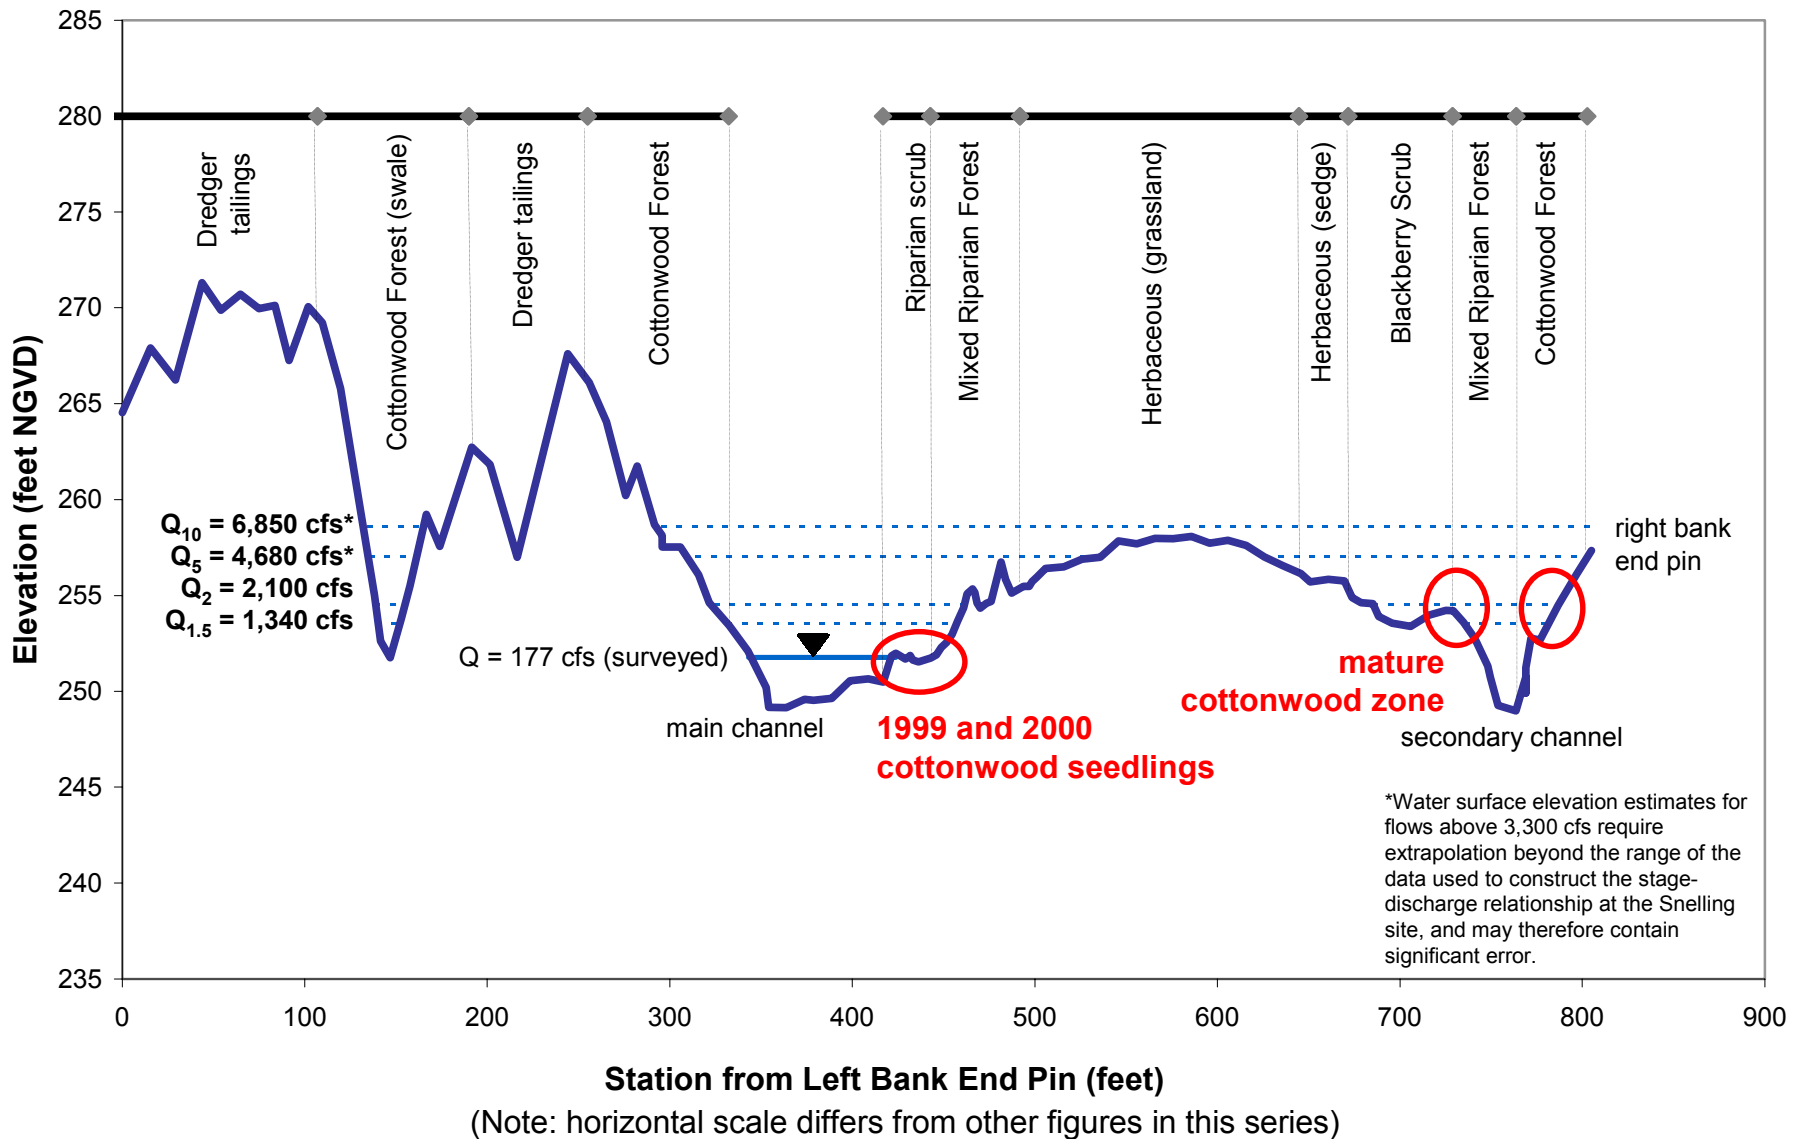
**Figure 6.5-5. Snelling cross section 13+95, showing elevation and inundation frequency of current cottonwood germination zone and root crown elevation of mature cottonwoods.** Current seedlings germinate within the bankfull channel. Mature trees are inundated at flows corresponding to the post-dam 1.5 to 5-year recurrence intervals.

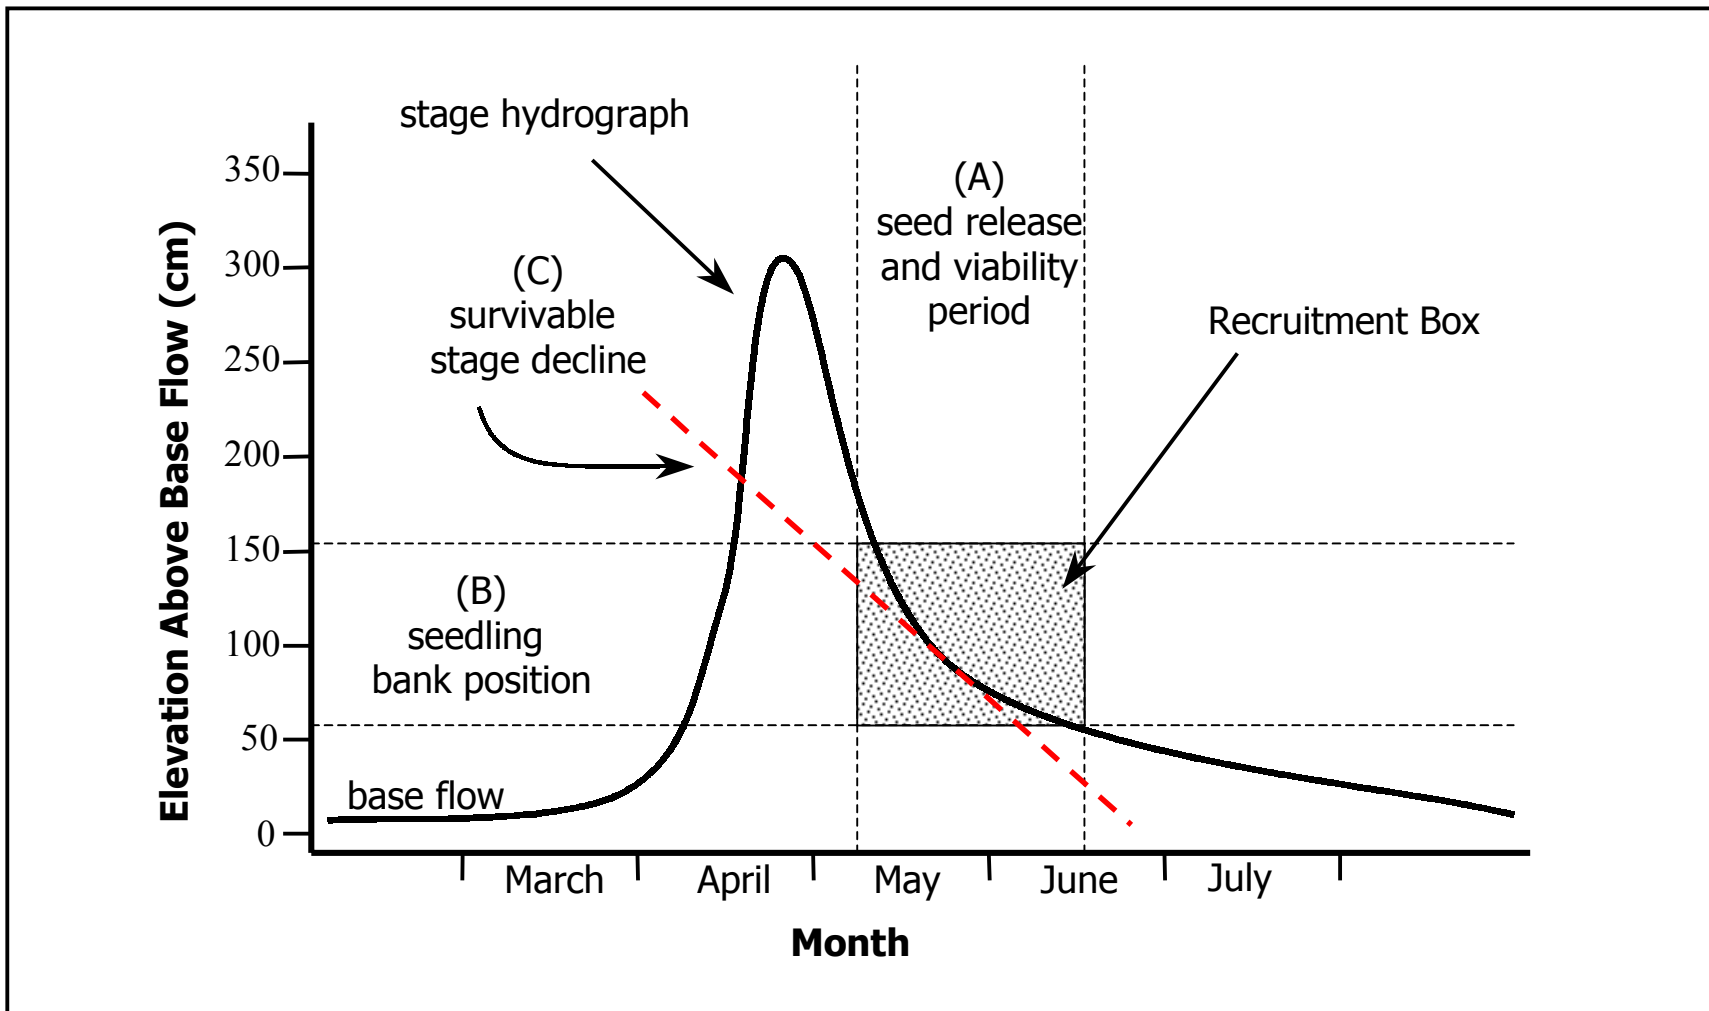
**Figure 6.5-6. The 'Recruitment Box' concept** (adapted from Mahoney and Rood, 1998). The recruitment box is a space defined in elevation and time in which seedlings of riparian plant species are likely to become successfully established based on stream flow conditions. The graph represents the relationship between the stream hydrograph and the timing of (A) the seed release and viability period for a particular riparian plant species; (B) the range of bank elevations (or stream stages) at which successful seedling recruitment is likely to occur for that species; and (C) the survivable rate of stream stage decline determined by the seedling's ability to maintain functional contact with the receding water table through root elongation.

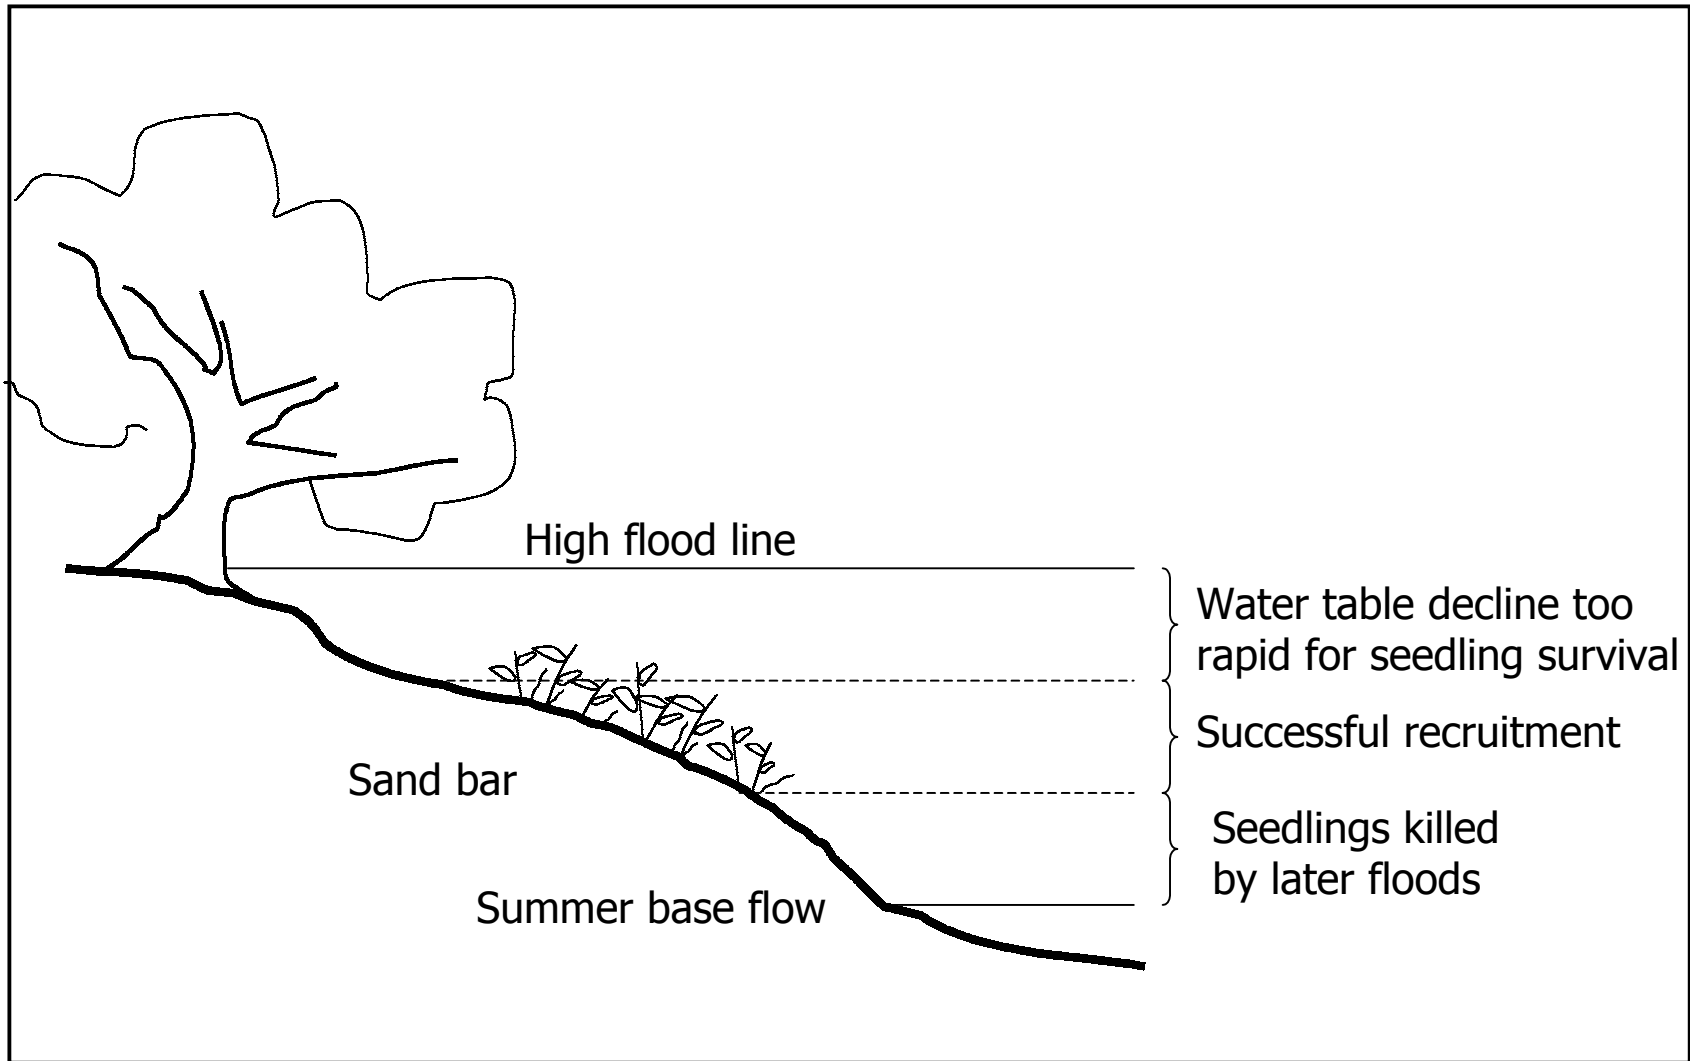
**Figure 6.5-7. Cottonwood and willow recruitment patterns.**
