## **Merced River Corridor Restoration Plan Baseline Studies**

# **Volume II: Geomorphic and Riparian Vegetation Investigations Report**

**VOLUME II  
GEOMORPHIC AND RIPARIAN VEGETATION  
INVESTIGATIONS REPORT**

Stillwater Sciences  
2532 Durant Avenue  
Berkeley, CA 94704

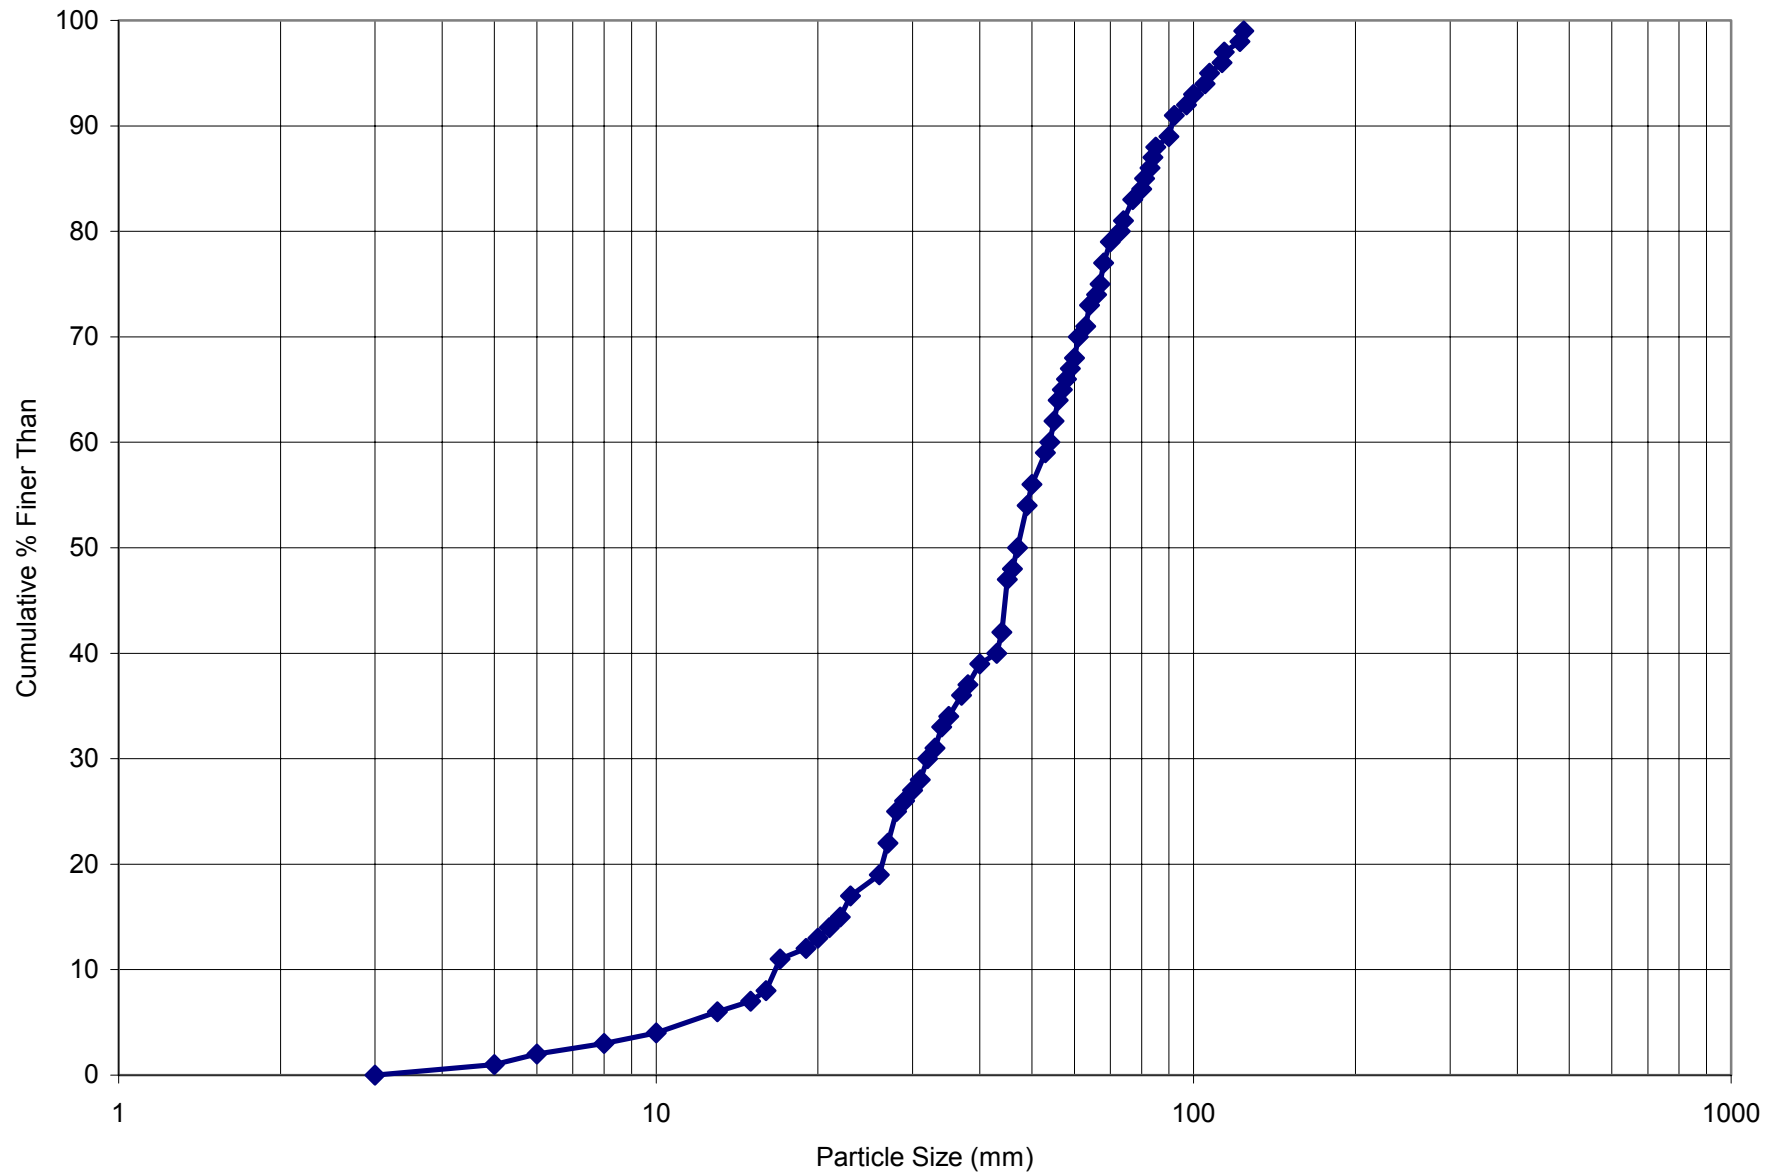
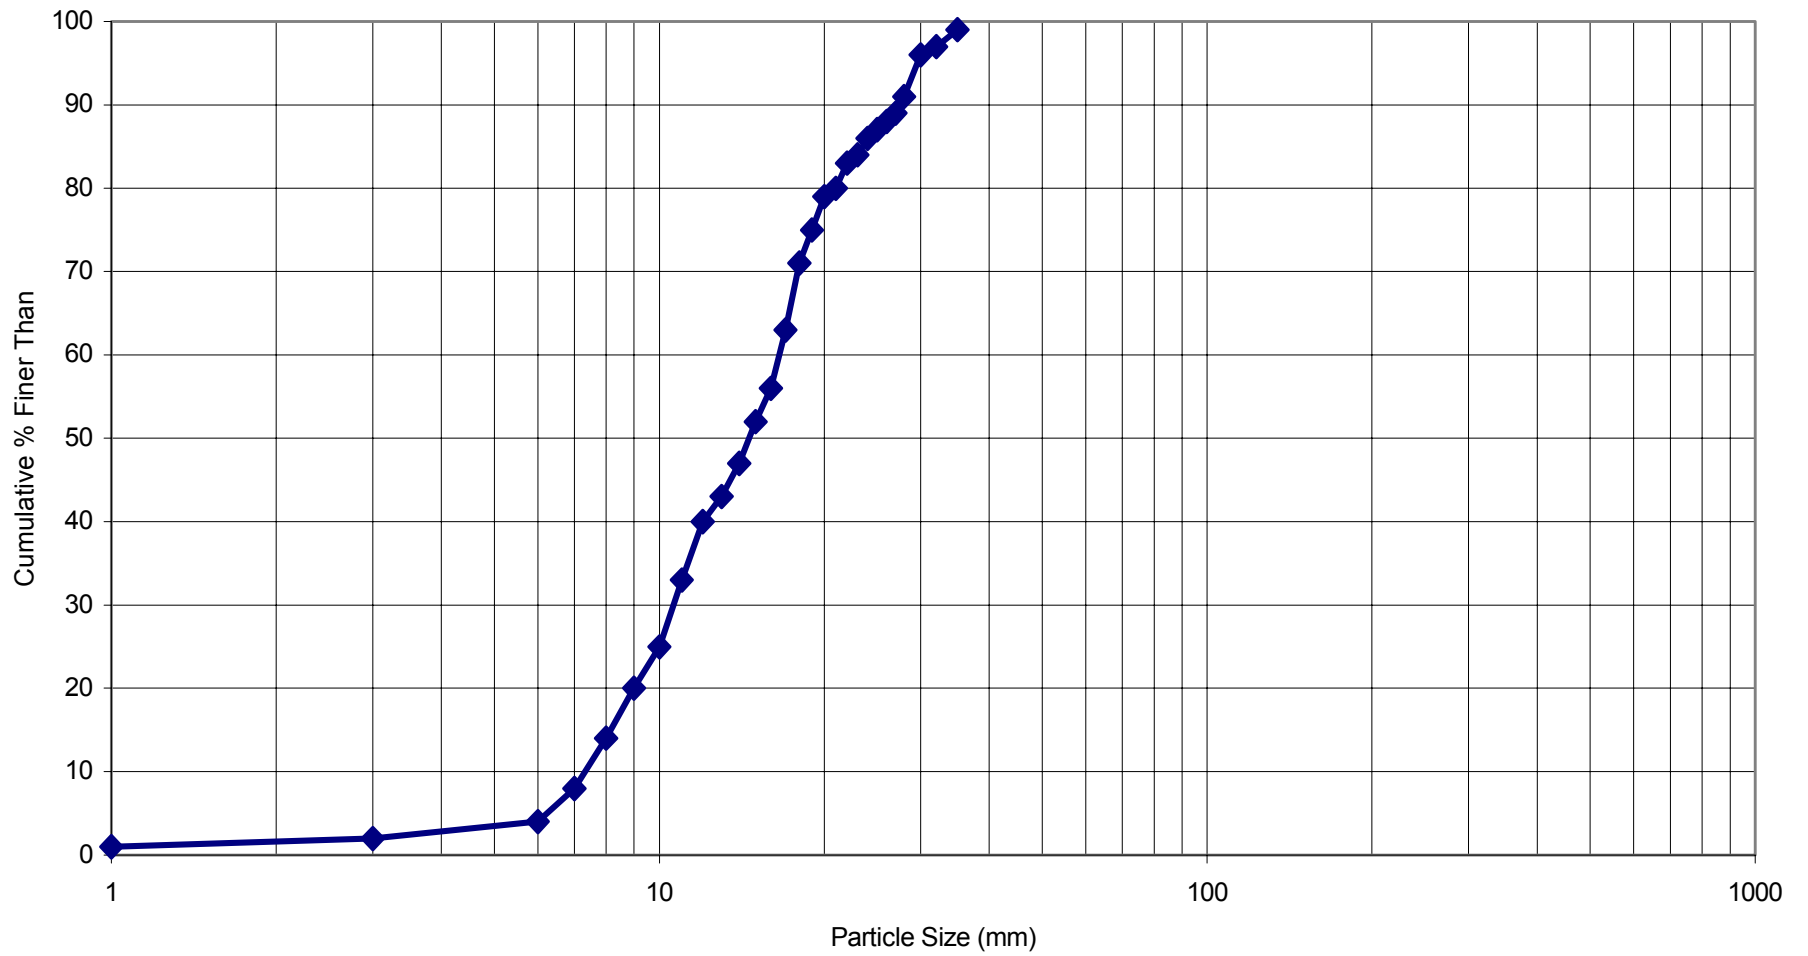
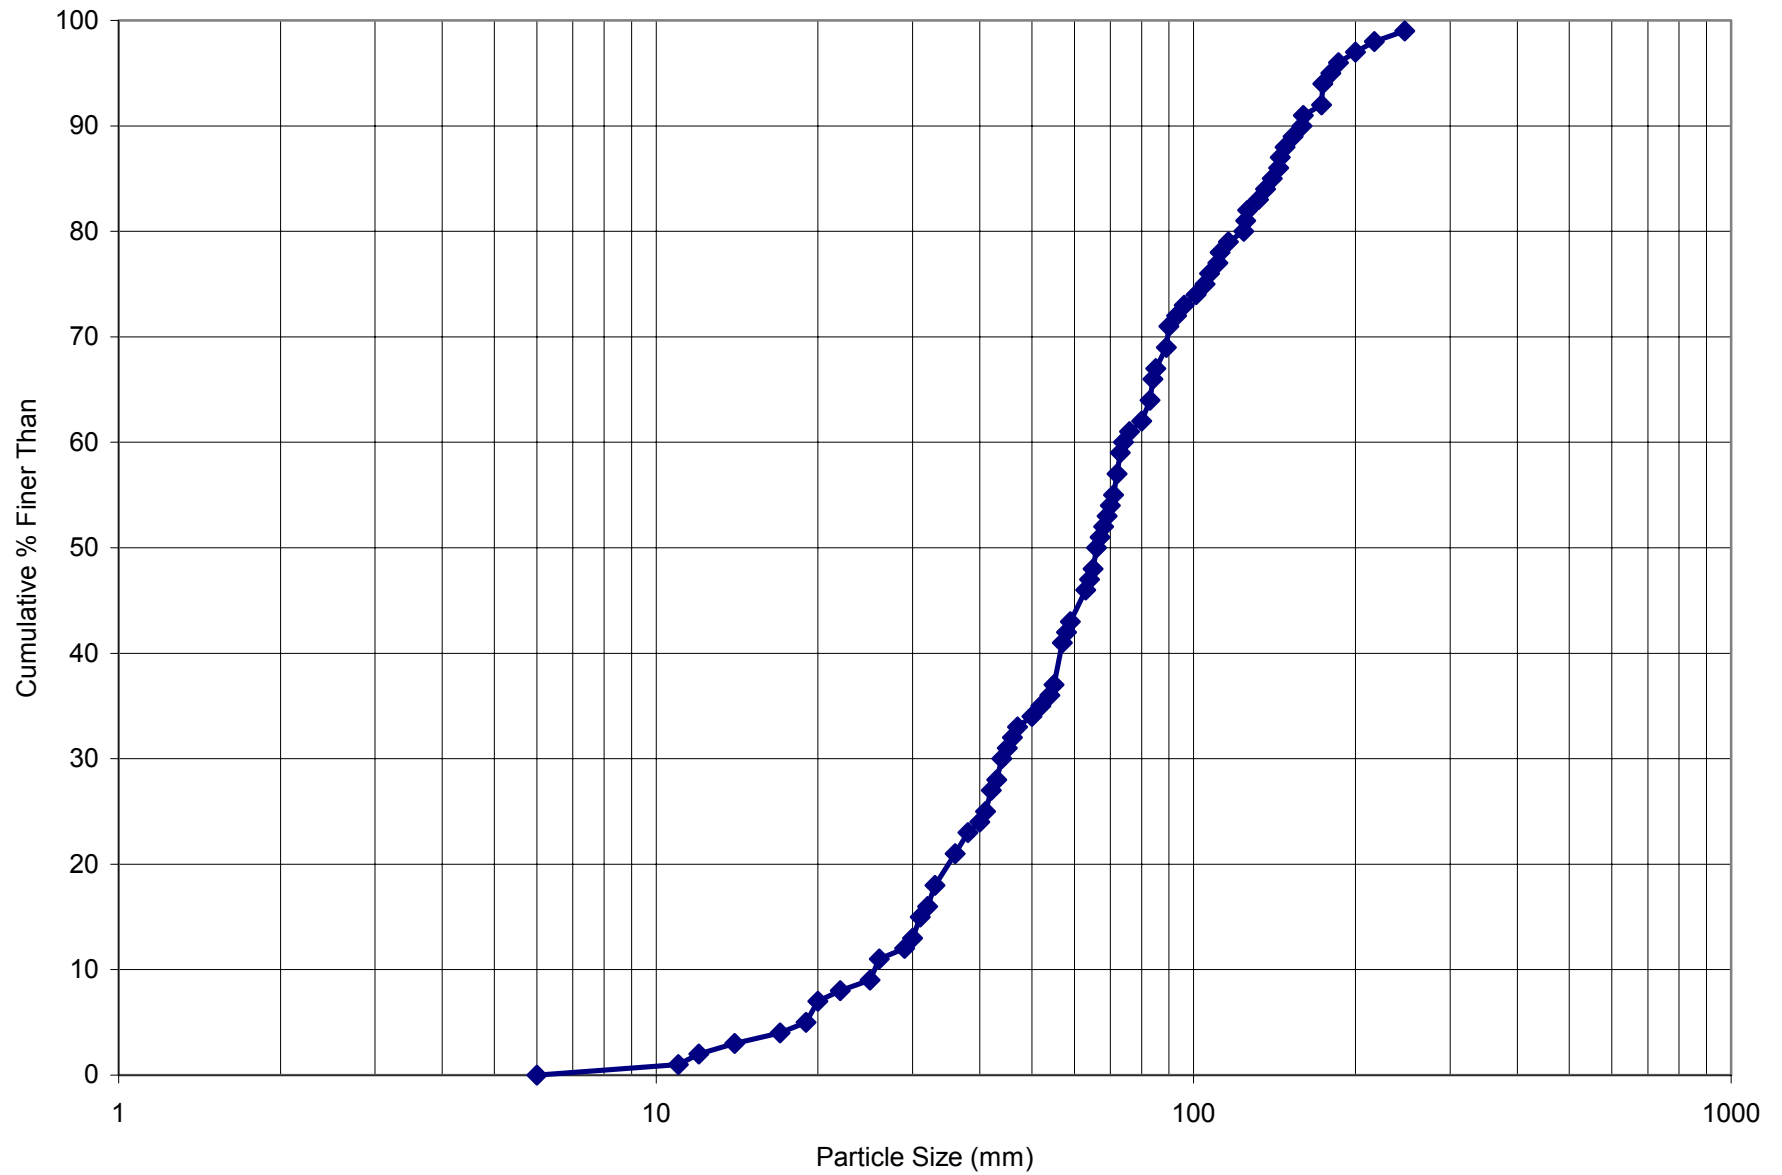
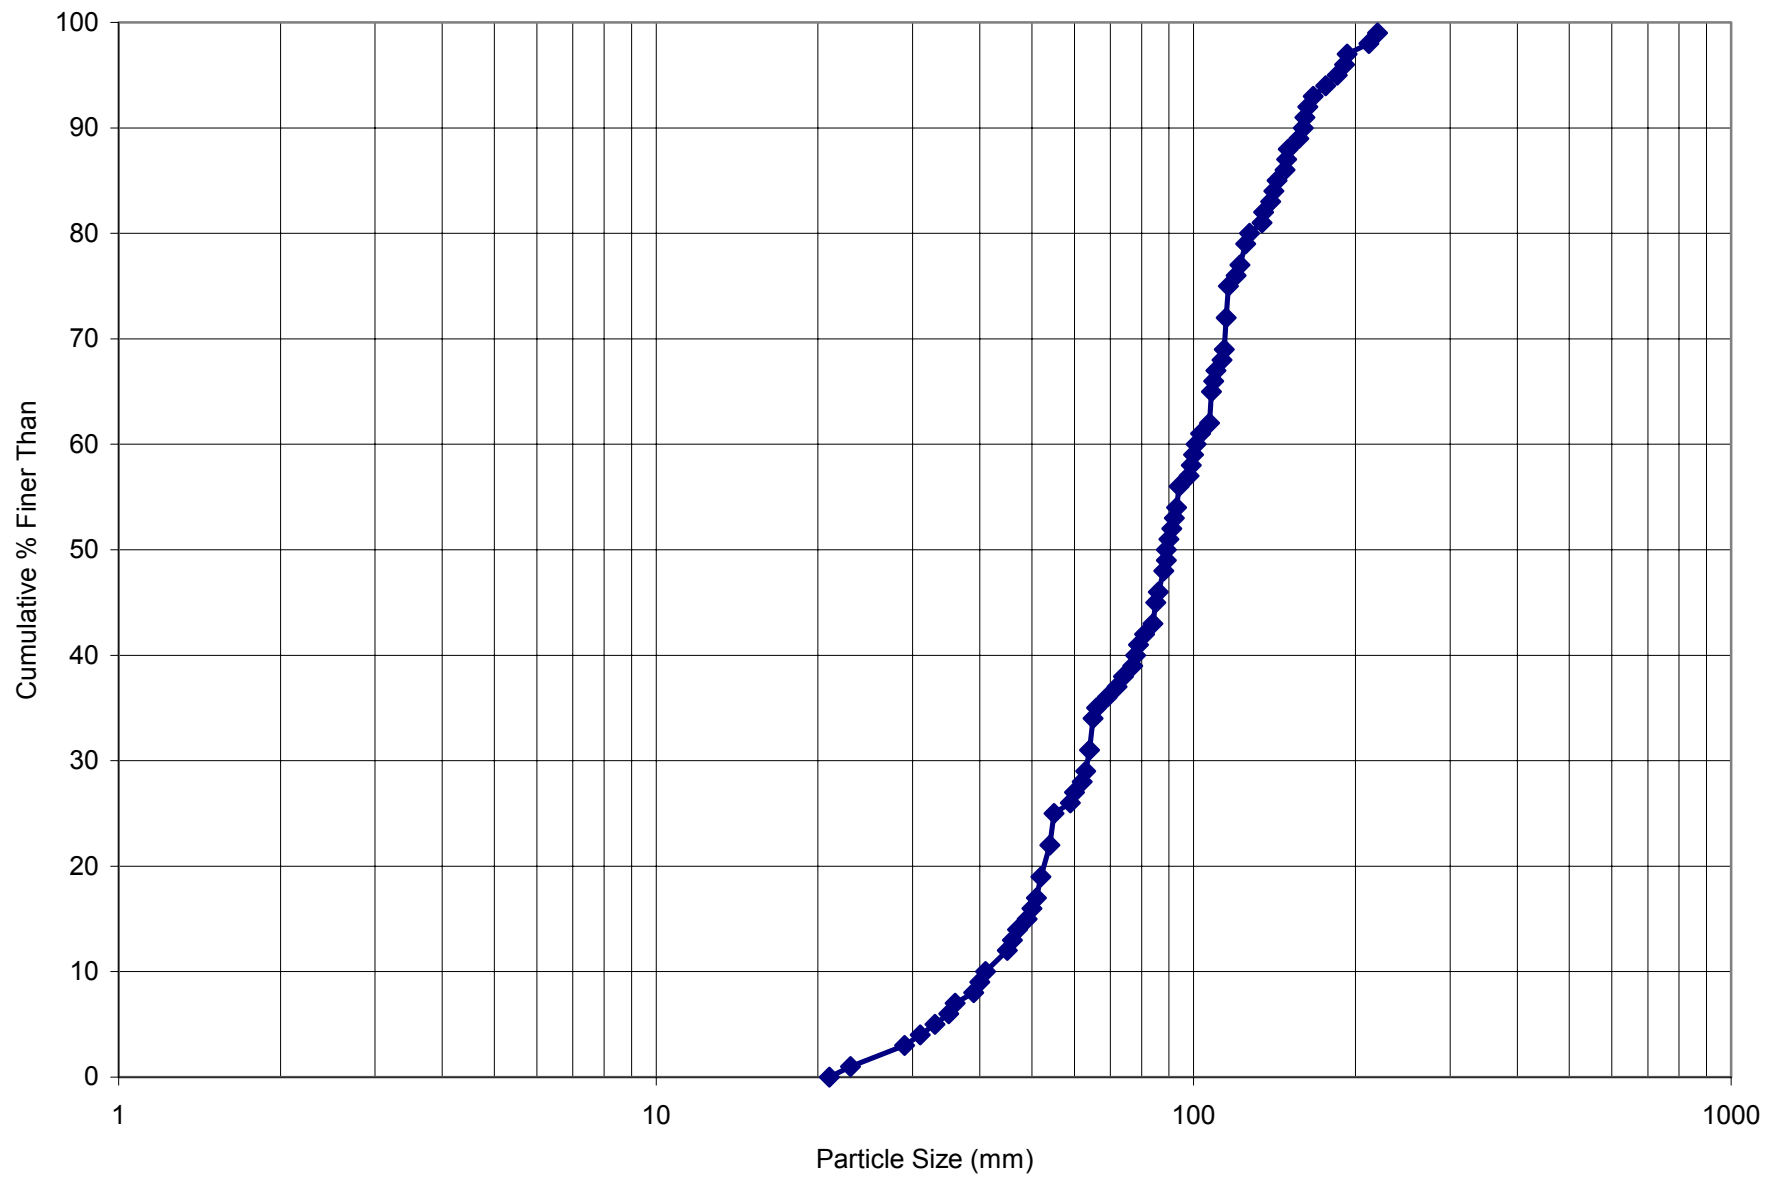
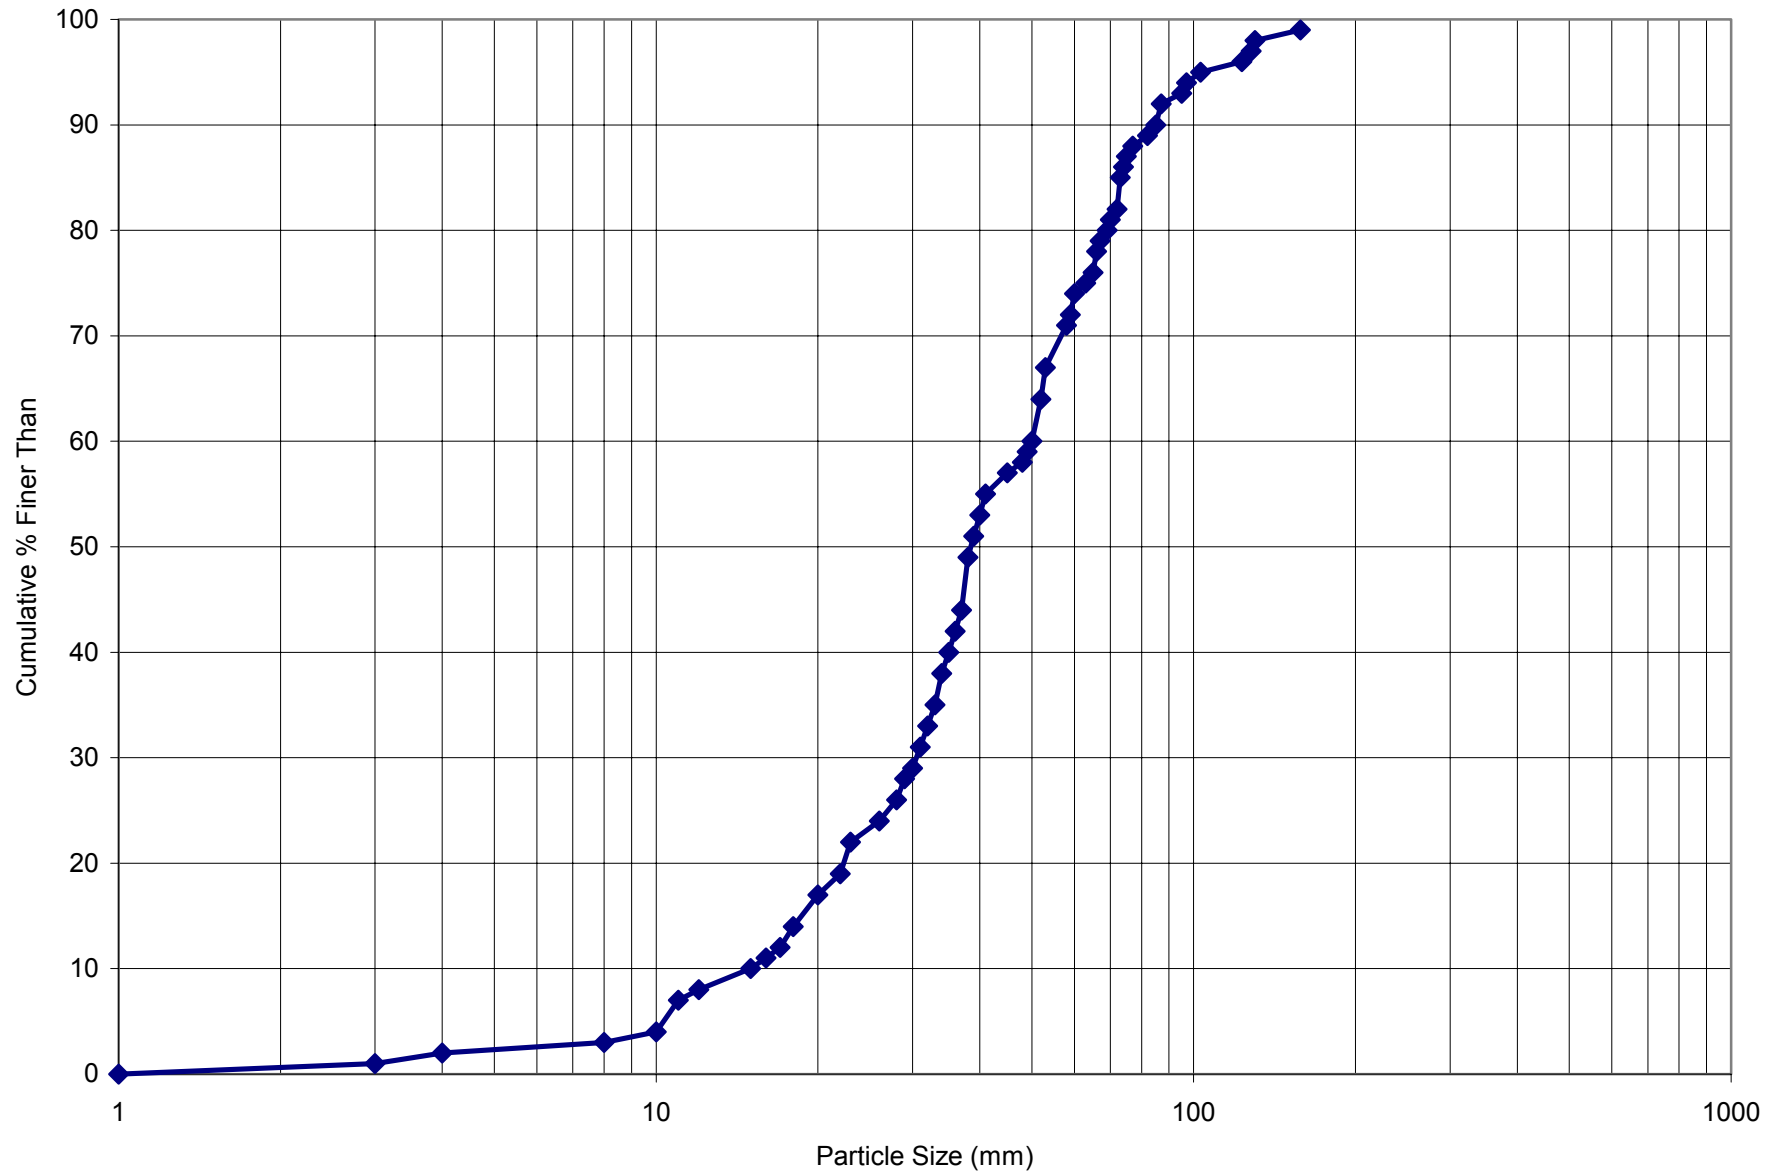
**Figure B-2. Snelling site pebble count 1.**

**Figure B-3. Snelling site pebble count 2.**

**Figure B-4. Snelling site pebble count 3A.**

**Figure B-5. Snelling site pebble count 3B.**

**Figure B-6. Snelling site pebble count 4.**

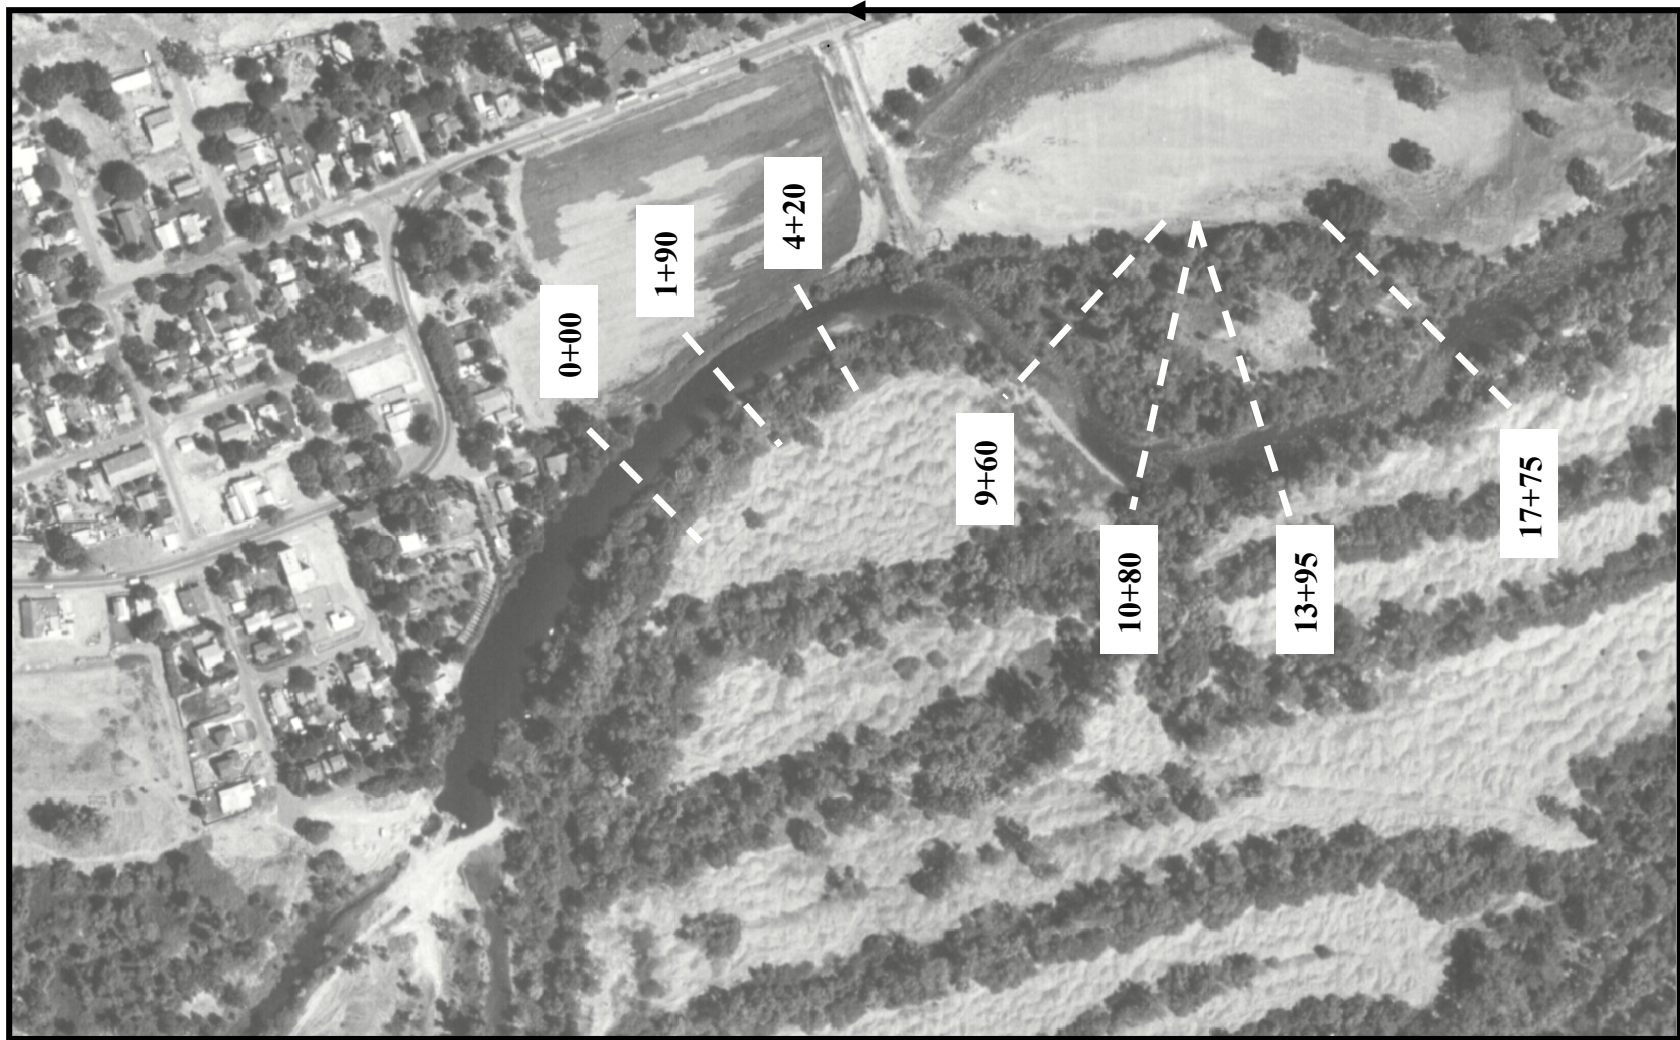
**Figure B-7. Cross section survey locations at the Snelling model site.**  
(photo: Merced County Planning and Community Development Department 1998)
