## **Merced River Corridor Restoration Plan Baseline Studies**

# **Volume II: Geomorphic and Riparian Vegetation Investigations Report**

**VOLUME II  
GEOMORPHIC AND RIPARIAN VEGETATION  
INVESTIGATIONS REPORT**

Stillwater Sciences  
2532 Durant Avenue  
Berkeley, CA 94704

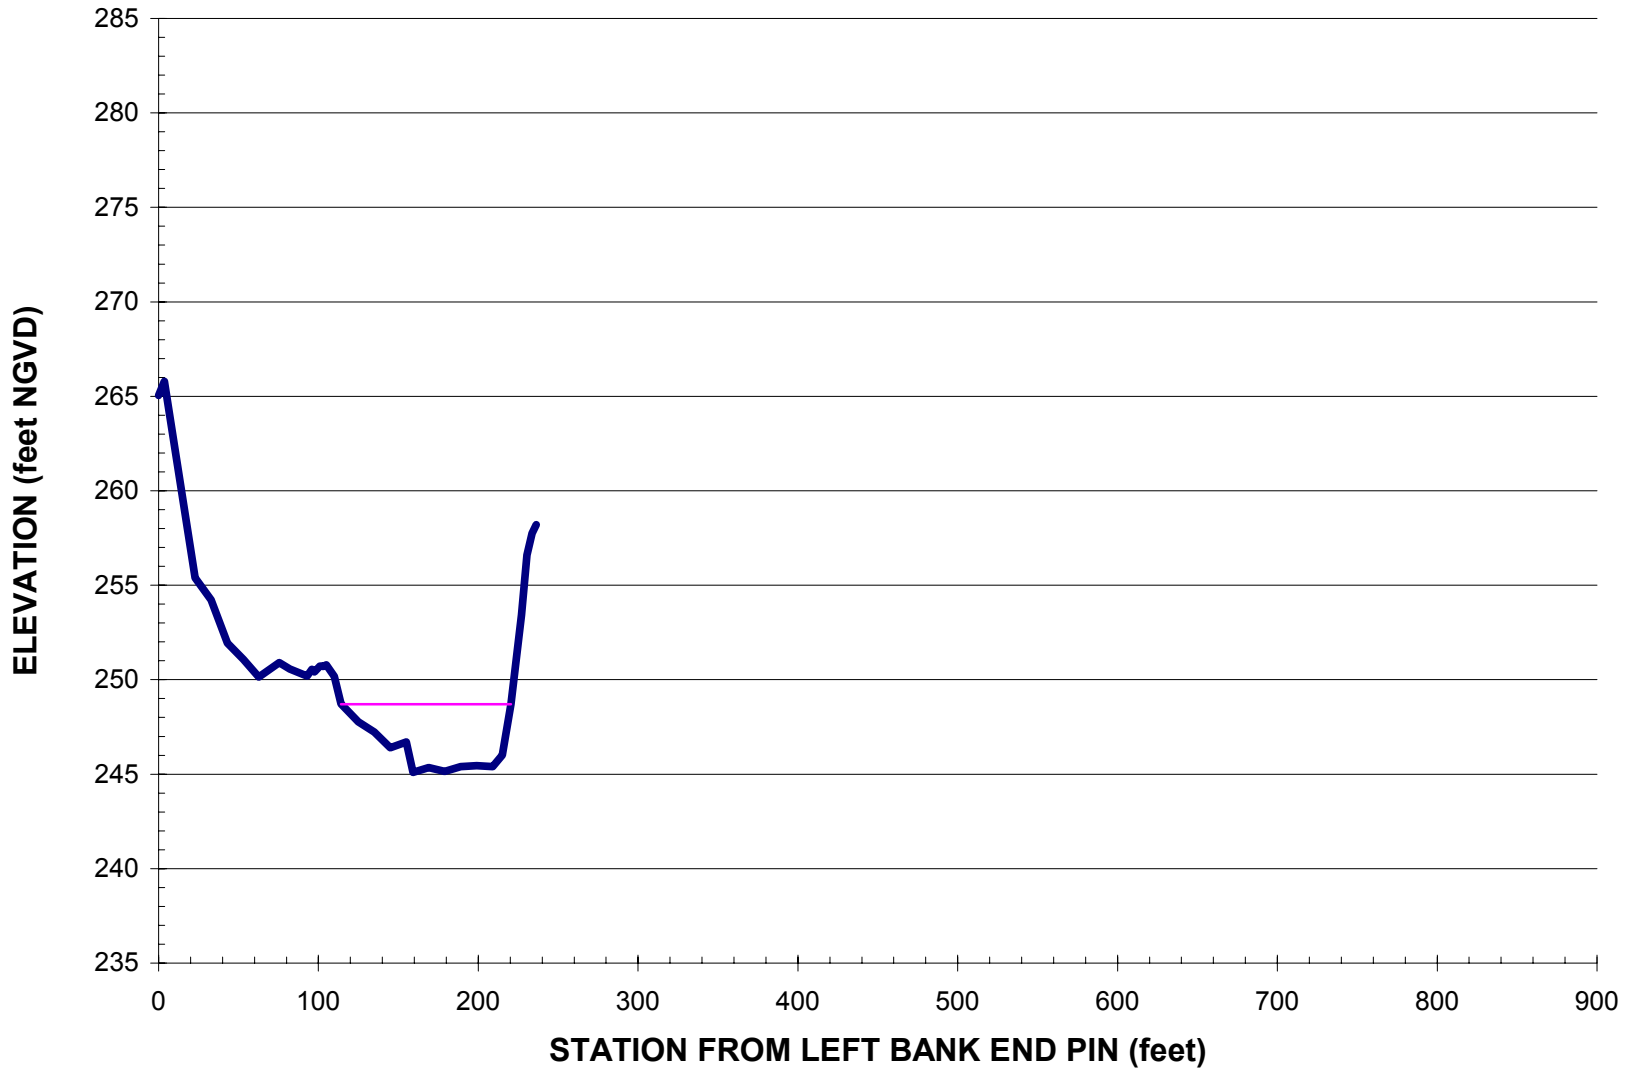
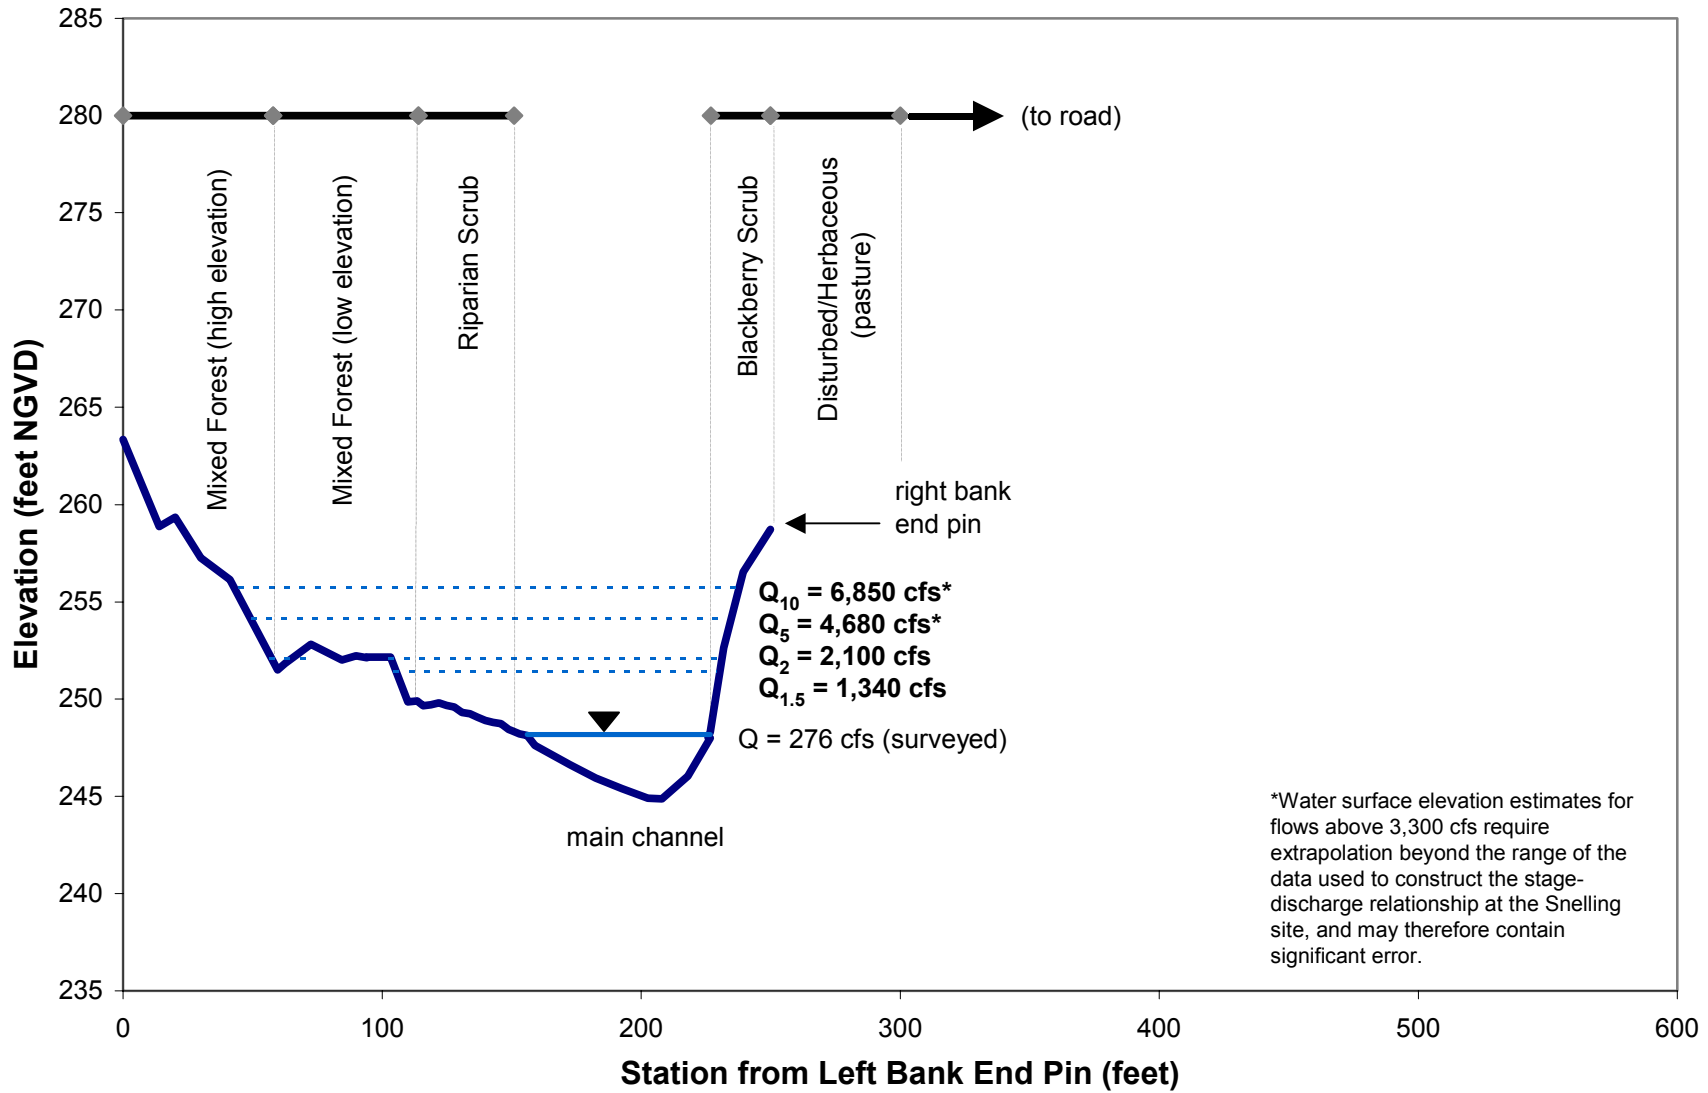
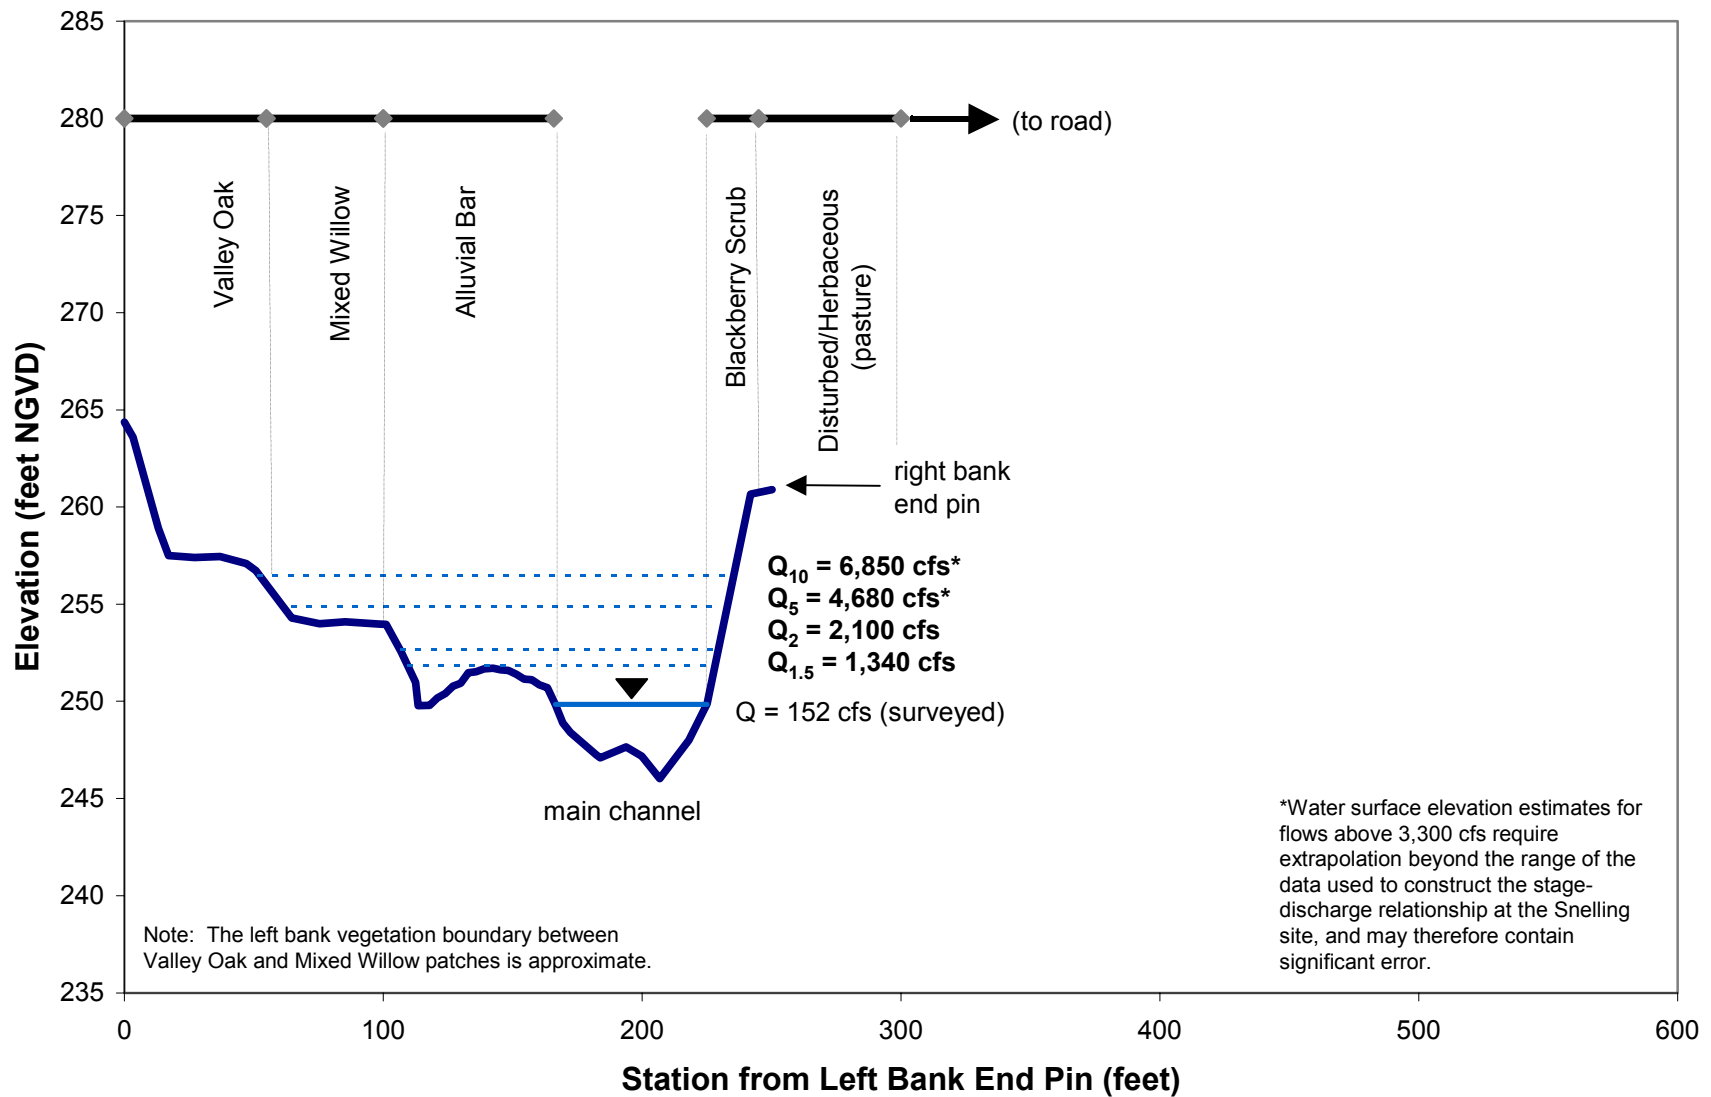
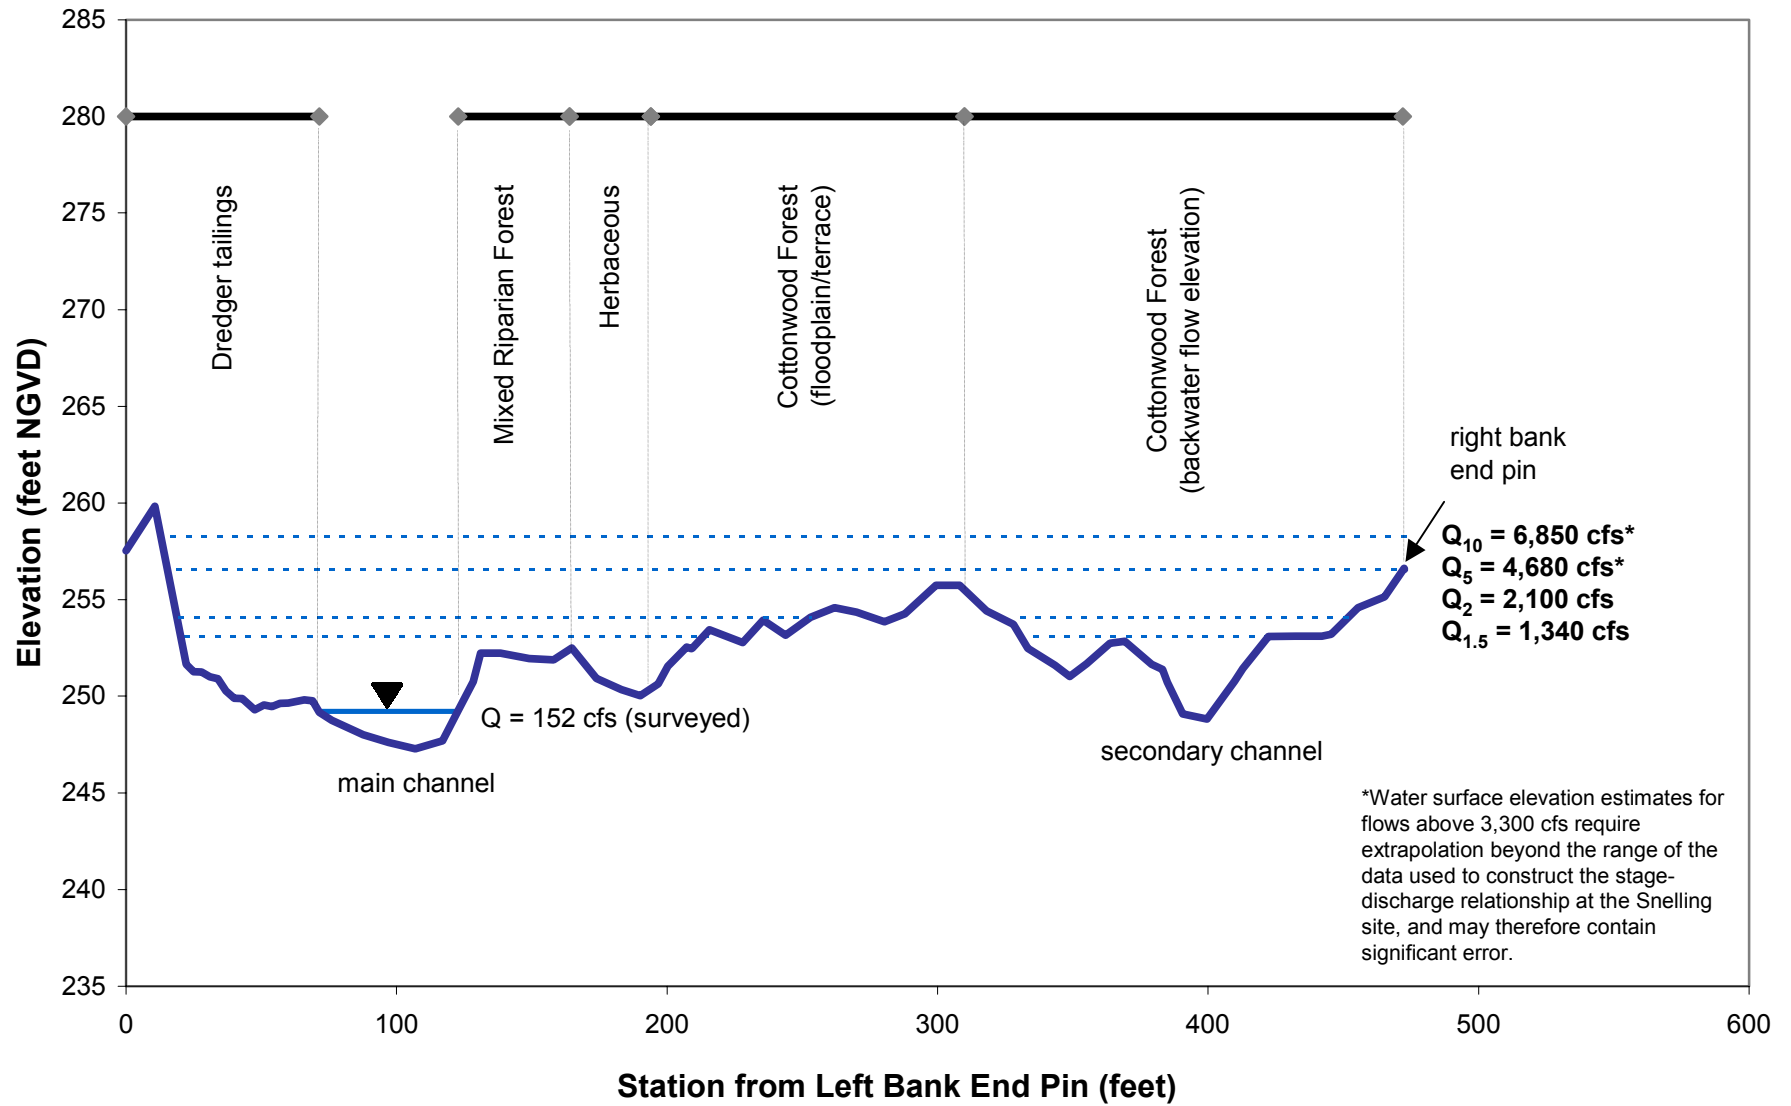
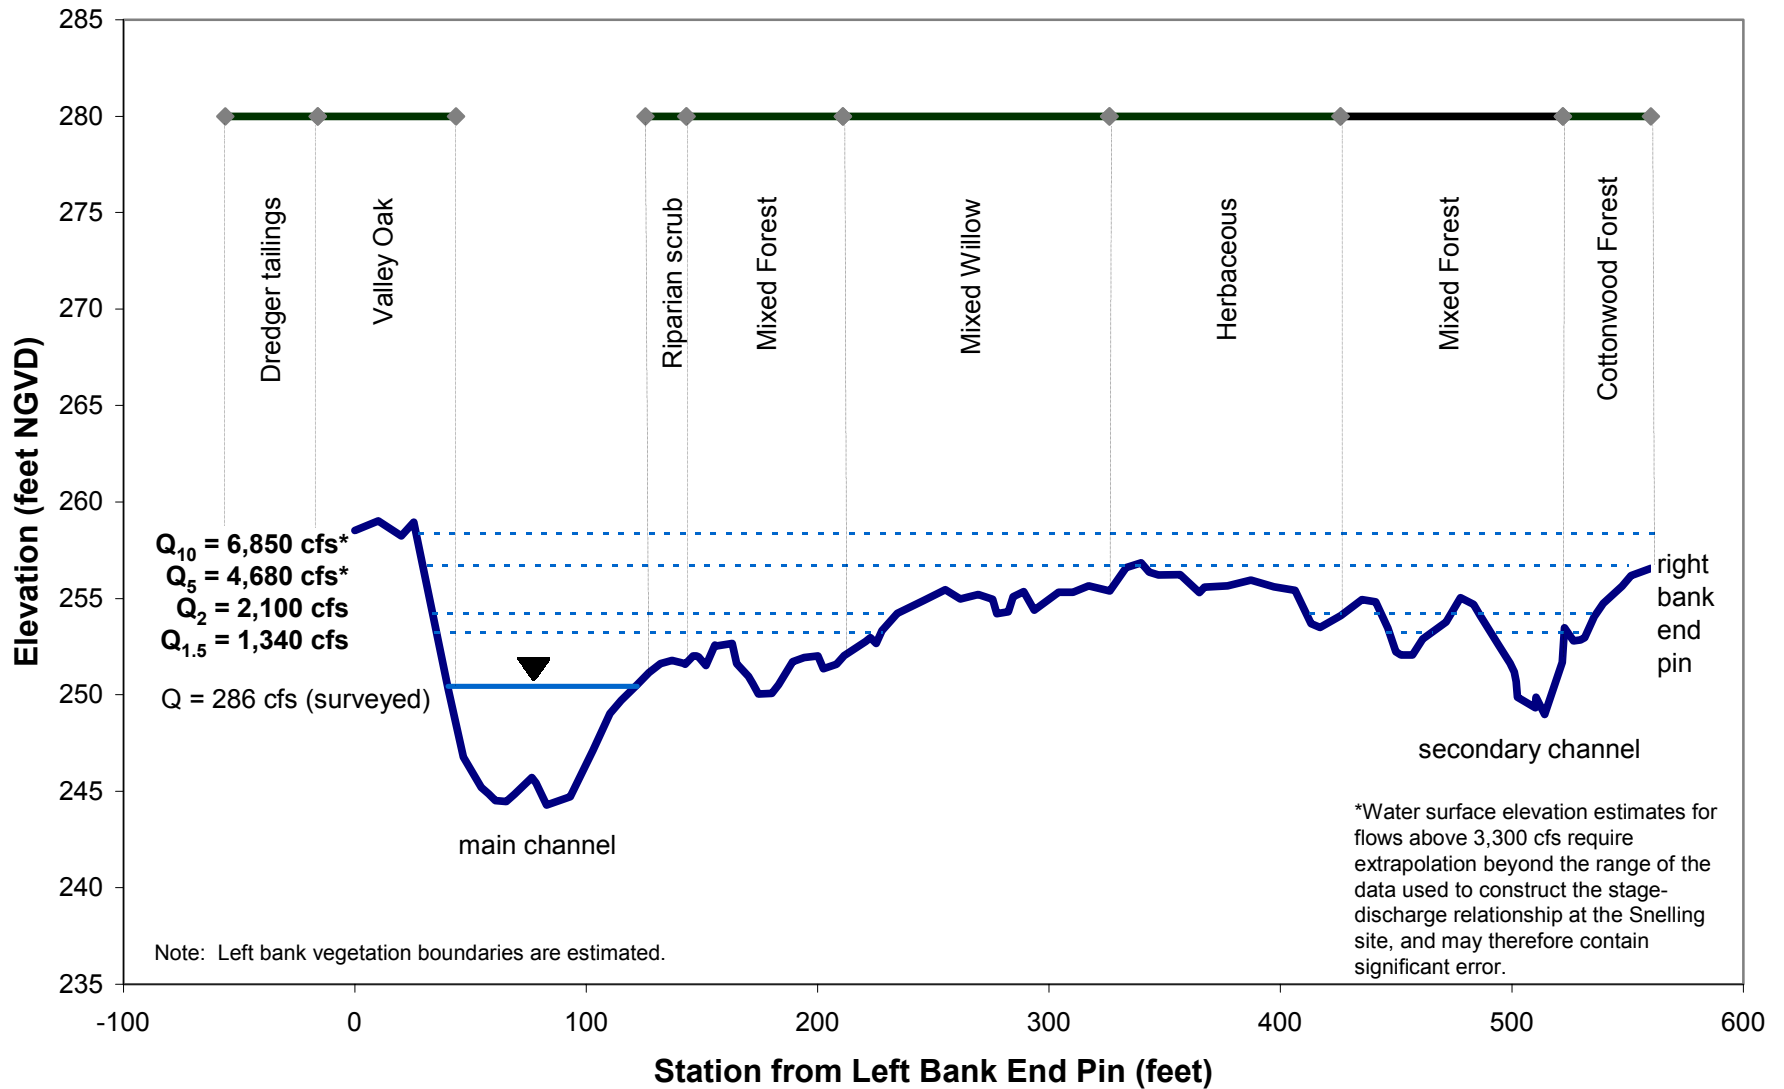
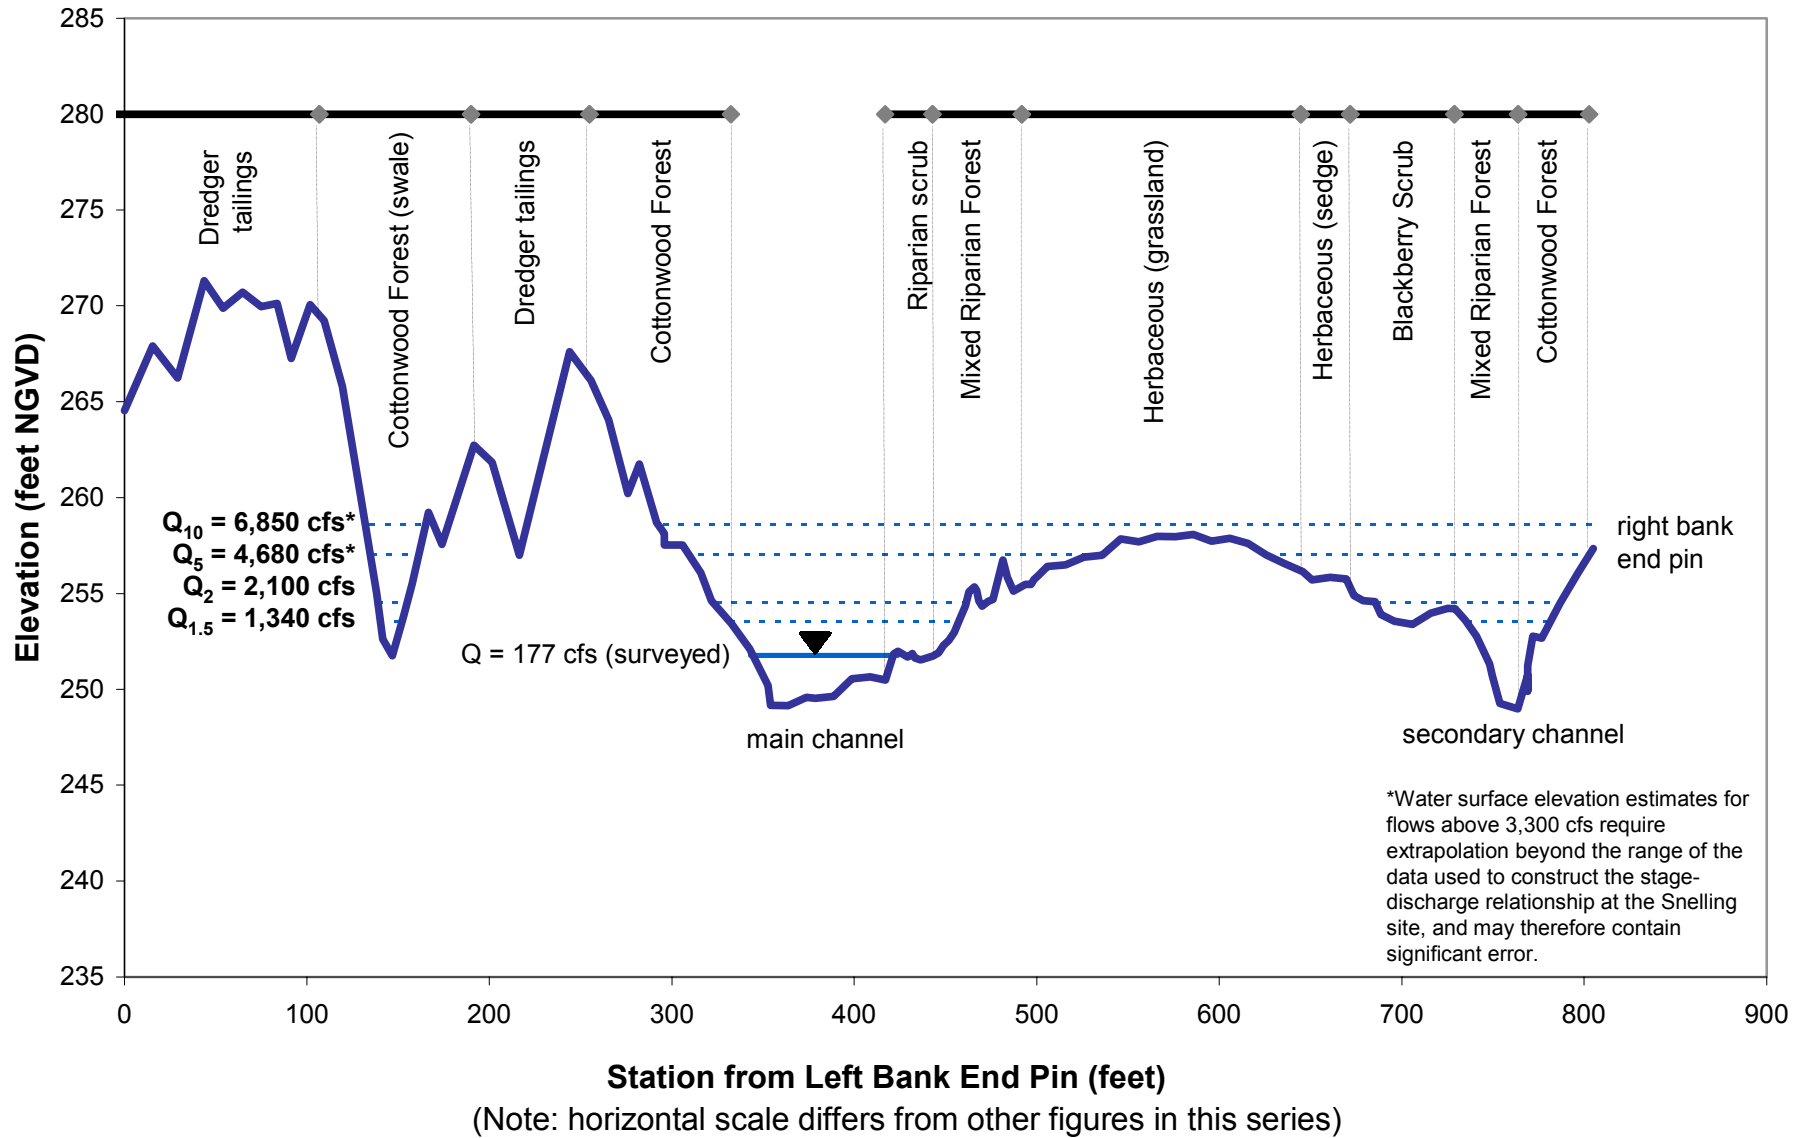
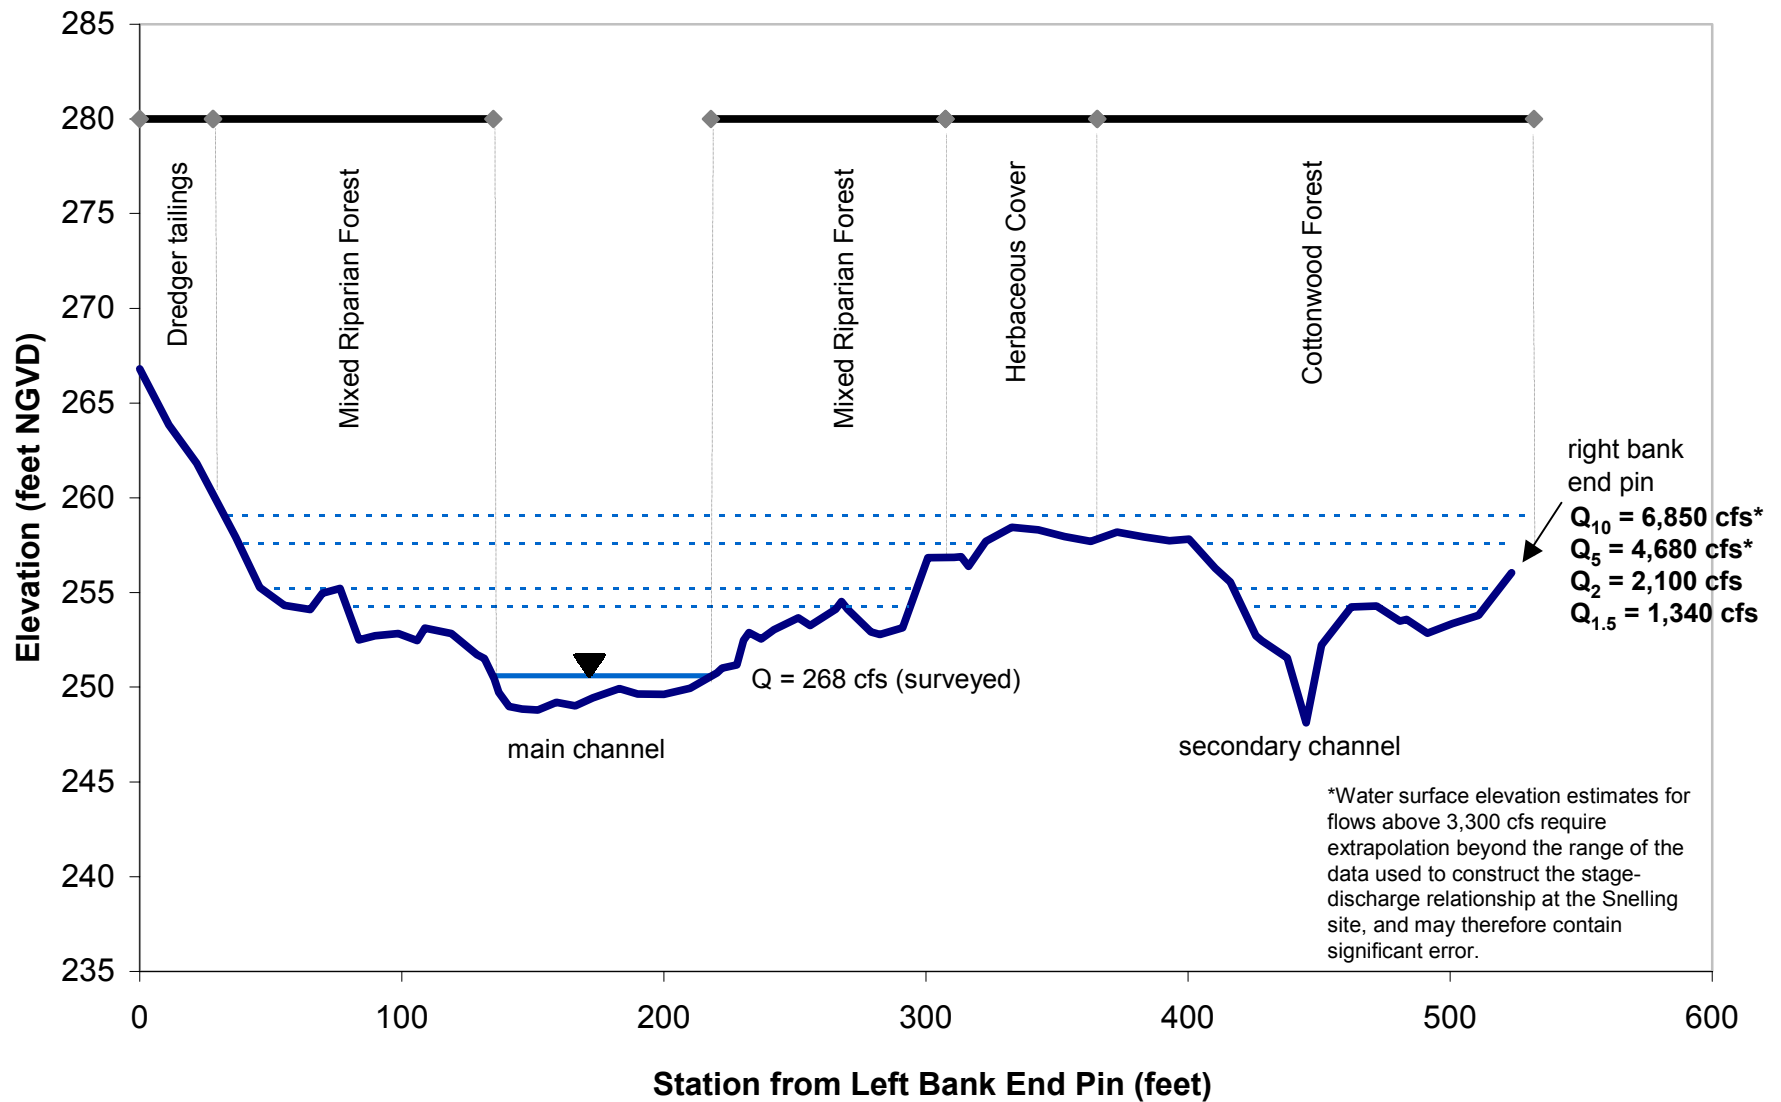
**Figure B-8. Snelling Site topographic cross section 0+00.**

**Figure B-9. Snelling Site vegetation cover and topographic cross section 1+90.**

**Figure B-10. Snelling Site vegetation cover and topographic cross section 4+20.**

**Figure B-11. Snelling Site vegetation cover and topographic cross section 9+60.**

**Figure B-12. Snelling Site vegetation cover and topographic cross section 10+80.**

**Figure B-13. Snelling Site vegetation cover and topographic cross section 13+95.**

**Figure B-14. Snelling Site vegetation cover and topographic cross section 17+75.**

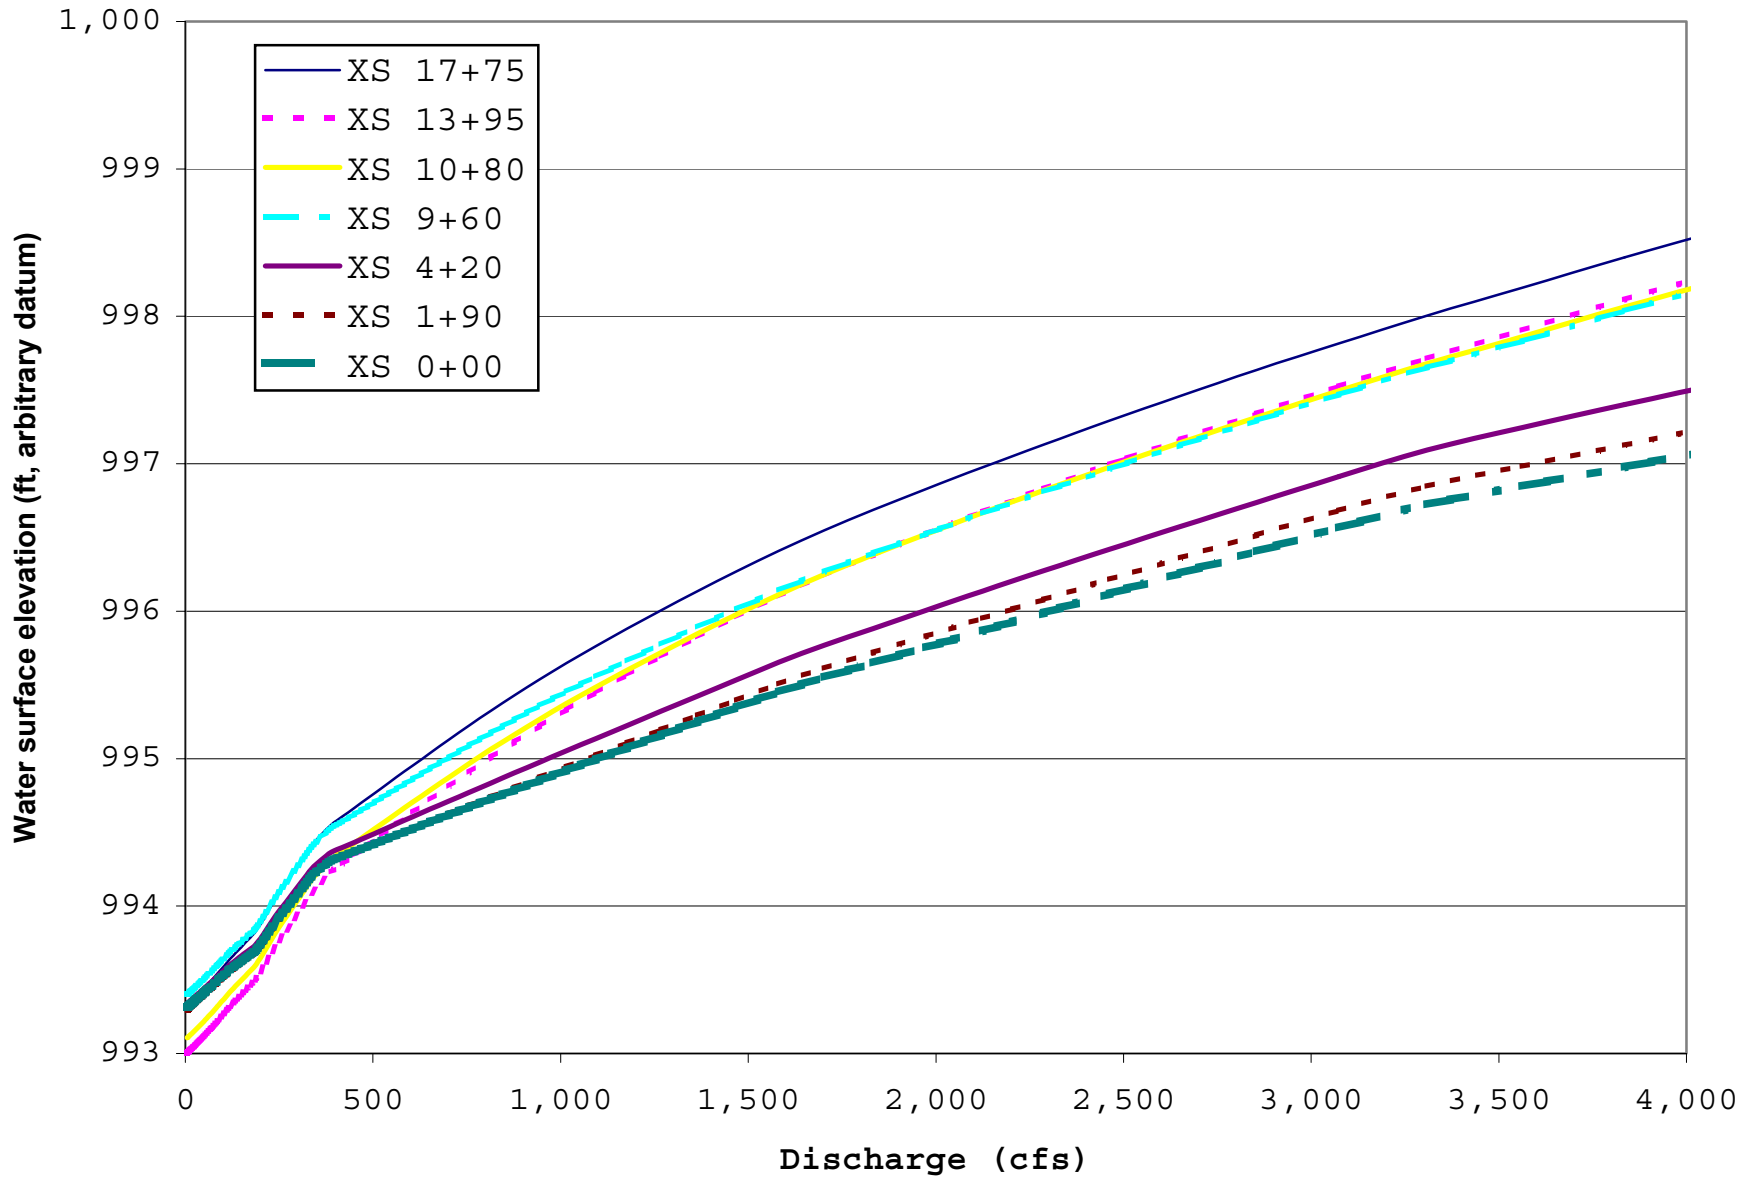
**Figure B-15. Snelling model site rating curves.**
