## **Merced River Corridor Restoration Plan Baseline Studies**

# **Volume II: Geomorphic and Riparian Vegetation Investigations Report**

**VOLUME II  
GEOMORPHIC AND RIPARIAN VEGETATION  
INVESTIGATIONS REPORT**

Stillwater Sciences  
2532 Durant Avenue  
Berkeley, CA 94704

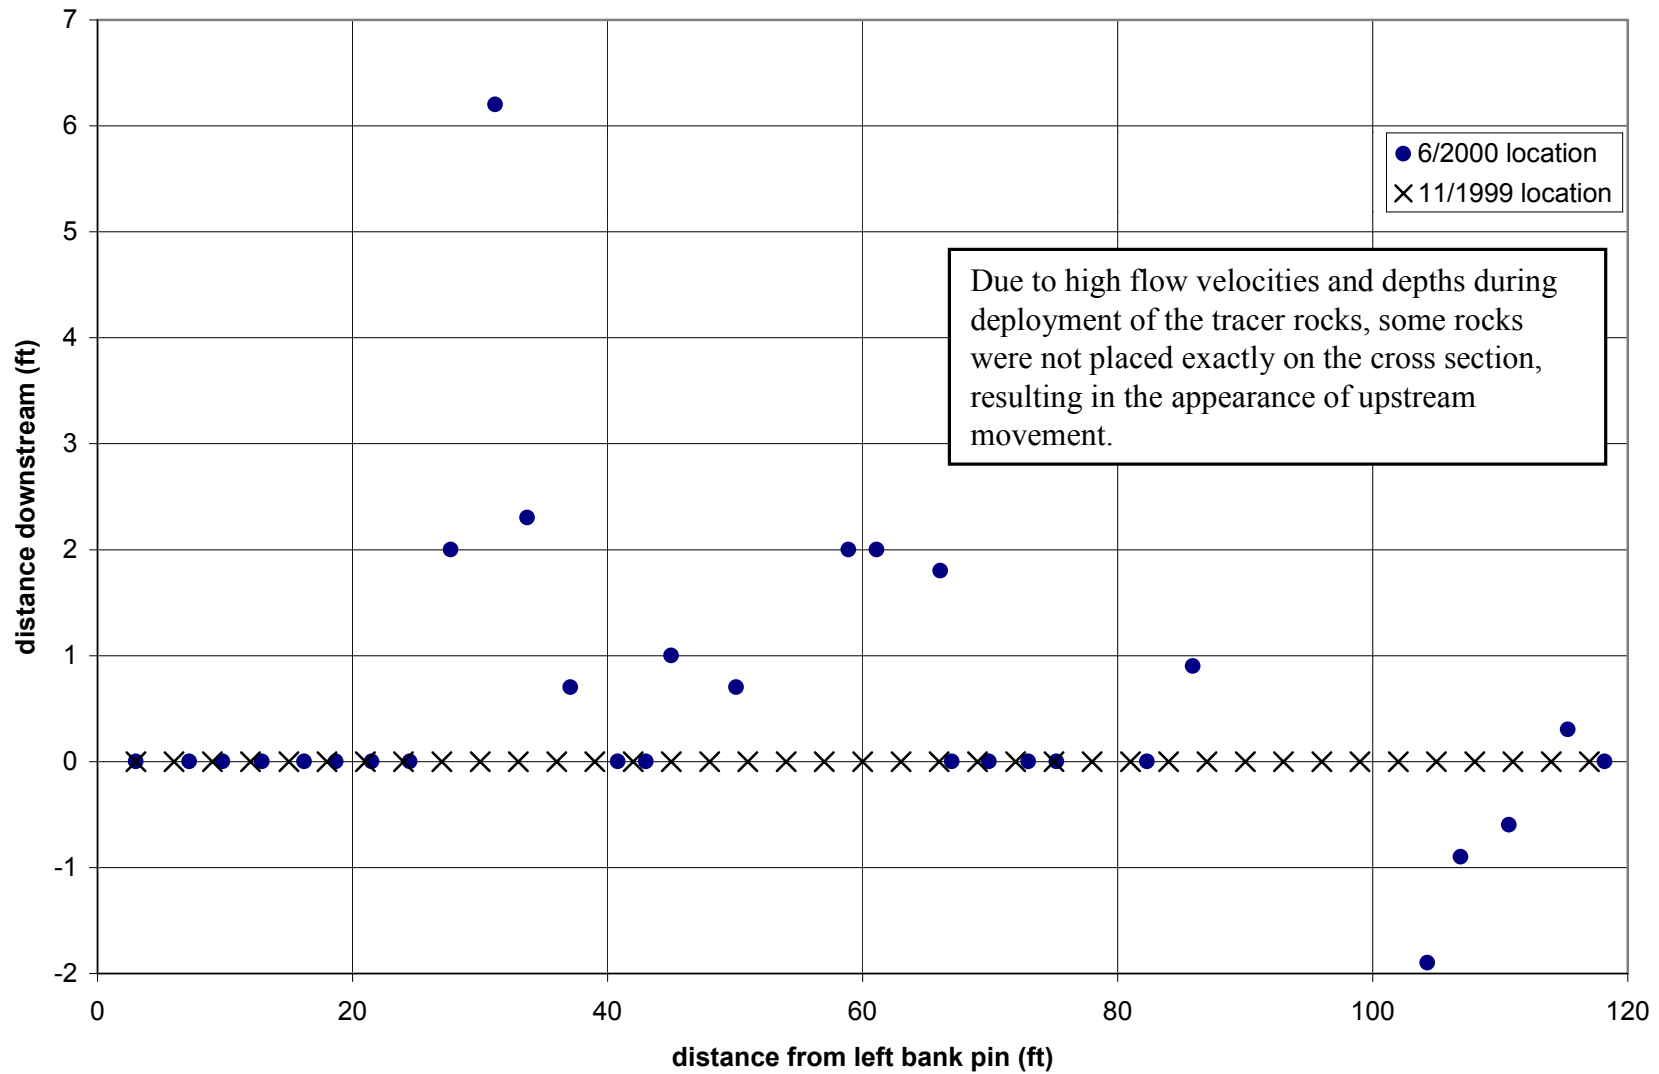
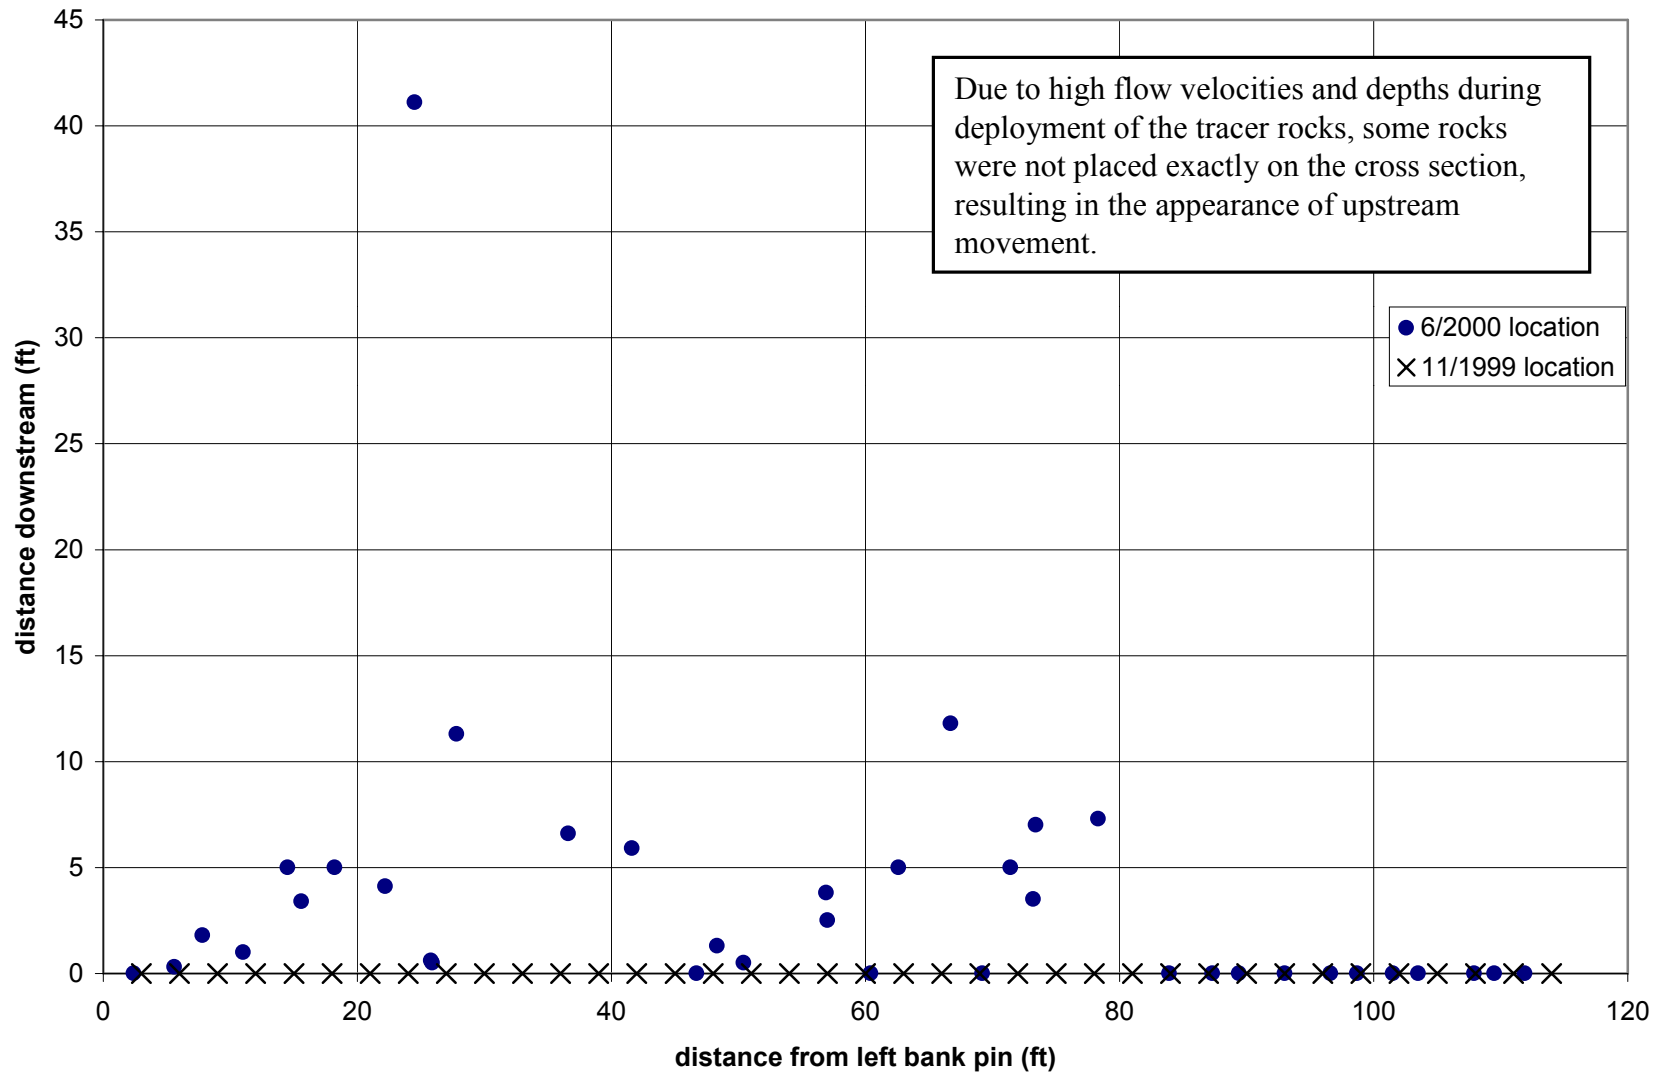
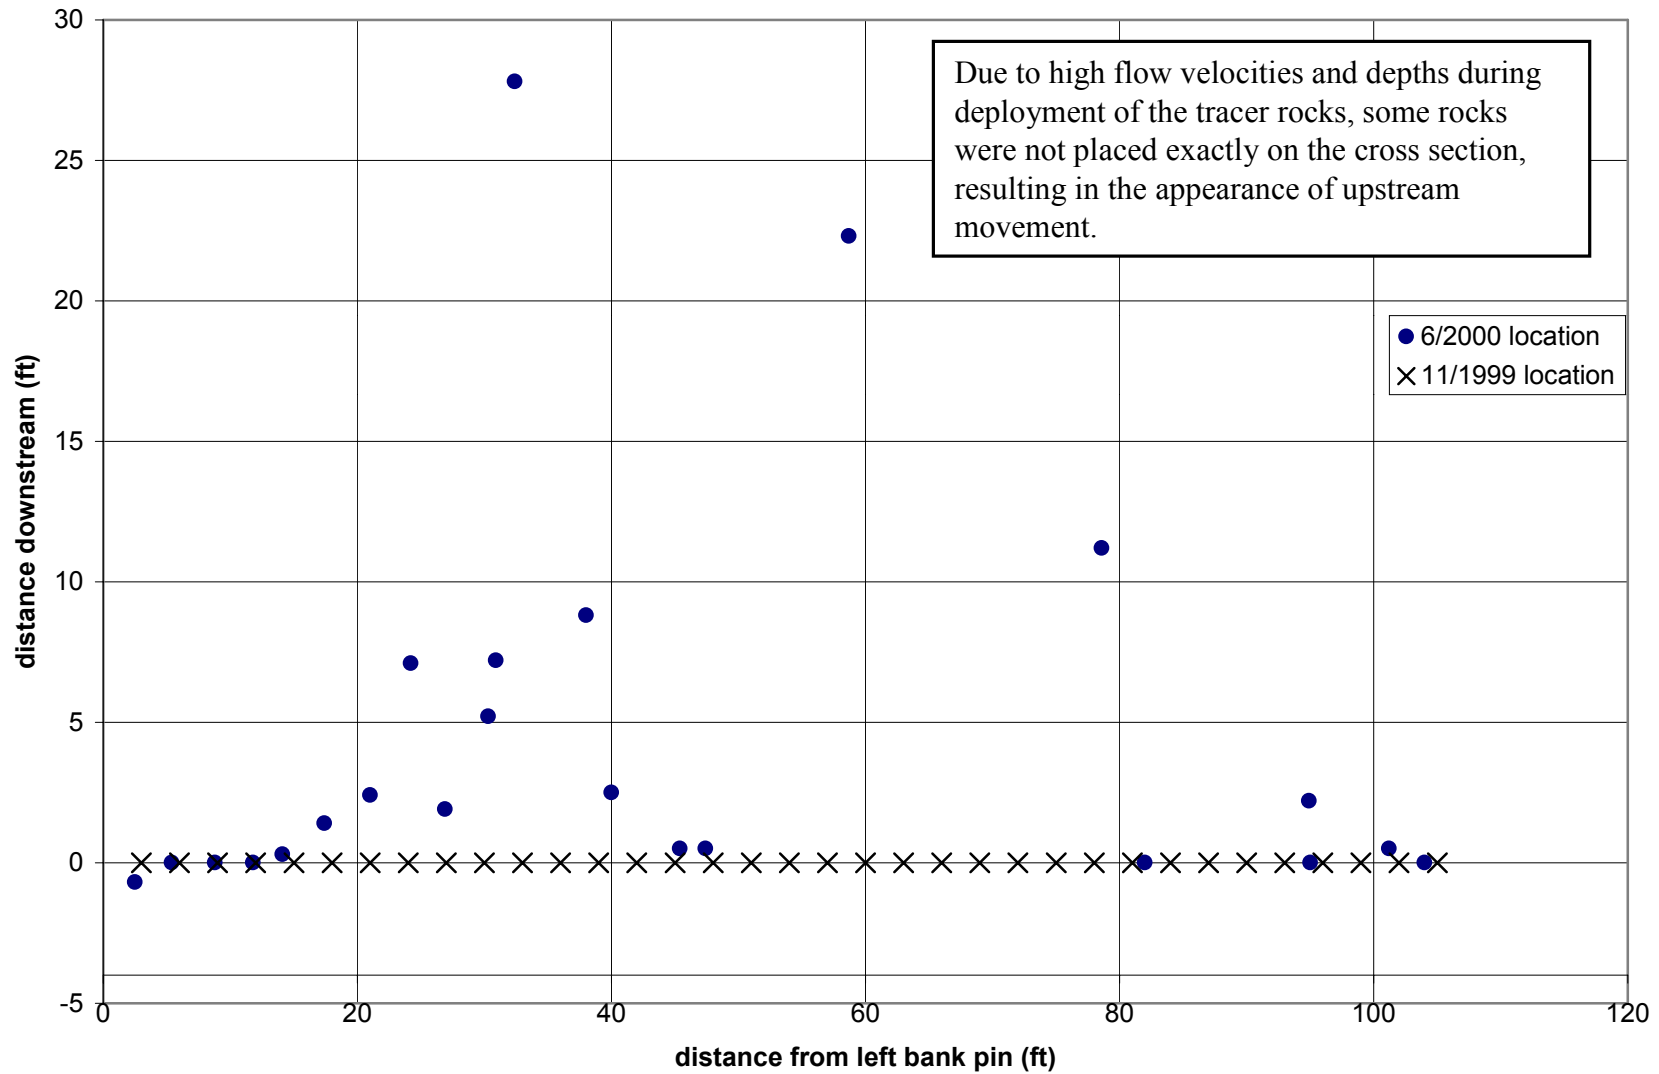
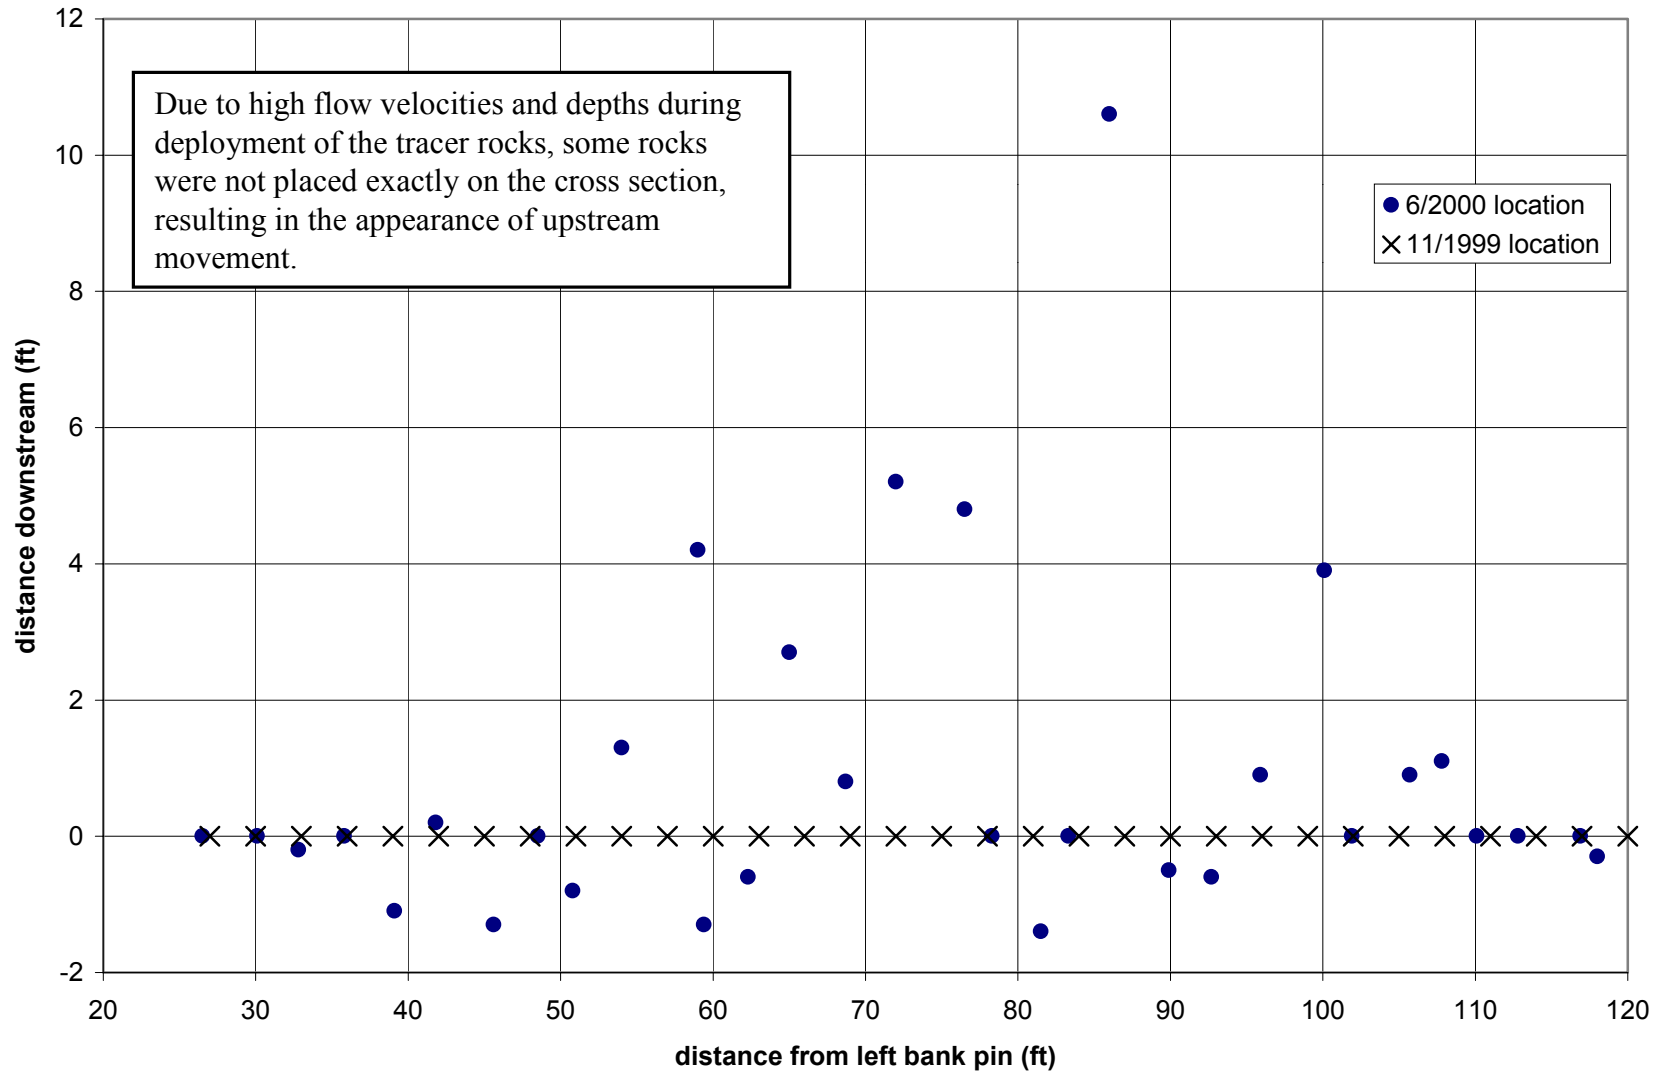
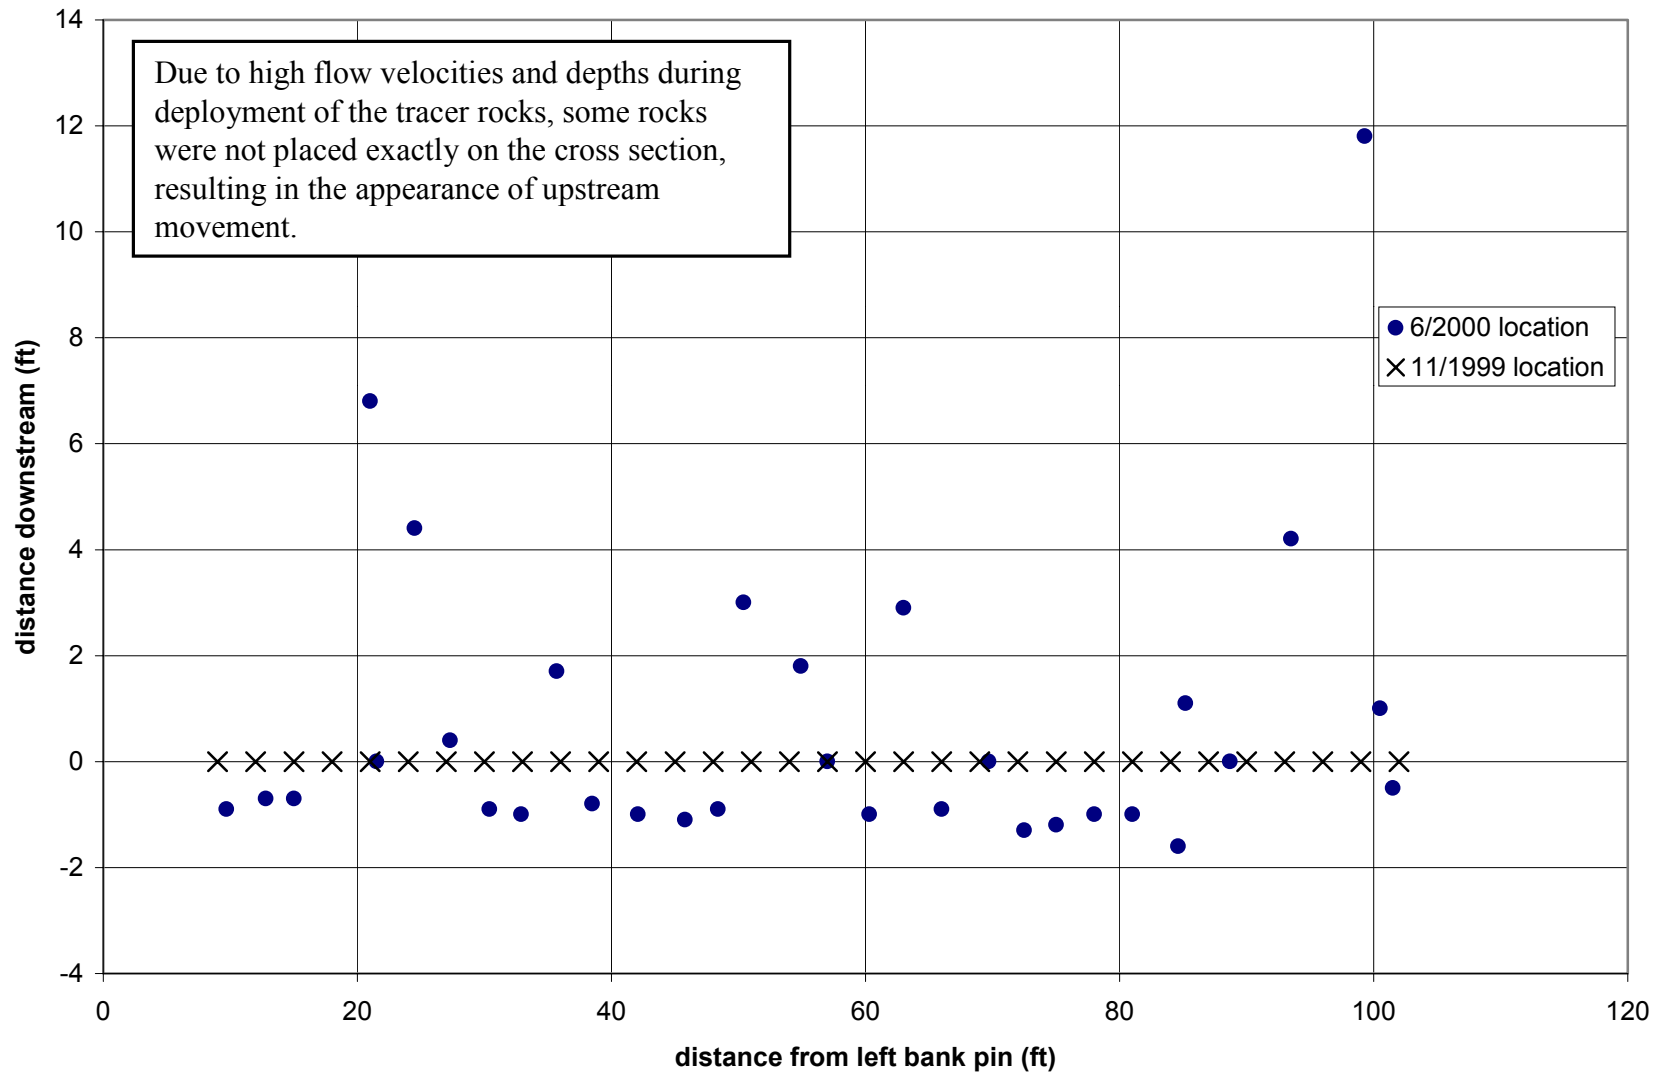
**Figure D-1. Distance traveled downstream by marked rocks in Snelling Site cross section 1+90.**

**Figure D-2. Distance traveled downstream by marked rocks in Snelling Site cross section 4+20.**

**Figure D-3. Distance traveled downstream by marked rocks in Snelling Site cross section 9+60.**

**Figure D-4. Distance traveled downstream by marked rocks in Snelling Site cross section 13+95.**

**Figure D-5. Distance traveled downstream by marked rocks in Snelling Site cross section 17+75.**
