Merced River Corridor Restoration Plan Baseline Studies

Volume I: Identification of Social, Institutional, and Infrastructural Opportunities and Constraints

**MERCED RIVER CORRIDOR RESTORATION PLAN
BASELINE STUDIES**

**VOLUME I:
IDENTIFICATION OF SOCIAL, INSTITUTIONAL, AND
INFRASTRUCTURAL OPPORTUNITIES AND CONSTRAINTS**

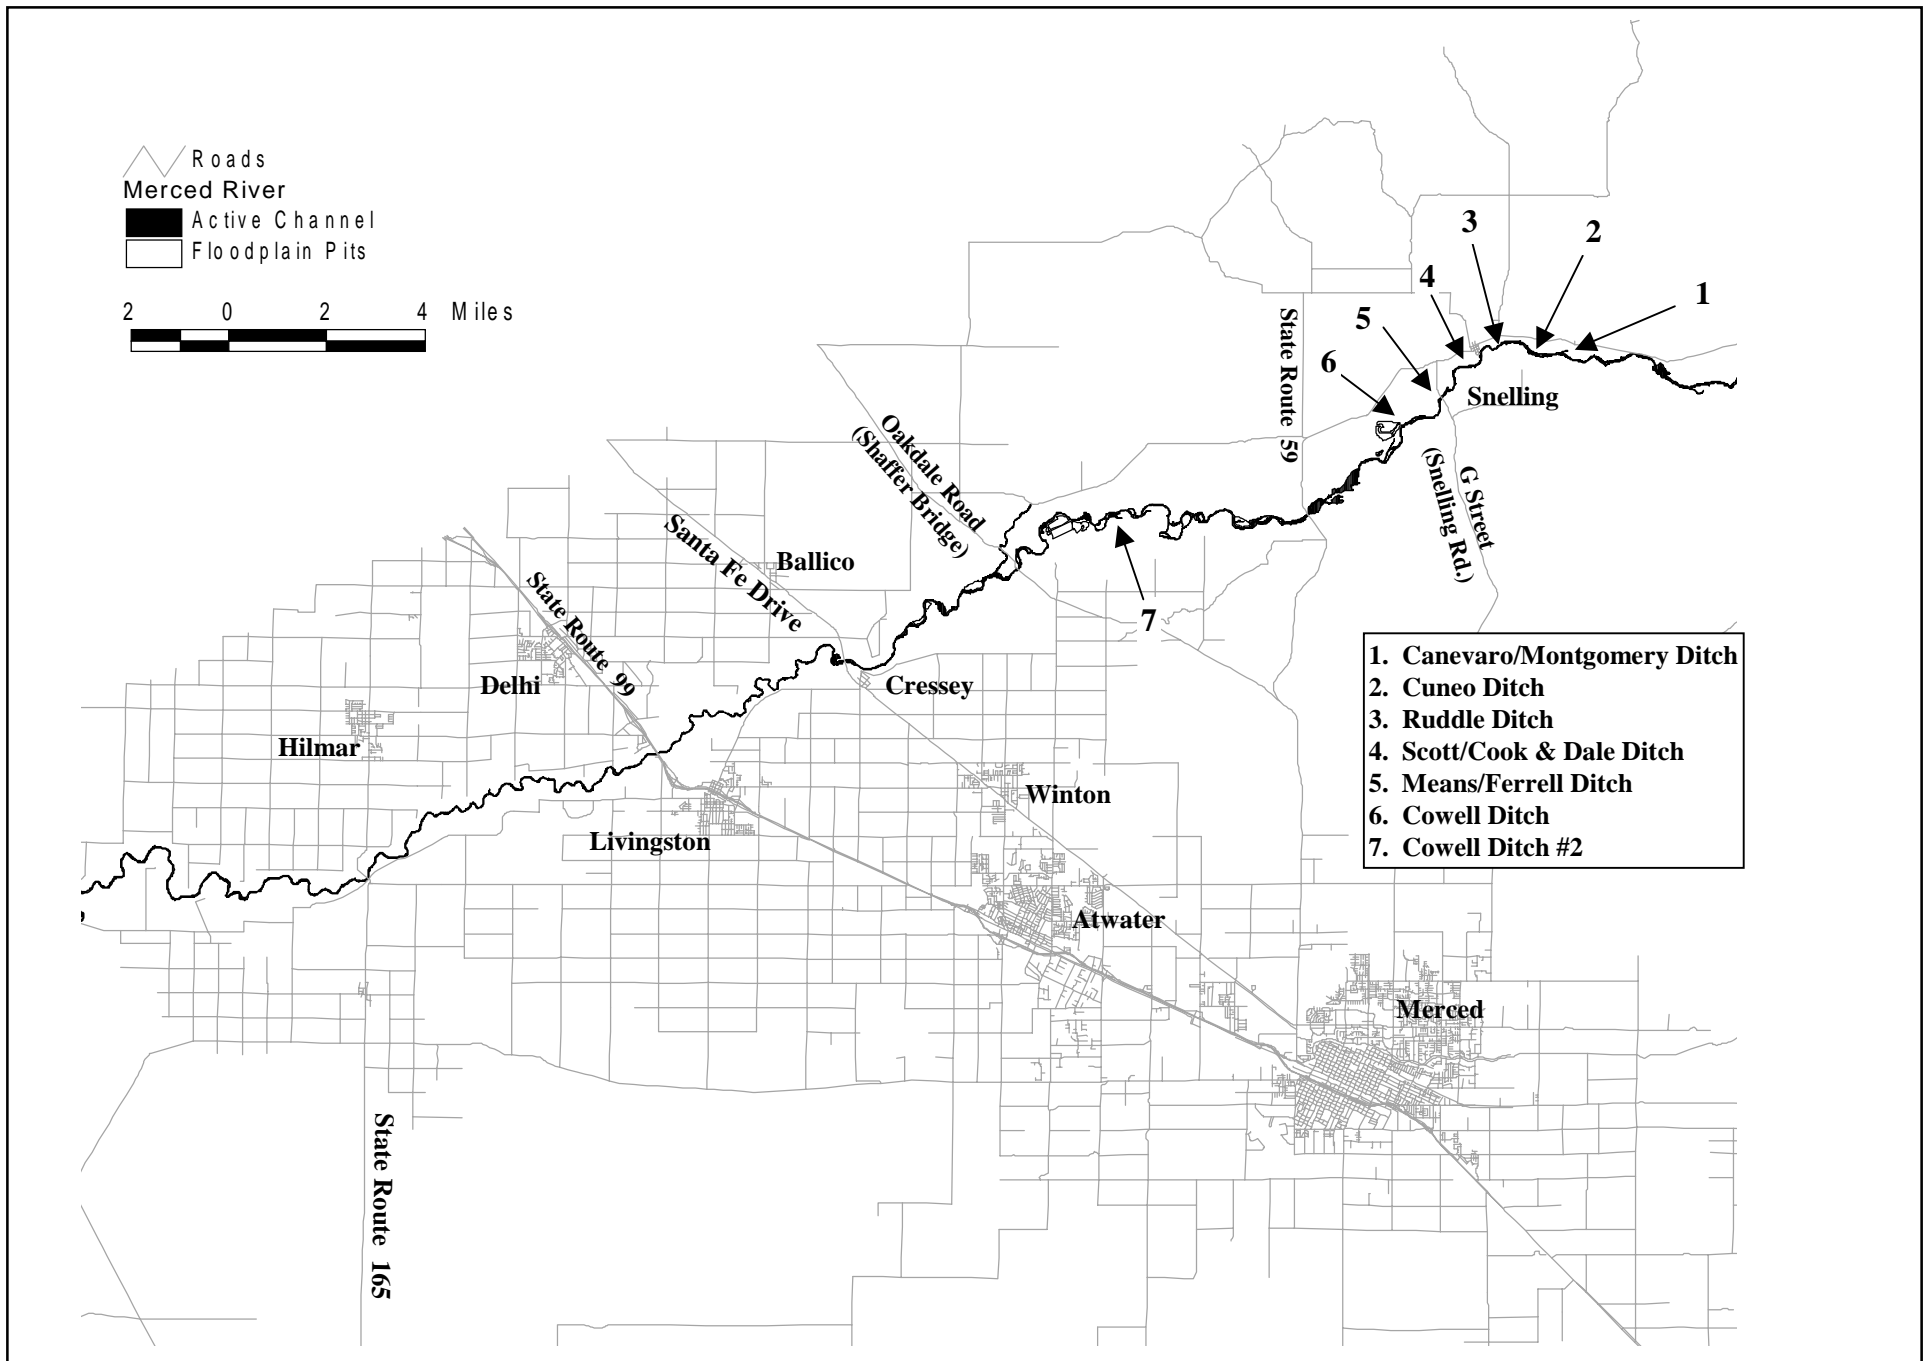
Figure 8. Riparian water use diversion ditches.

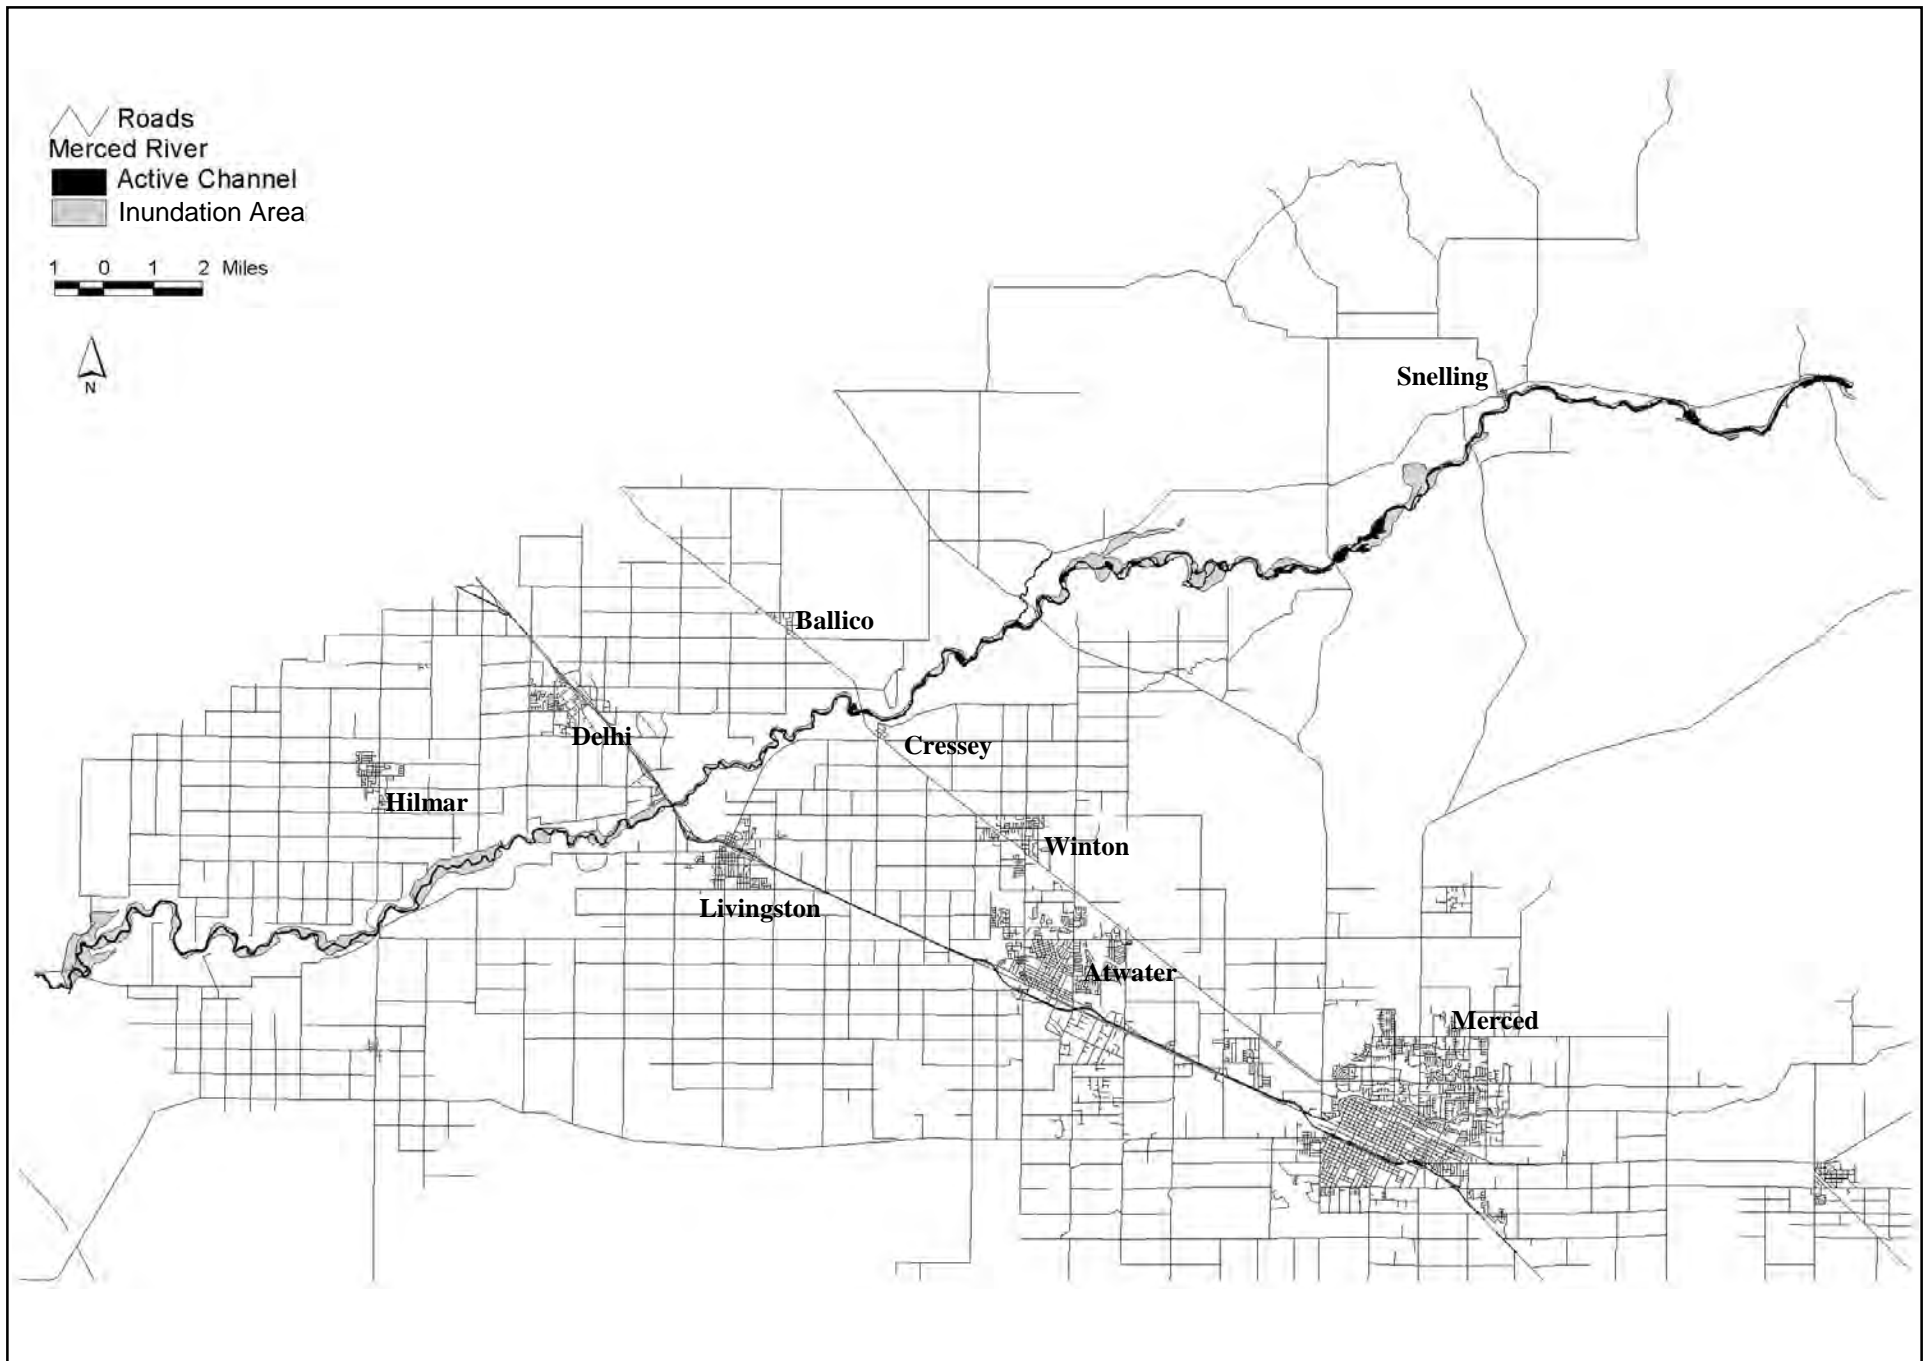
Figure 9. Area inundated by January 1997 high flows.
 Source: Corps of Engineers, unpublished data.

The rain flood space period is between November 1 and March 15. By November 1, Lake McClure storage must be reduced to 675,000 acre-feet by Merced ID. Depending on forecasted snowmelt runoff, Merced ID may begin storing water above 675,000 acre-feet as early as March 15. The maximum release of 6,000 cfs, as measured at Stevinson, includes releases from the New Exchequer Dam, local runoff, and inflow from Dry Creek. There could be some flooding or minimal property damage associated with this flow. During extreme runoff in January 1997, the USACE concurred with Merced ID’s emergency deviation from established operation rules in its decision to increase release from 6,000 cfs to 8,000 cfs. During this release, flow in the Merced River peaked at 8,080 cfs (measured at Snelling). In the upstream reaches of the analysis area, the channel accommodated this flow, although the Route 59 bridge had to be closed due to the danger of bridge failure from an undermined spread footing. In the lower reaches of the river, however, private levees were breached at several locations and agricultural and dairy lands were flooded (Figure 9). It has been pointed out at Stakeholder Group

The U.S. Geological Survey determined in studies conducted in the 1960s that the Merced River channel can convey 6,000 cfs without overbank flooding (Blodgett and Bertoldi 1968). In January 1997, flows of up to 8,080 cfs (measured at Snelling) caused levee breaches and flooding of agricultural lands immediately above Shaffer Bridge; near the confluence of the San Joaquin River, the flooding was more pronounced and extended into dairies and agricultural land.

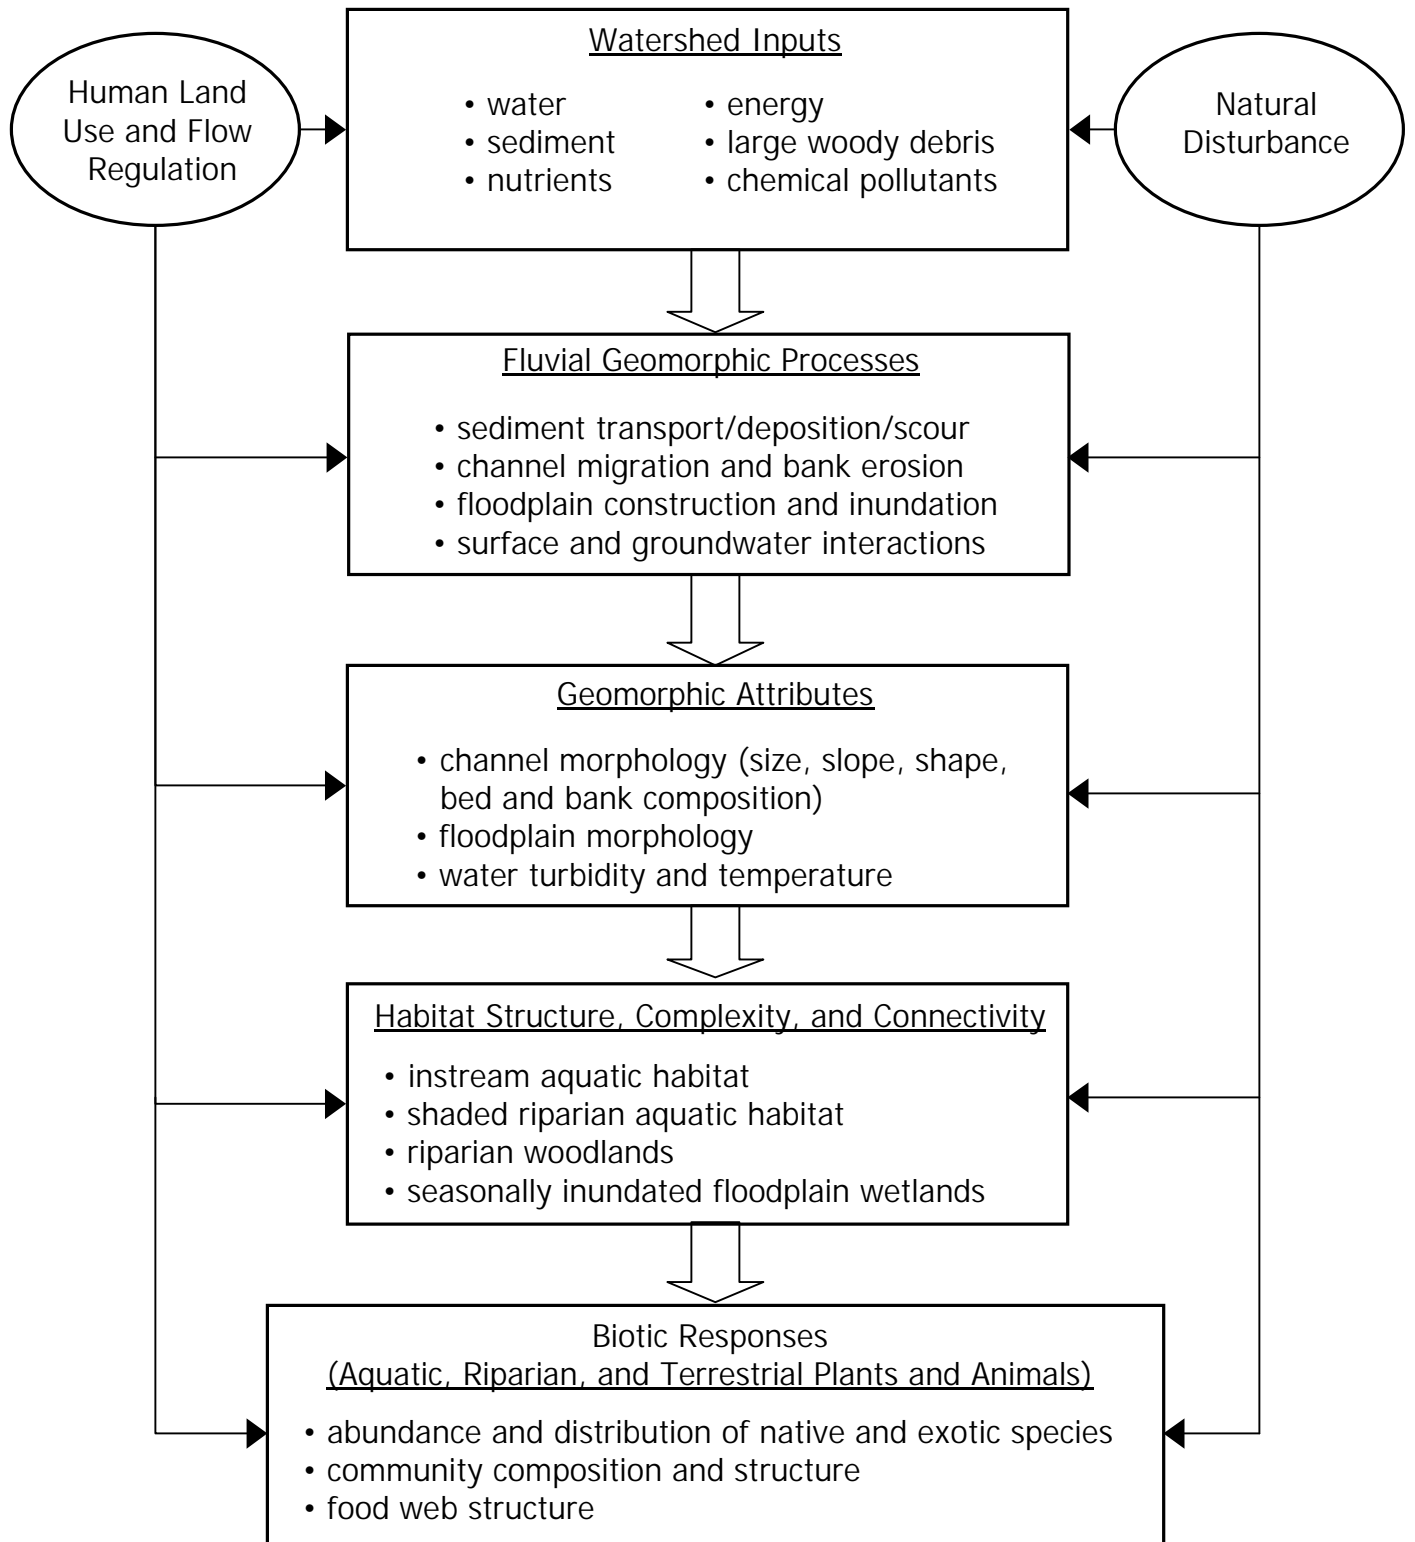
Figure 2-1. A simplified conceptual model of the physical and ecological linkages in alluvial river-floodplain systems.

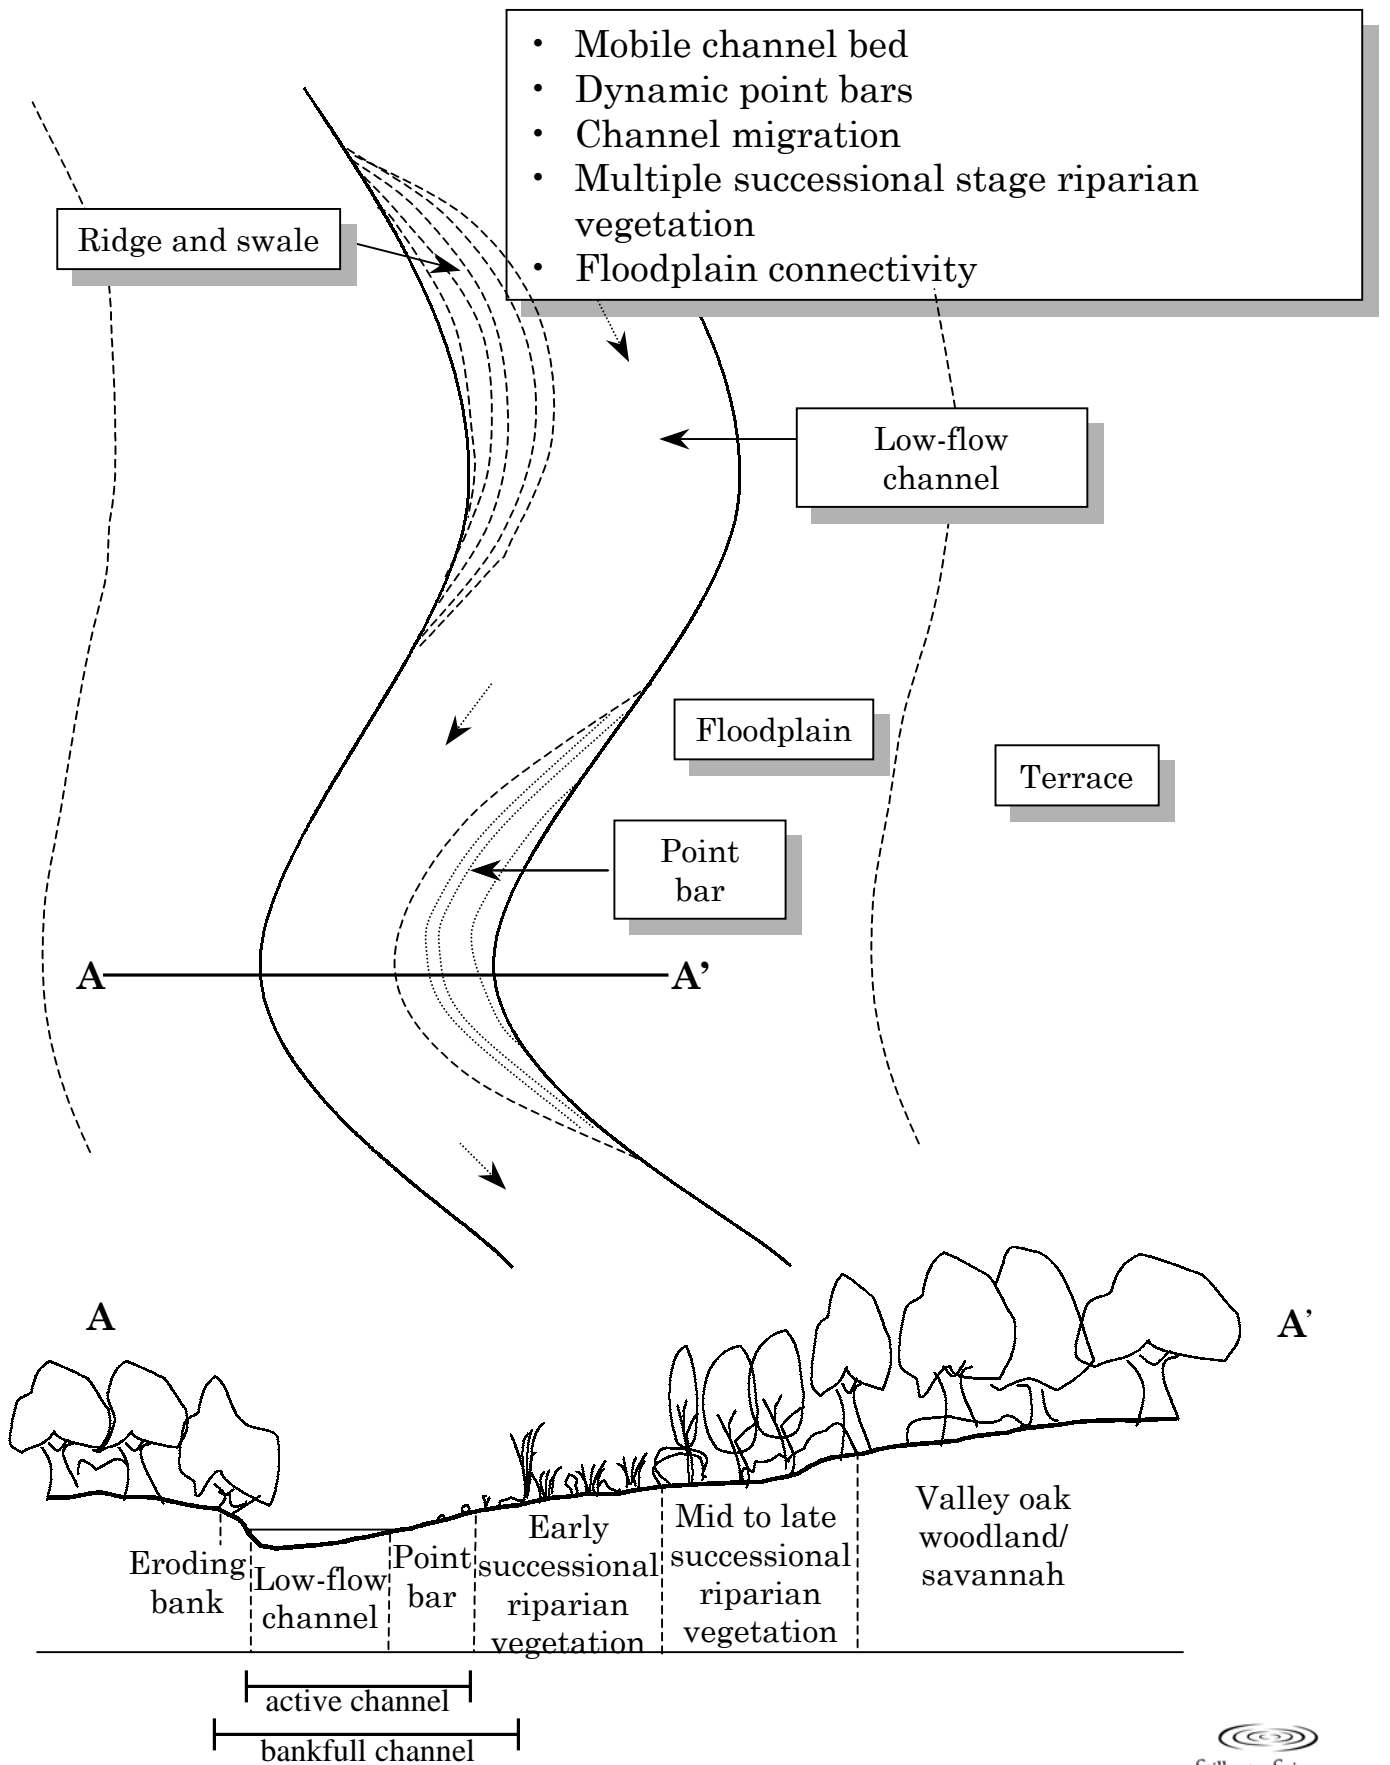
Figure 2-2. Conceptual diagram of a “healthy” alluvial river system.

- temporally variable streamflow patterns;
- channel morphology that is scaled to flow conditions and sediment supplies that are balanced with sediment transport capacity;
- frequent scour of the bed surface and periodic scour of the bed sub-surface;
- channel migration and/or avulsion;
- frequent floodplain inundation; and
- a self-sustaining, diverse riparian corridor.

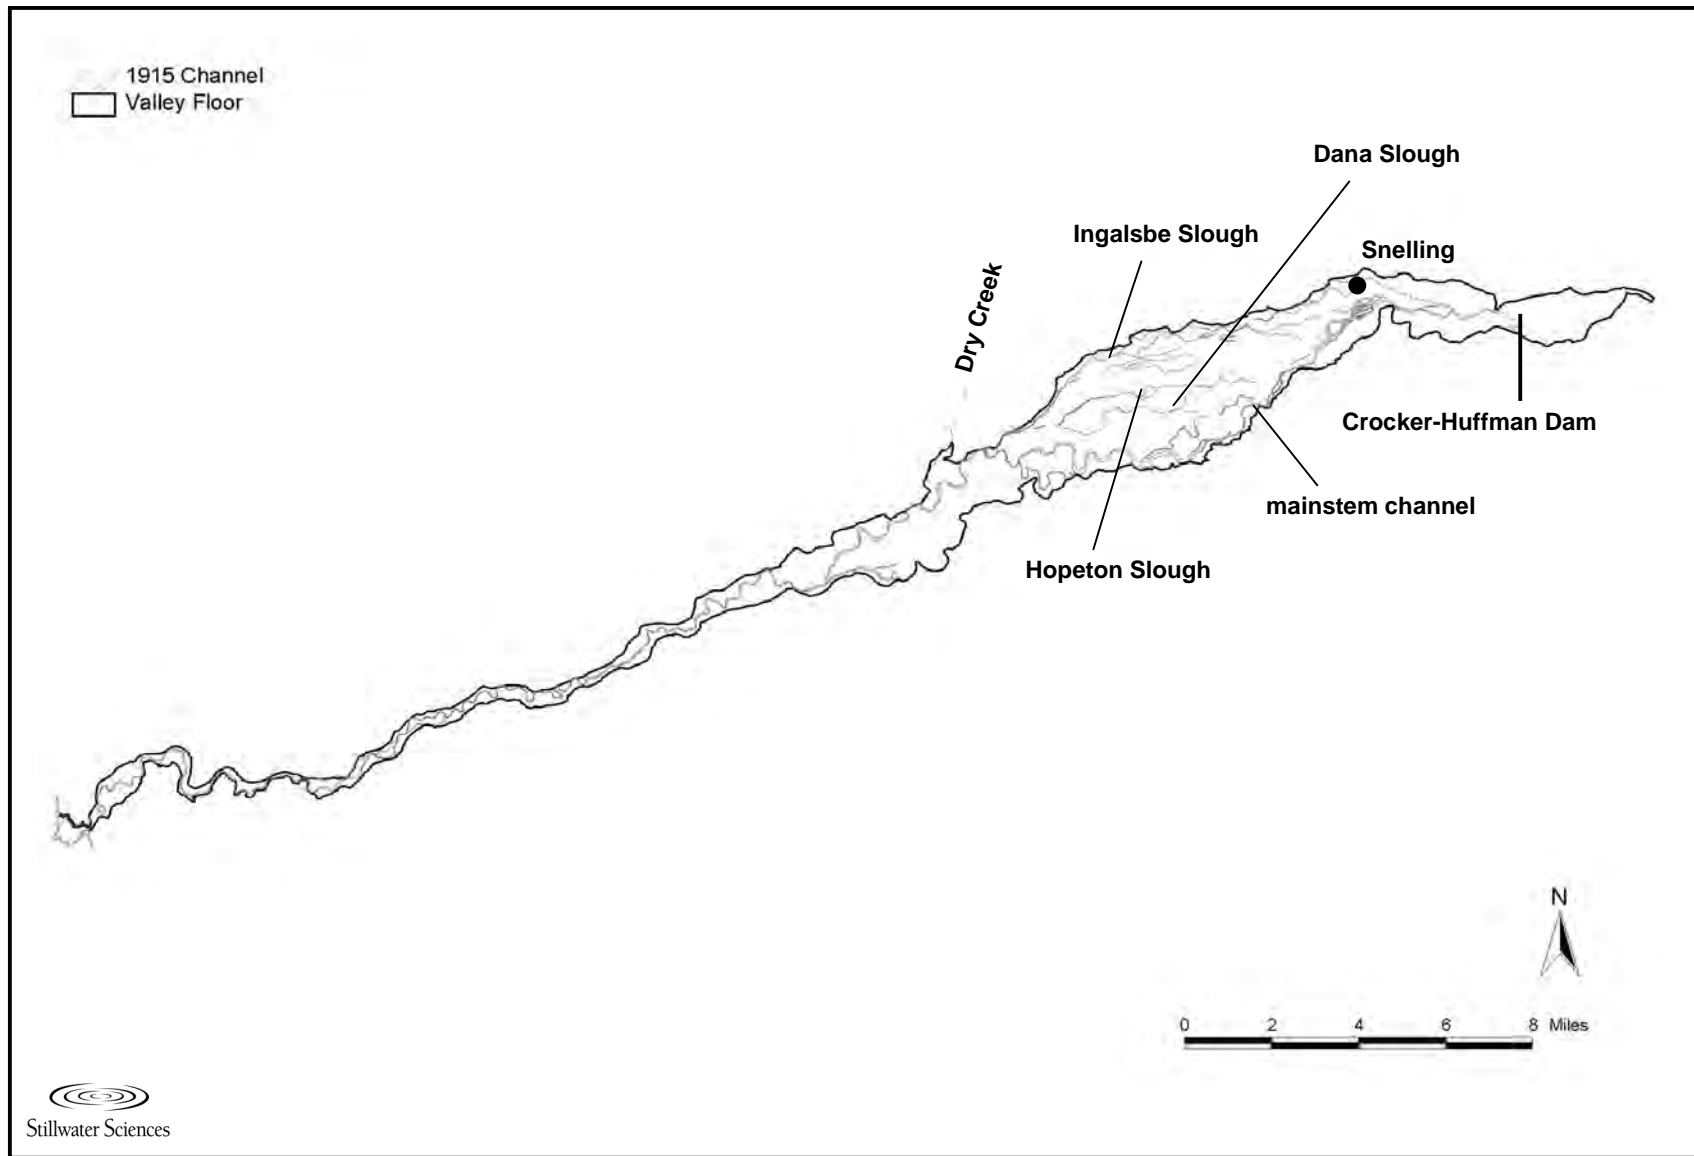
Figure 3.1-2. Merced River alluvial valley floor boundary and 1915 channel alignment.

(The alluvial valley floor was identified and digitized using geologic maps and 1:24,000-scale topographic maps. The 1915 channel alignment was digitized from historical 1:31,680-scale topographic maps.)

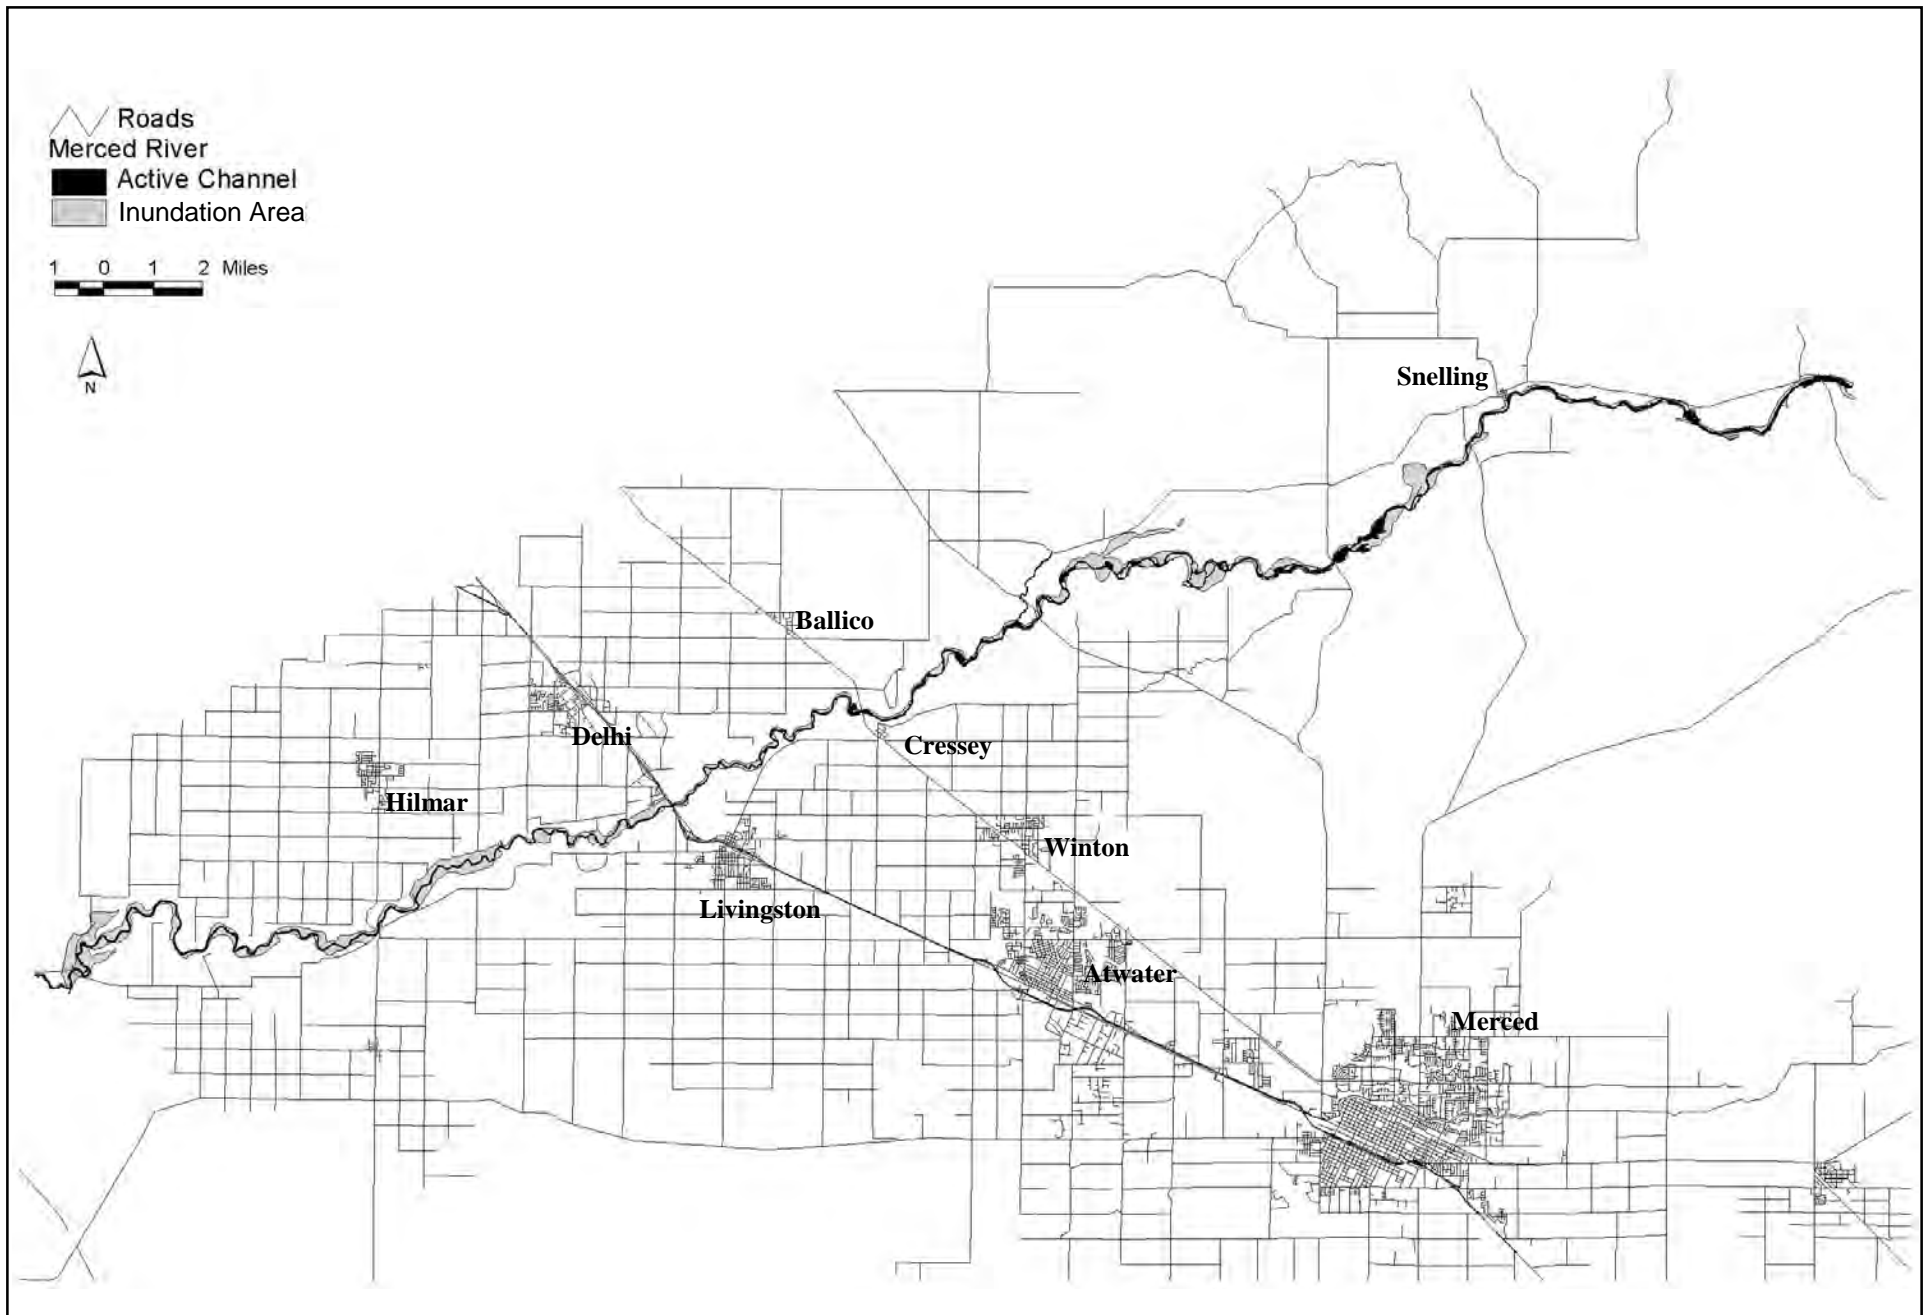
Figure 3.2-1. Area inundated by January 1997 flood.

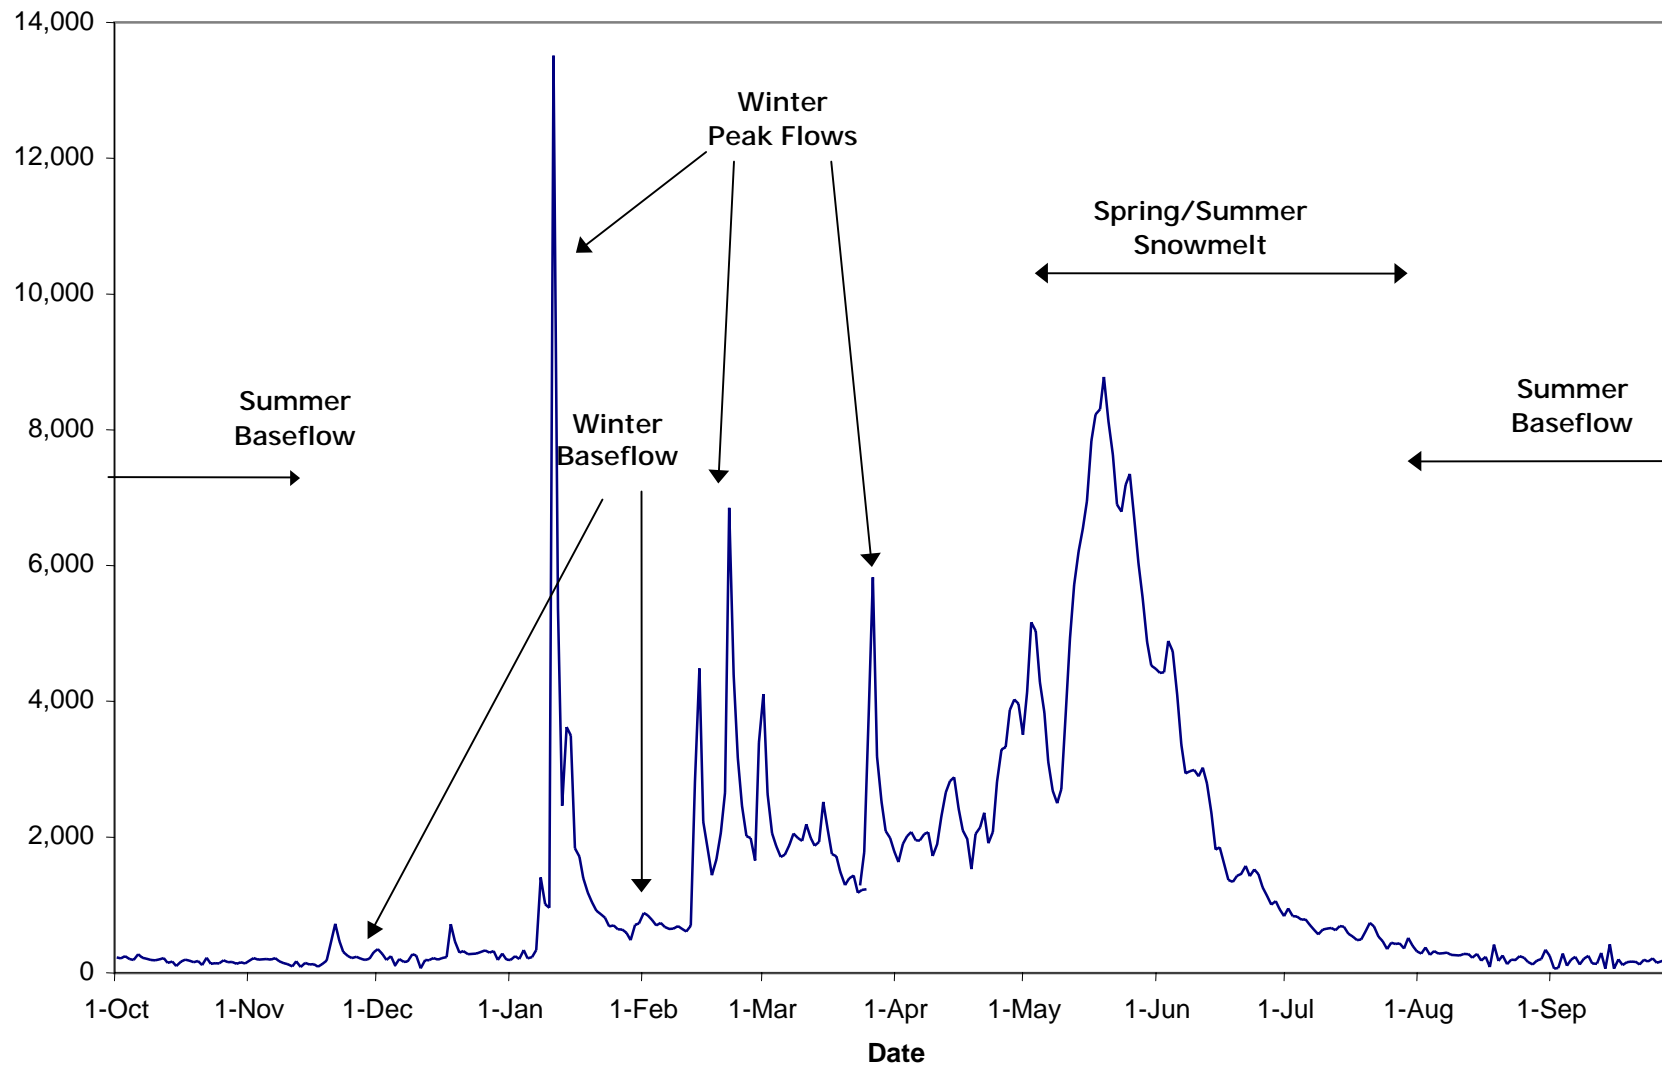
Figure 4.1-1. Hydrograph components for unregulated flow conditions in the Merced River.
 (Hydrograph shown is estimated inflow to Lake McClure for water year 1979, representative of a median water year.)
 (source: Merced Irrigation District)

In most river systems, streamflow conditions are highly variable. In the eastside Central Valley rivers, natural flow conditions are characterized by low flows in summer and early fall, large but brief flow peaks in winter generated by rain storms, and prolonged high flows in spring generated by snowmelt from upper Sierra Nevada watersheds. Each of these components of the natural hydrograph drives processes that shape and sustain the river-floodplain system. Alteration of any of these components causes alterations to the river ecosystem structure and function.

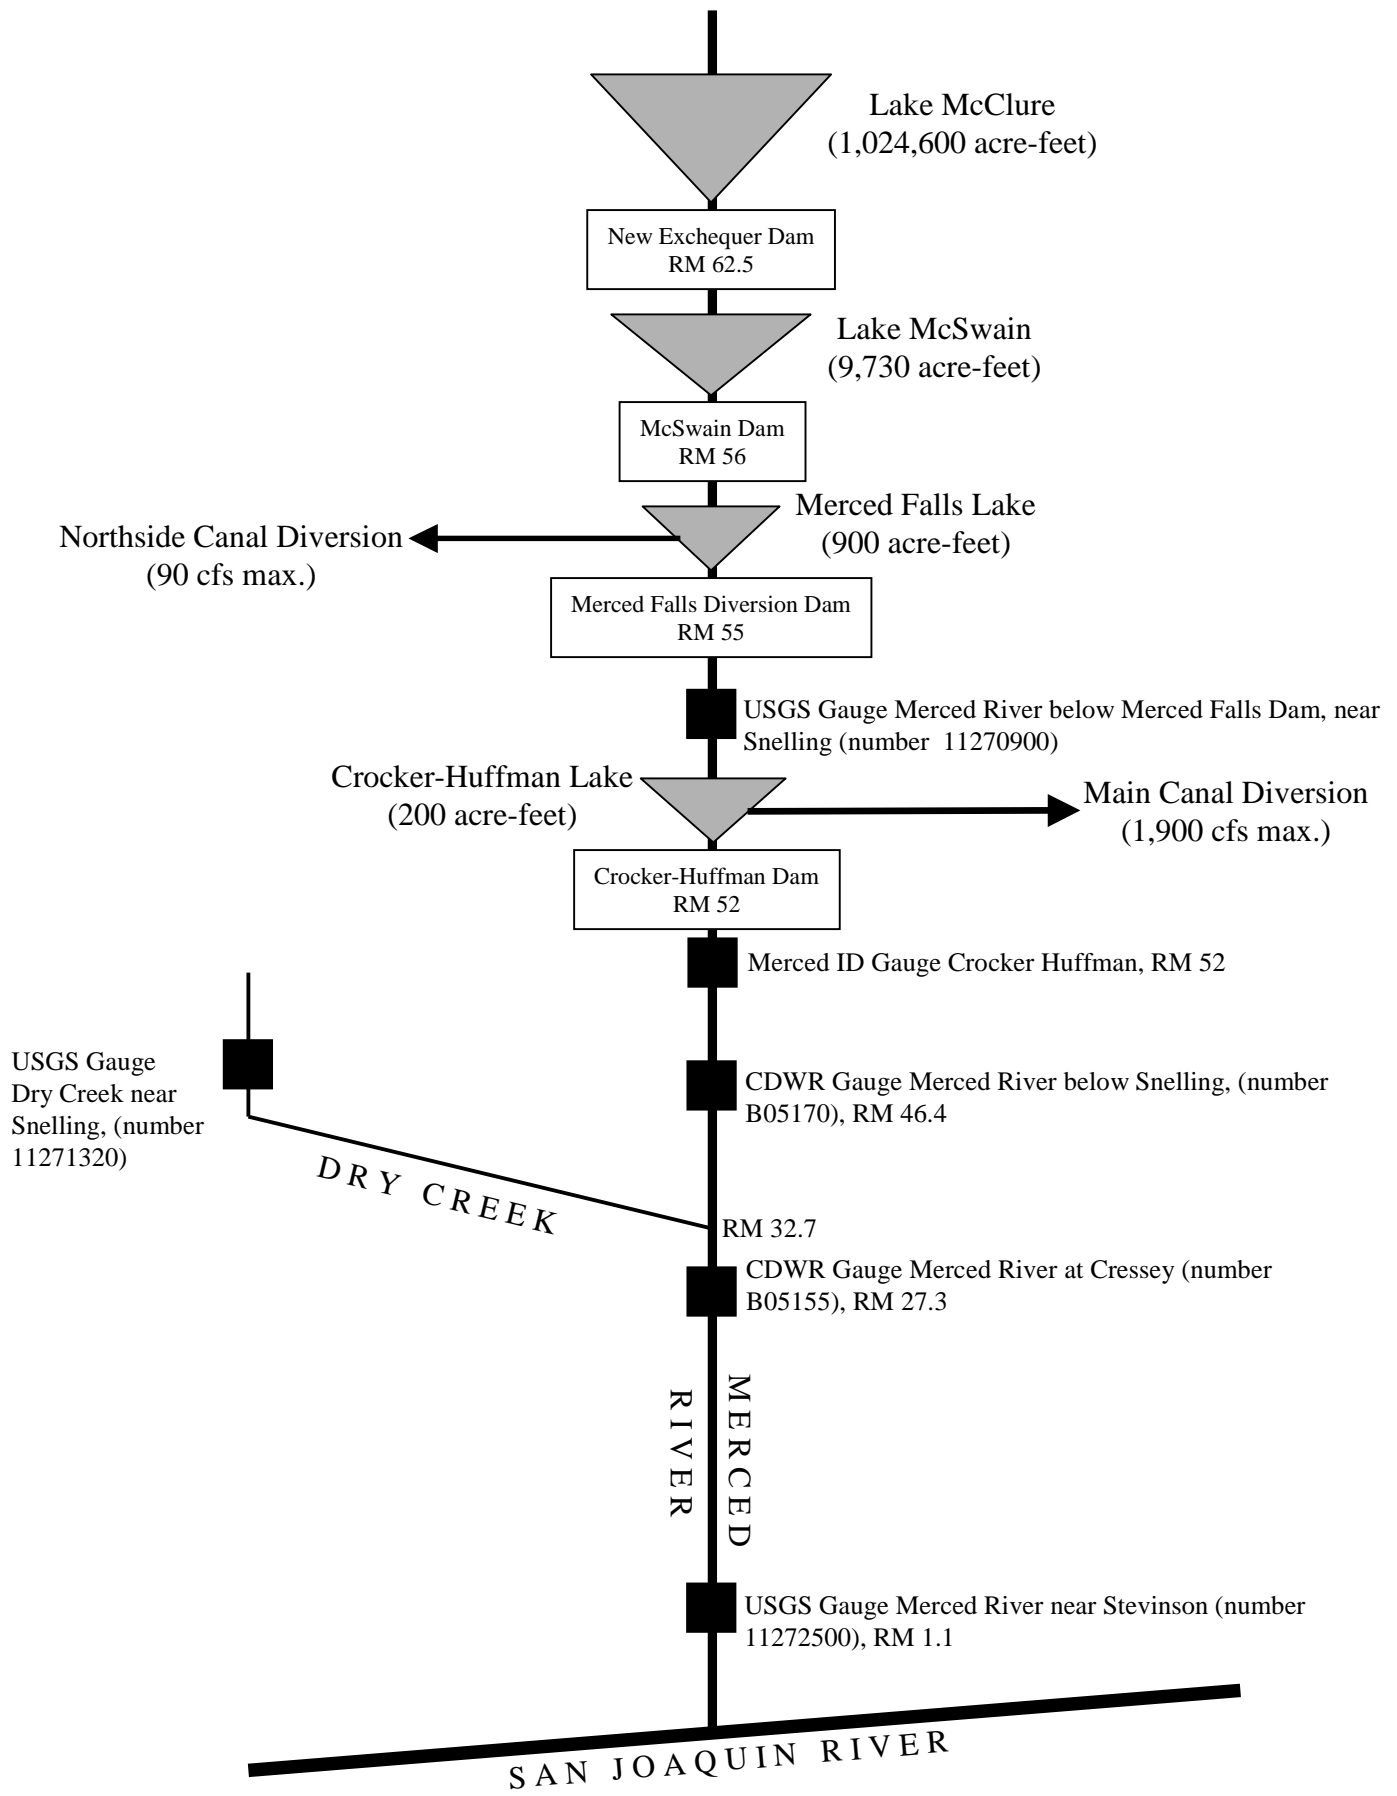
Figure 4.2-1. Schematic diagram of Merced River dams, reservoirs, diversions and flow gauges.

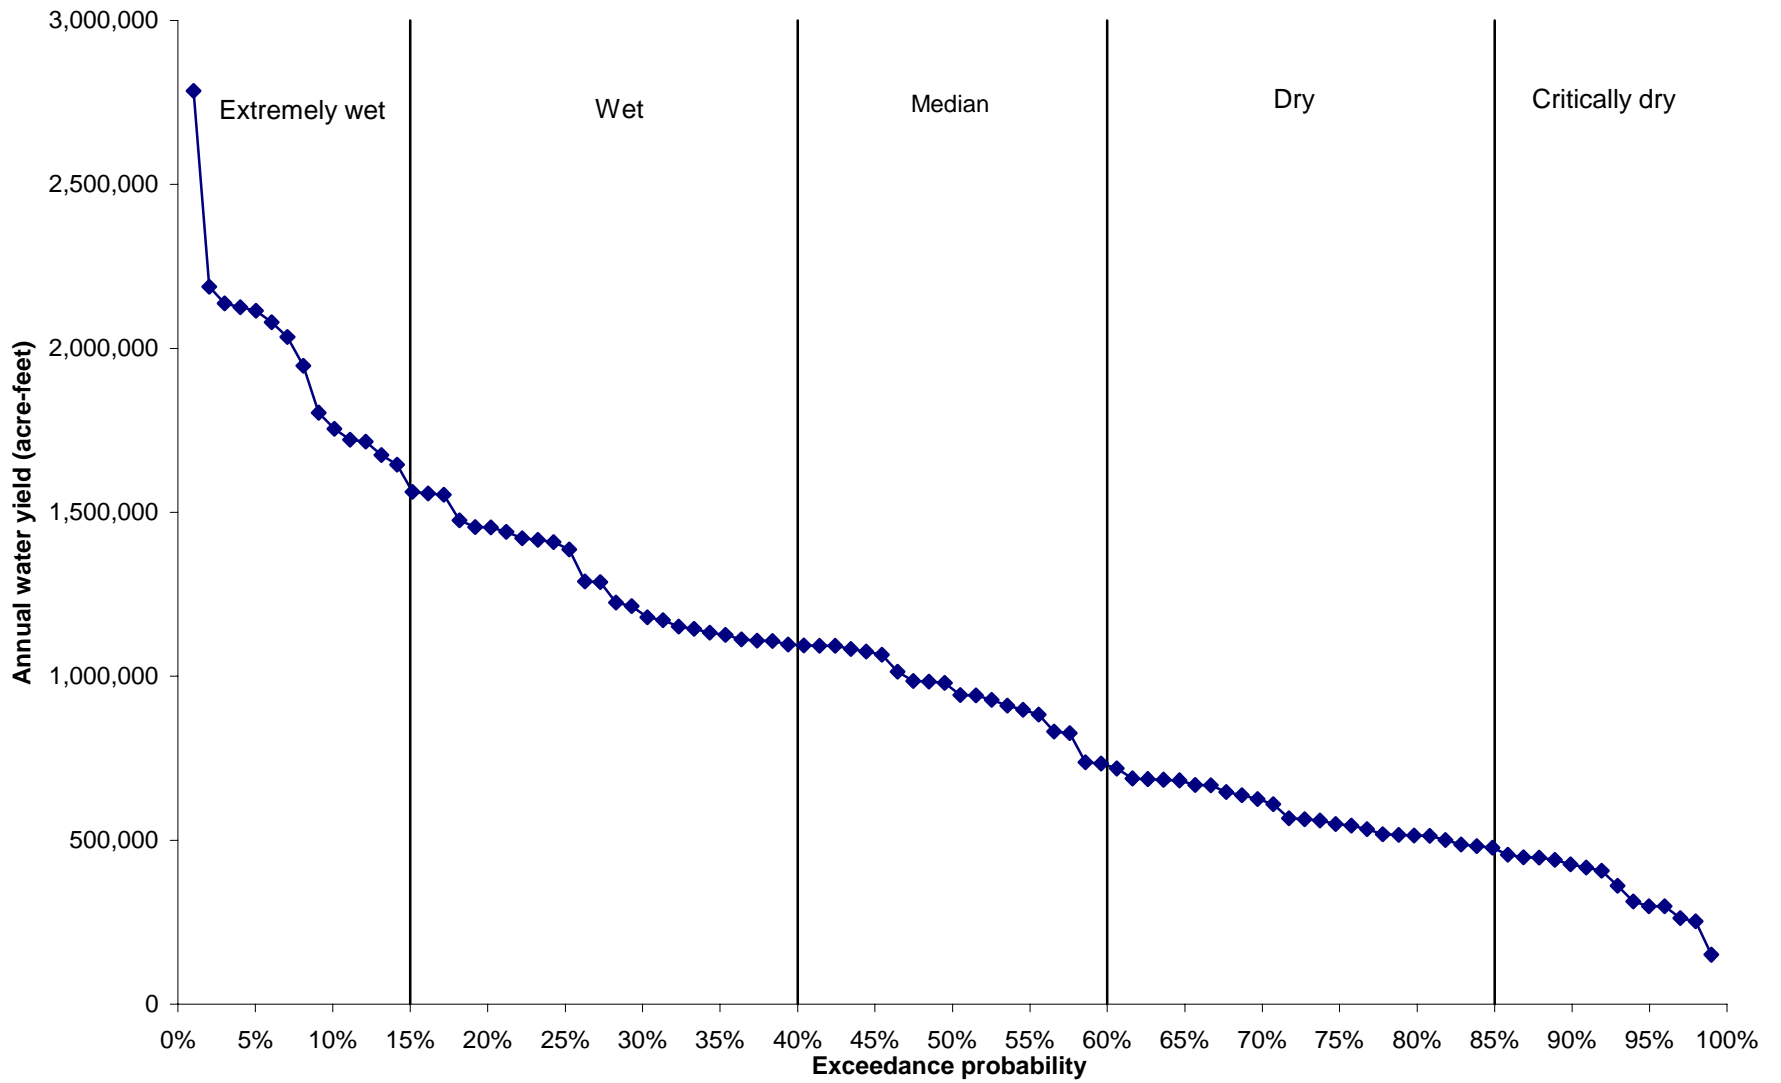
Figure 4.2-3. Cumulative plot of ranked annual water yields from the Merced River (1902–1998).
