Merced River Corridor Restoration Plan Baseline Studies

Volume I: Identification of Social, Institutional, and Infrastructural Opportunities and Constraints

**MERCED RIVER CORRIDOR RESTORATION PLAN
BASELINE STUDIES**

**VOLUME I:
IDENTIFICATION OF SOCIAL, INSTITUTIONAL, AND
INFRASTRUCTURAL OPPORTUNITIES AND CONSTRAINTS**

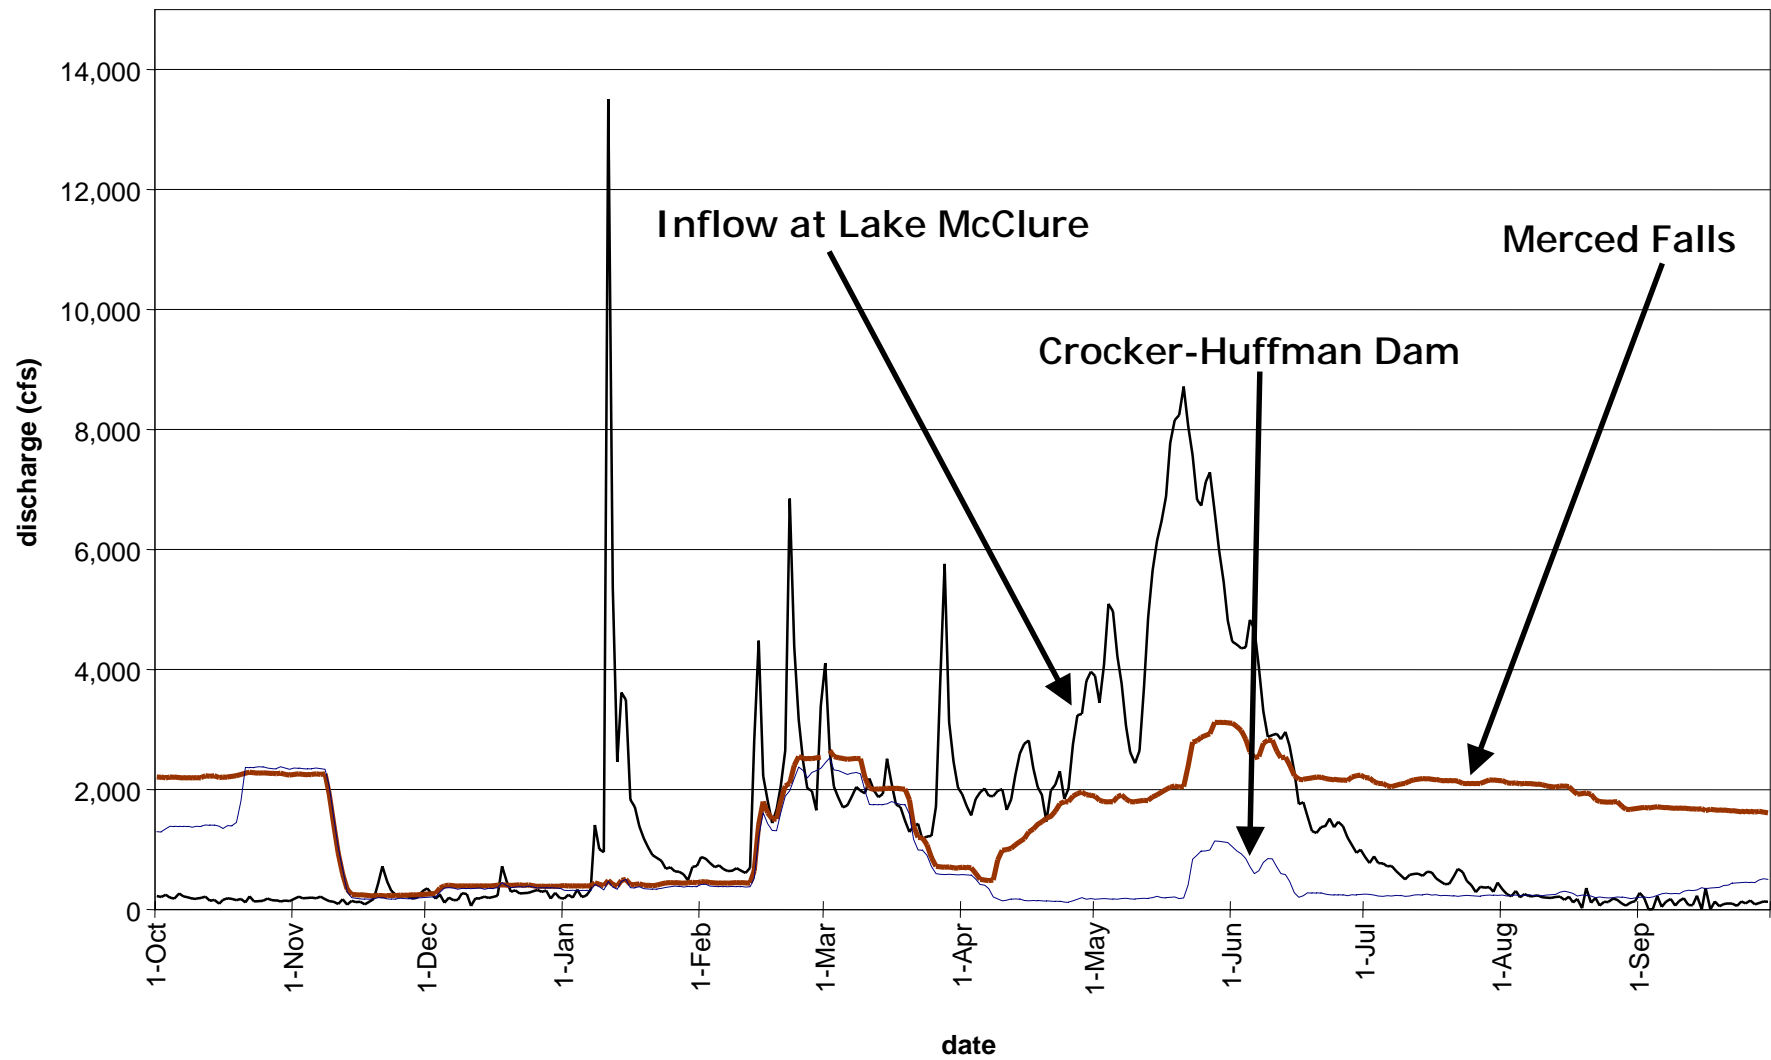
Figure 4.2-4C. Annual hydrographs of inflow to Lake McClure and flow at Merced Falls and Crocker-Huffman Dam for a median year (water year 1979).

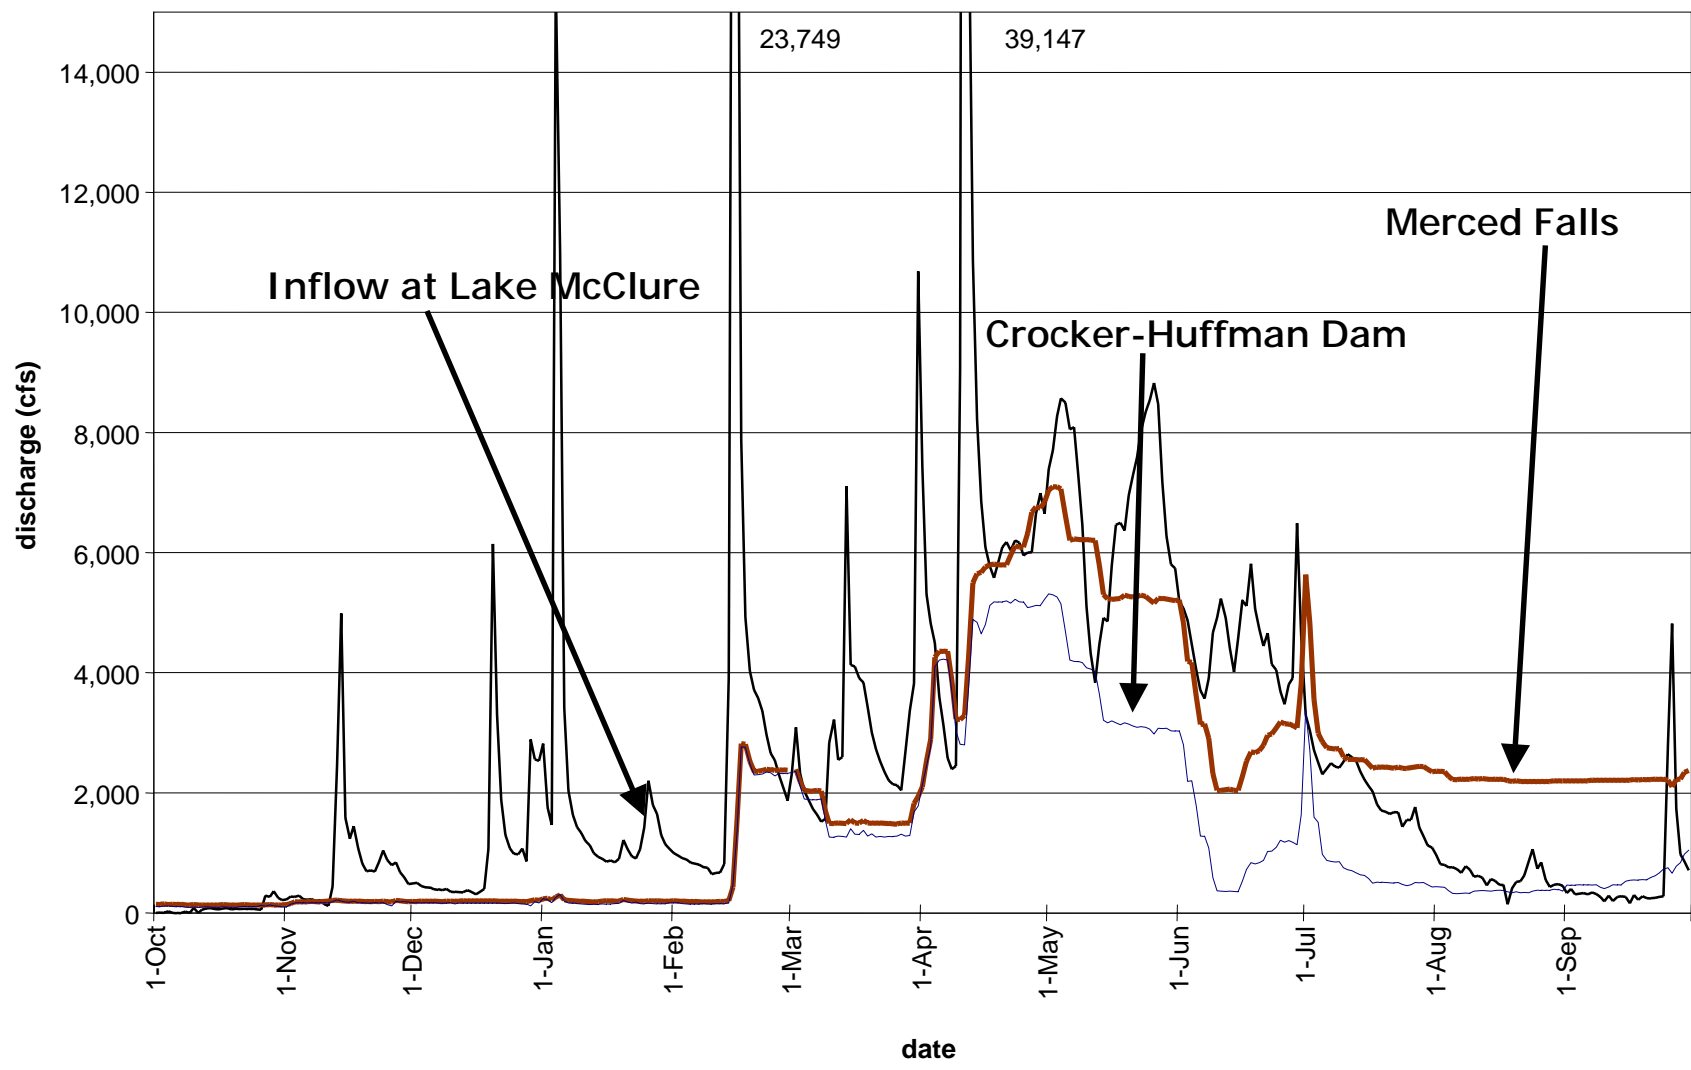
Figure 4.2-4E. Annual hydrographs of inflow to Lake McClure and flow at Merced Falls and Crocker-Huffman Dam for an extremely wet year (water year 1982).

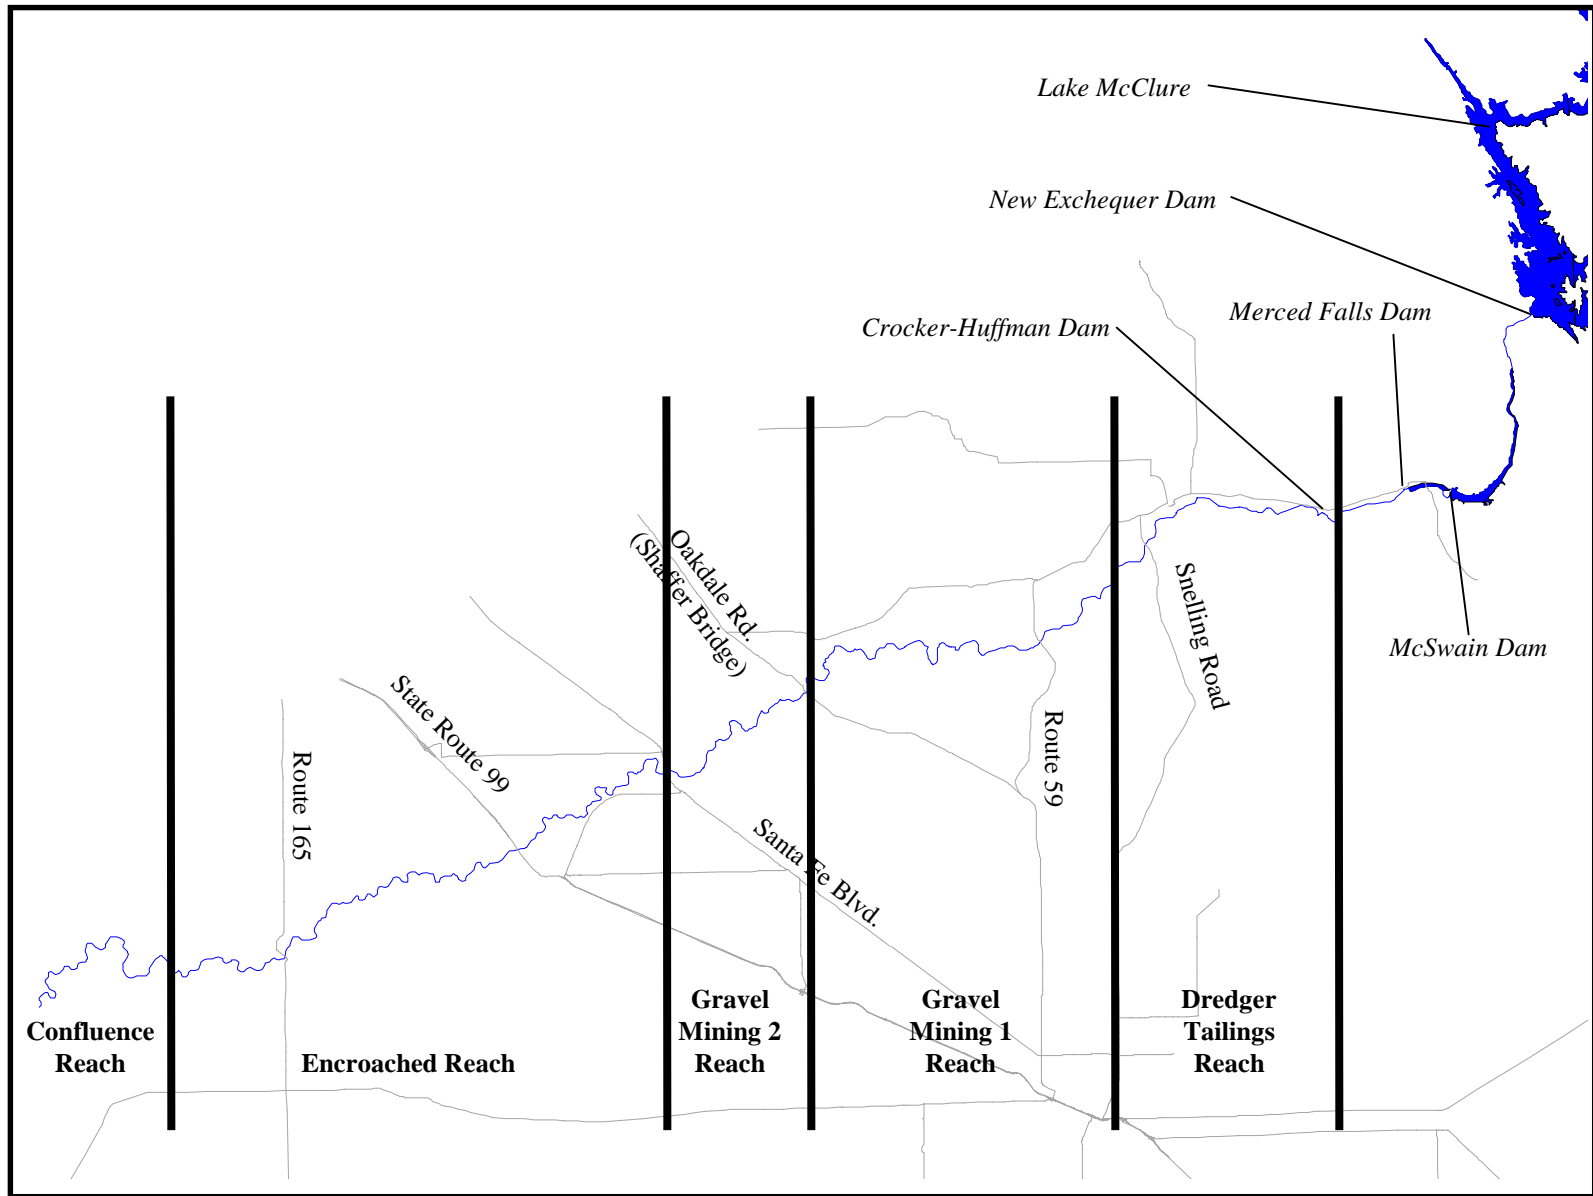
Figure 5.1-1. Merced River reaches delineation.

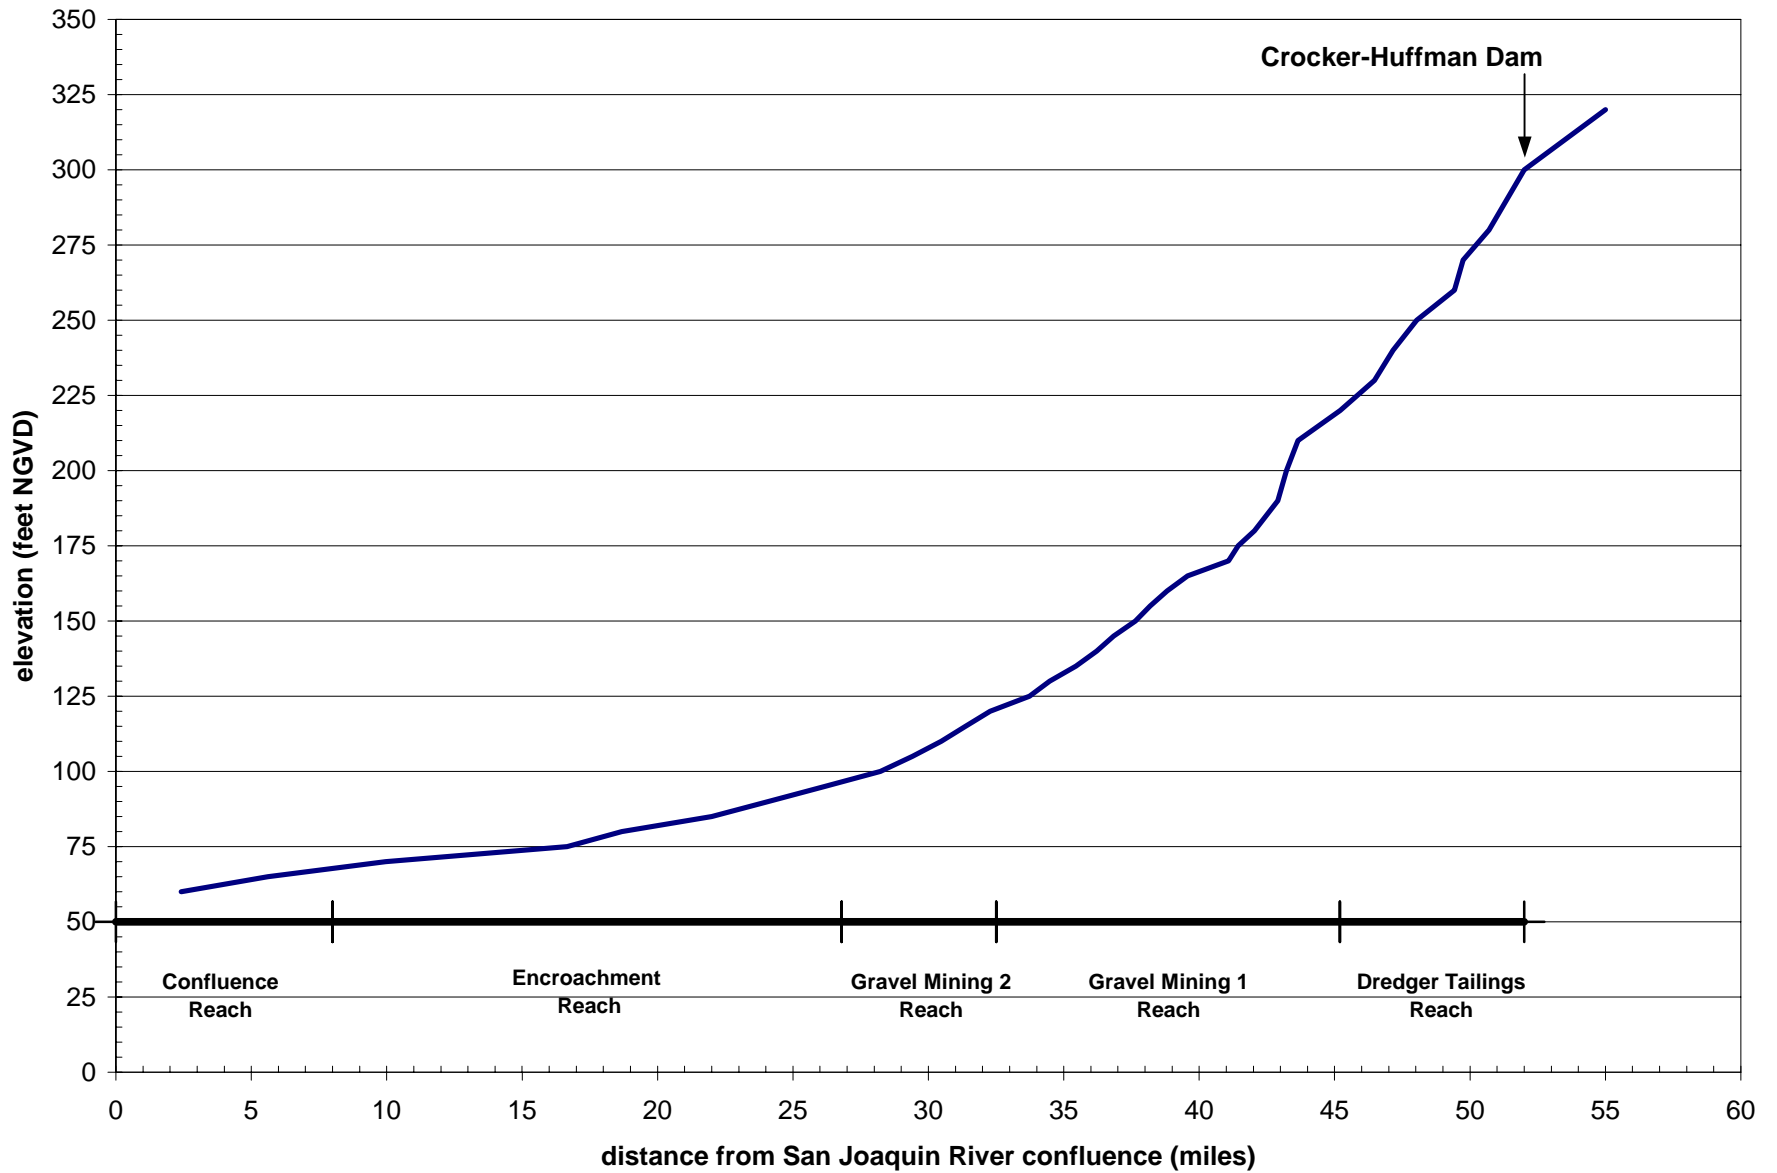
Figure 5.1-2. Merced River longitudinal profile.
 (from U. S. Geological Survey 1:24,000-scale topographic maps)

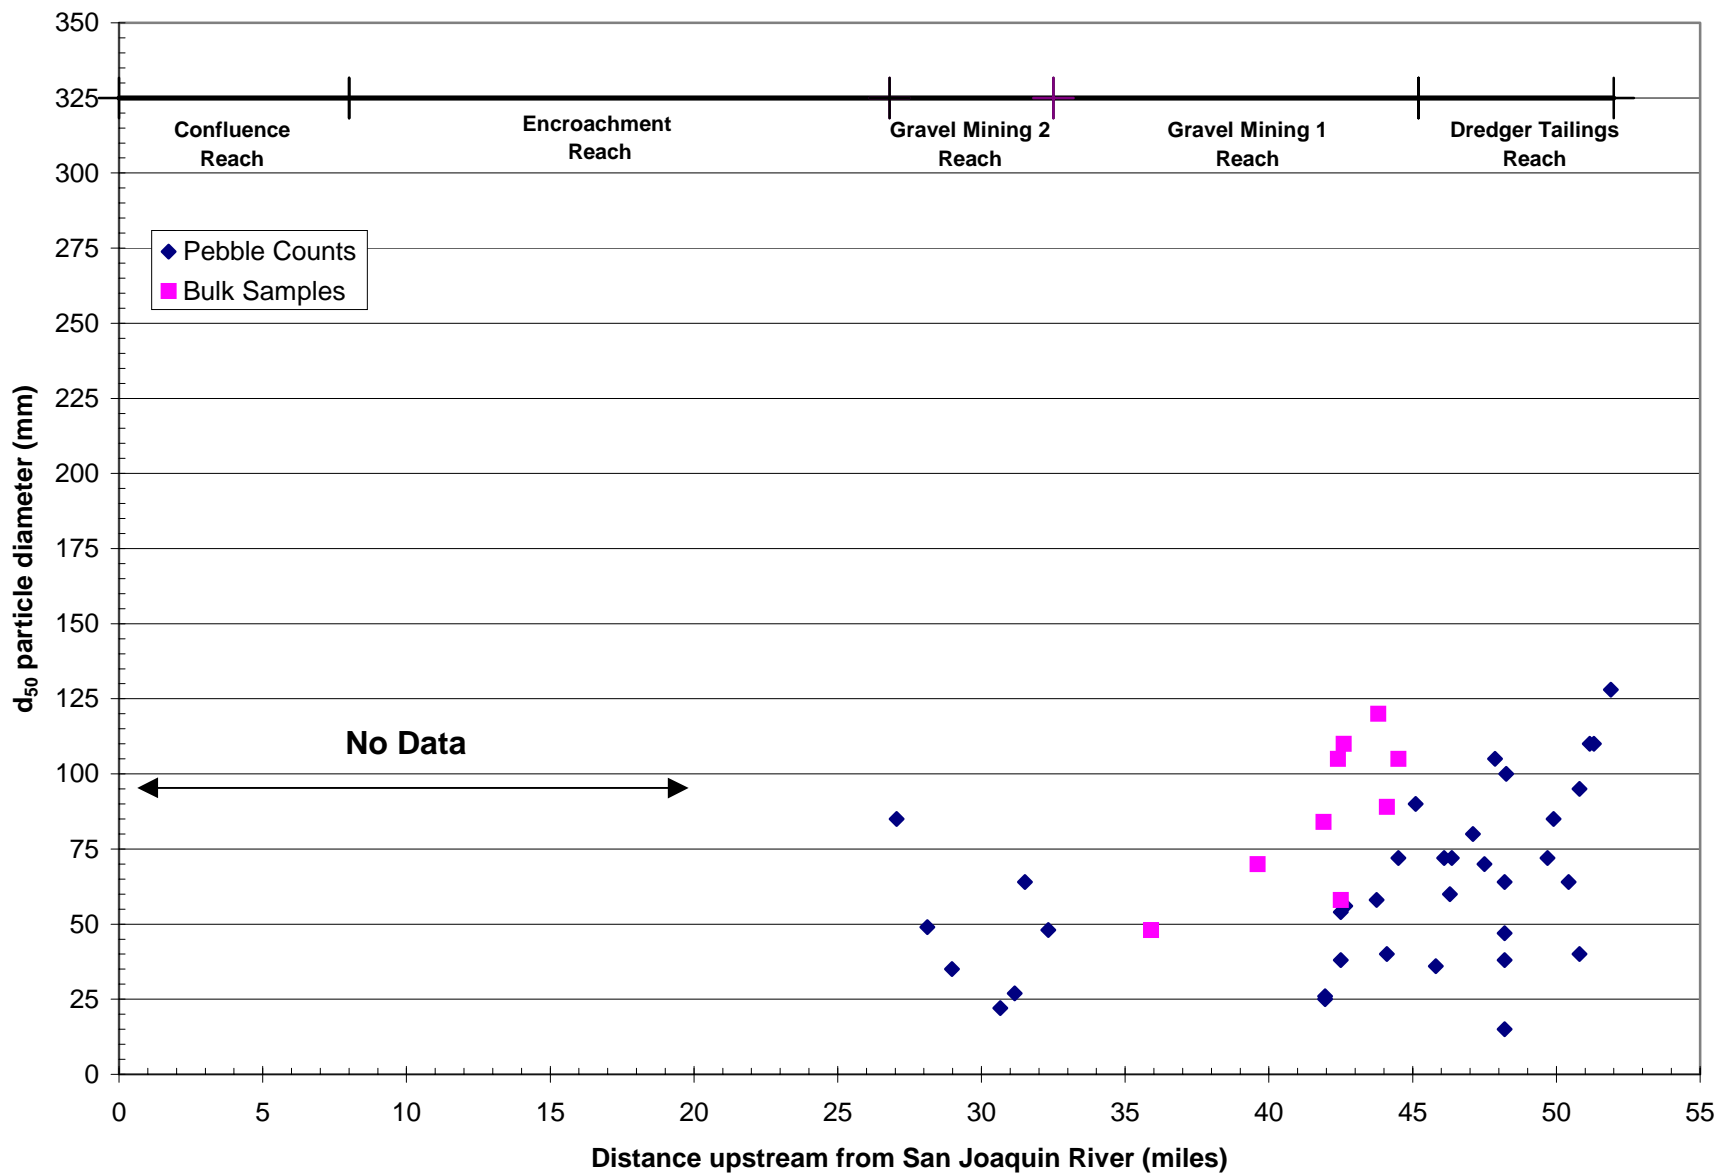
Figure 5.1-3. Merced River surface particle size - D_{50} .
 (sources: CDWR 1994b, Vick 1995)

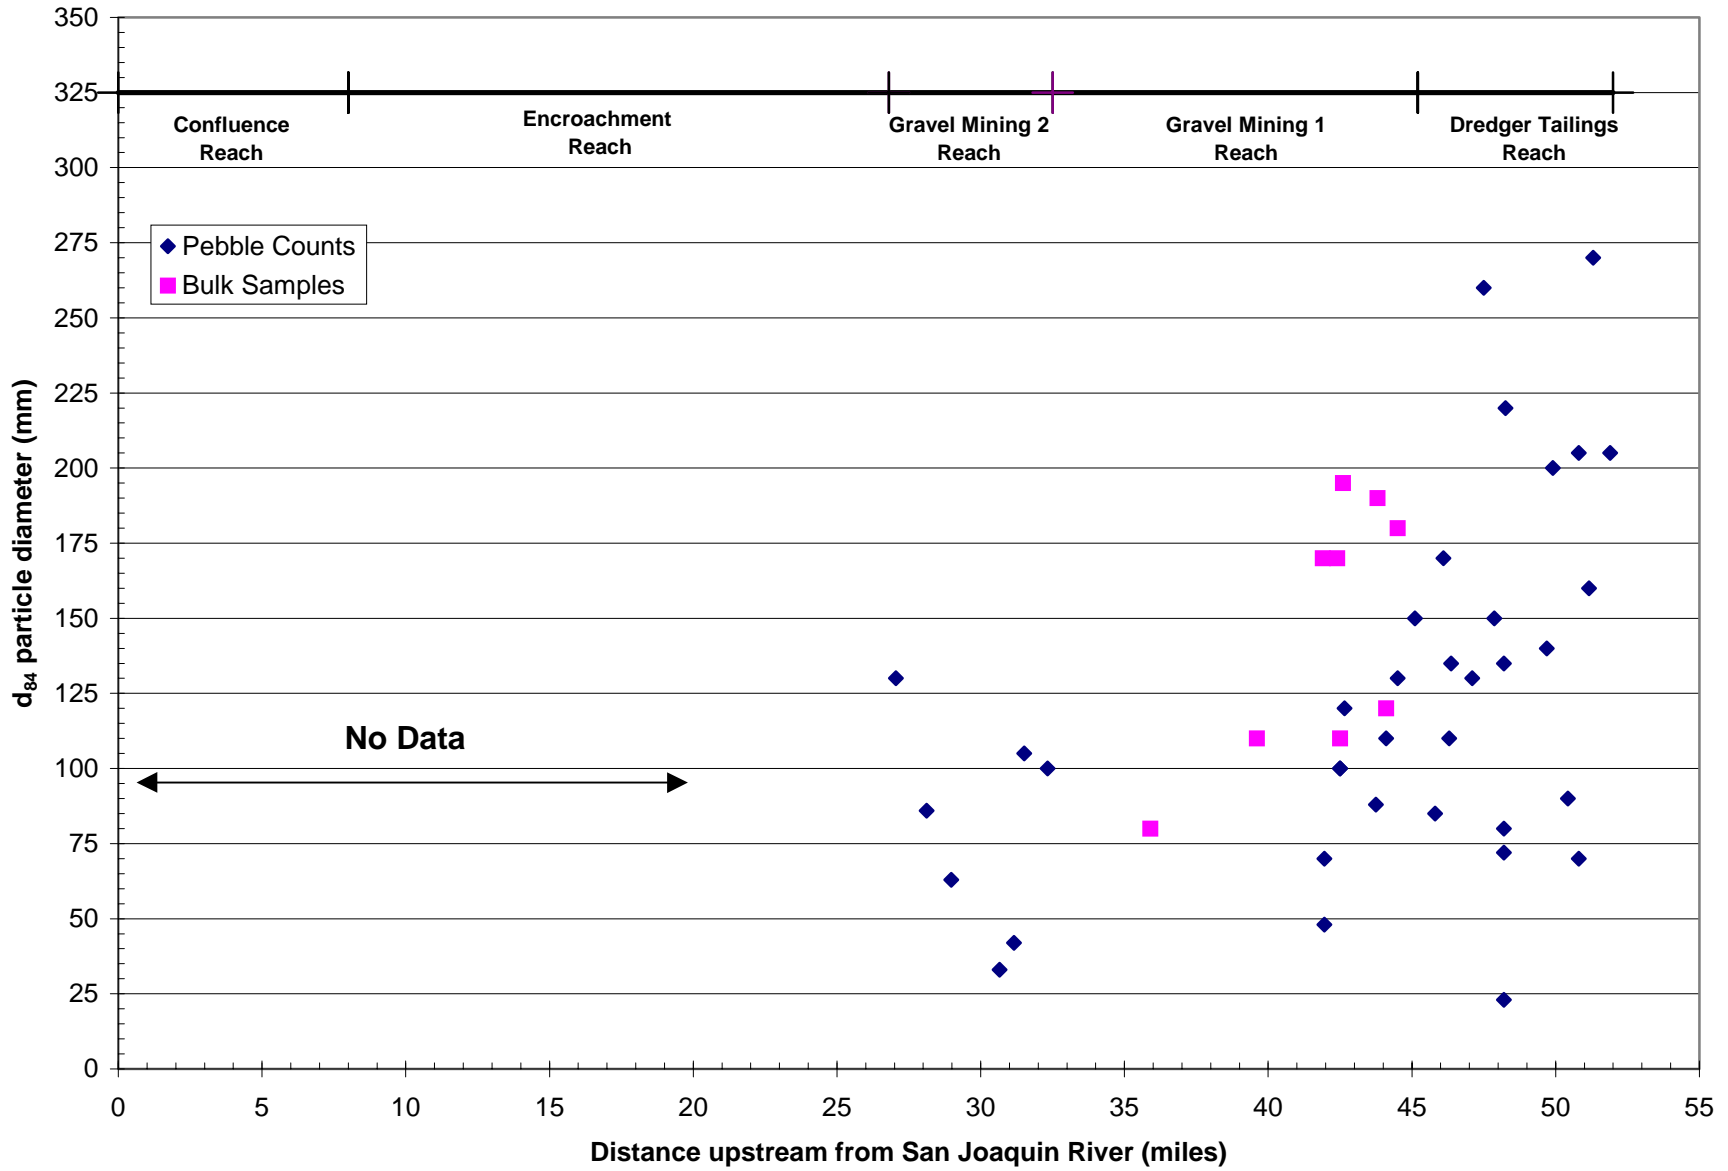
Figure 5.1-4. Merced River surface particle size - D_{84} .
 (sources: CDWR 1994b, Vick 1995)

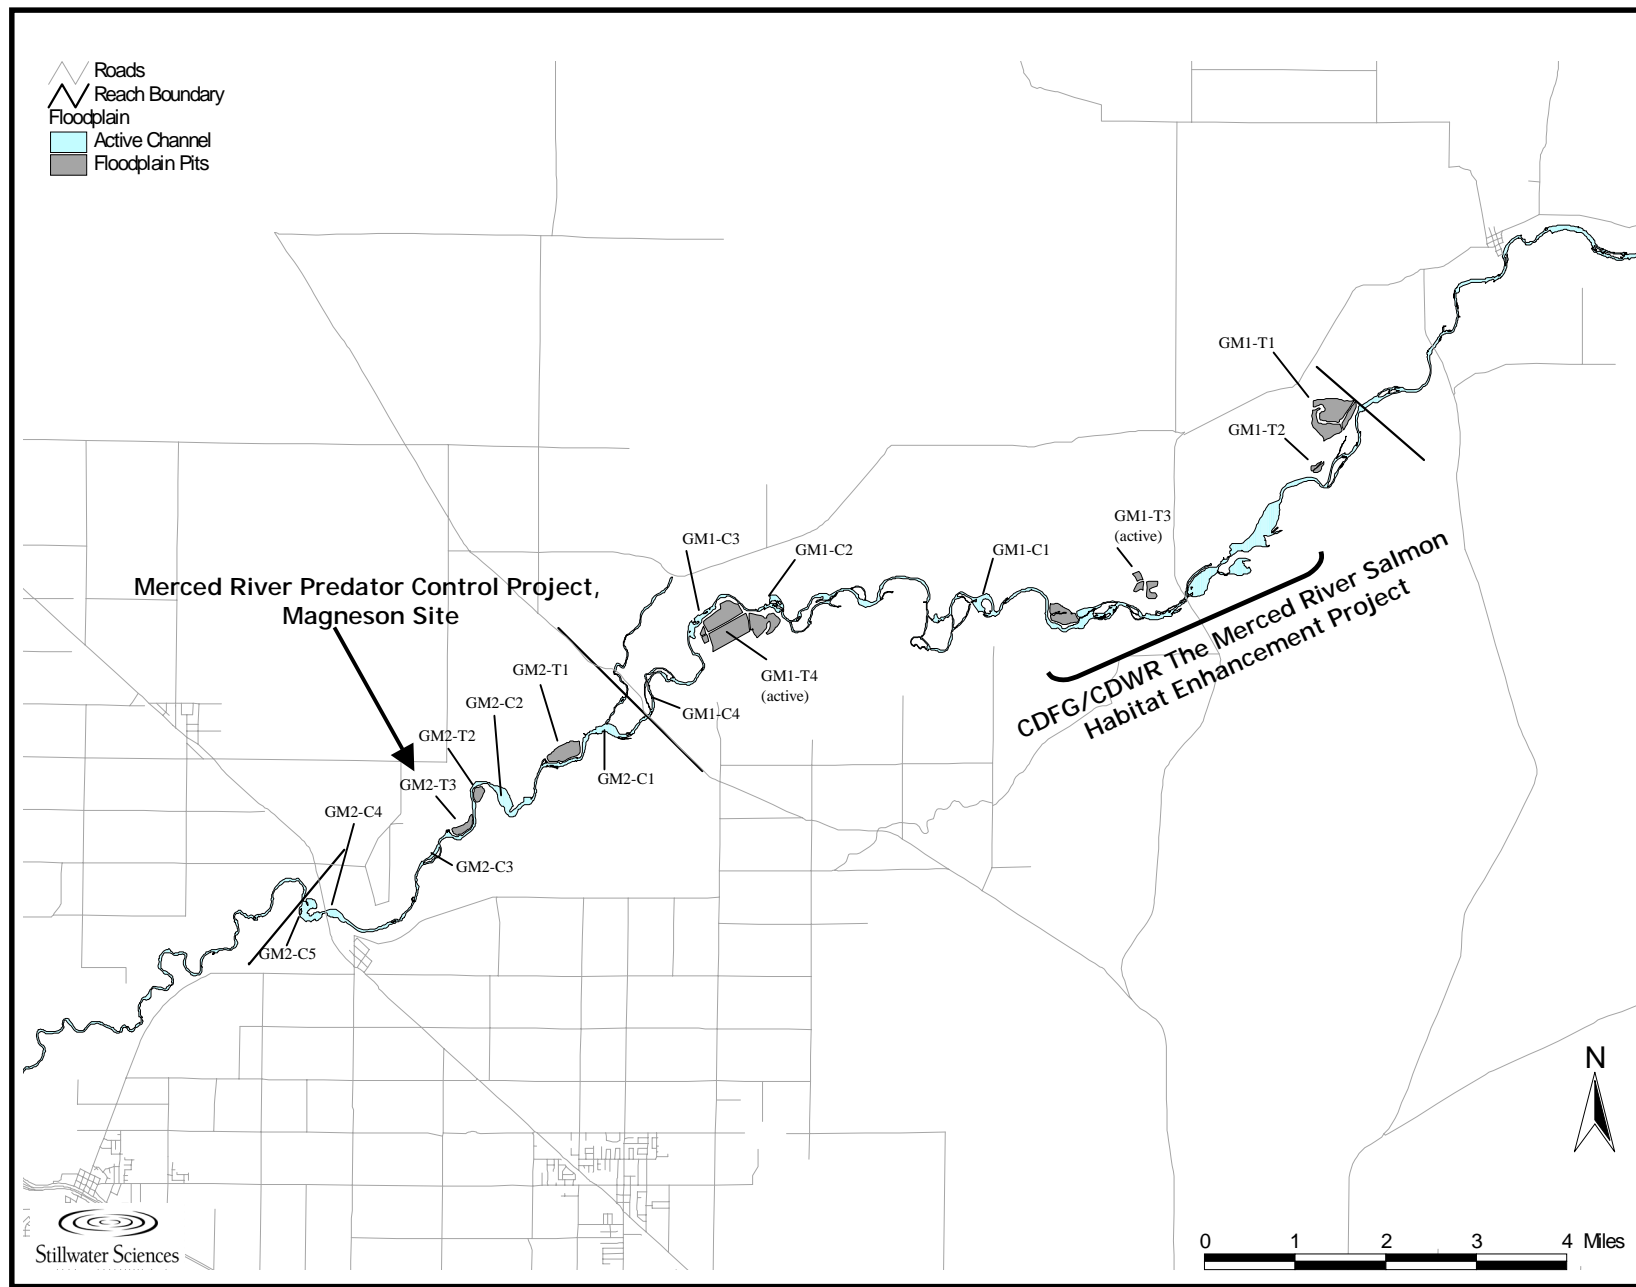
Figure 5.1-8. Terrace and in-channel aggregate mines in the Gravel Mining 1 and Gravel Mining 2 reaches.

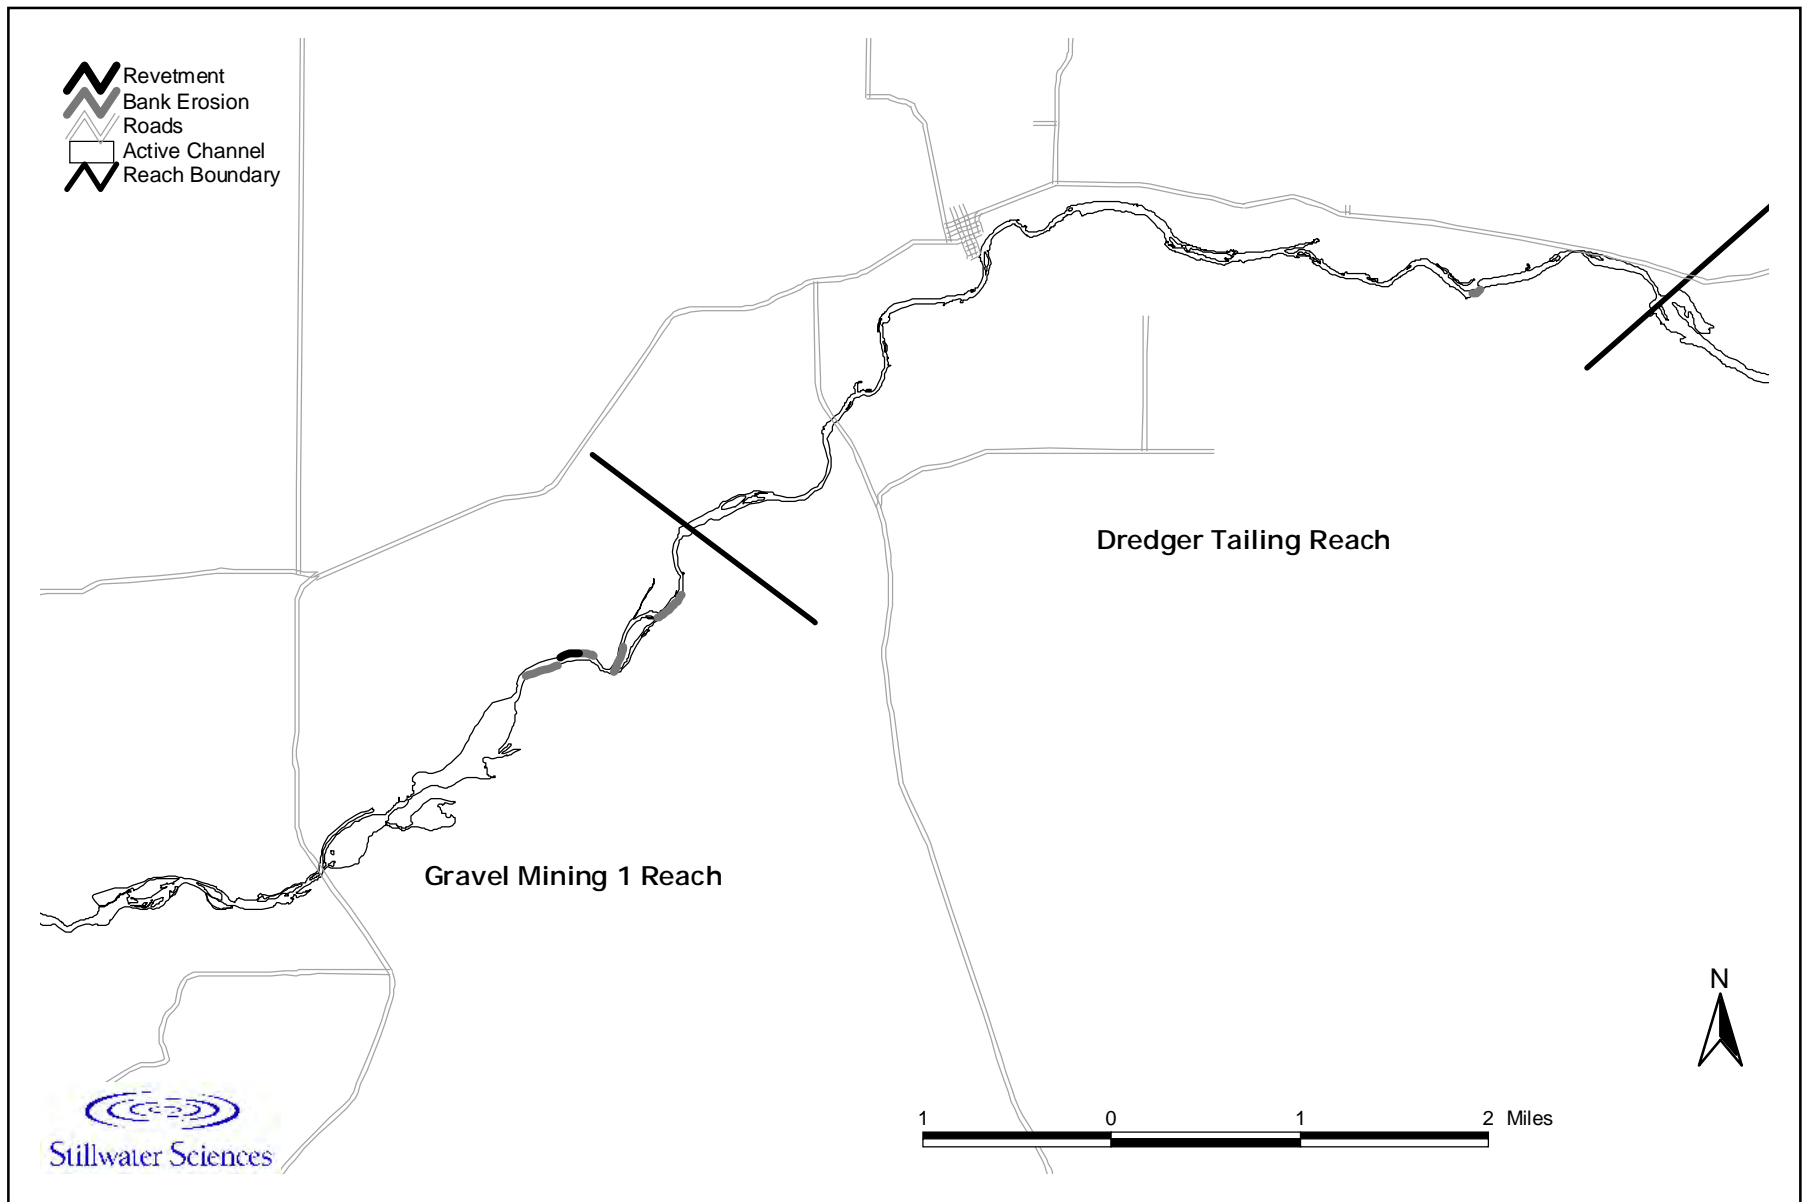
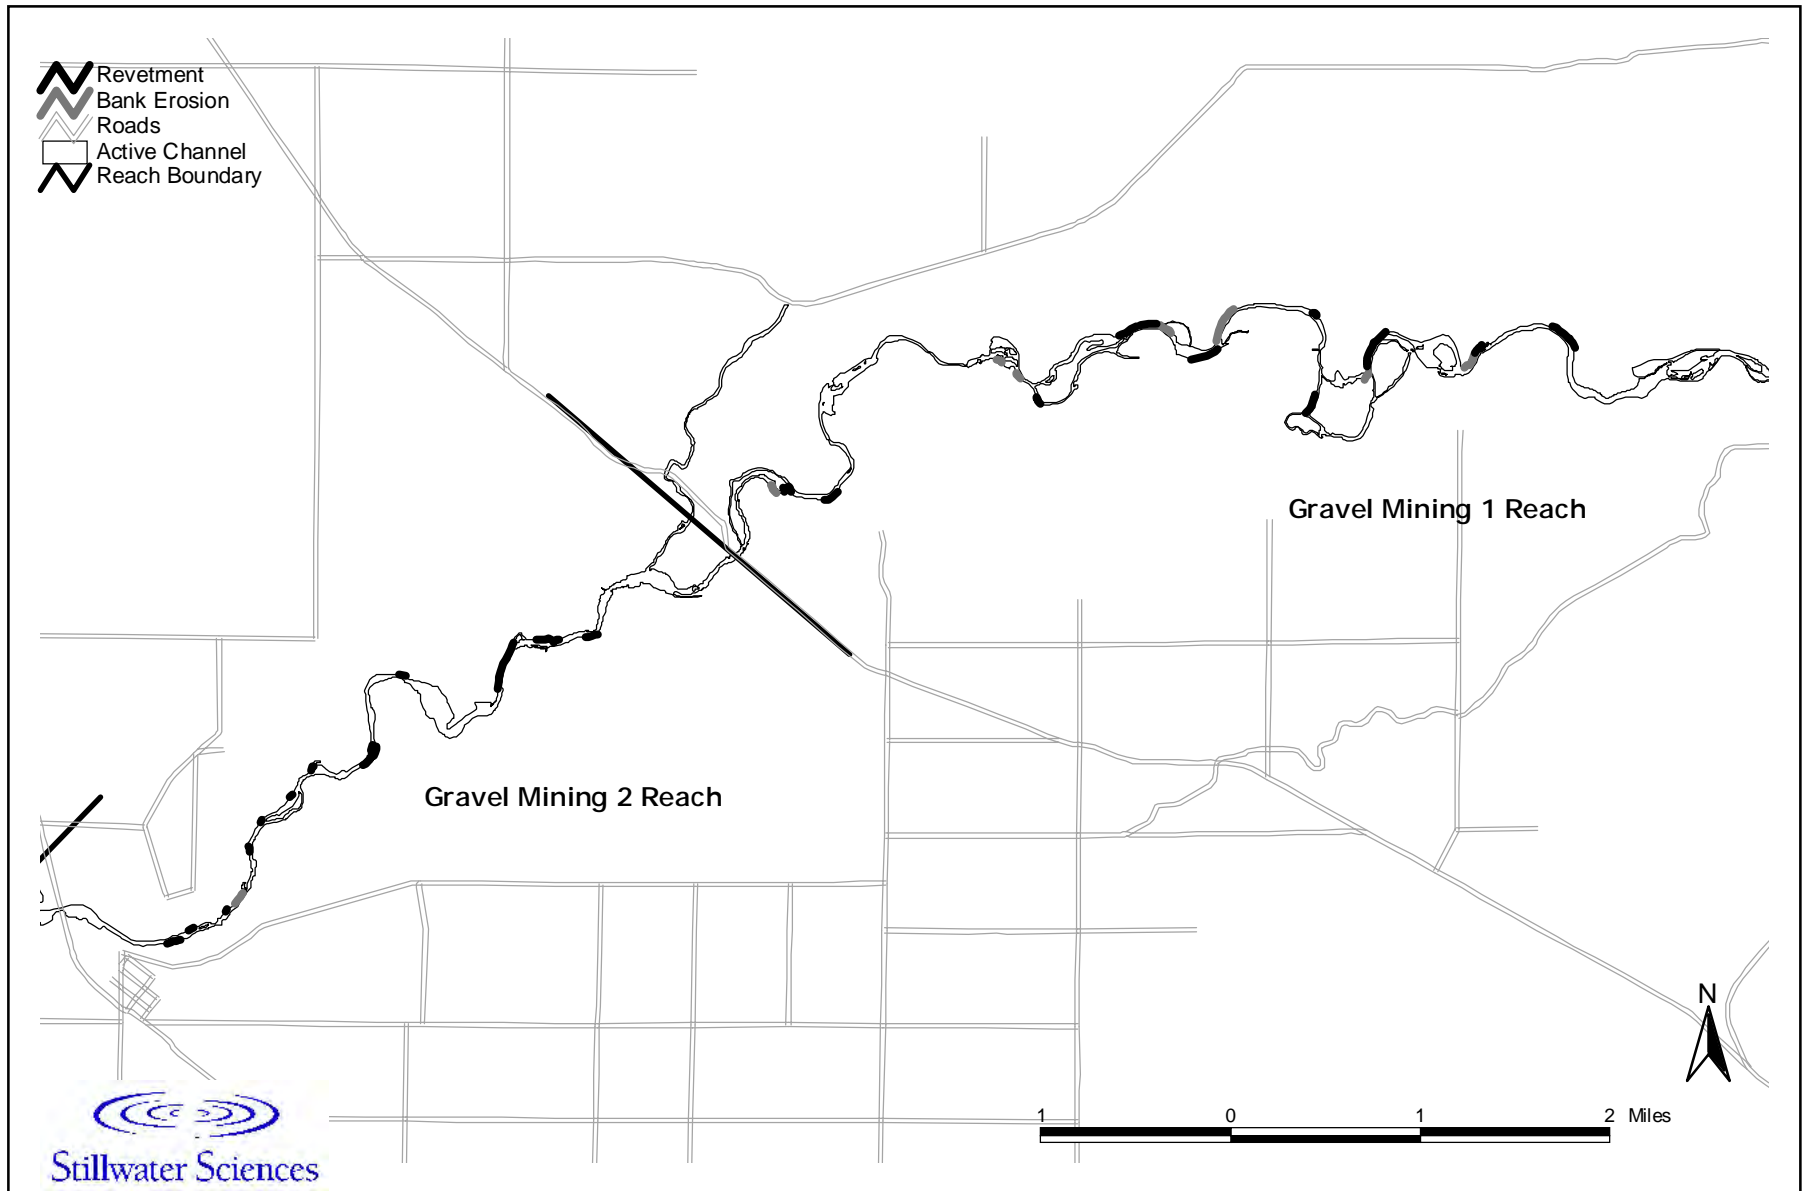
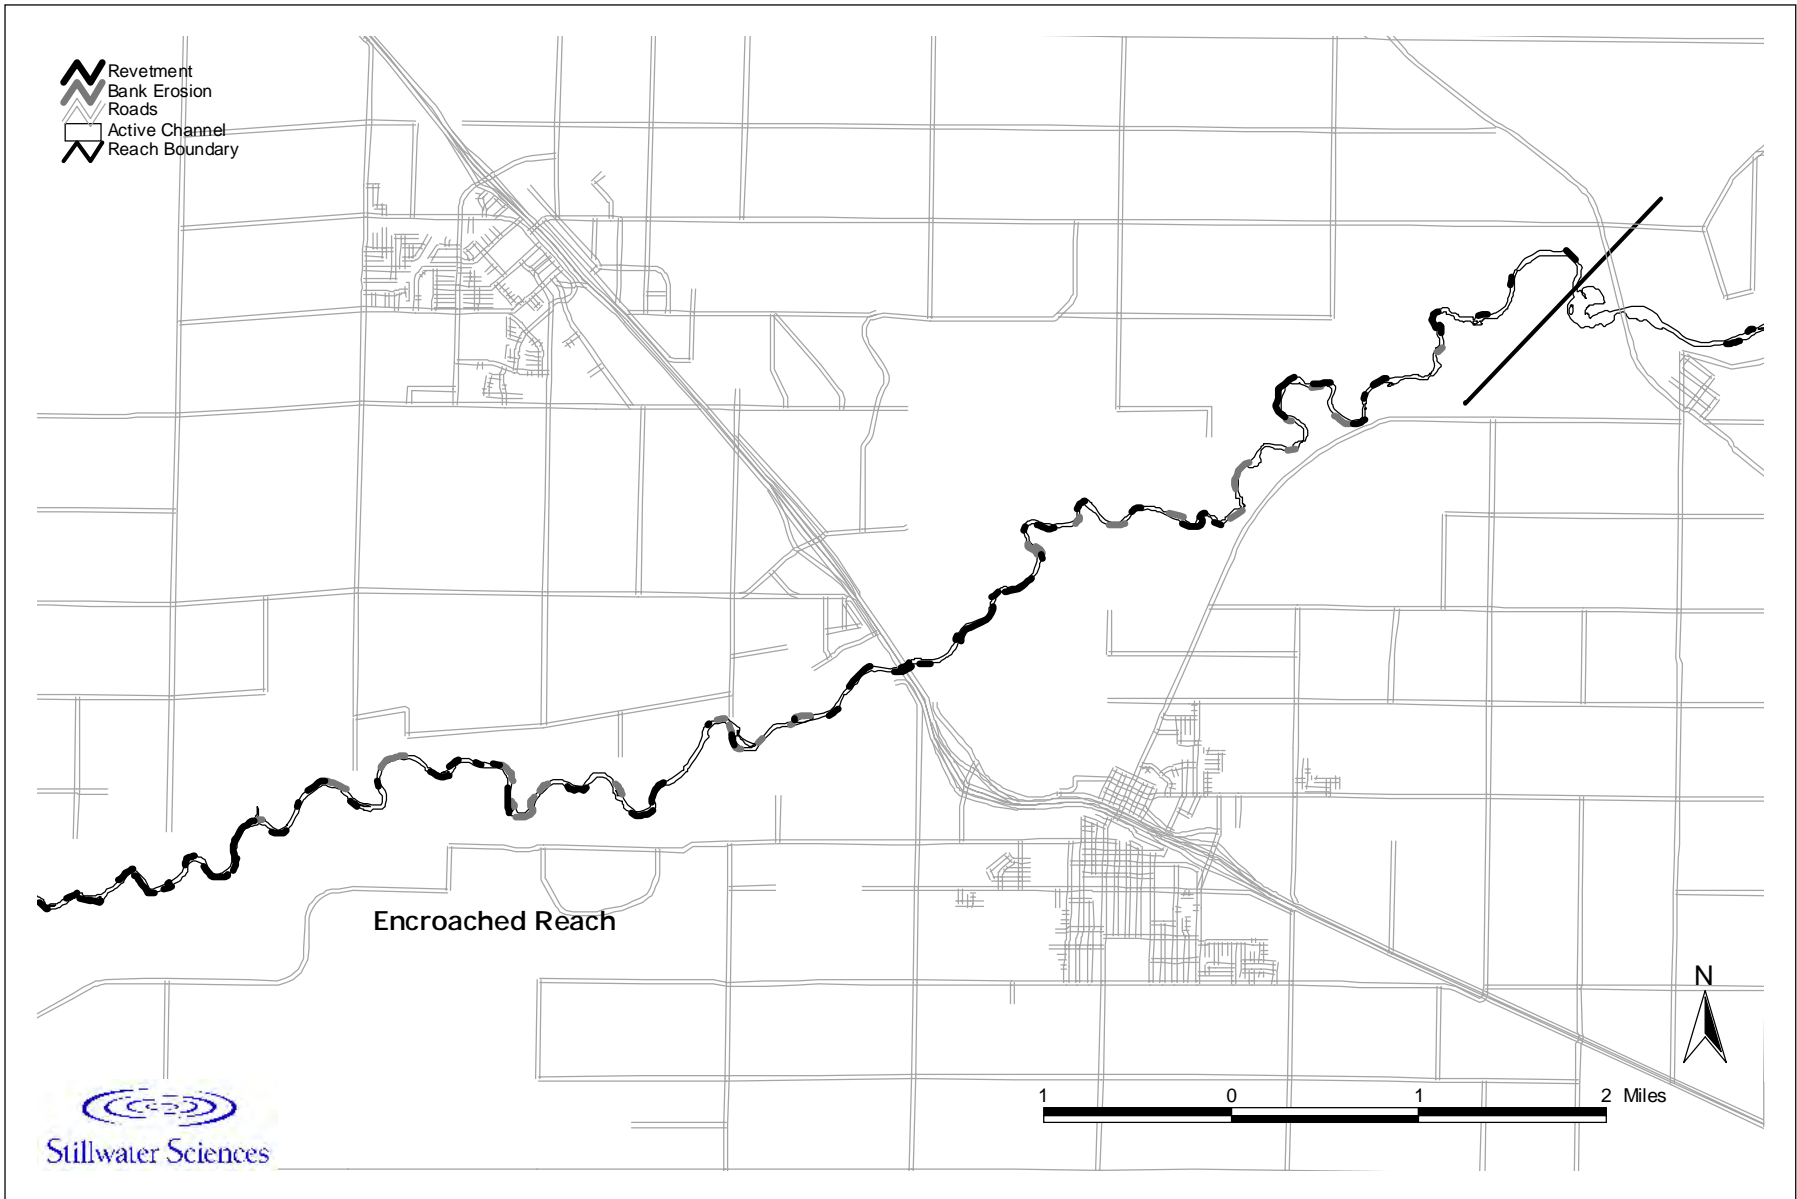
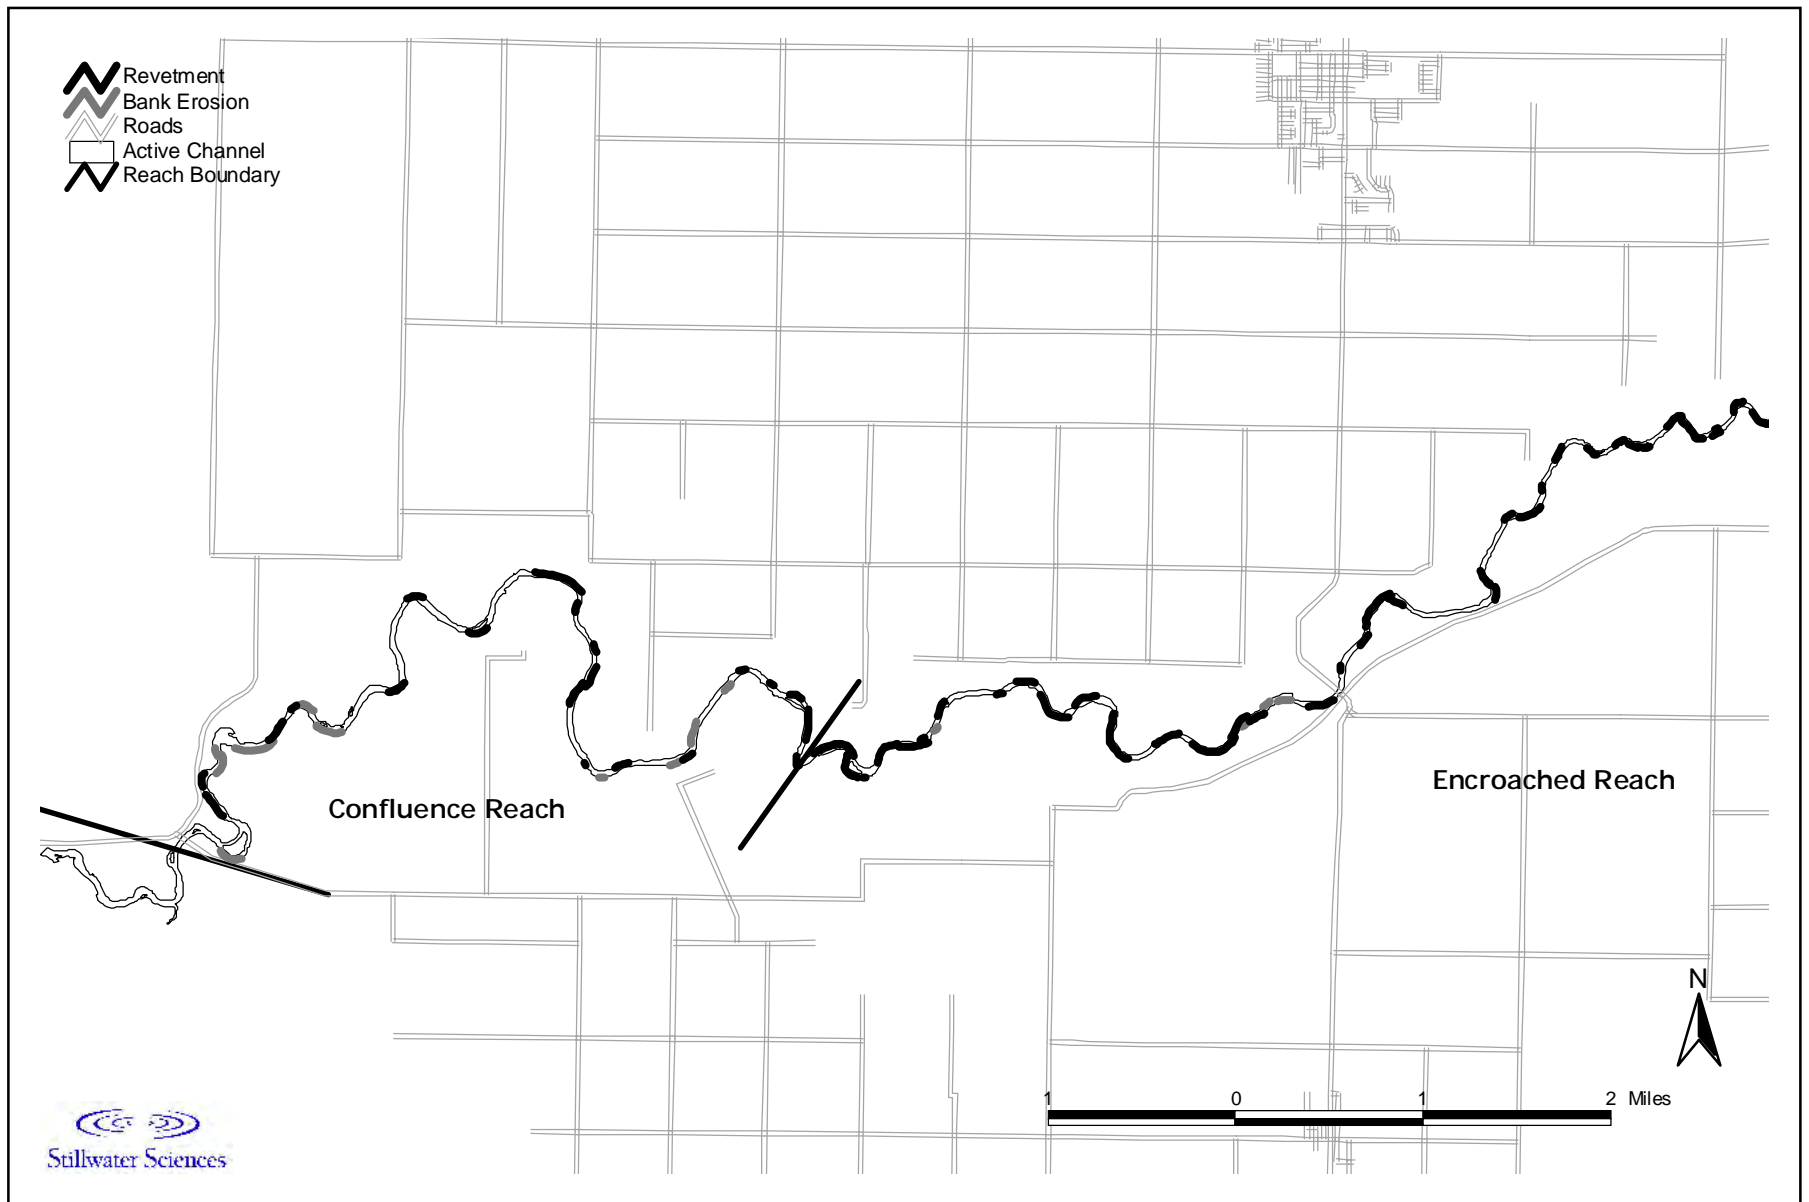
Figure 5.2-1A. Bank erosion and revetment in the Merced River.

Lastly, several roads (both public and private), private levees, wastewater treatment plants, and other structures are located immediately adjacent to the river. Many of these structures are vulnerable to bank erosion, and many are currently protected by bank revetment or rubble placed on the banks to reduce erosion. Actions in the restoration plan cannot increase the vulnerability of these structures to damage from bank erosion.
