Merced River Corridor Restoration Plan Baseline Studies

Volume I: Identification of Social, Institutional, and Infrastructural Opportunities and Constraints

**MERCED RIVER CORRIDOR RESTORATION PLAN
BASELINE STUDIES**

**VOLUME I:
IDENTIFICATION OF SOCIAL, INSTITUTIONAL, AND
INFRASTRUCTURAL OPPORTUNITIES AND CONSTRAINTS**

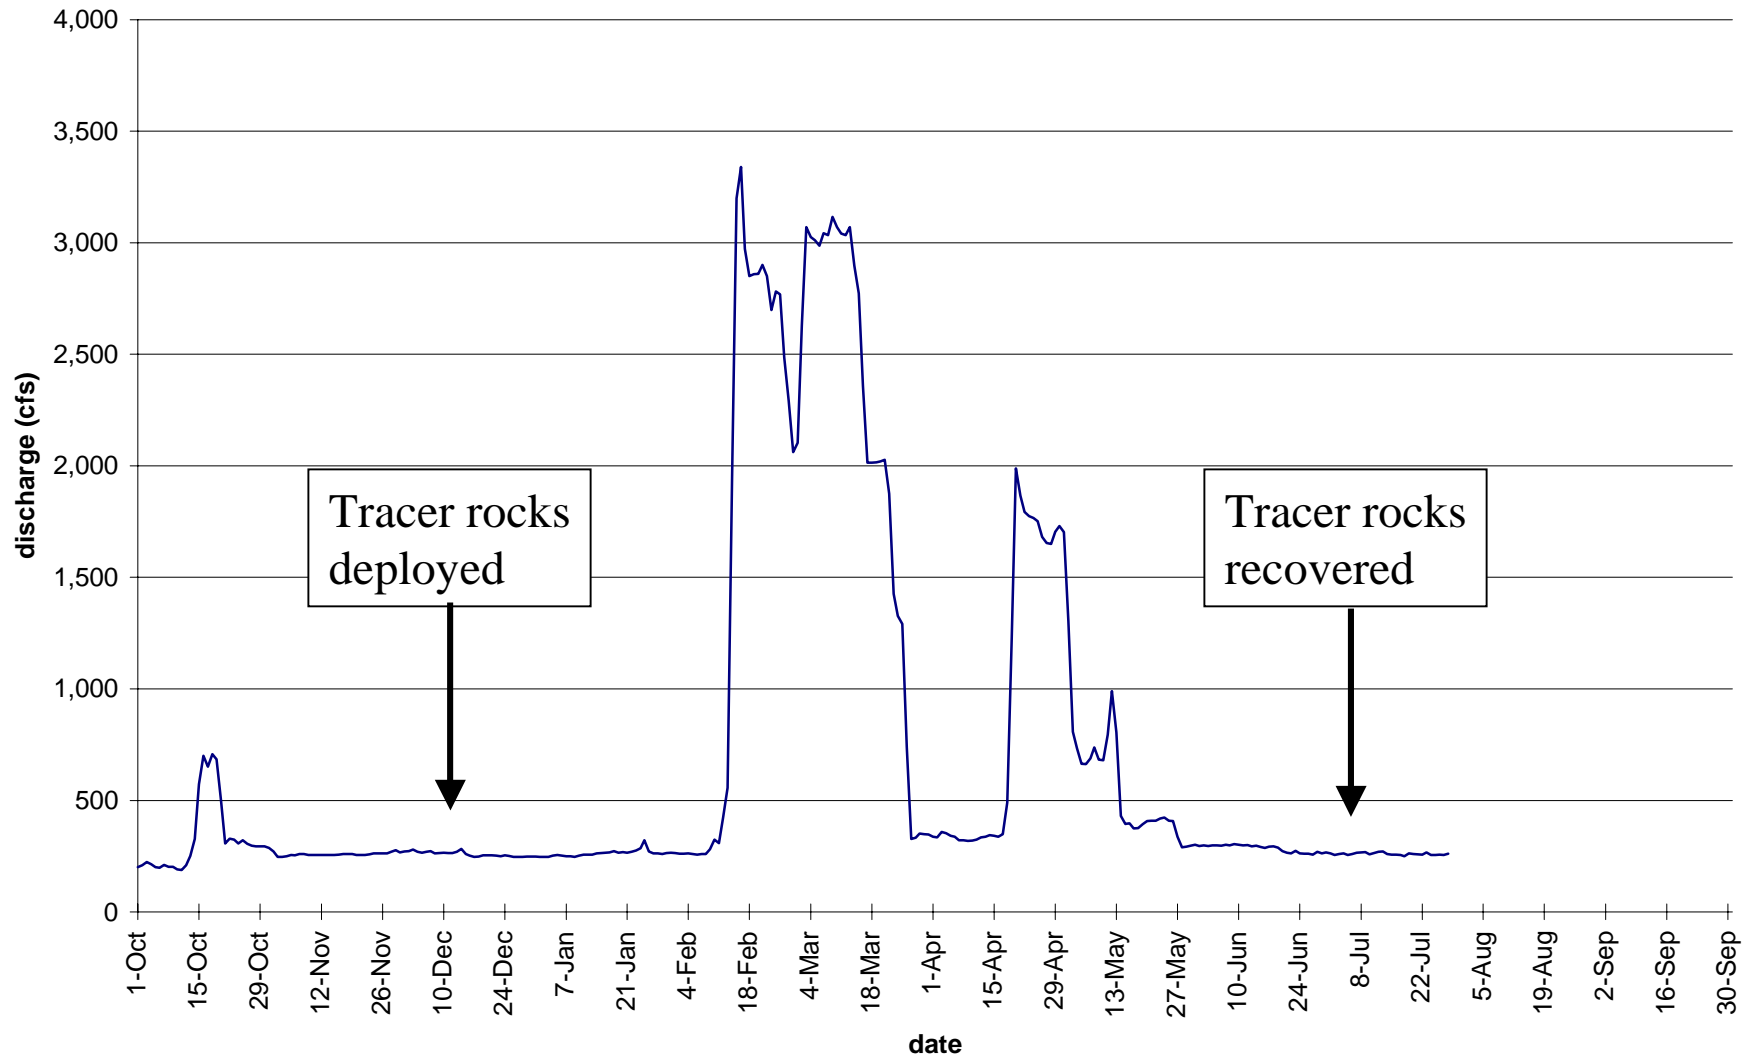
Figure 5.3-3. Flows at the Snelling Site between tracer rock deployment and recovery.
 (source: Merced Irrigation District Crocker-Huffman gauge)

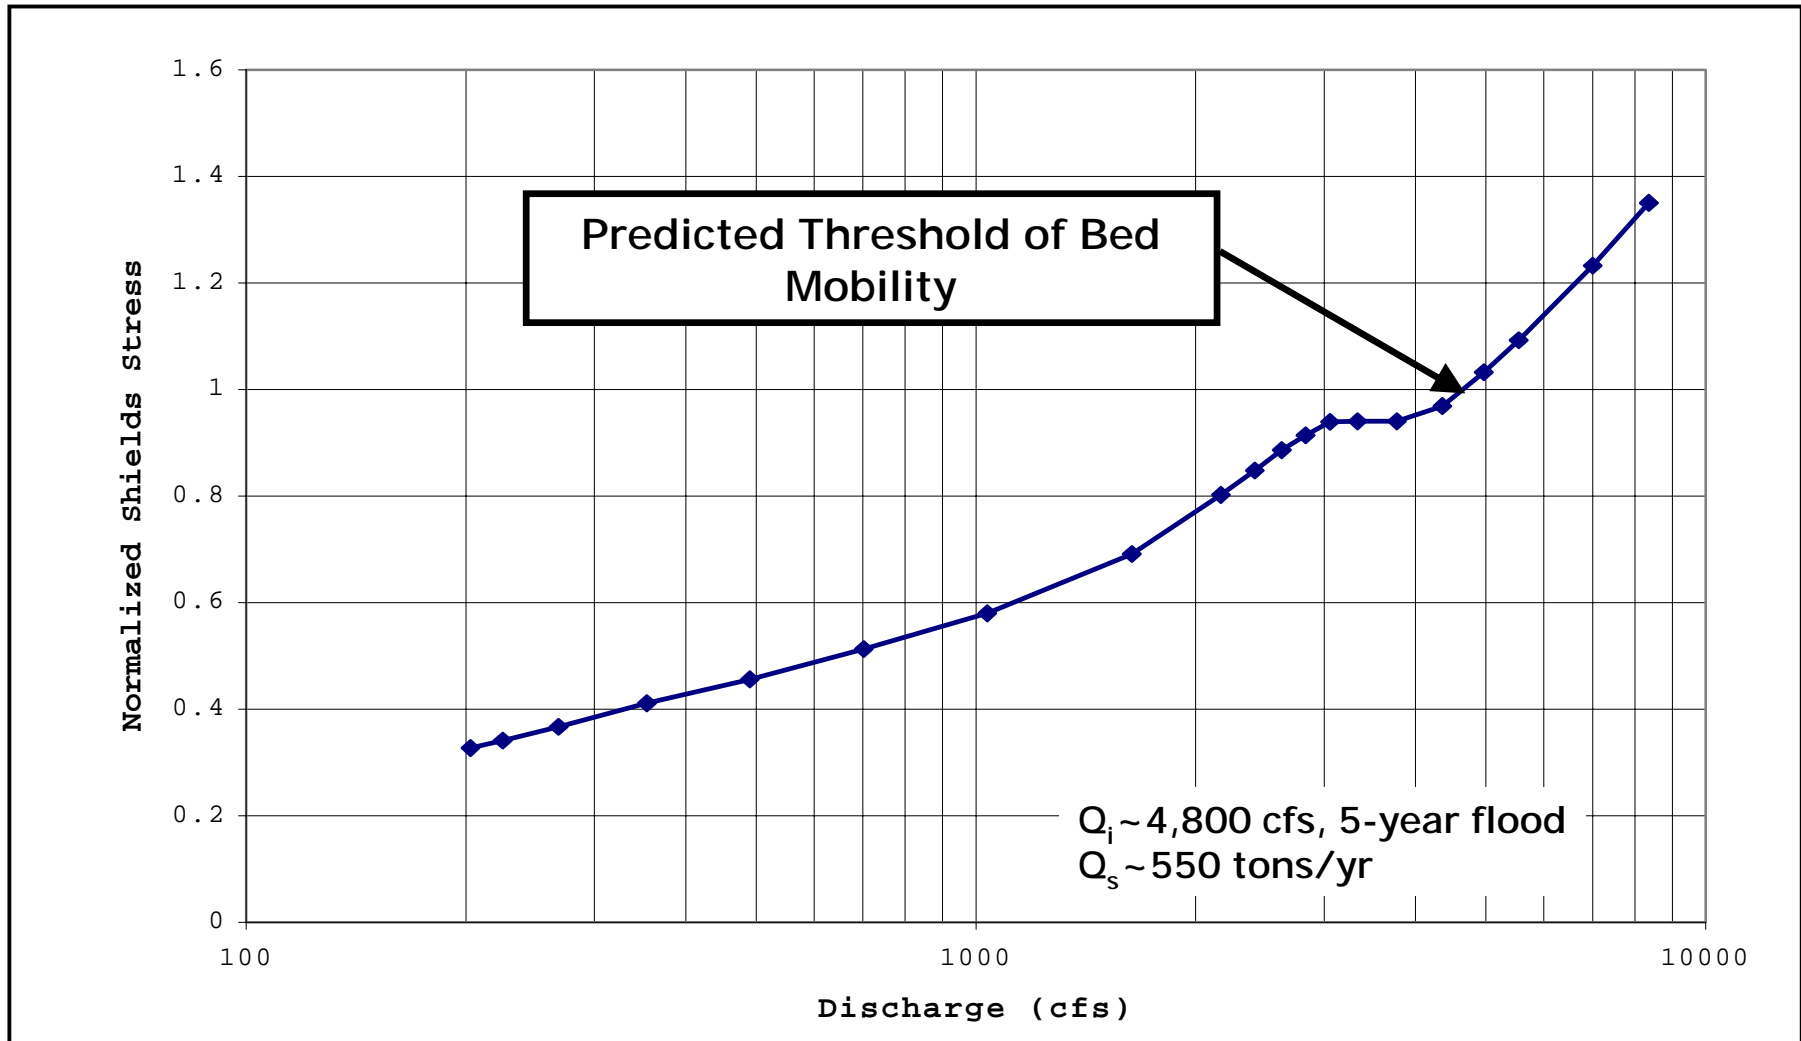
Figure 5.3-5. Normalized Shields stress versus discharge for the Snelling Site.

(The channel bed is predicted to be in motion when the normalized Shields stress is ≥ 1 .)

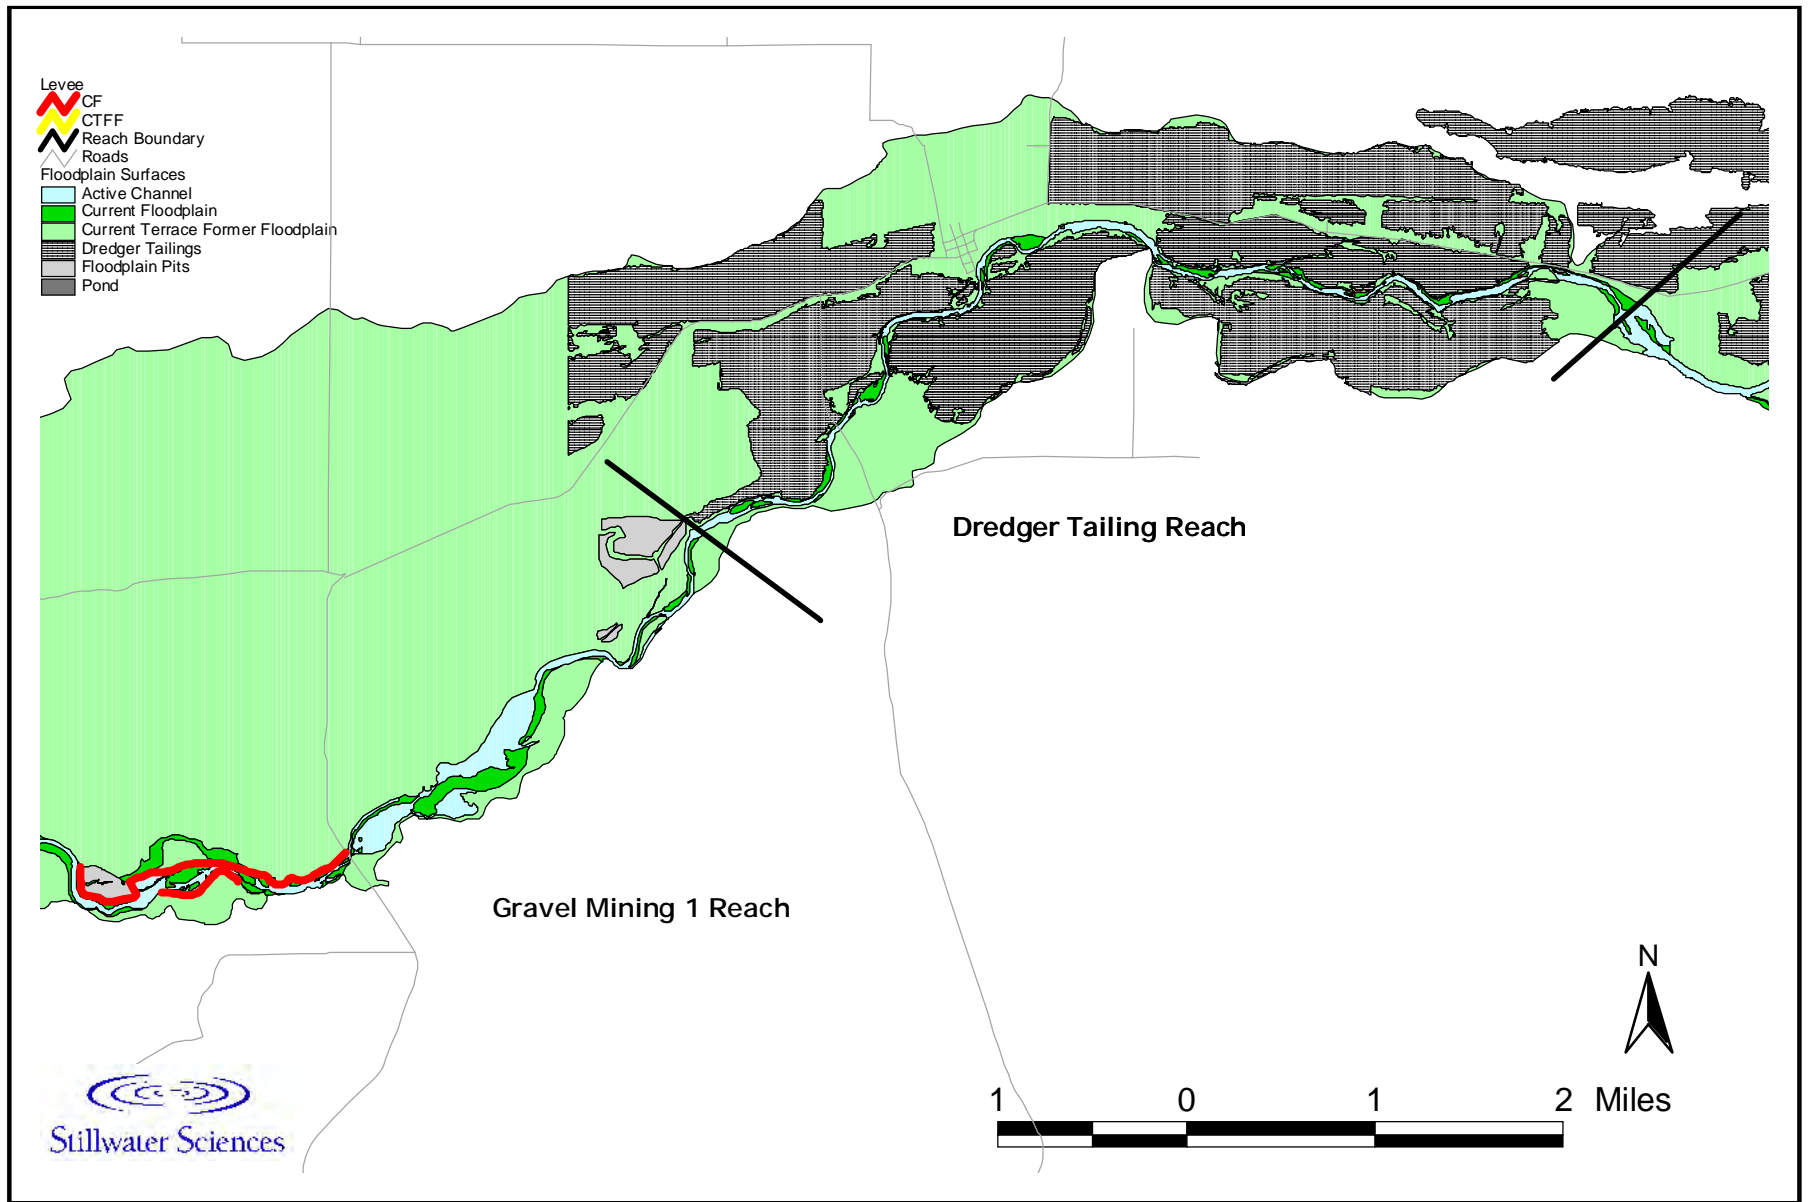
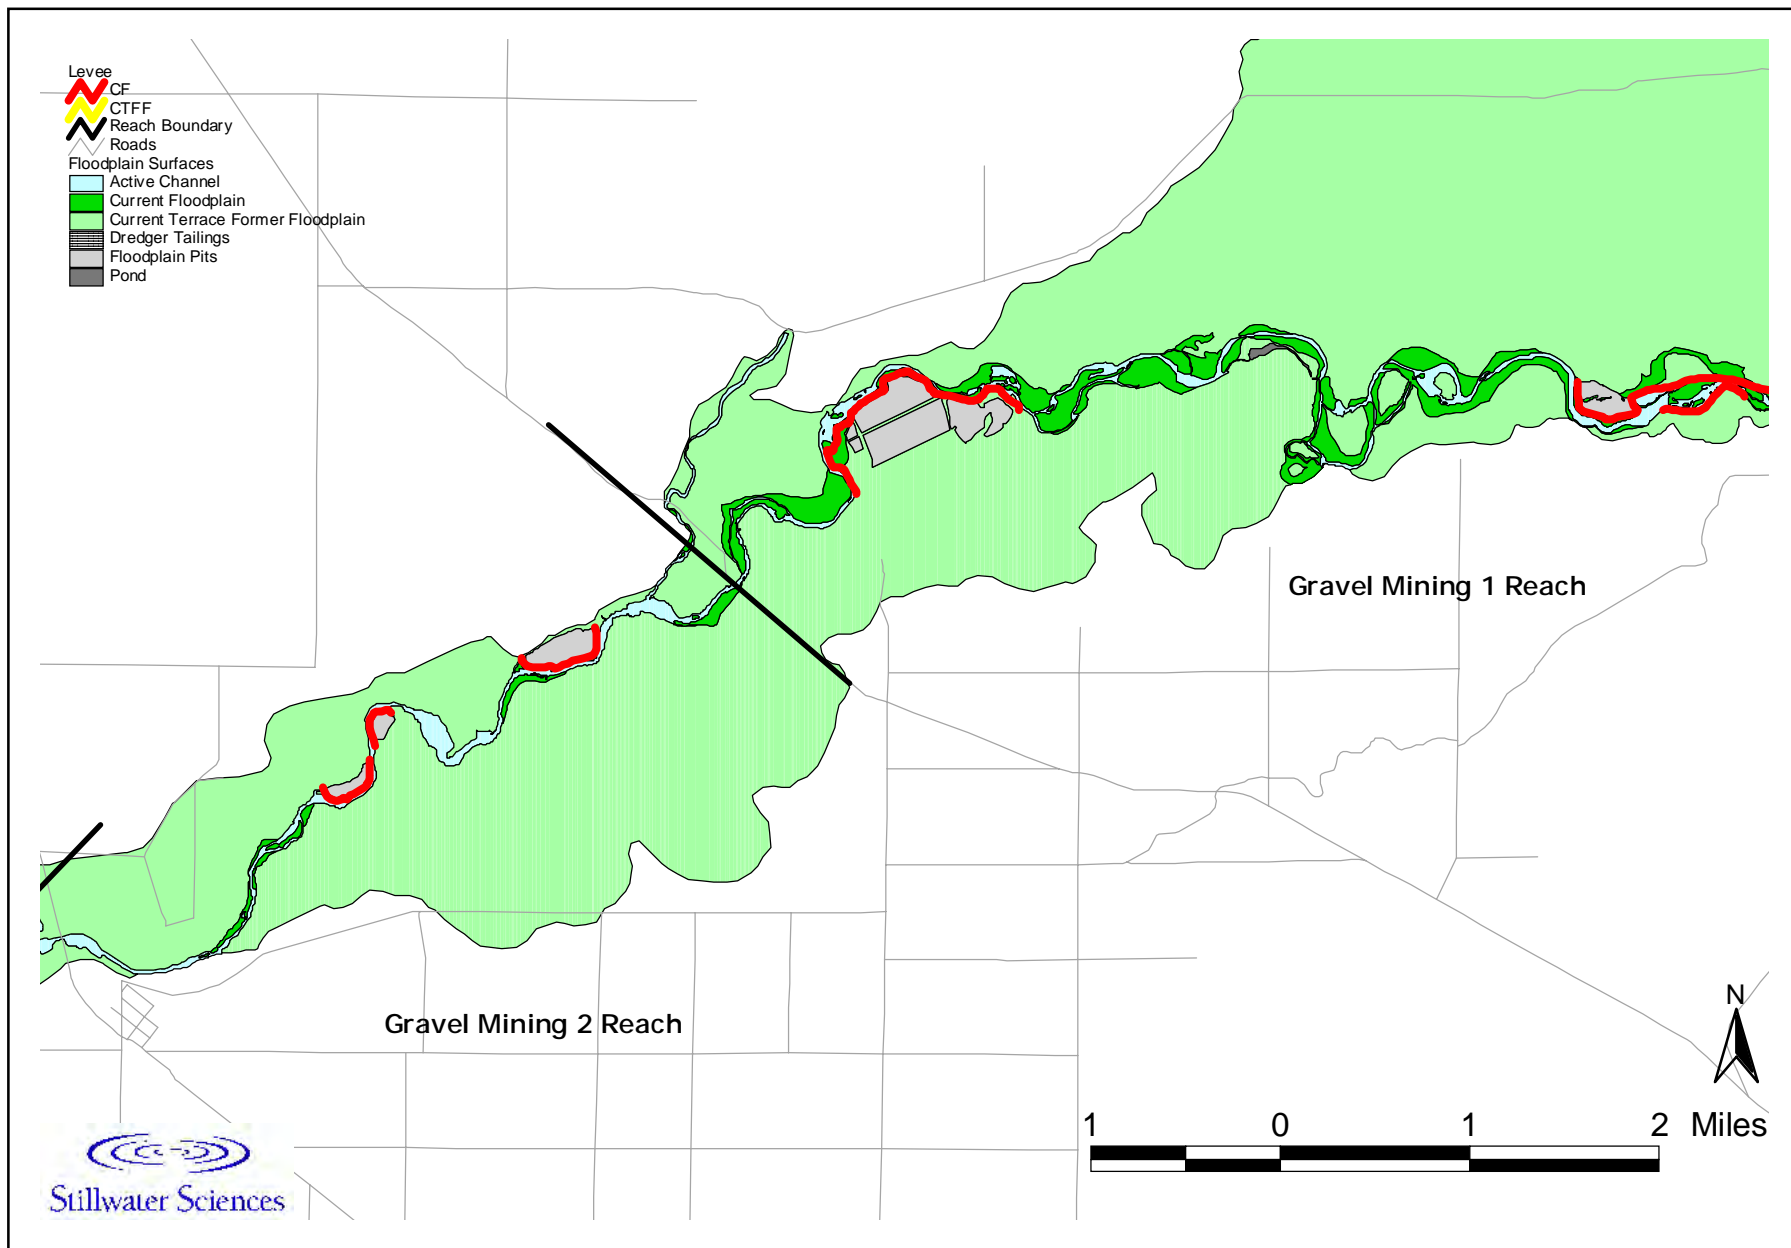
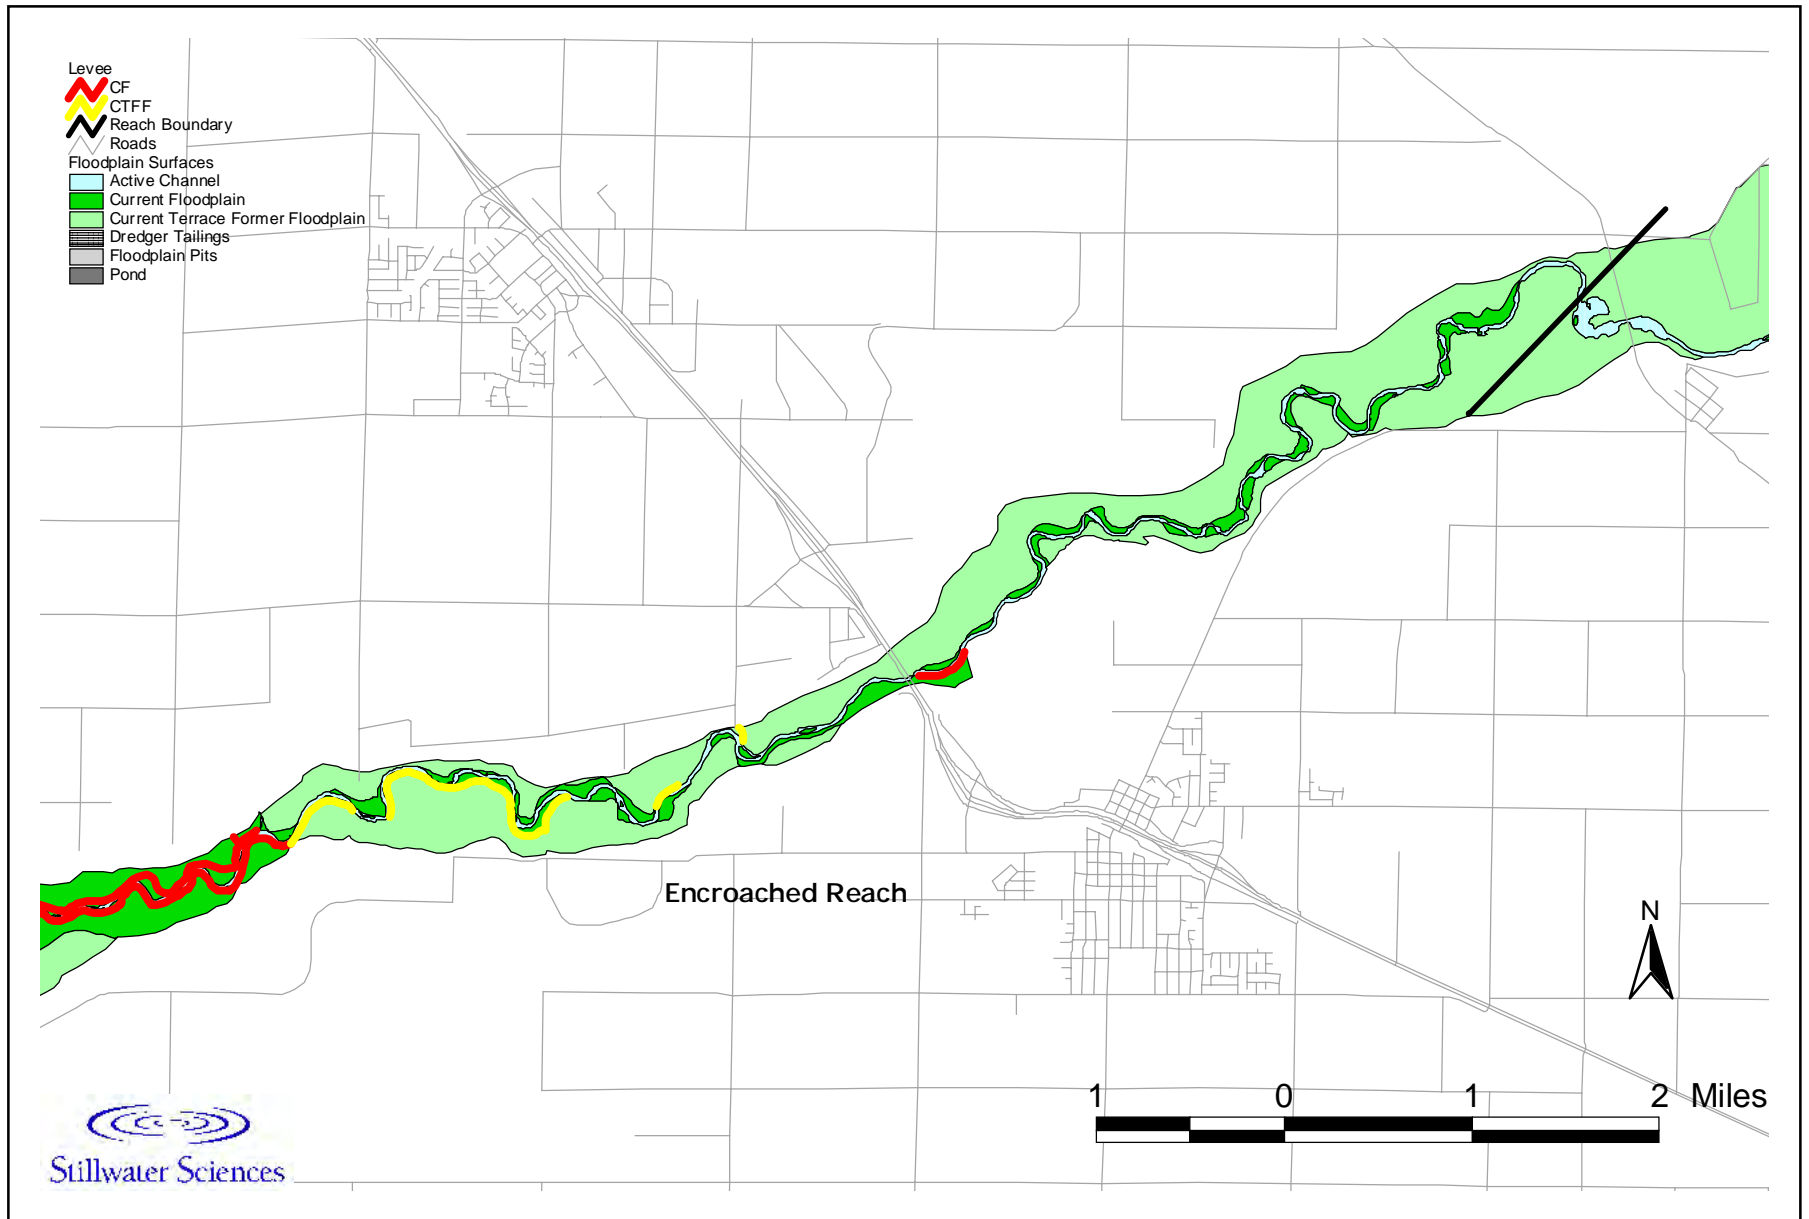
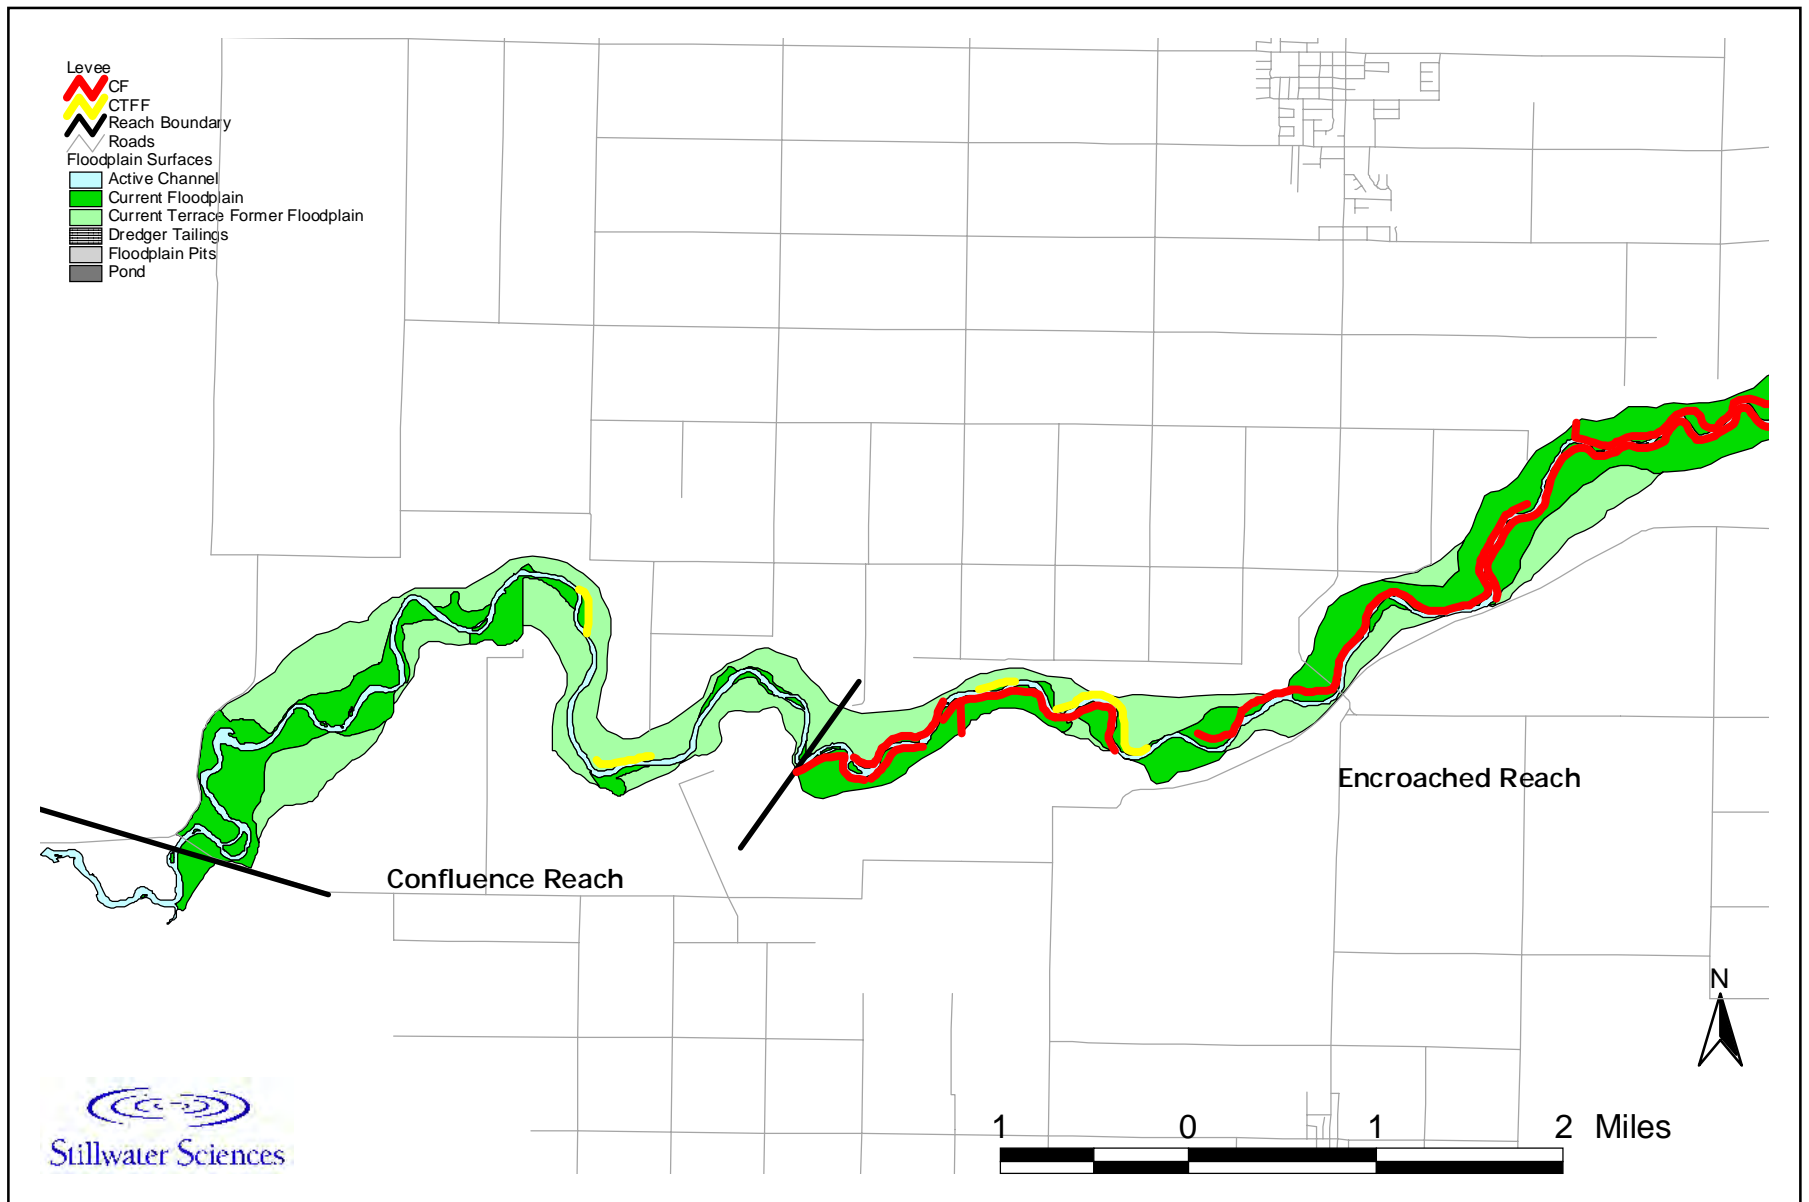
Figure 5.5-1A. Merced River current and historic floodplain and levees

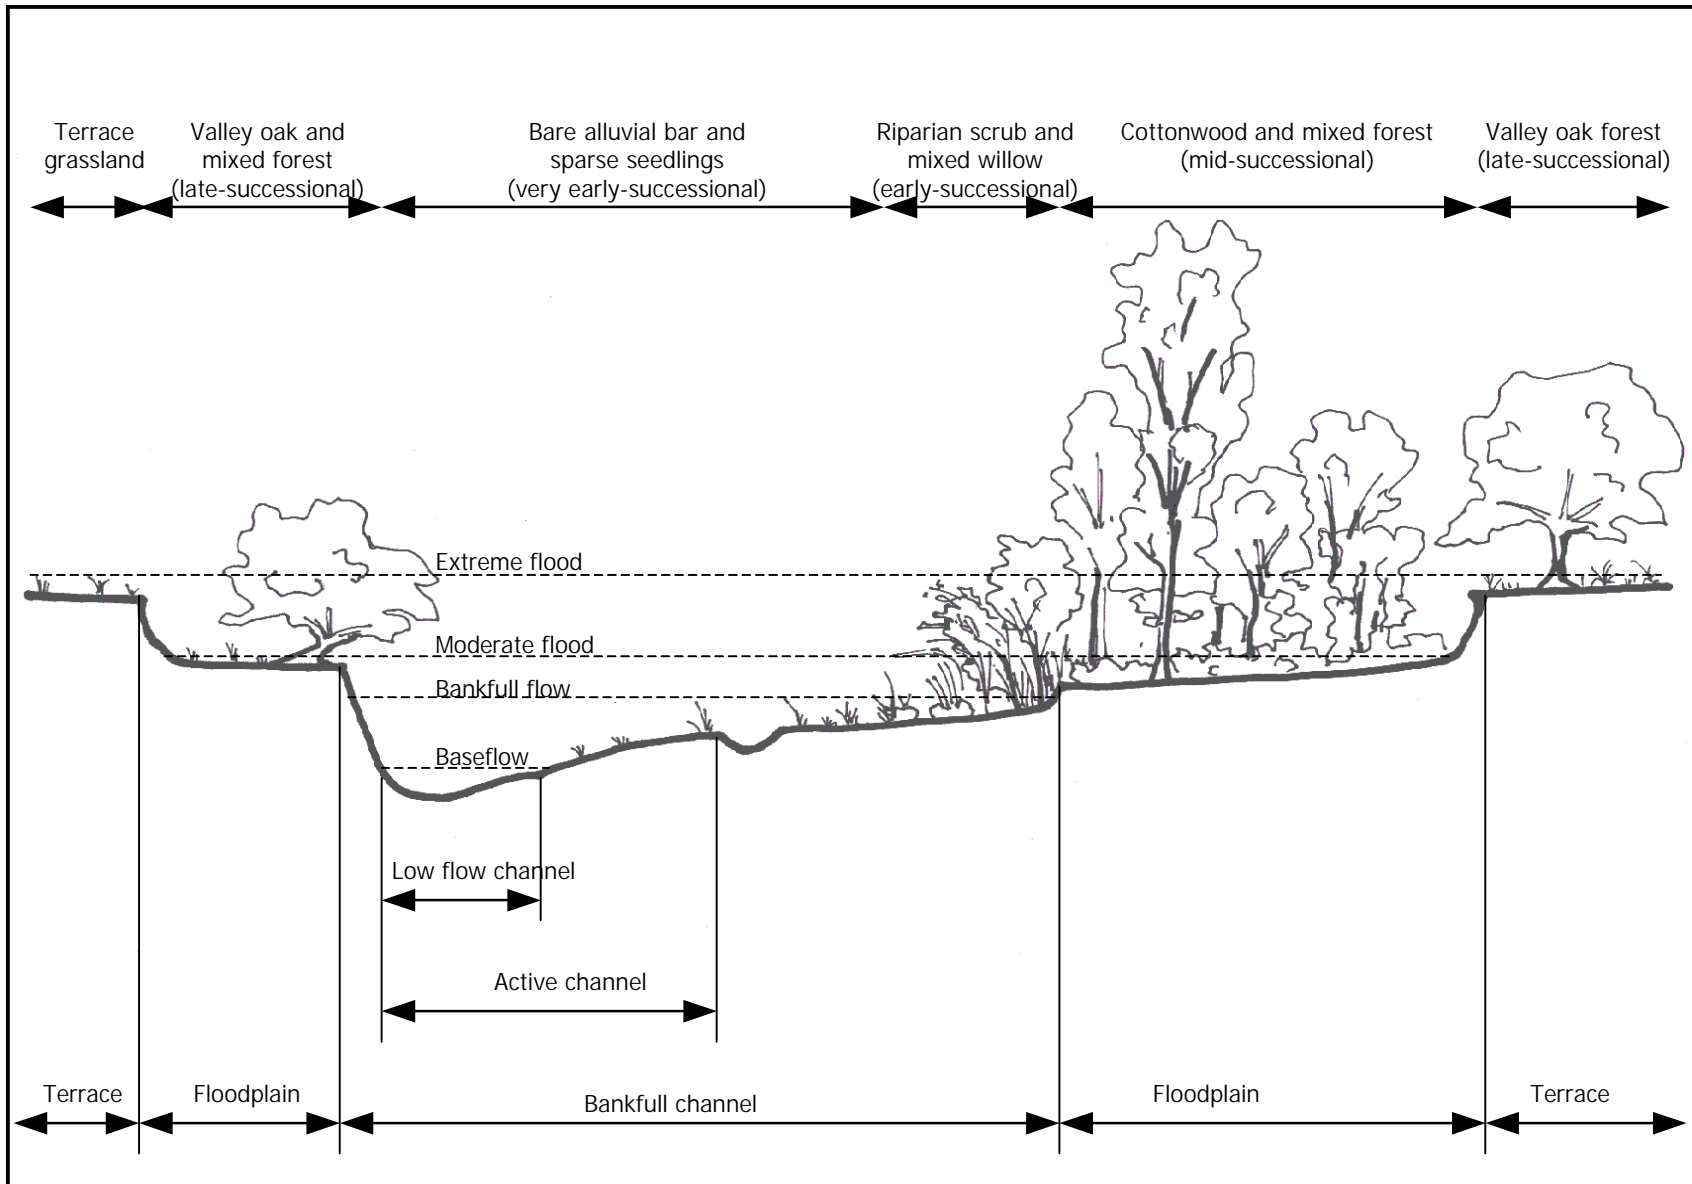
Figure 5.6-1. Schematic cross section of the "healthy" alluvial river.

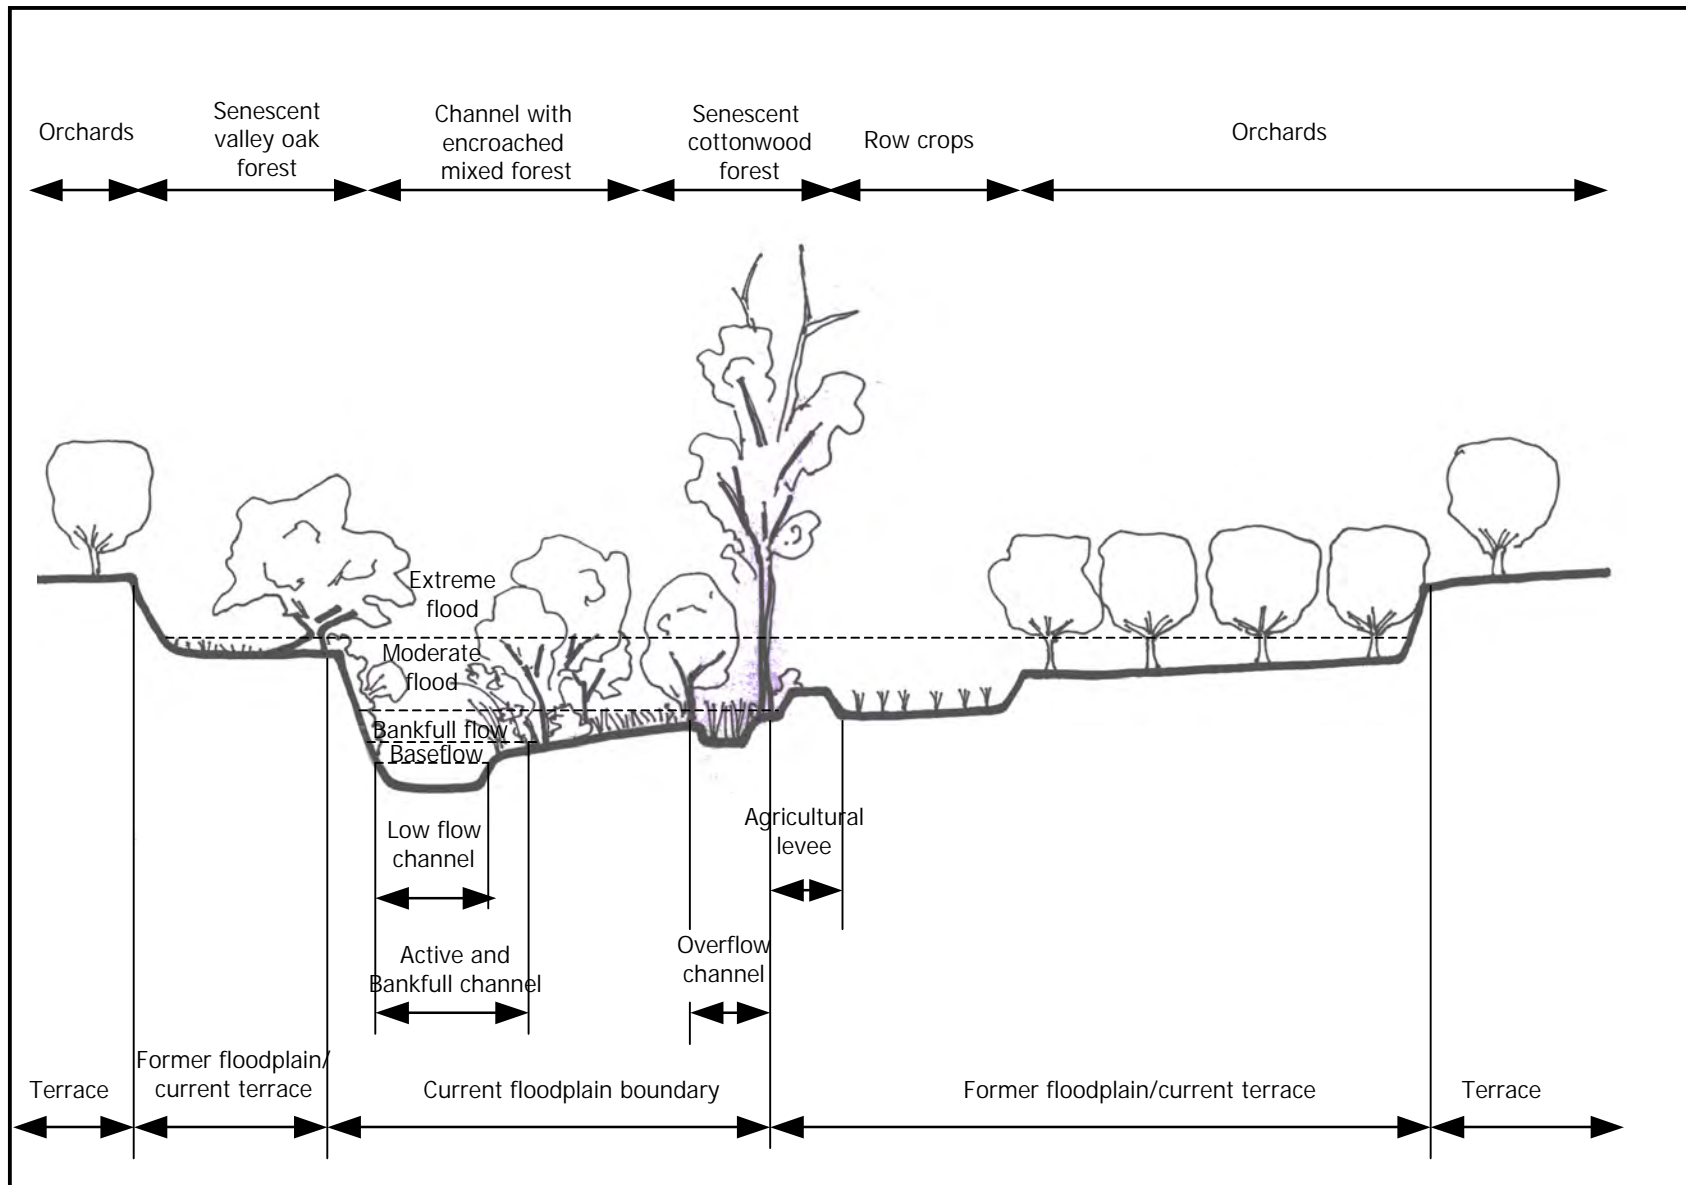
Figure 5.6-2. Schematic cross section of a river channel with encroached riparian vegetation.

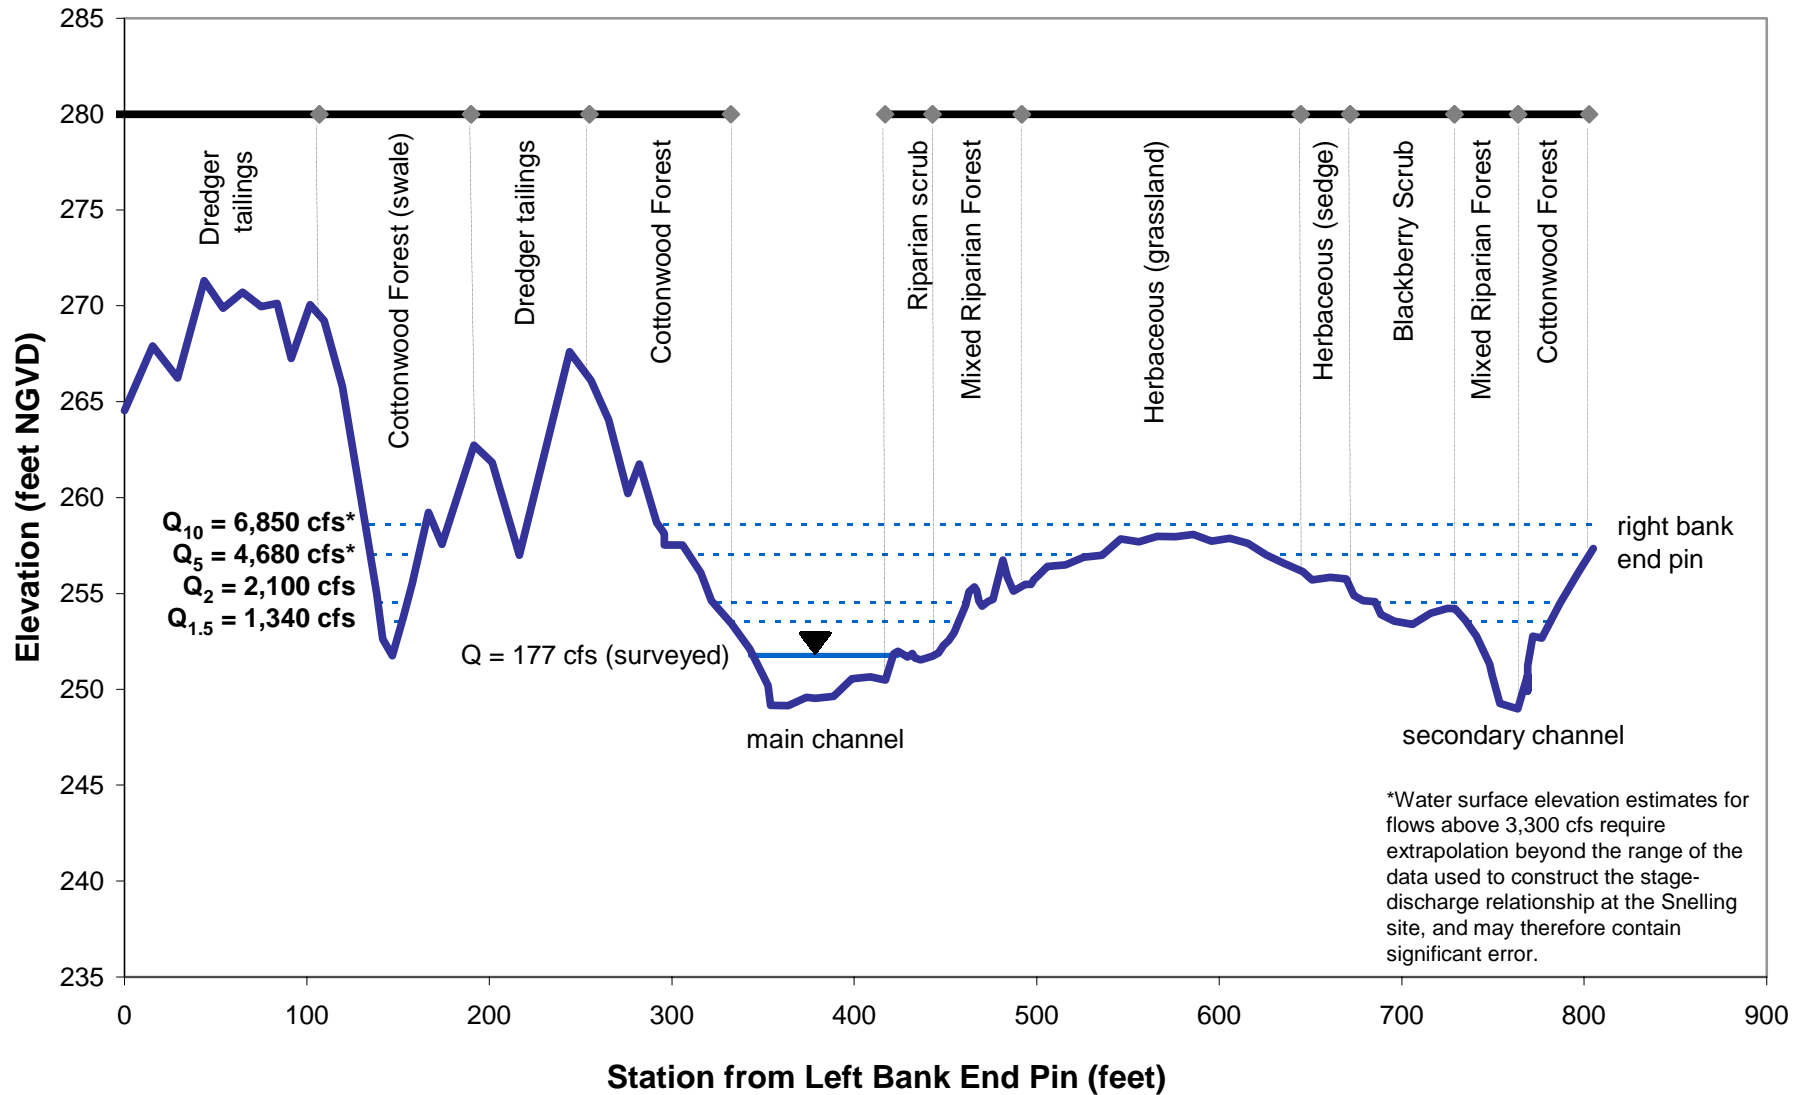
Figure 6.3-2. Snelling Site vegetation cover and topographic cross section 13+95.

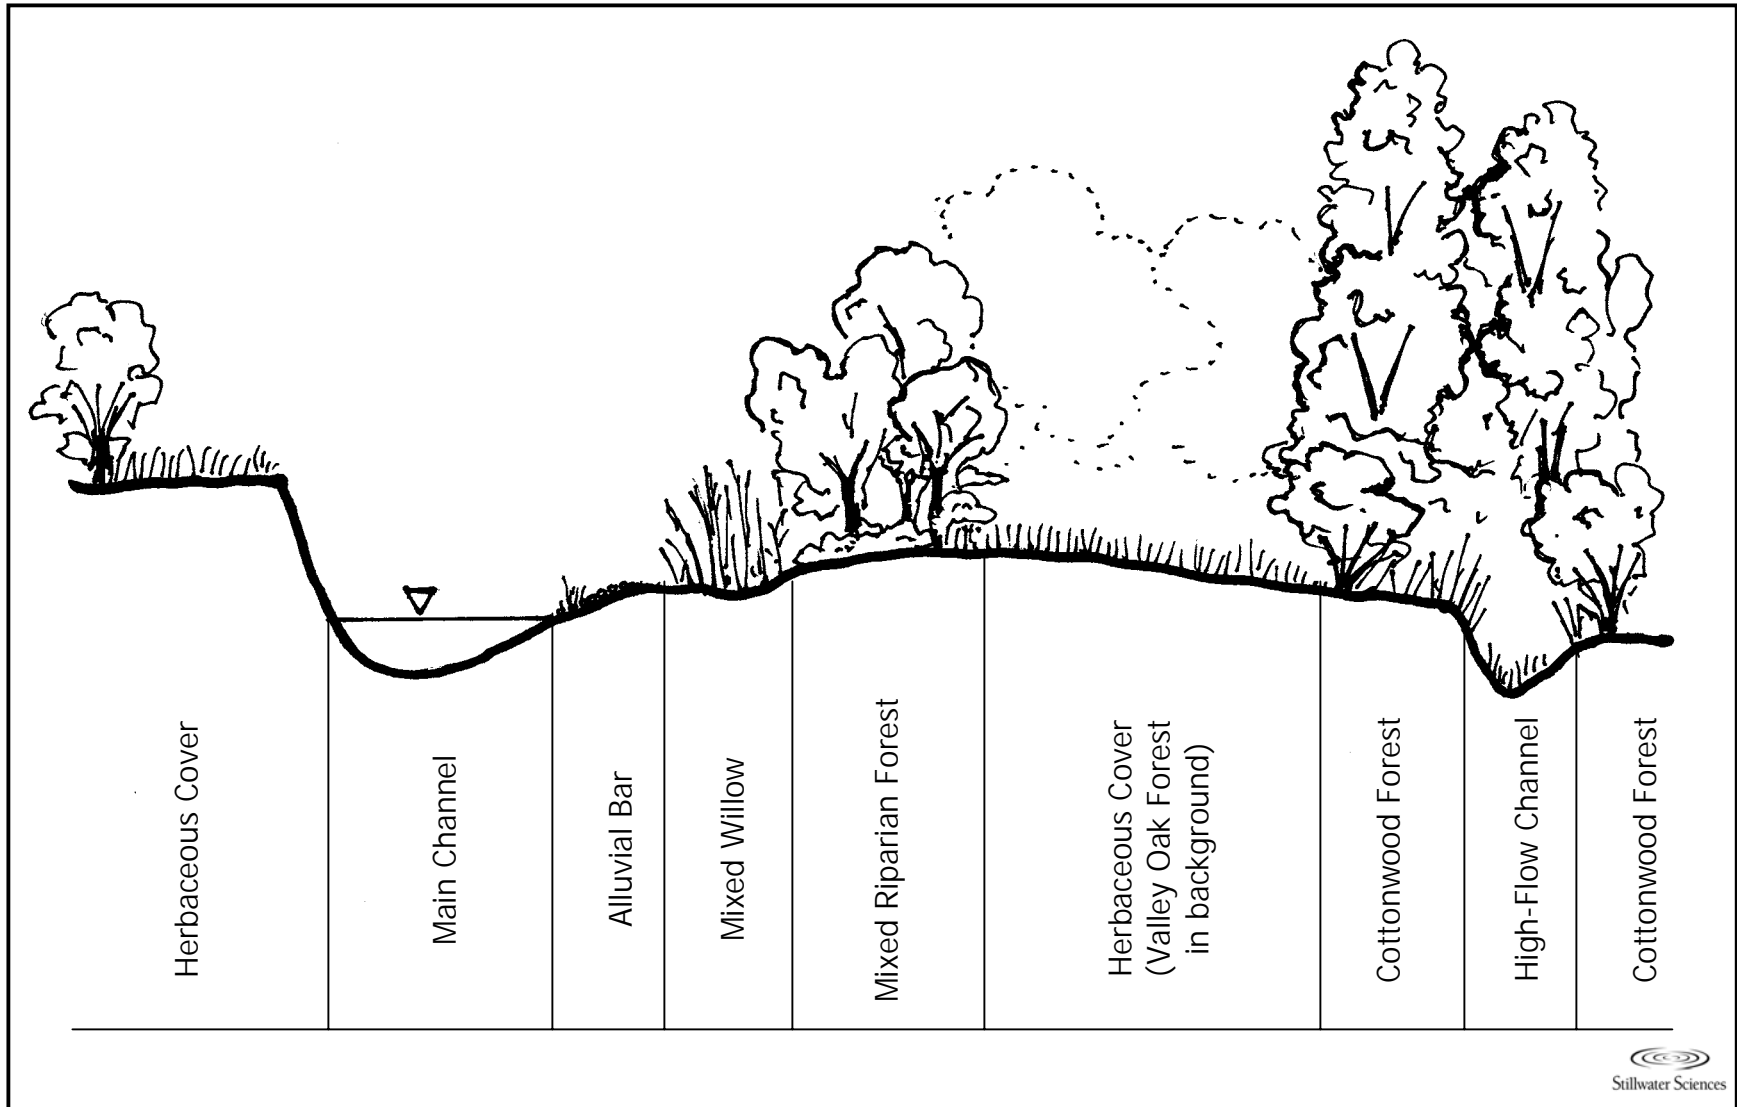
Figure 6.4-1. Generalized vegetation toposequence for least disturbed sites on the Merced River.

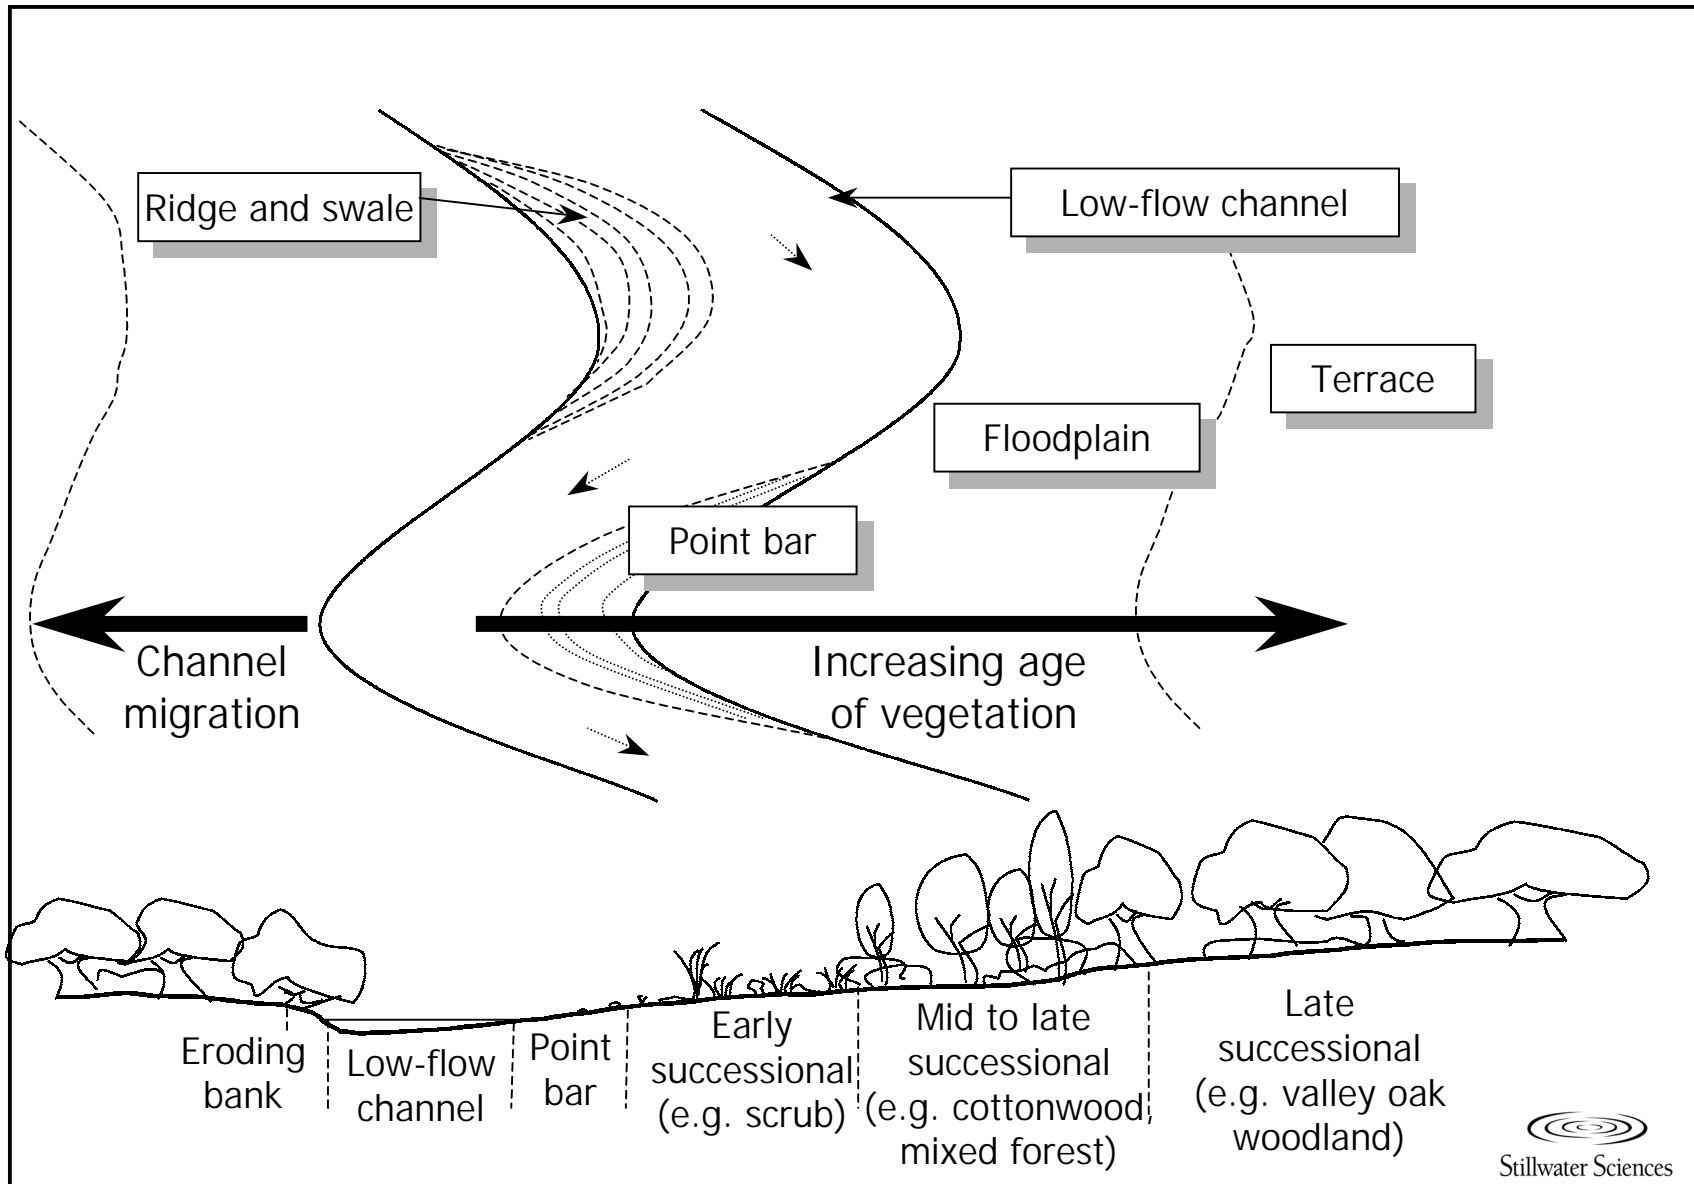
Figure 6.5-2. Schematic diagram of riparian succession.
