Merced River Corridor Restoration Plan Baseline Studies

Volume I: Identification of Social, Institutional, and Infrastructural Opportunities and Constraints

**MERCED RIVER CORRIDOR RESTORATION PLAN
BASELINE STUDIES**

**VOLUME I:
IDENTIFICATION OF SOCIAL, INSTITUTIONAL, AND
INFRASTRUCTURAL OPPORTUNITIES AND CONSTRAINTS**

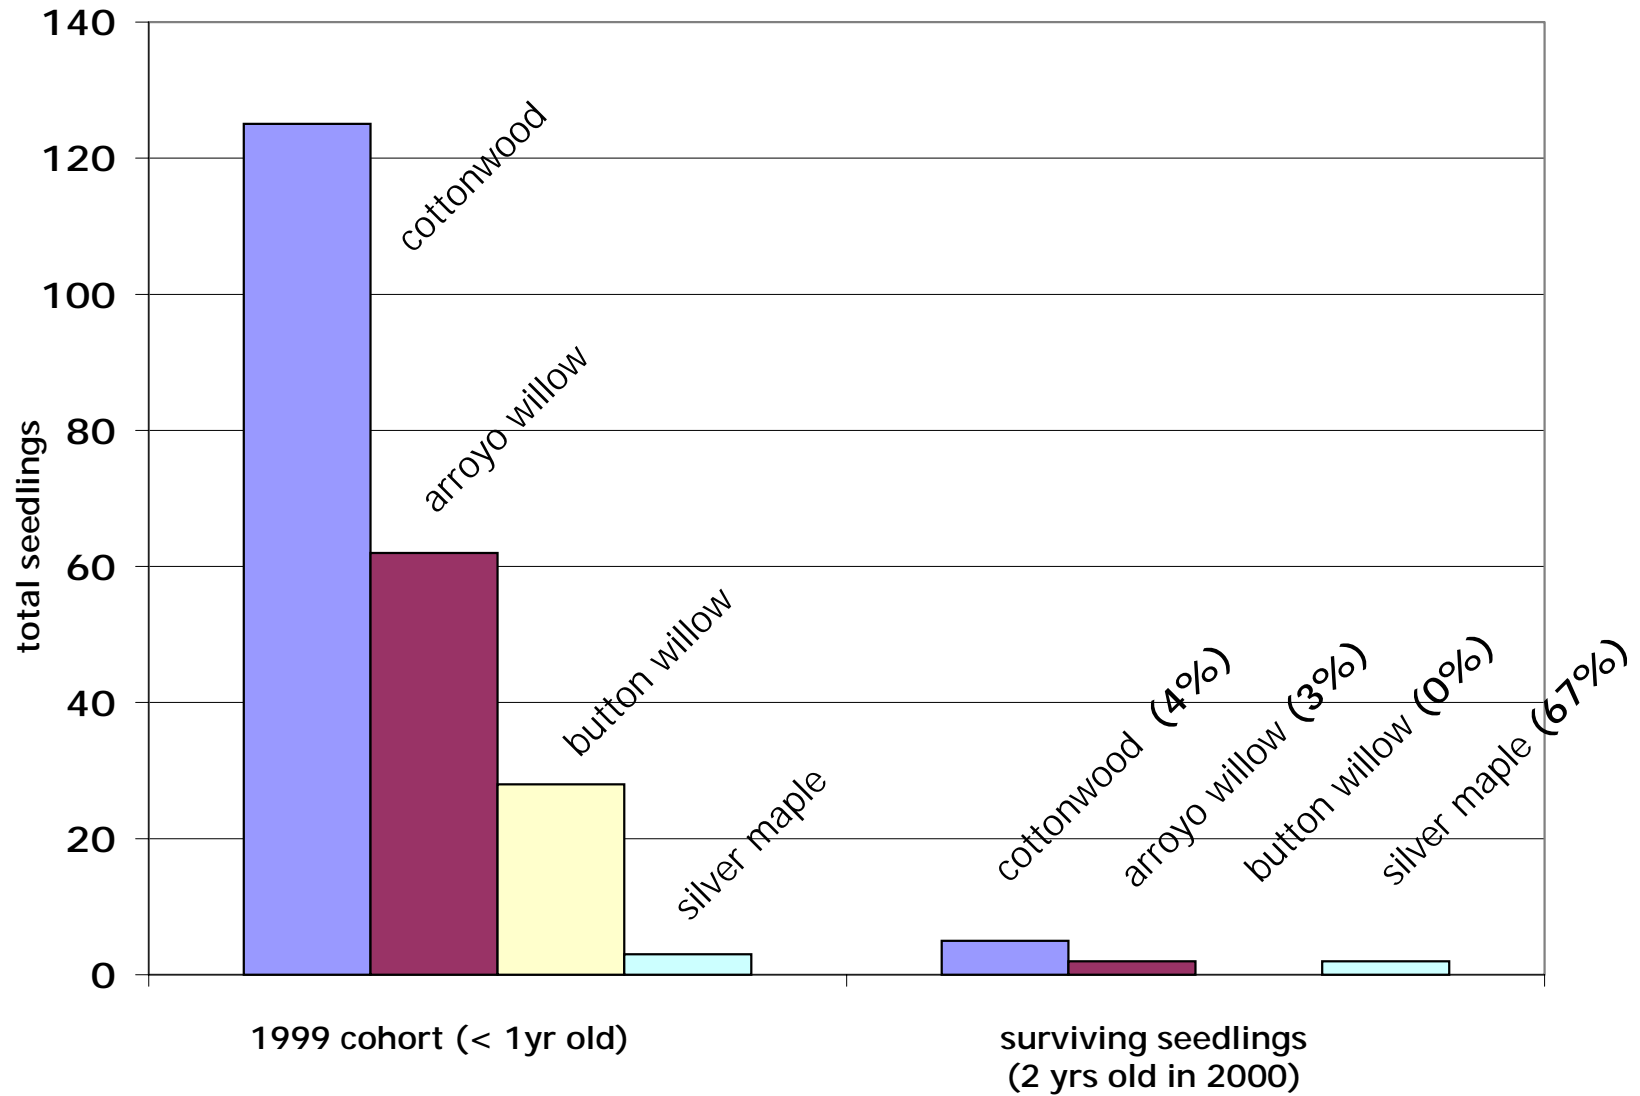
Figure 6.5-3. Seedling survival between October 1999 and June 2000, Snelling cross section 13+95. Percent survival for each species is in parentheses.

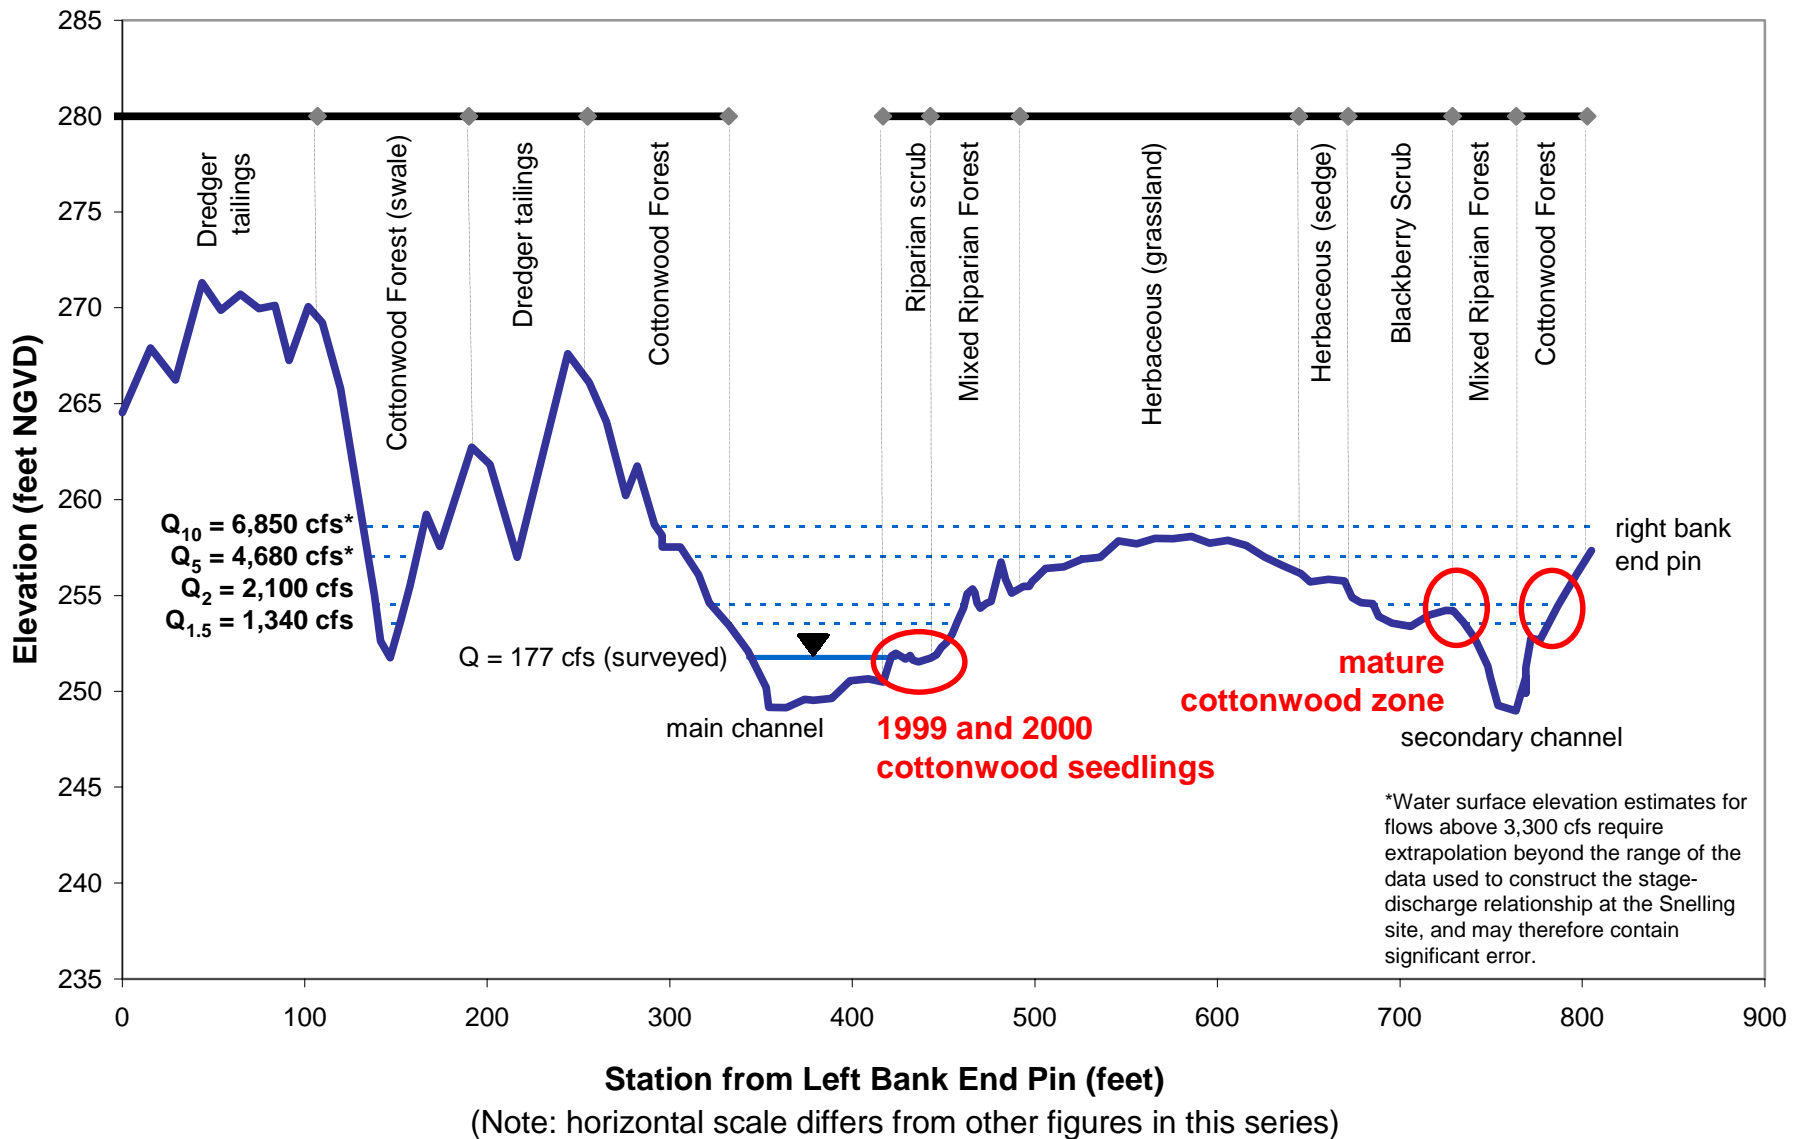
Figure 6.5-5. Snelling cross section 13+95, showing elevation and inundation frequency of current cottonwood germination zone and root crown elevation of mature cottonwoods. Current seedlings germinate within the bankfull channel. Mature trees are inundated at flows corresponding to the post-dam 1.5 to 5-year recurrence intervals.

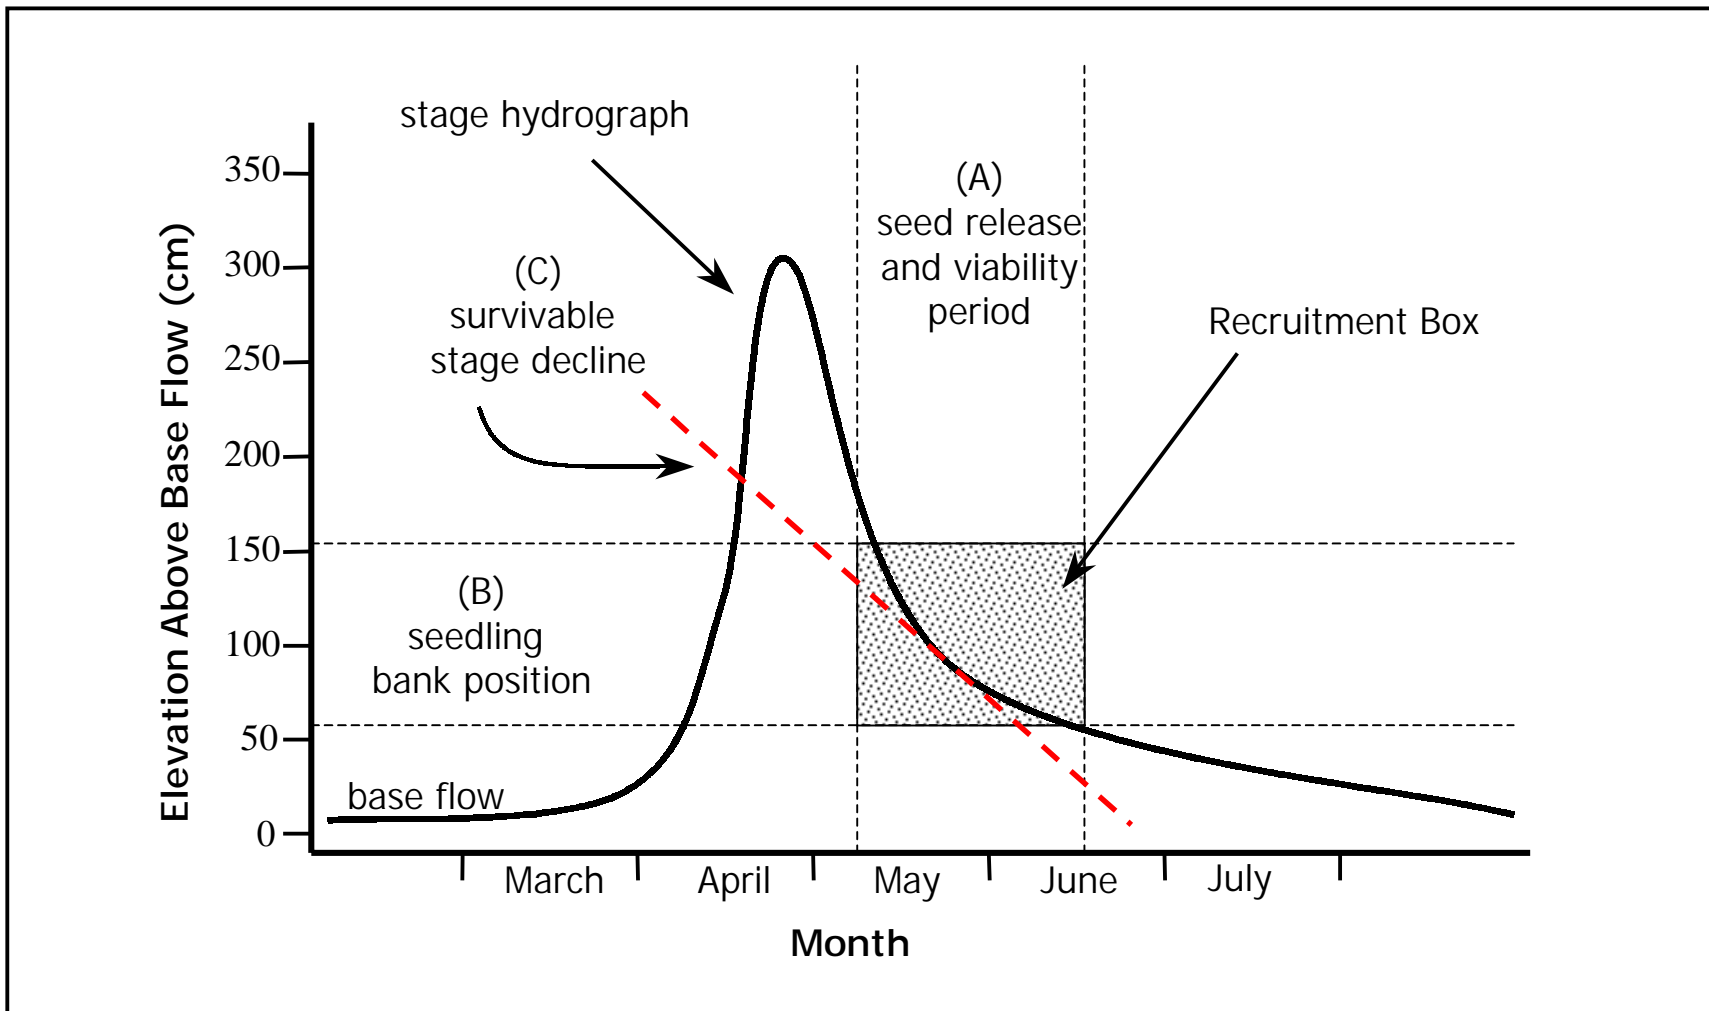
Figure 6.5-6. The 'Recruitment Box' concept (adapted from Mahoney and Rood, 1998). The recruitment box is a space defined in elevation and time in which seedlings of riparian plant species are likely to become successfully established based on stream flow conditions. The graph represents the relationship between the stream hydrograph and the timing of (A) the seed release and viability period for a particular riparian plant species; (B) the range of bank elevations (or stream stages) at which successful seedling recruitment is likely to occur for that species; and (C) the survivable rate of stream stage decline determined by the seedling's ability to maintain functional contact with the receding water table through root elongation.

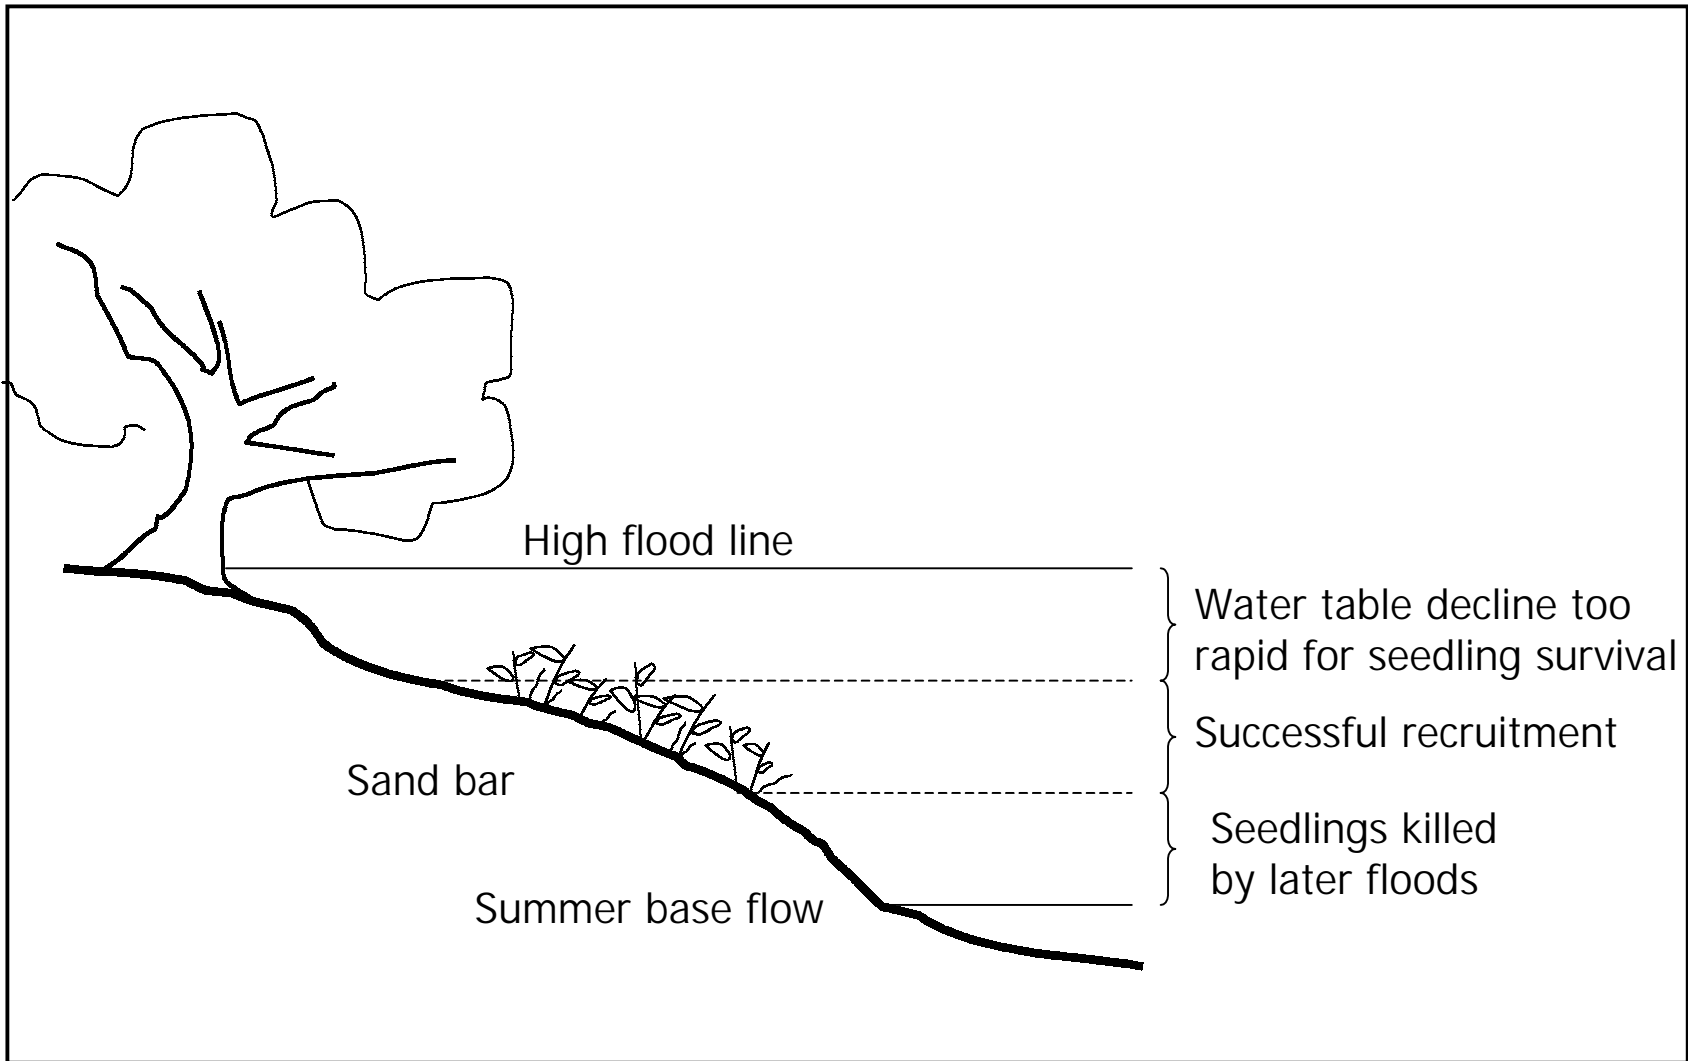
Figure 6.5-7. Cottonwood and willow recruitment patterns.

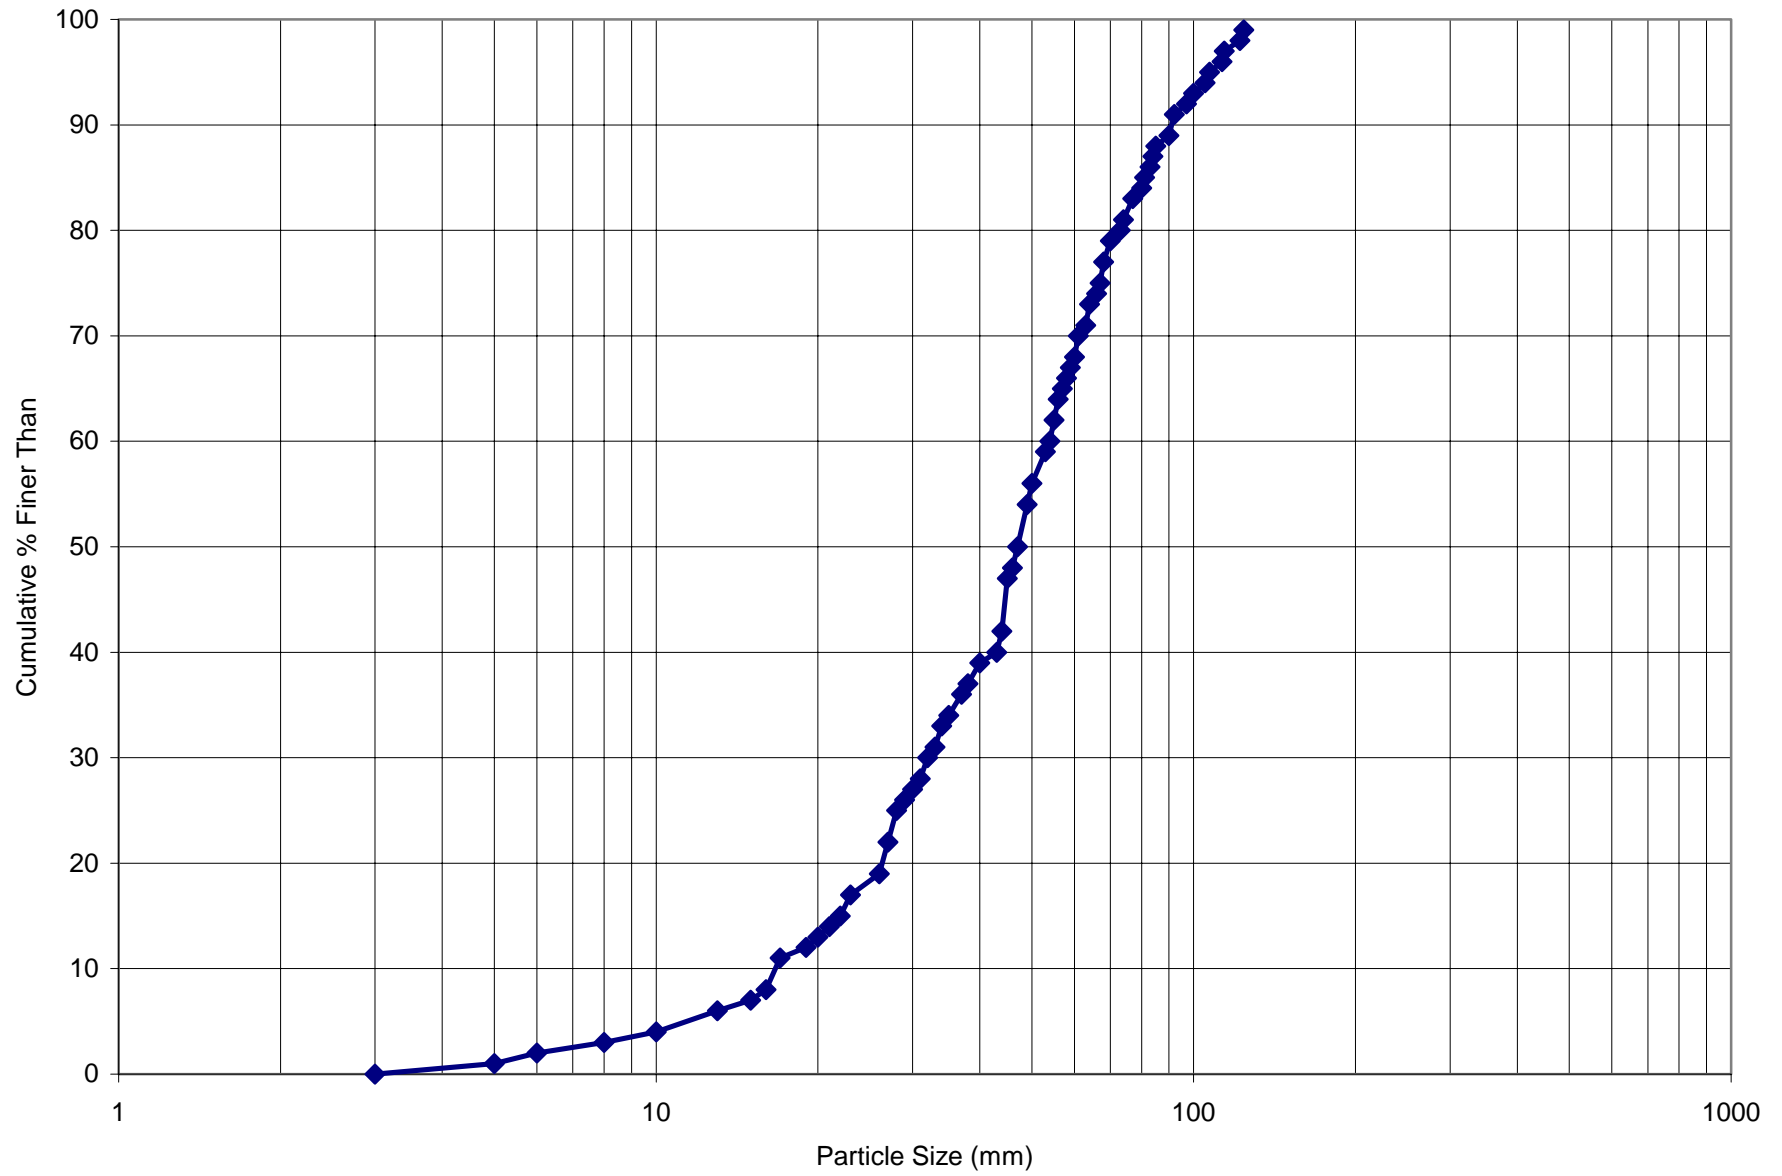
Figure B-2. Snelling site pebble count 1.

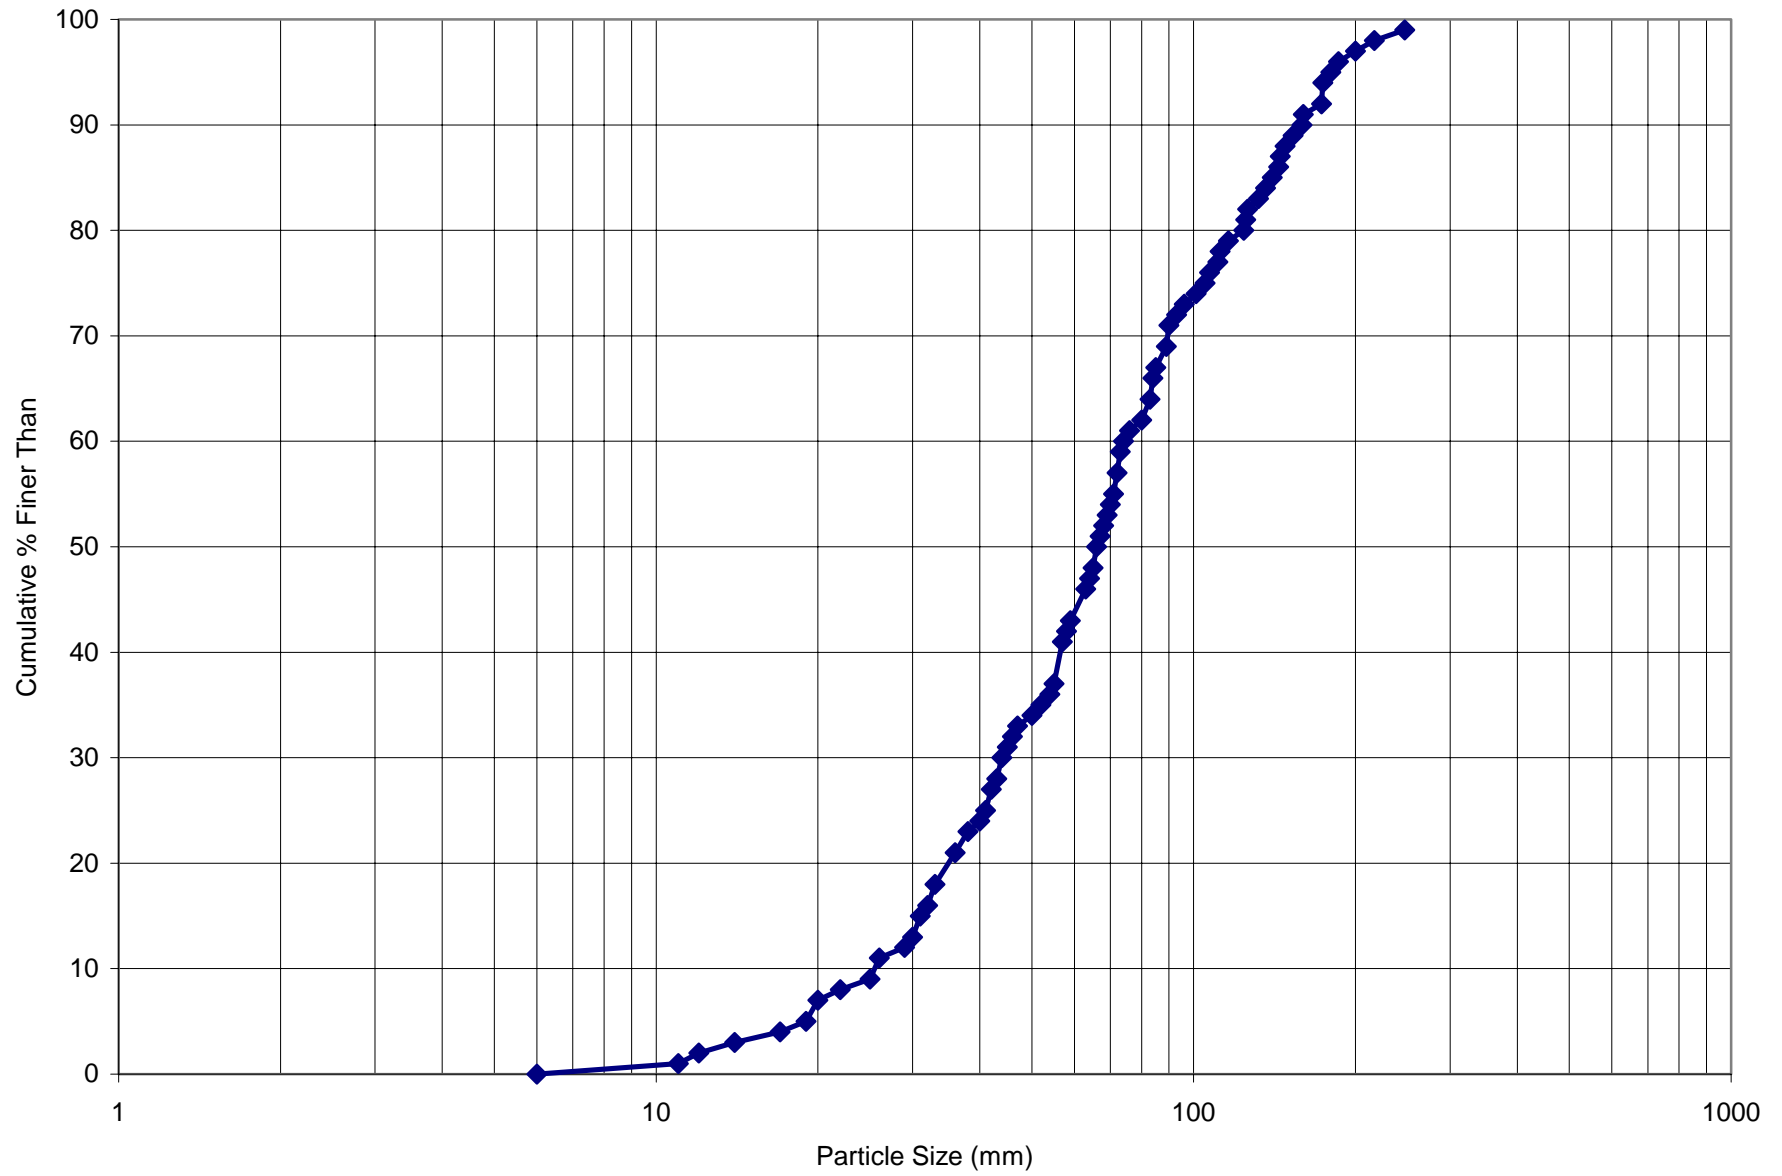
Figure B-4. Snelling site pebble count 3A.

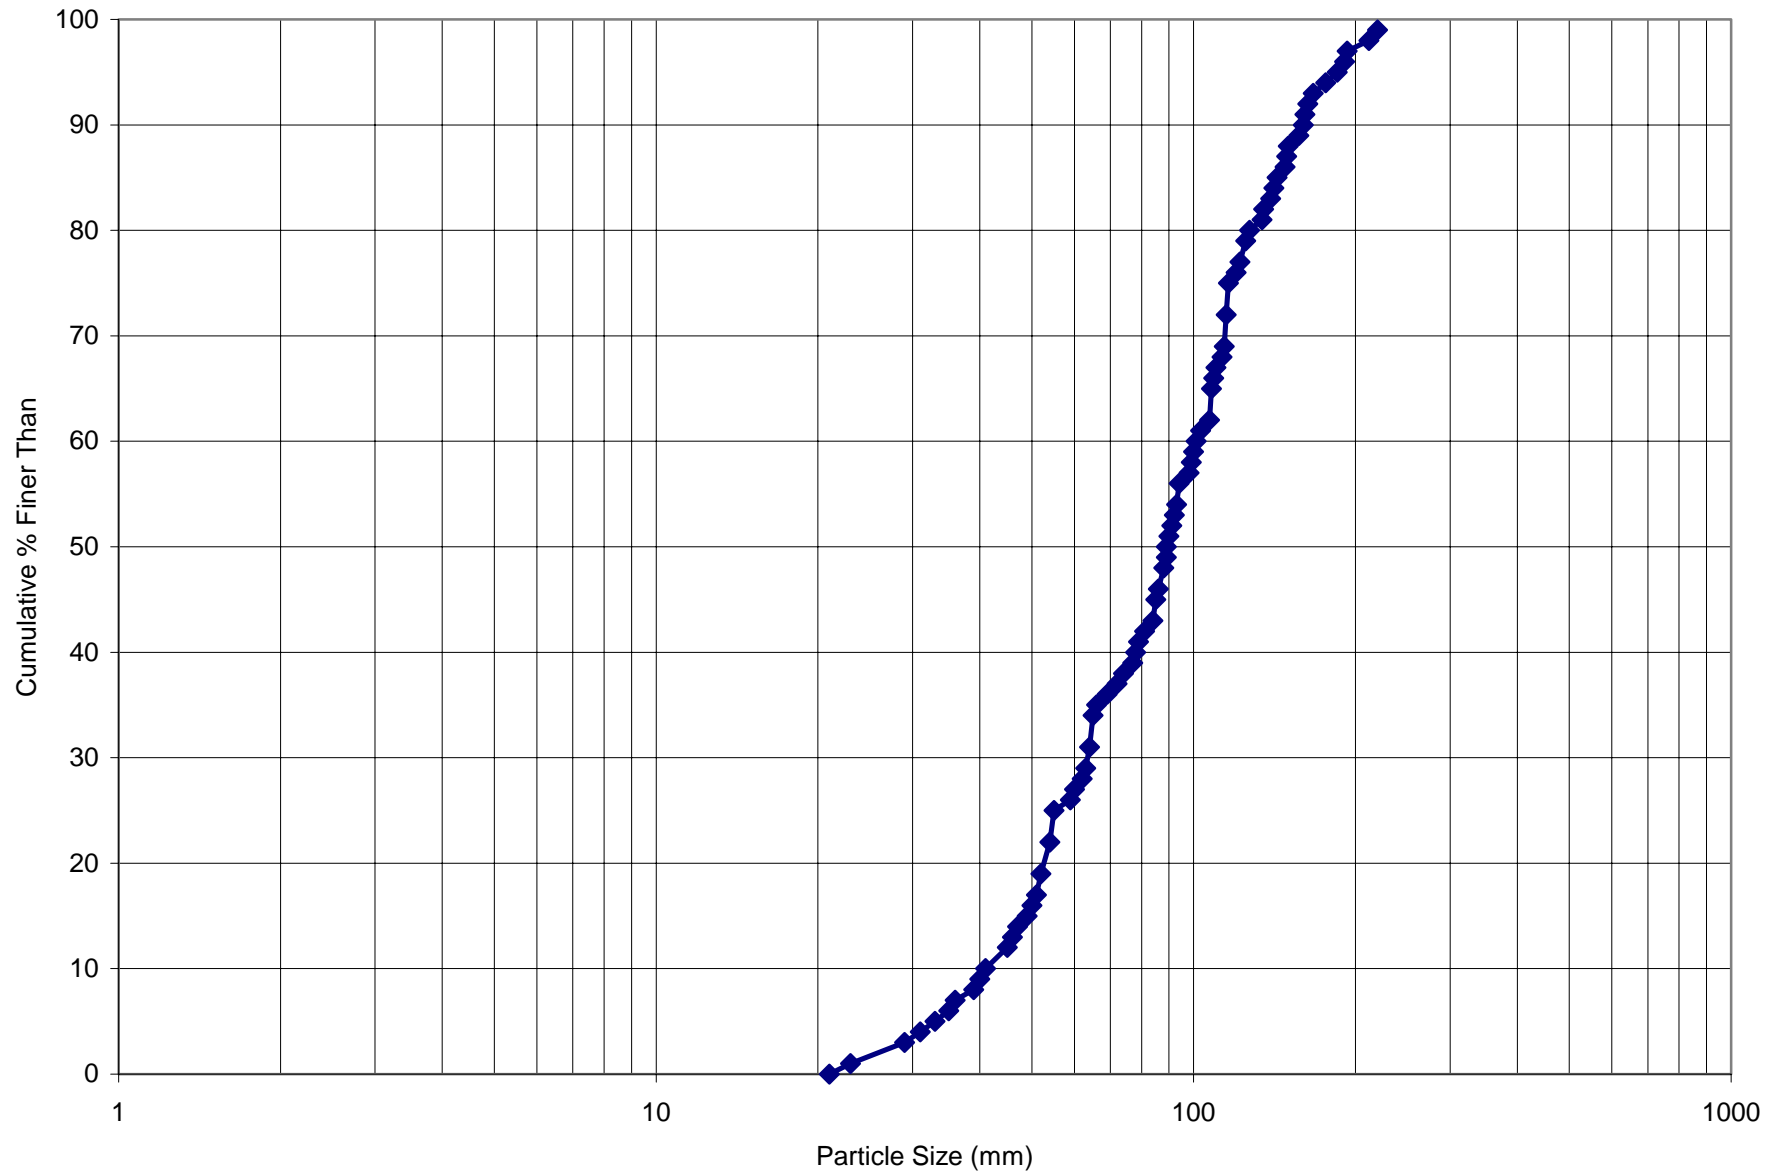
Figure B-5. Snelling site pebble count 3B.

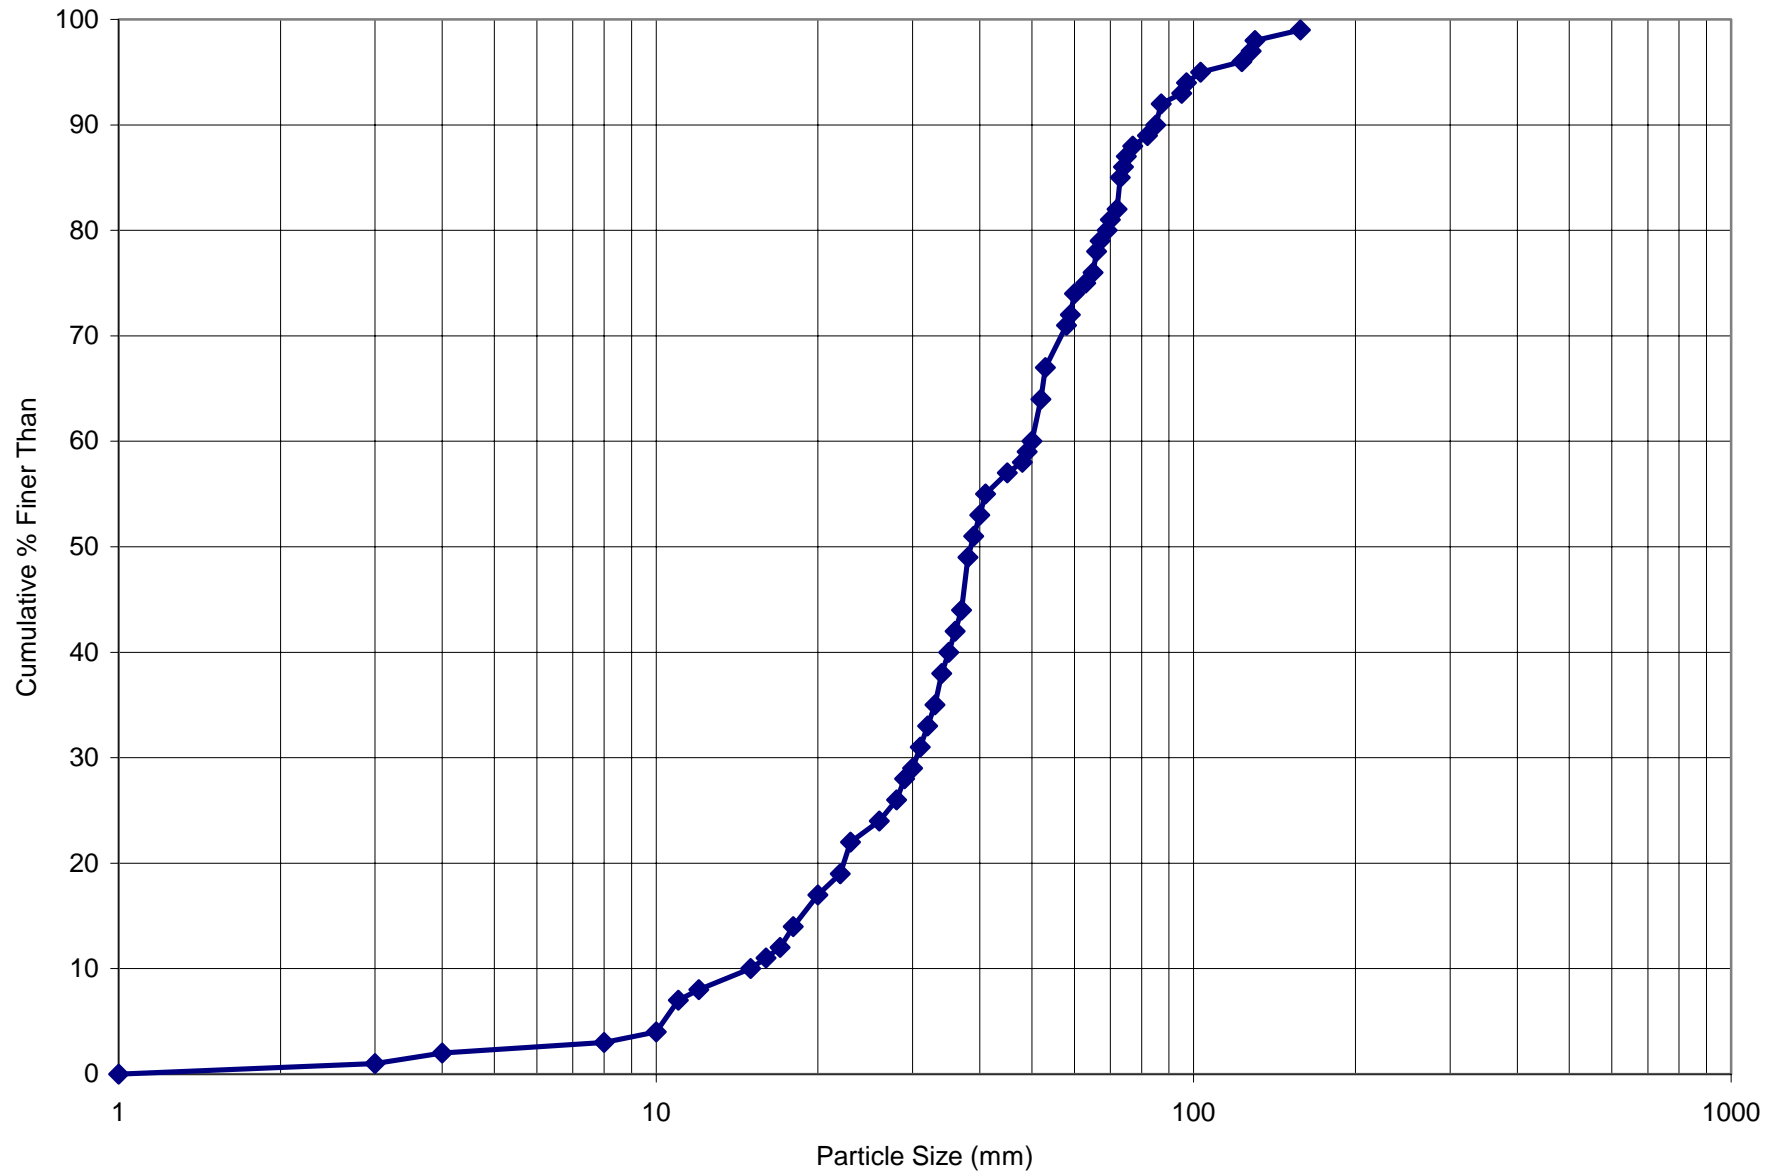
Figure B-6. Snelling site pebble count 4.

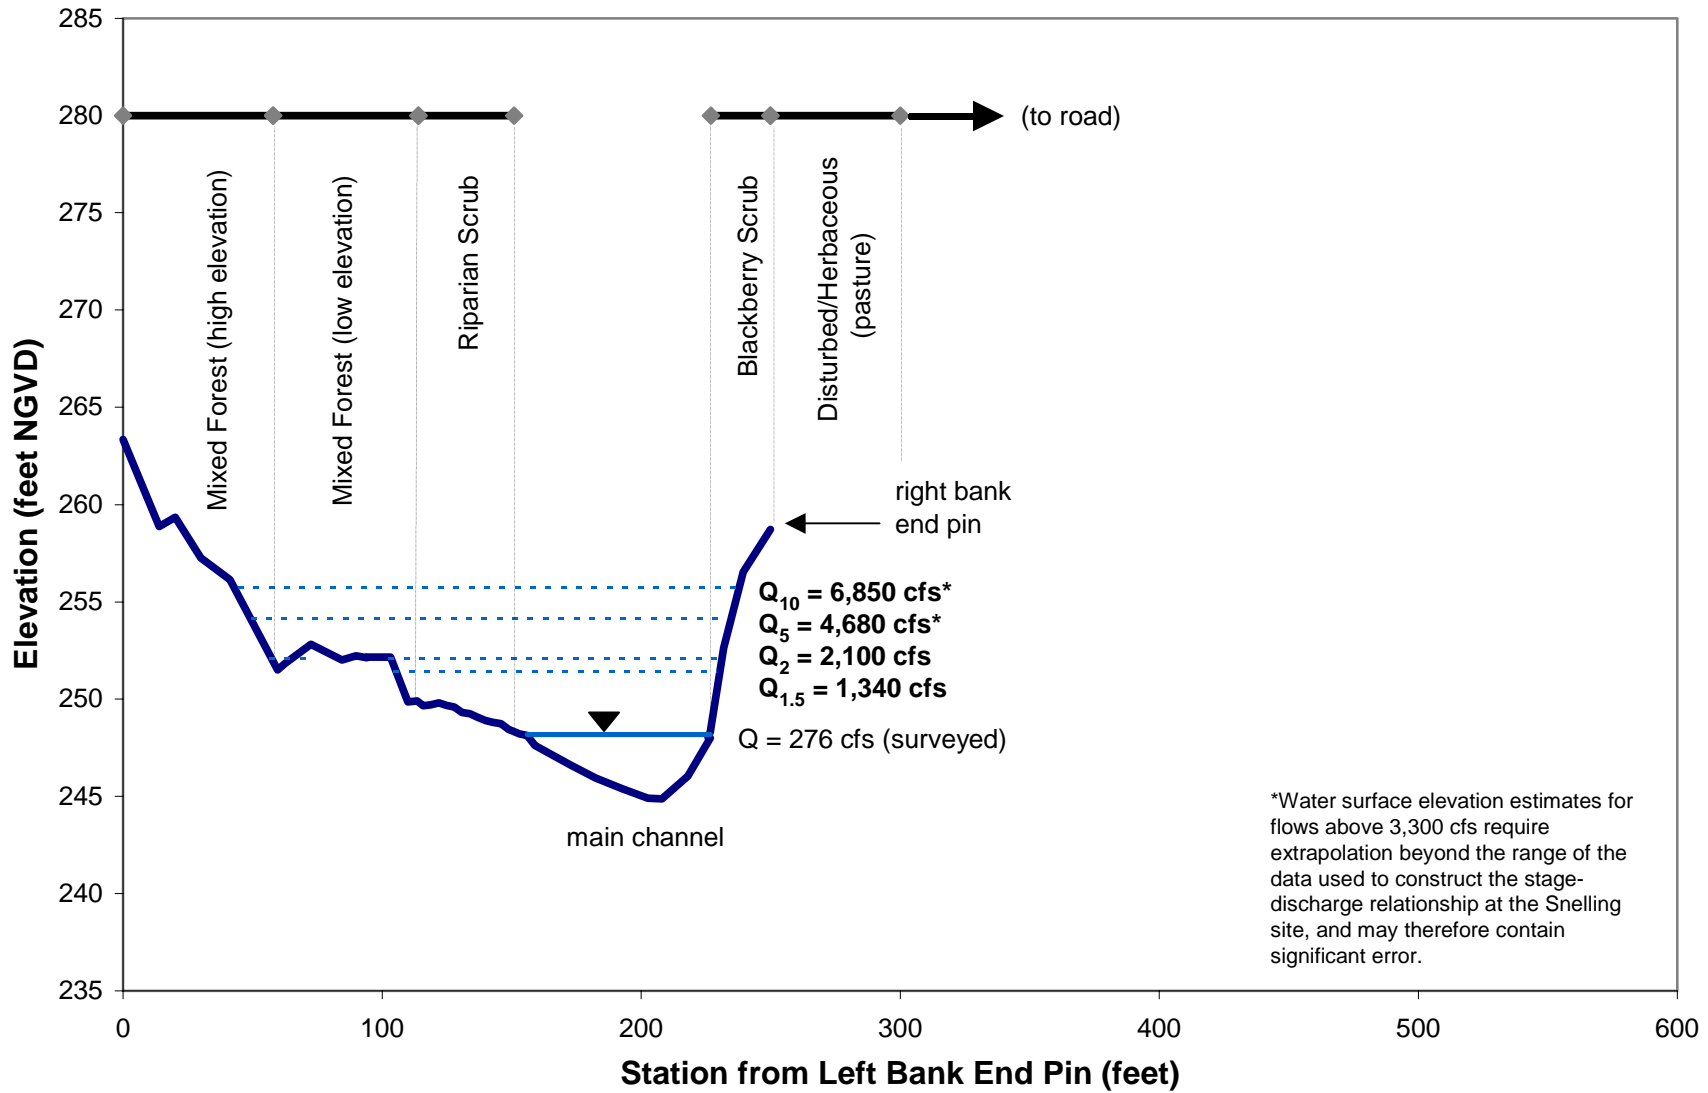
Figure B-9. Snelling Site vegetation cover and topographic cross section 1+90.

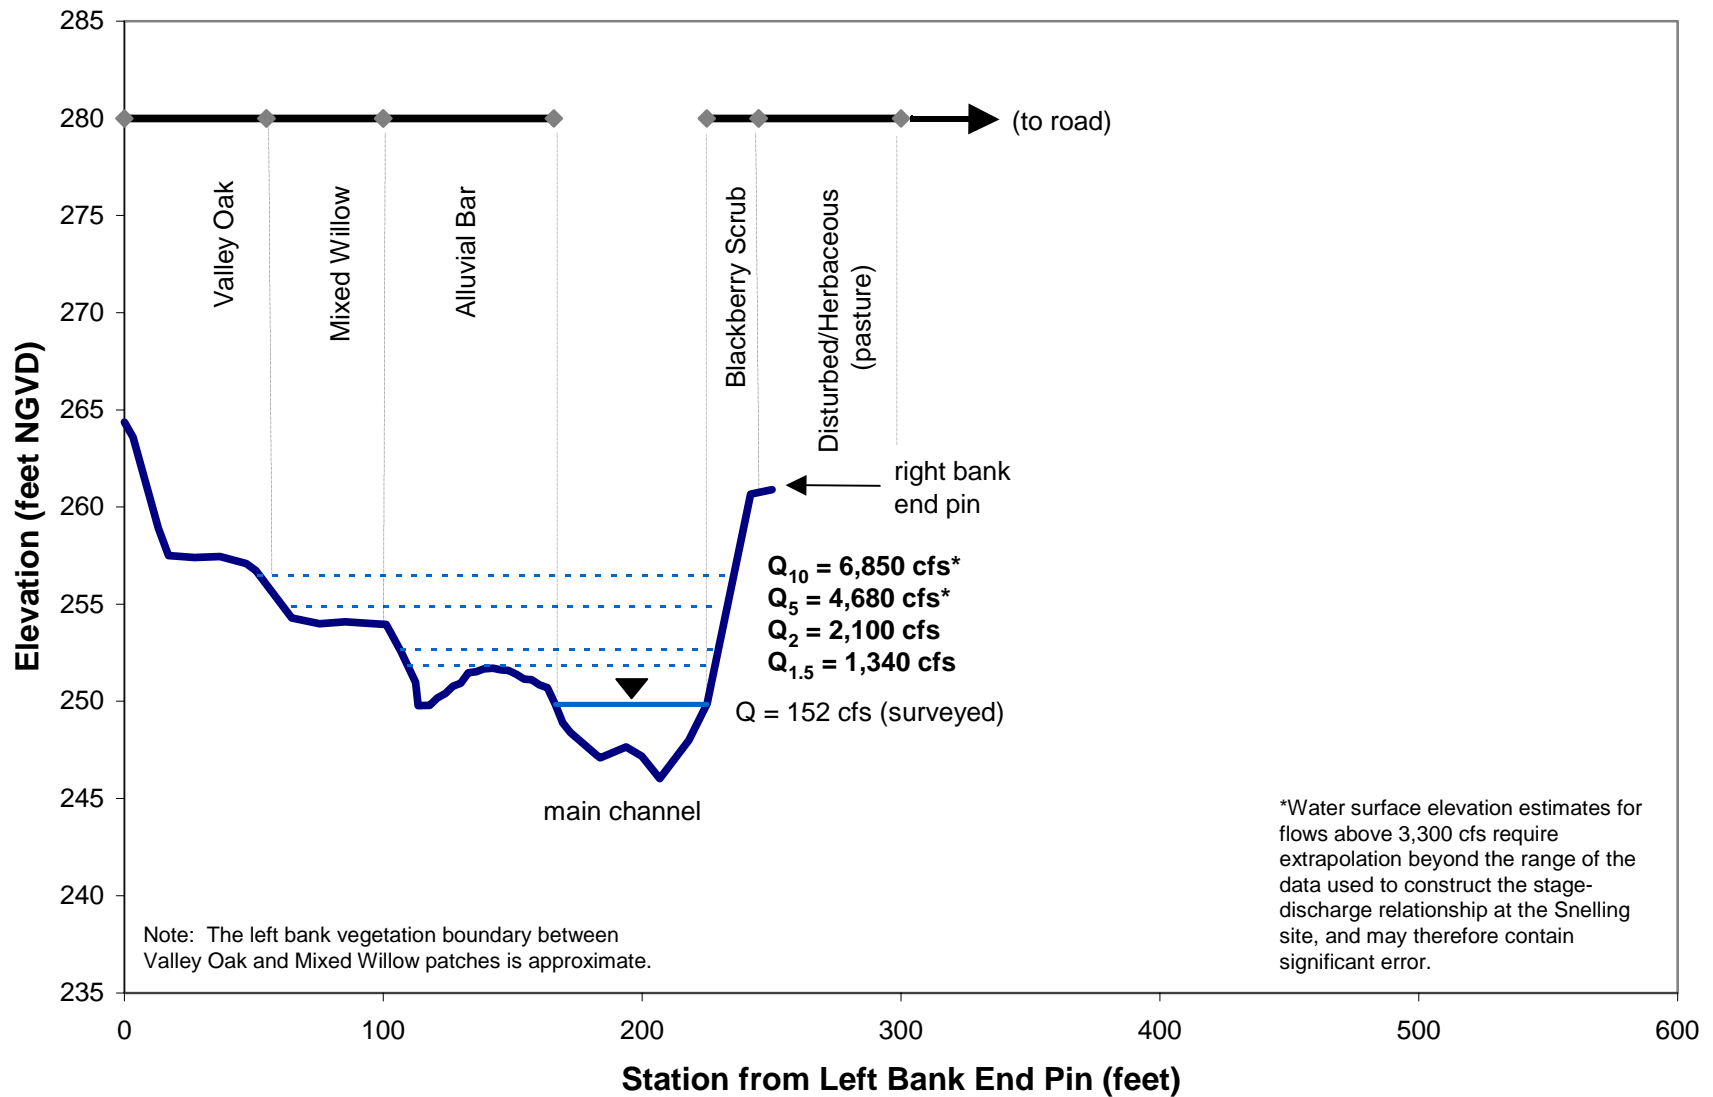
Figure B-10. Snelling Site vegetation cover and topographic cross section 4+20.

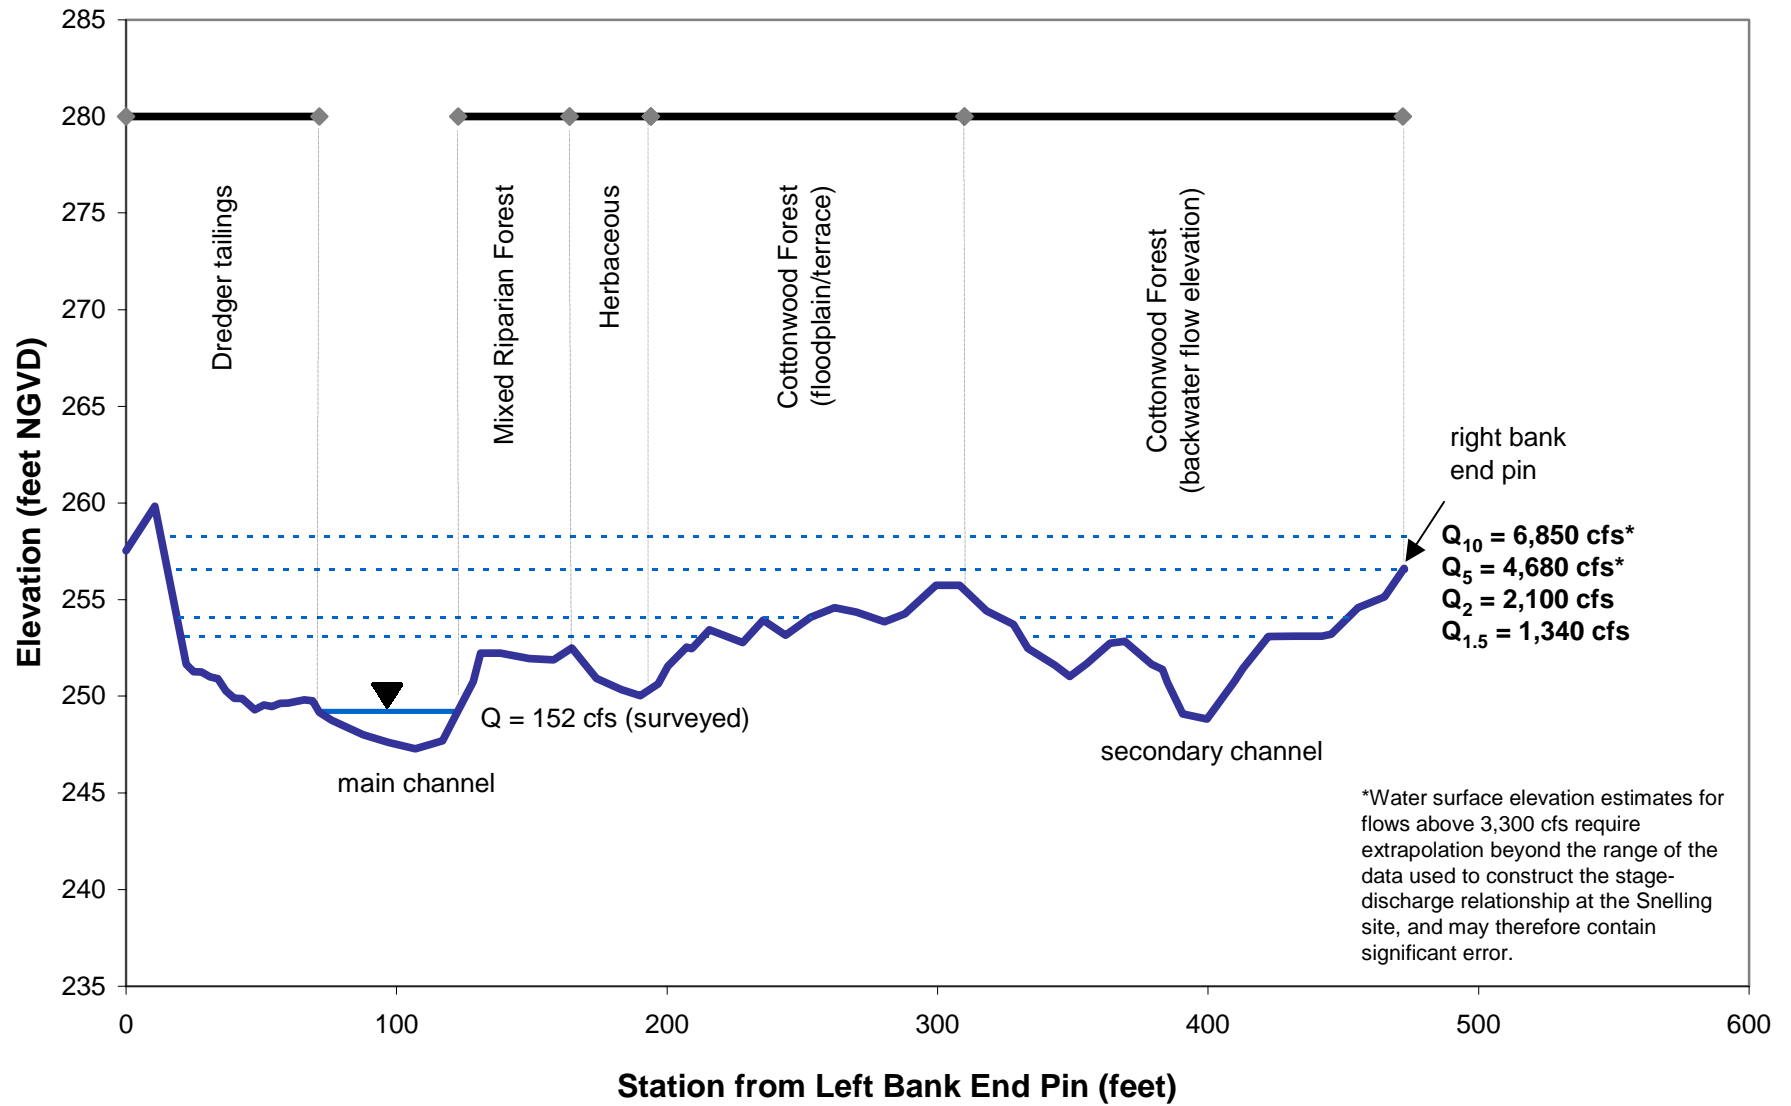
Figure B-11. Snelling Site vegetation cover and topographic cross section 9+60.
