Merced River Corridor Restoration Plan Baseline Studies

Volume I: Identification of Social, Institutional, and Infrastructural Opportunities and Constraints

**MERCED RIVER CORRIDOR RESTORATION PLAN
BASELINE STUDIES**

**VOLUME I:
IDENTIFICATION OF SOCIAL, INSTITUTIONAL, AND
INFRASTRUCTURAL OPPORTUNITIES AND CONSTRAINTS**

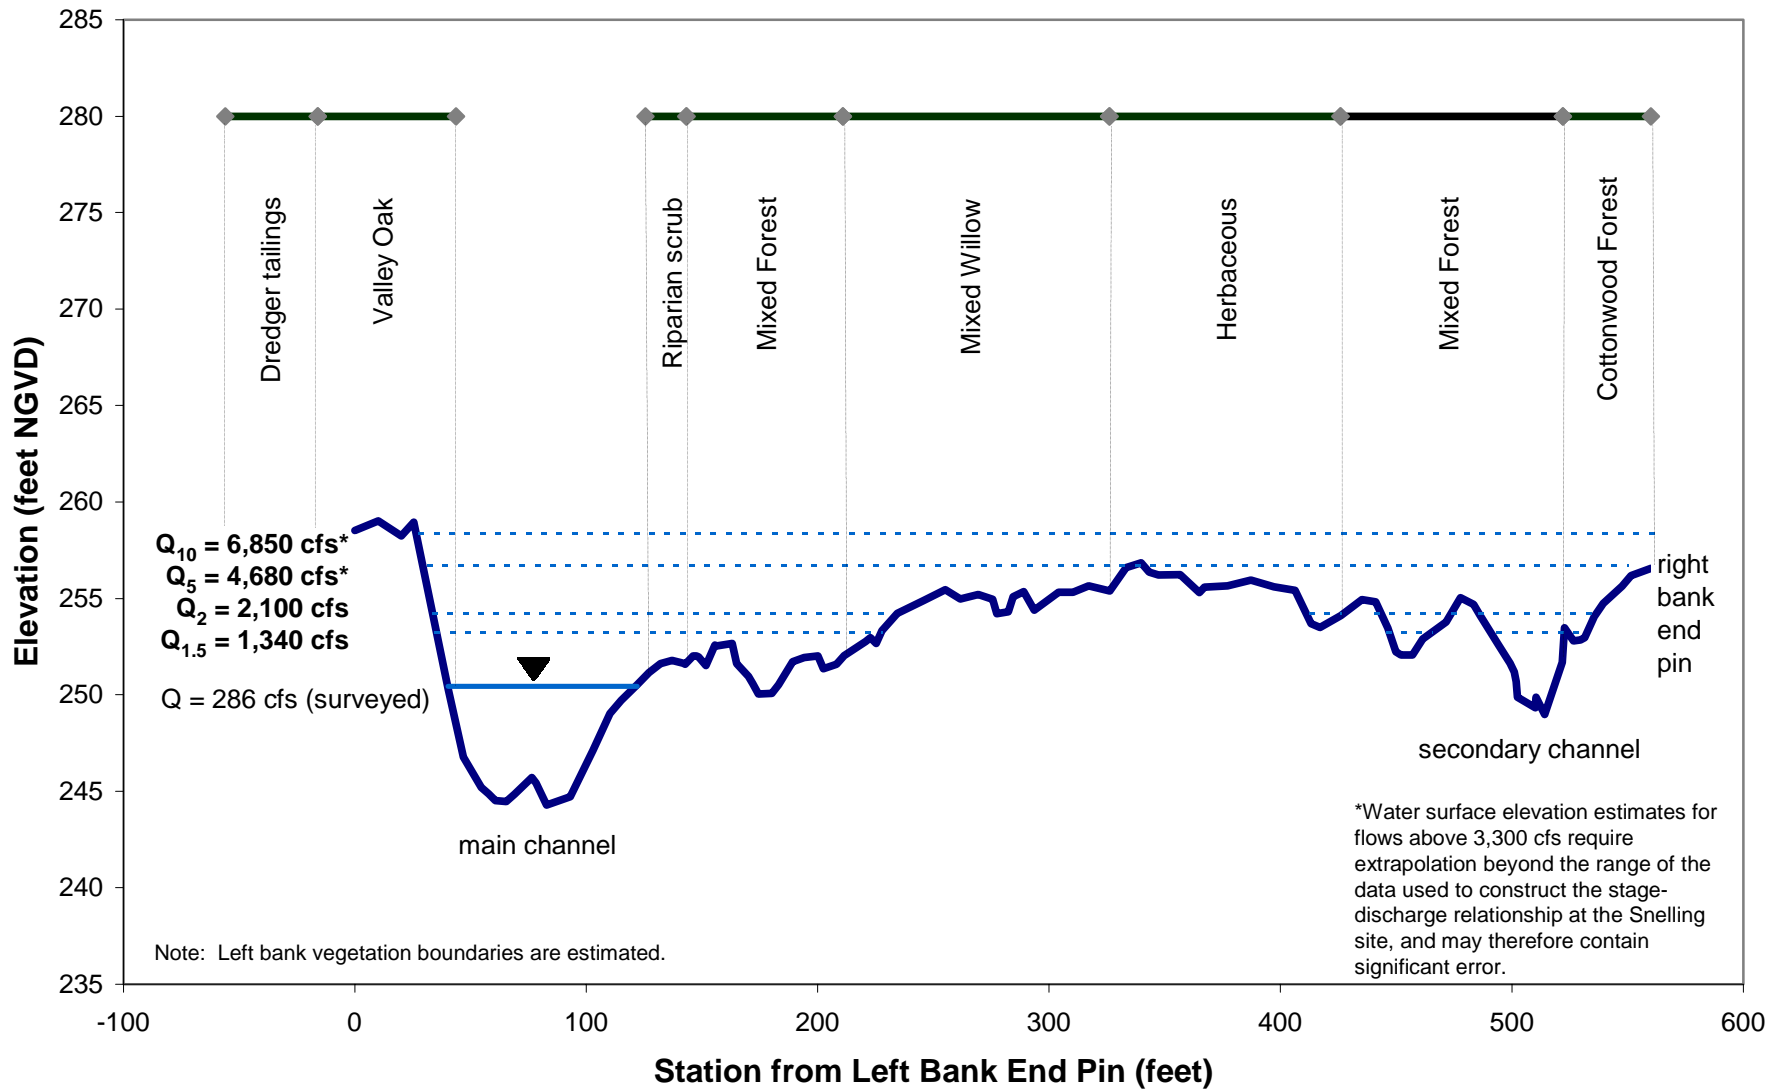
Figure B-12. Snelling Site vegetation cover and topographic cross section 10+80.

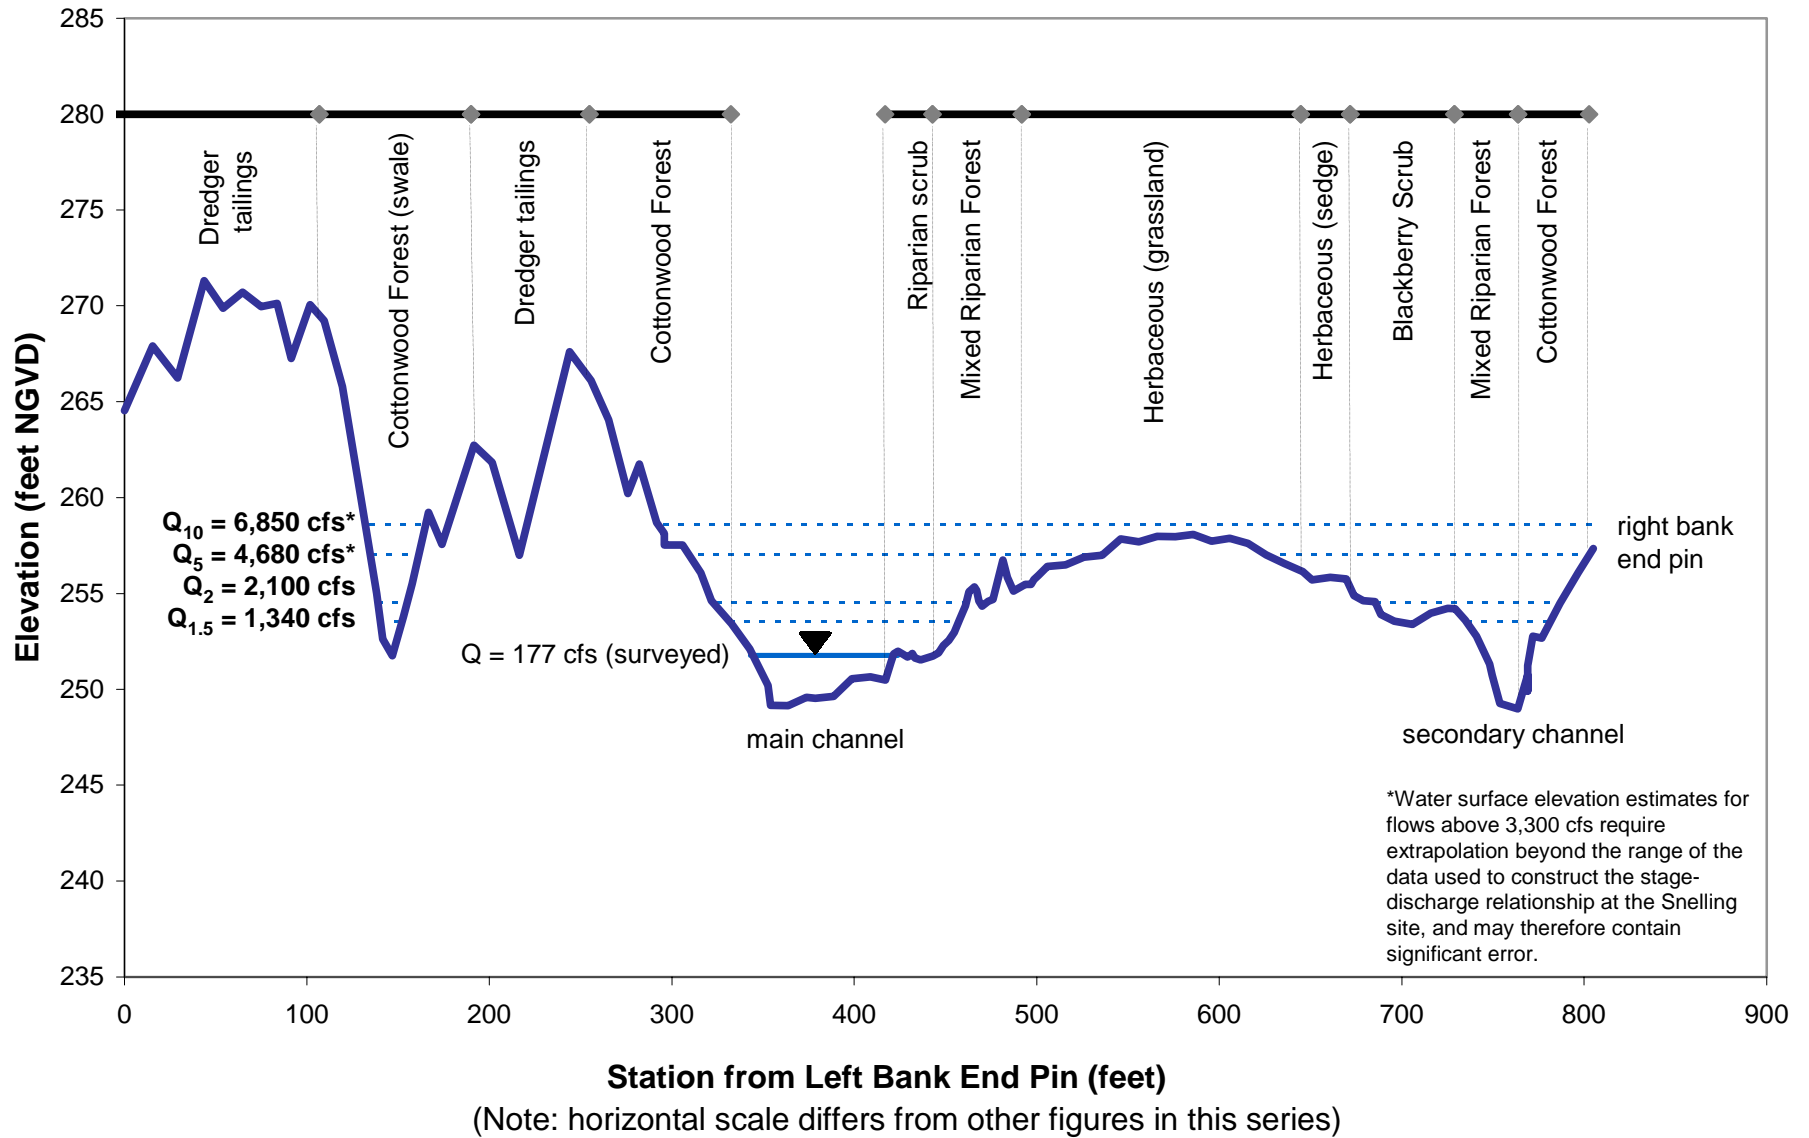
Figure B-13. Snelling Site vegetation cover and topographic cross section 13+95.

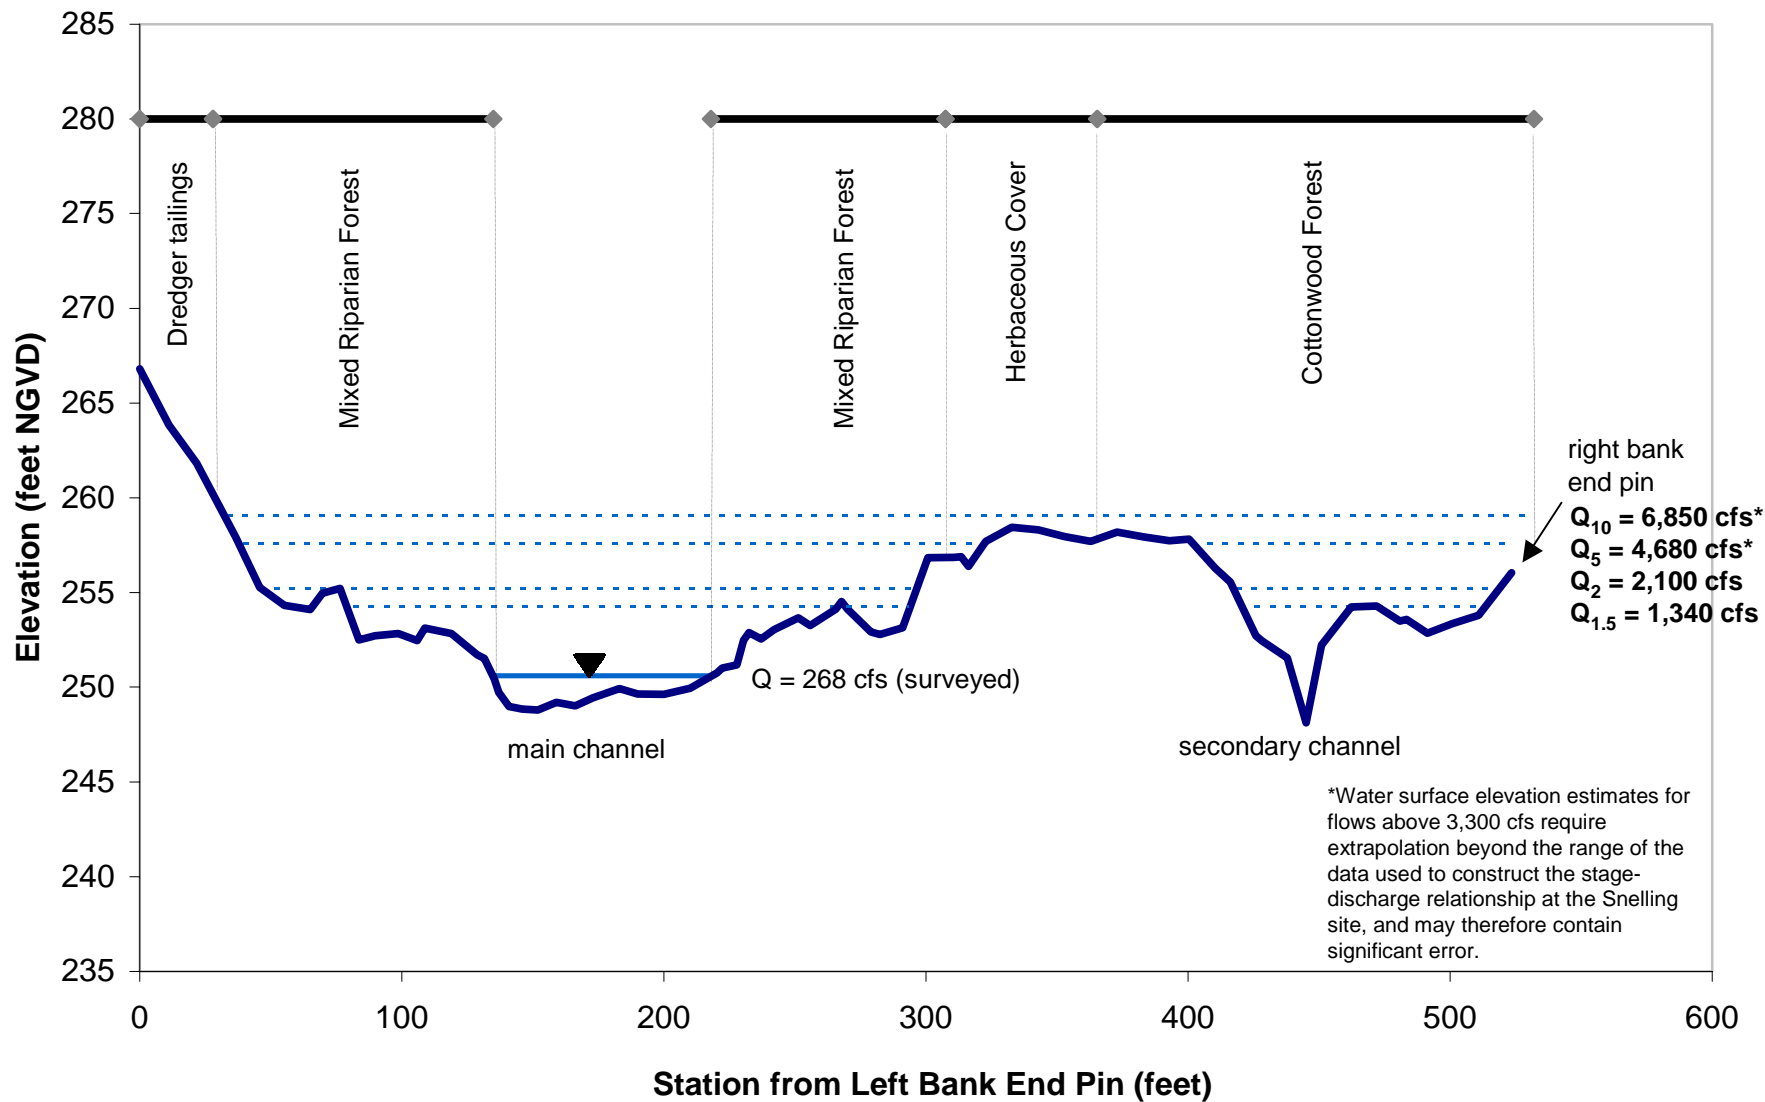
Figure B-14. Snelling Site vegetation cover and topographic cross section 17+75.

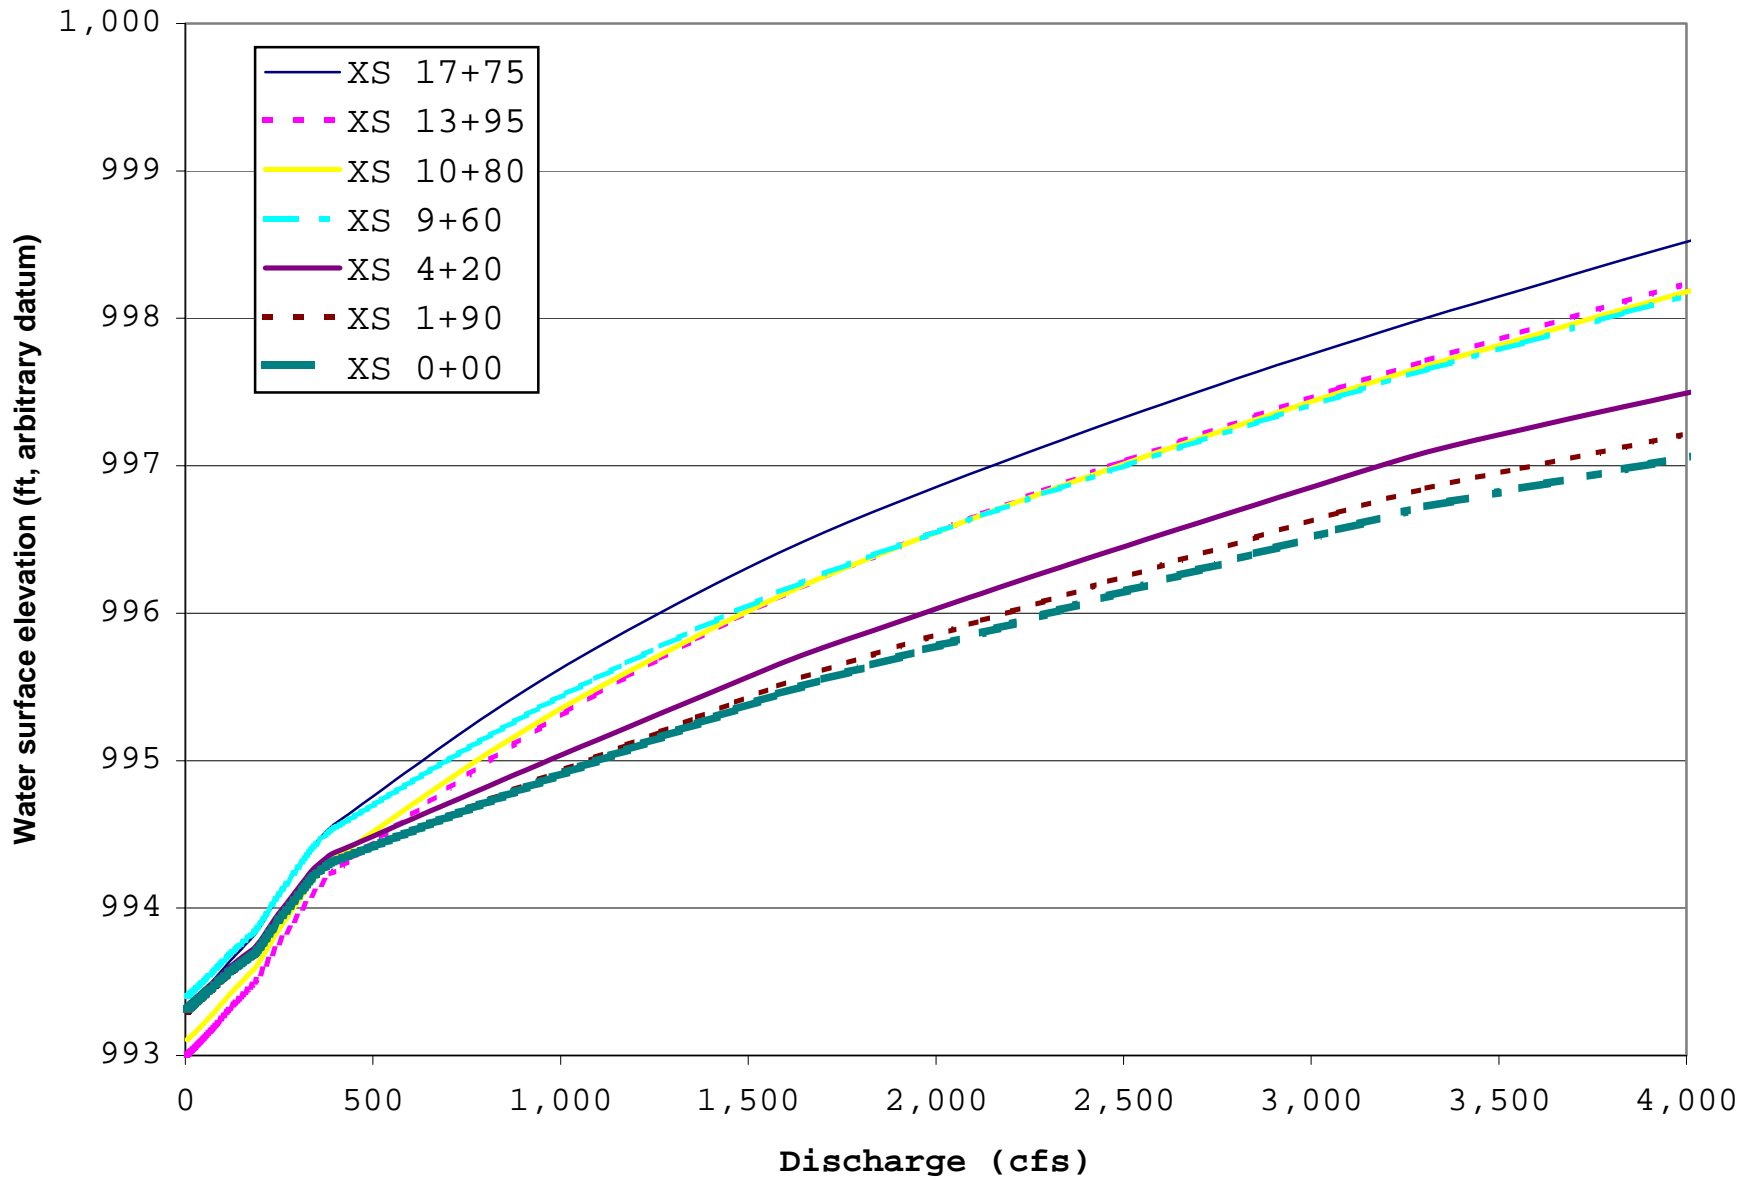
Figure B-15. Snelling model site rating curves.
