Merced River Corridor Restoration Plan Phase IV: Dredger Tailings Reach

Technical Memorandum #5 **Mercury Assessment of the Merced River Ranch**

Prepared for
CALFED ERP
Sacramento, California
Recipient Agreement No. ERP-02-P12-D

October 2004

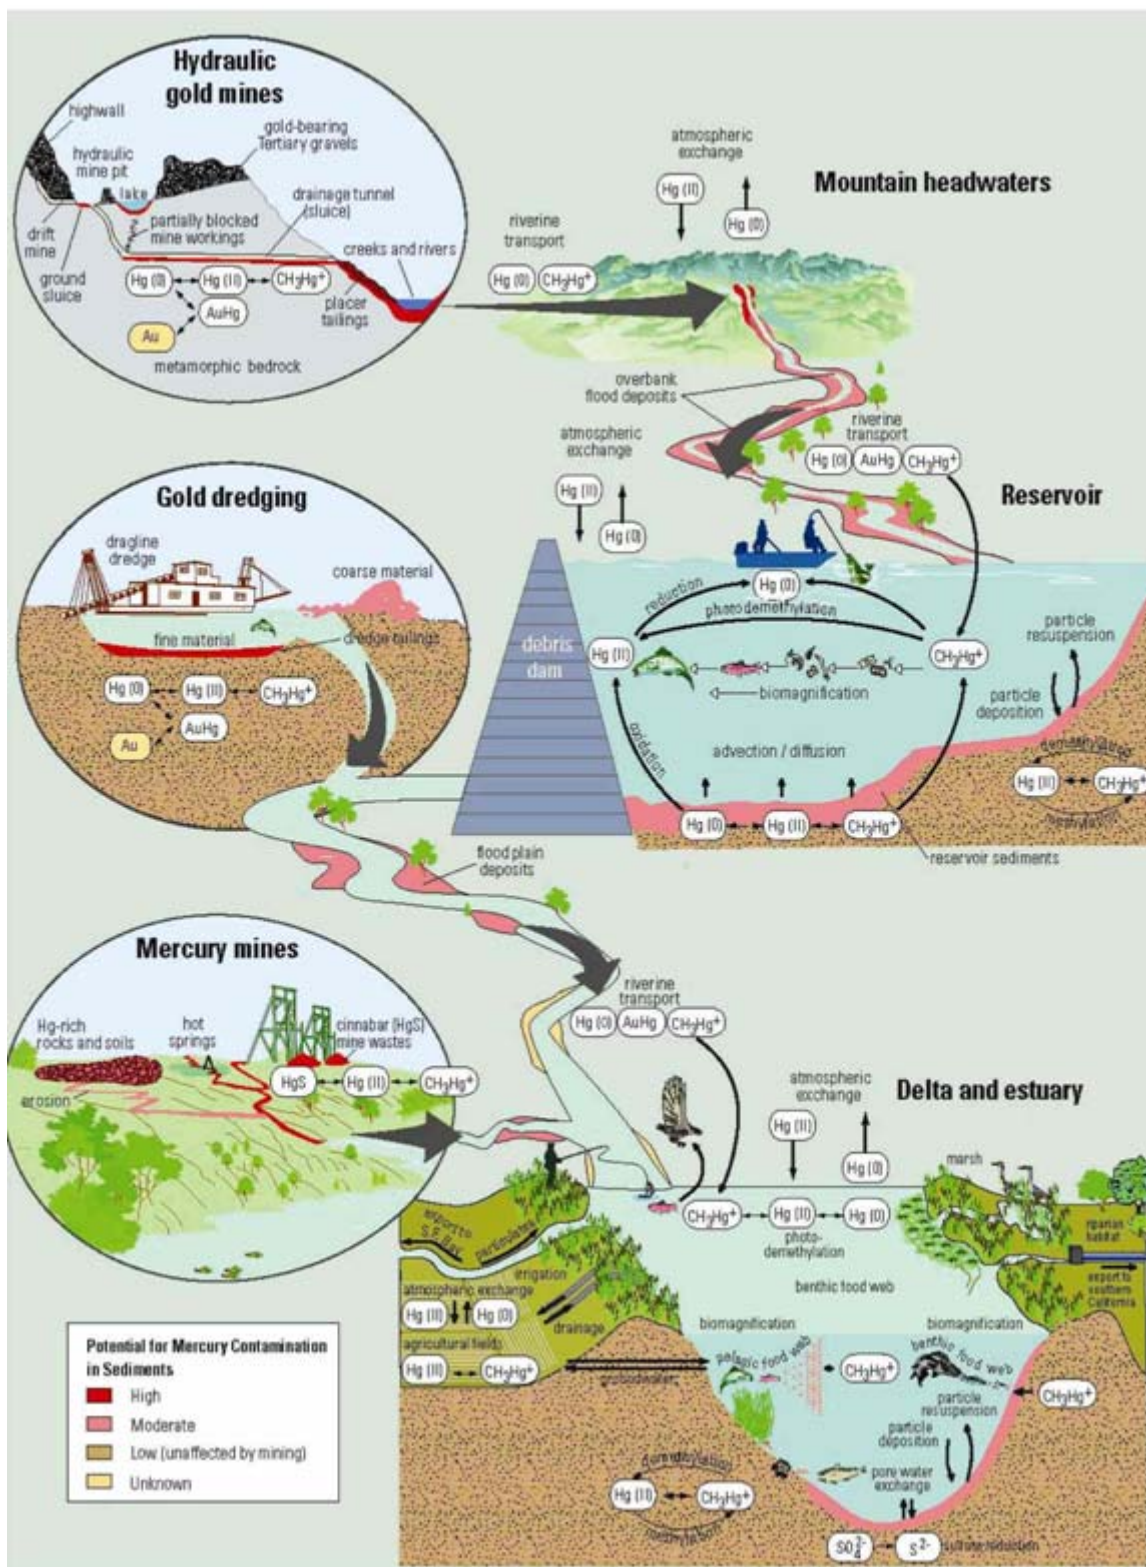
FIGURE 2 Conceptual model of mercury sources and cycling in the San Francisco Bay-Delta ecosystem, which is here defined as the combined watershed, Delta, and Bay (Weiner et al. 2003).

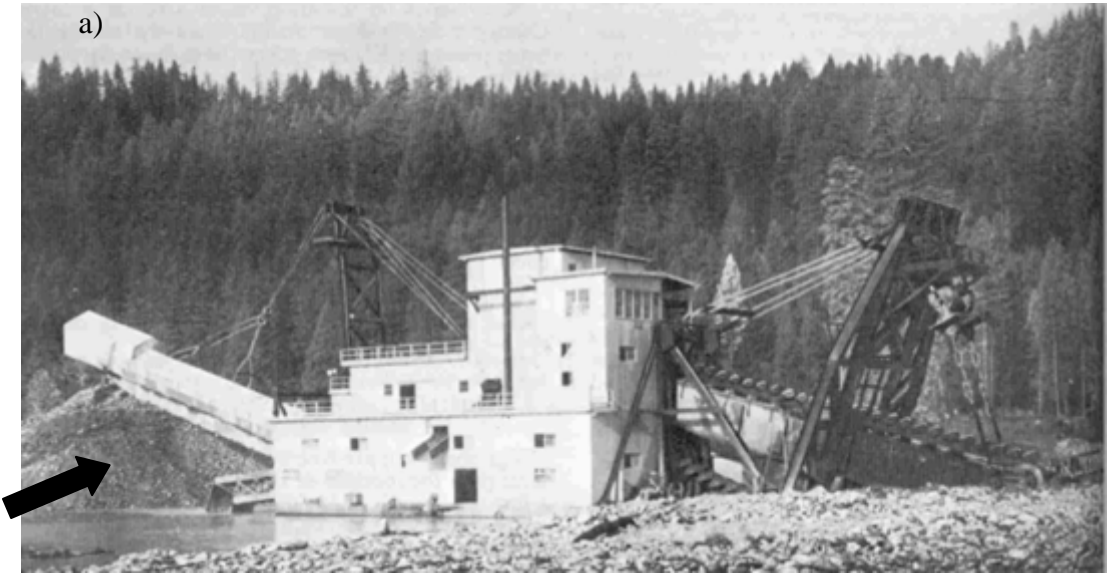
FIGURE 3

Photographs of early- to mid-1900s dredger operations in Northern California. Arrows indicate the large tailings piles created as material was discharged from the back of the dredgers. a) Carrville Gold Company Dredge, Trinity River District. Photo taken on the upper Trinity River in Trinity County in 1940. b) Natomas Company Dredge No. 8, Folsom District. Photo taken in 1953 in Sacramento County. Source: Clark (1998).

Dredging involved the use of barge-mounted processing equipment to remove and sort gold-bearing sand from alluvial deposits. A conveyor system of buckets on the front end of the dredge was used to scoop material, with some dredges removing 1.4–3.4x10⁶ cubic yards/year. Based on the Vick (1995) estimate of 7–14 x10⁶ tons of bedload removed from the Merced River channel by dredging activities, 0.2–0.4 x10⁶ tons per year or 4.2–8.4x10⁶ cubic yards per year (based on 2,203 kg/m³ from URS [2004]) would have been the capacity of the local dredges over the 30 years of documented dredging. The river channel and floodplain deposits were often excavated to bedrock, usually a depth of 6–11 m (20–36 ft) (Clark 1998).

Within the dredge, the bucket line discharged into hoppers that fed into a slowly rotating trammel for screening. The cobbles and oversized gravel (>0.5 in) slid down the trammel and dropped onto conveyors that carried them to the aft end of the dredge for discharge on the back banks of the dredging pond (Figure 3). The discharged material, or dredge stacker tailings, formed long rows on the floodplain as the dredge slowly progressed through the floodplain (Young 1970).

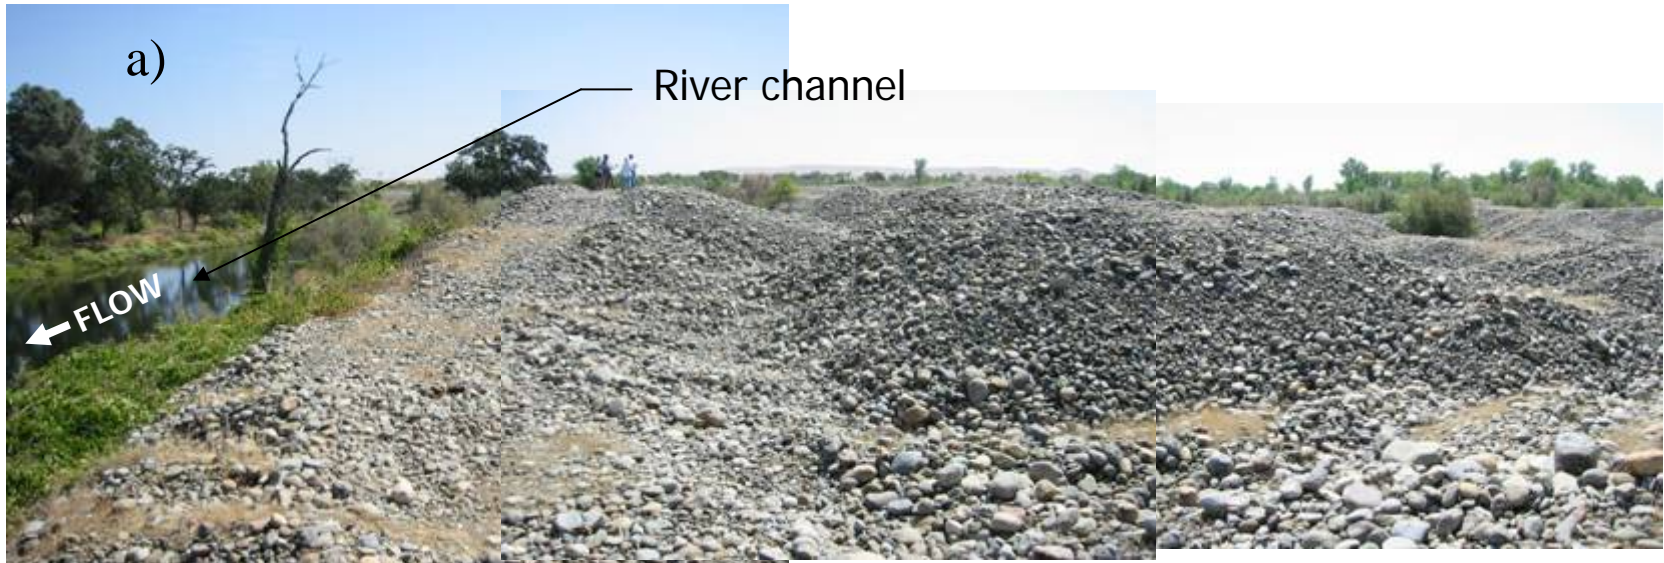
FIGURE 4

Current conditions of tailings piles at the Merced River Ranch. a) Picture showing river channel and sparse, weedy vegetation among the cobbles and boulders. Note people for scale. b) Schematic depicting narrow bands of non-native vegetation on the river banks and linear patches of vegetation confined to swales within the dredger tailings.

At the MRR, and generally within the DTR, mining and dredging activities have produced a river channel confined by piles of dredger tailings (Figure 4a). The tailings piles have replaced the natural floodplain soils and floodplain forest and have increased floodplain elevation along the river. Minimal stratigraphy has been found within the tailings piles of the DTR (URS 2004). A shallow (0.2 m) surface layer of coarse materials (larger

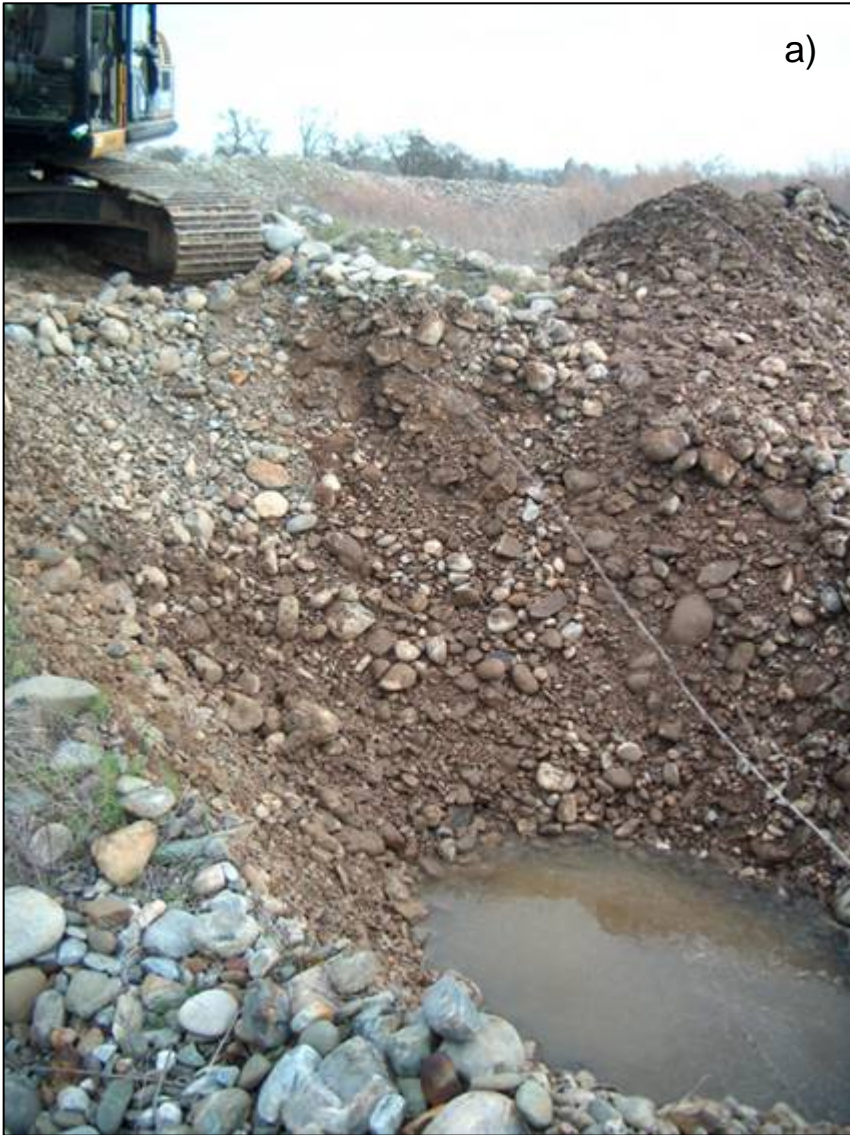
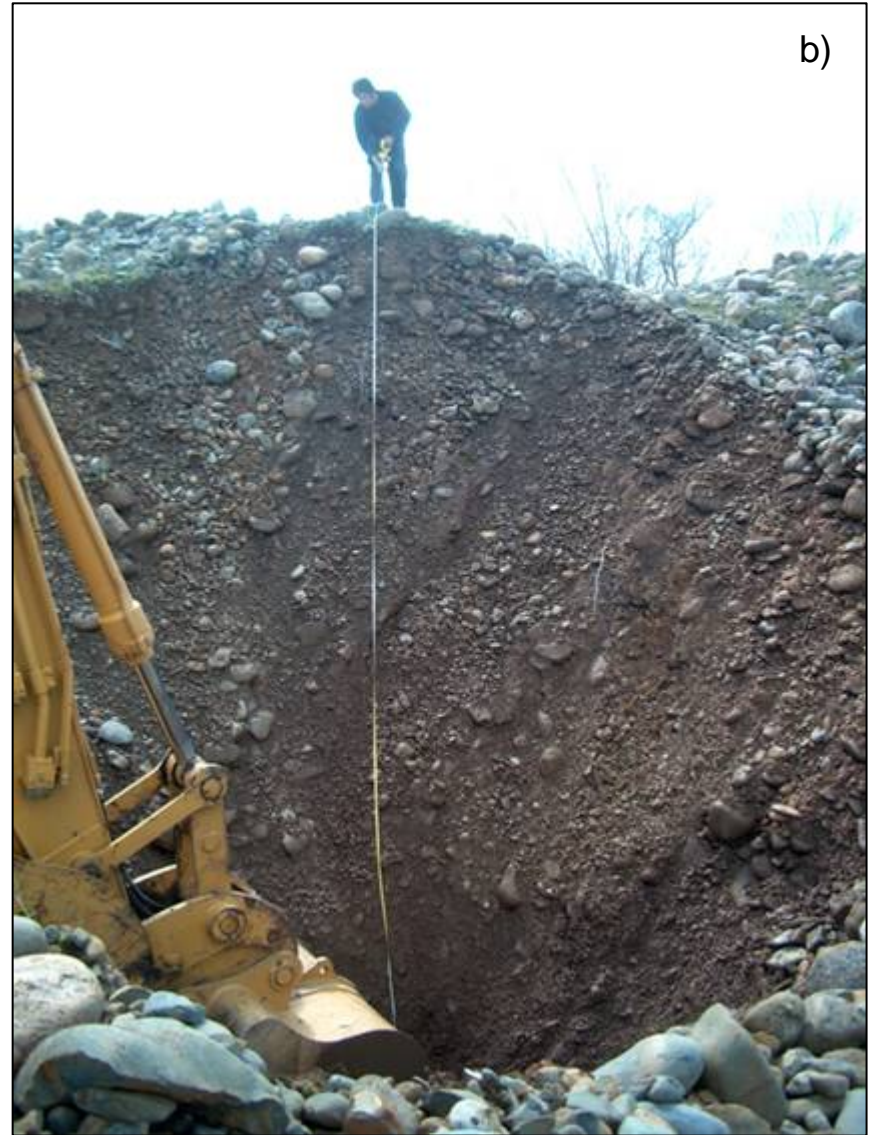
FIGURE 7

Dredger tailings excavation at the Merced River Ranch, February 23-27, 2004 (URS 2004). a) Side view of dredger tailings excavation pit. b) Excavation pit and groundwater at site T1.

a result of ambient storm conditions. There was no discernable pile stratification at the majority of sites; throughout the pile sites, wet fines adhered to larger rock surfaces mainly as clay globules or coatings. The wet conditions meant that there was no ultra-fine material lost as dust when the samples were removed from the pits or piles. Additionally, since the wet tailings samples were taken above rather than directly within or below the existing water table, fines were not observed to be lost by water slurry spilling out of the backhoe scoop.

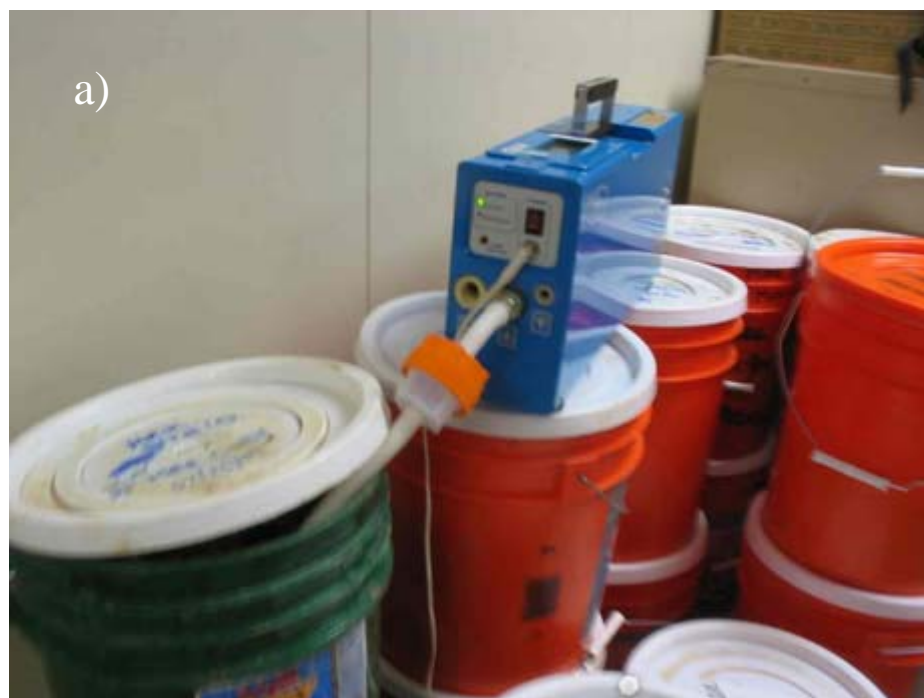
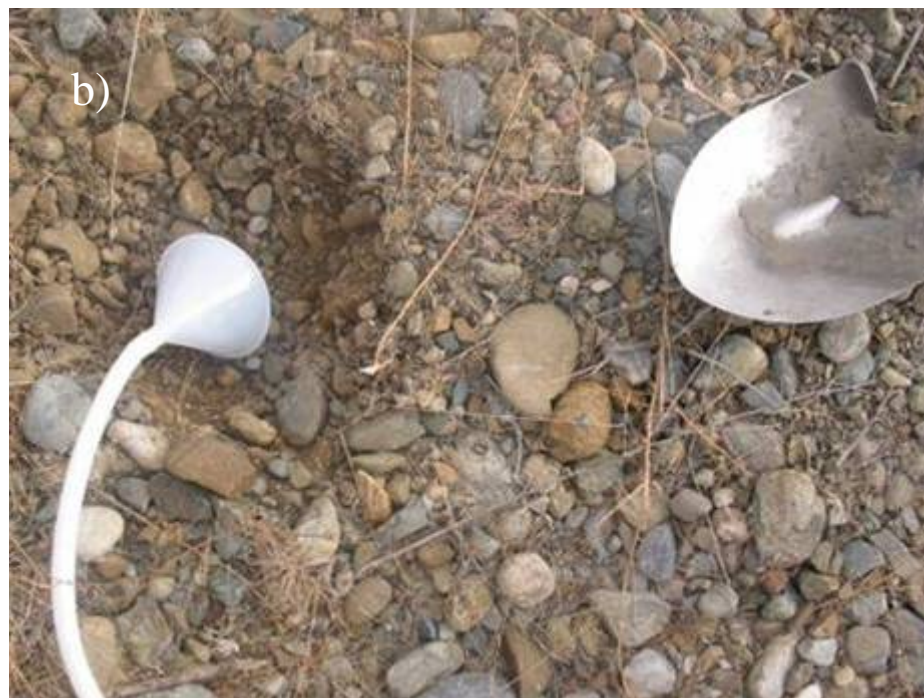
FIGURE 8
 Lumex sampling for mercury vapor (Hg^0). a) Lumex sampling the bucket headspace of composite samples, February 28, 2004. b) Lumex sucker head at site T7, November 1, 2003.

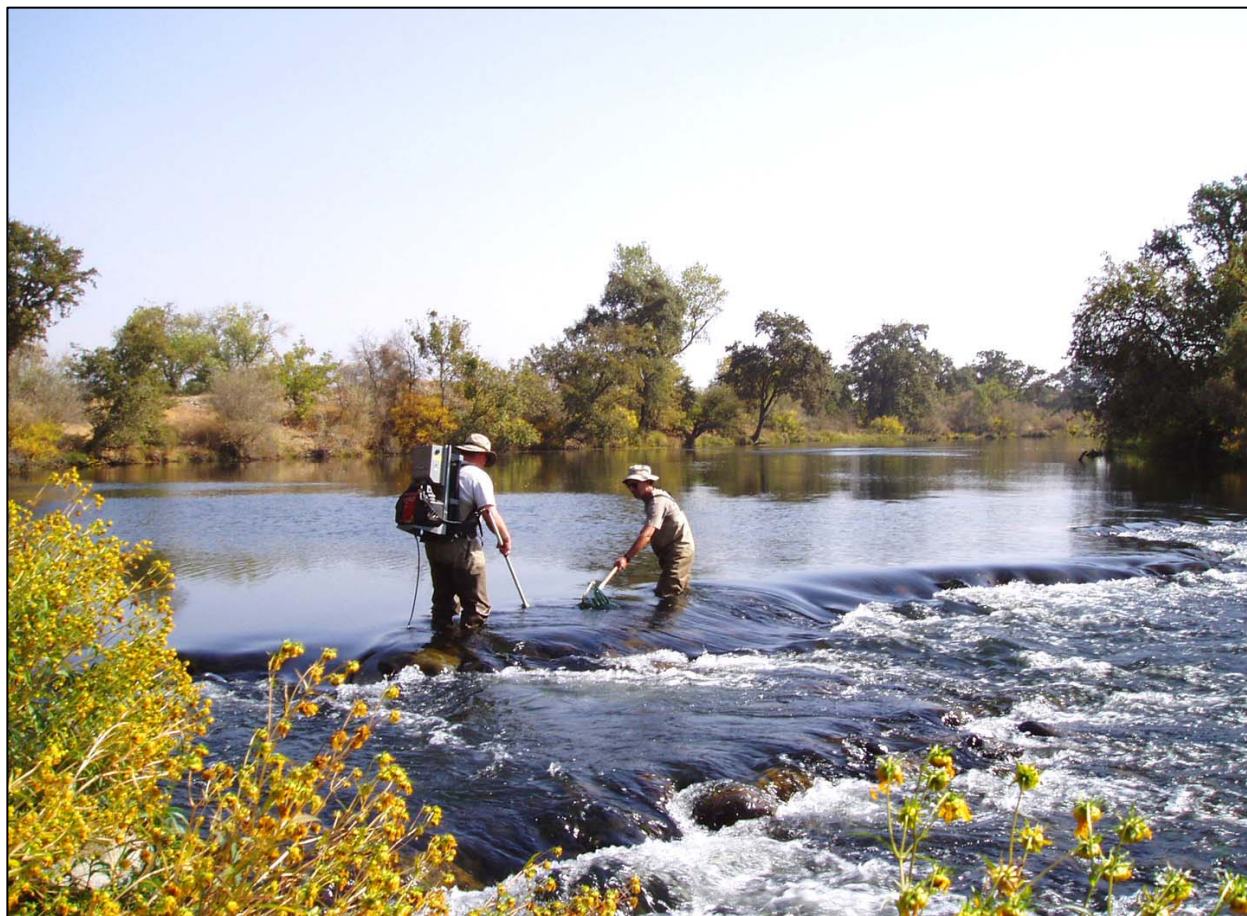
FIGURE 11
Backpack electroshocking at the Merced River Ranch site (RM 50), October 28-29, 2003.

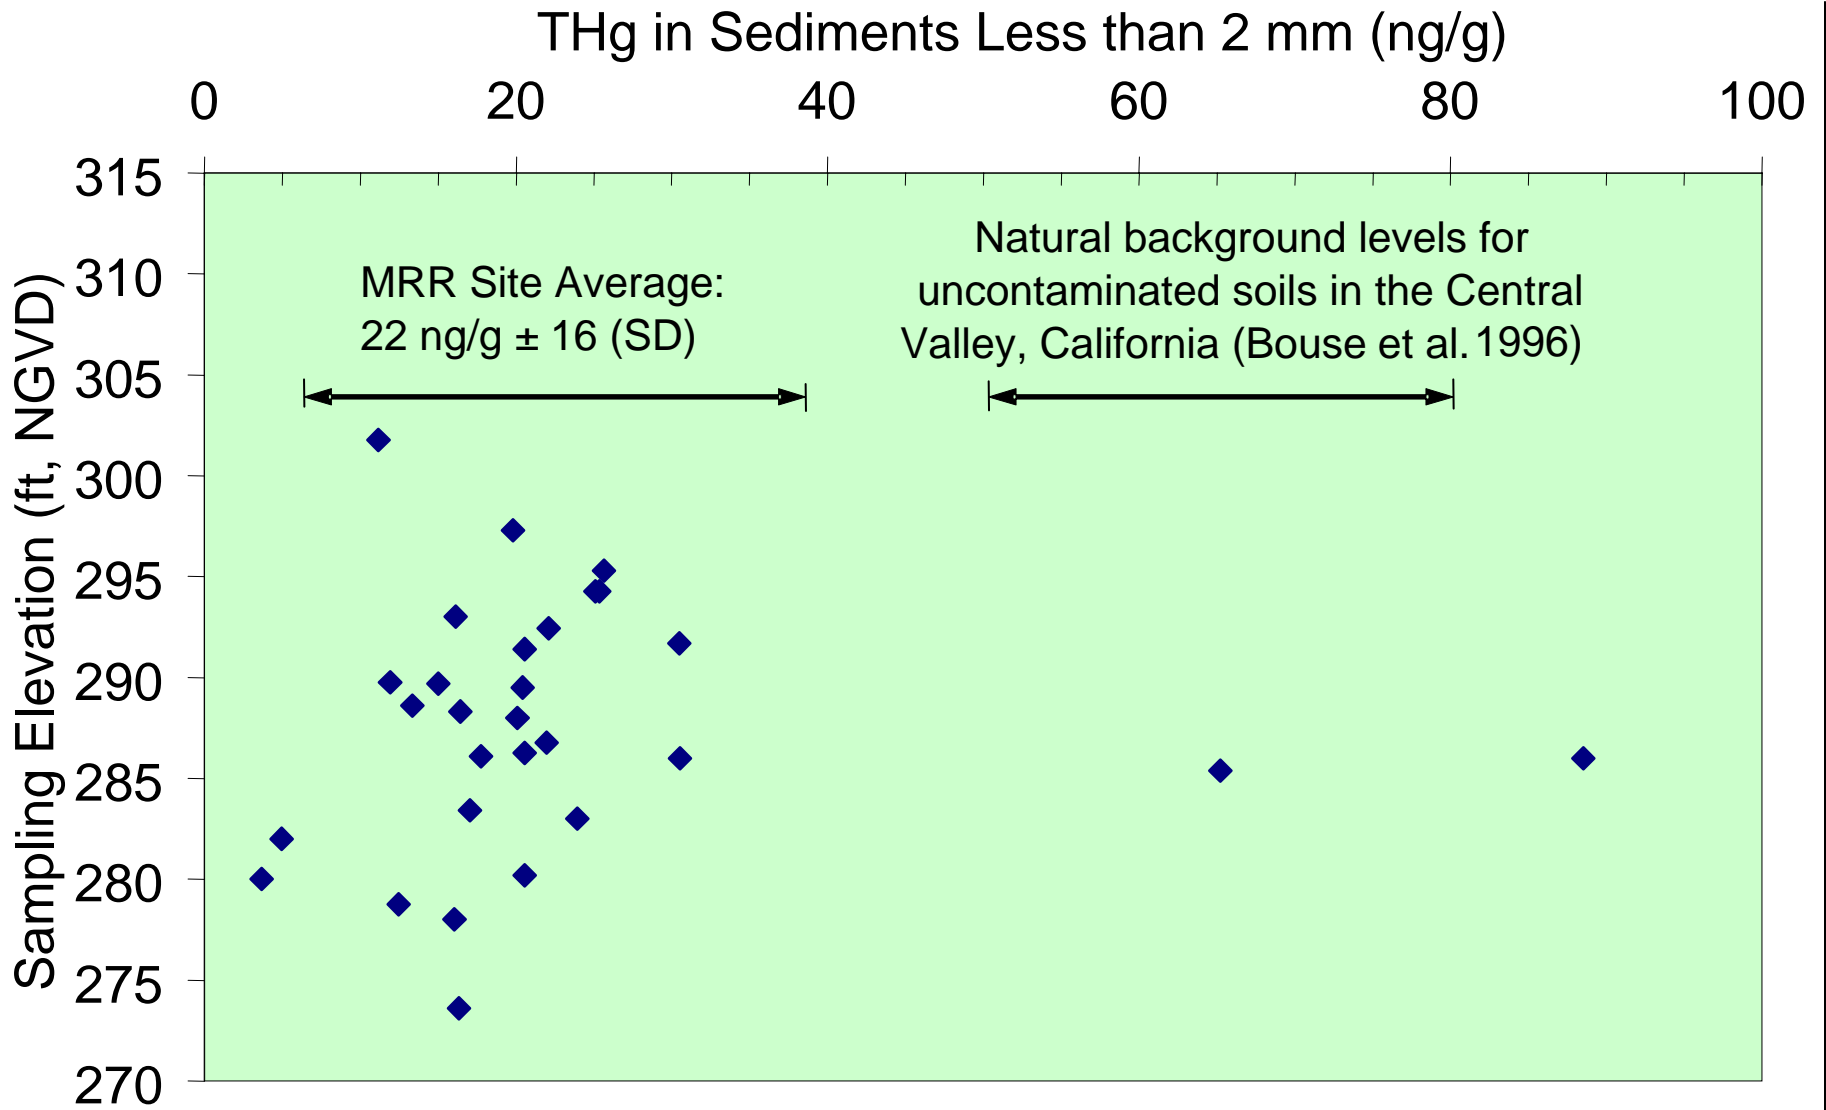
FIGURE 12

Total mercury in dredger tailings fine material. All points shown on the graph (n=31) were collected above groundwater elevation at the Merced River Ranch. Sampling elevations are based on GPS data. Mean groundwater elevation was 280±5 ft.

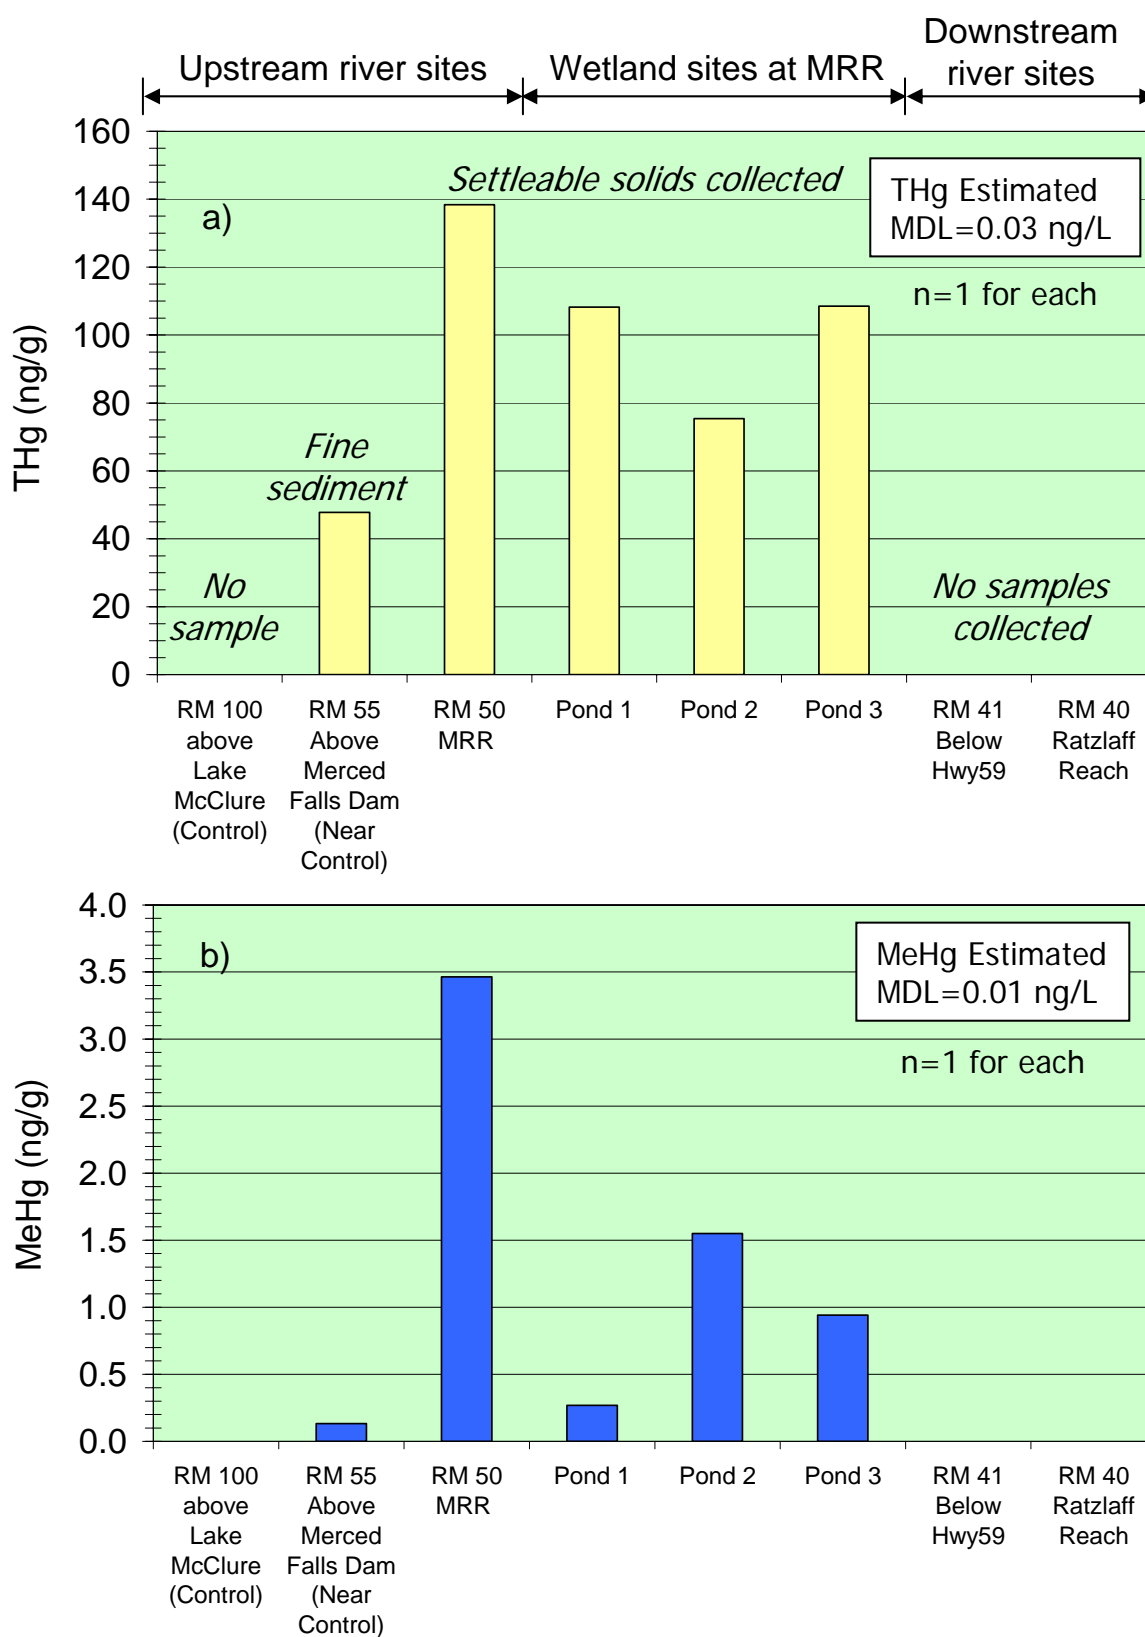
FIGURE 15
Mercury in fine sediments at sites along the Merced River. a) Total mercury (THg) and b) methylmercury (MeHg). Note the different scales on each graph.

The fine sediments collected at the two river sites and three MRR pond sites had the highest sediment mercury levels found during the study, ranging 48–138 ng/g by dry weight (Figure 15, Table 3-3). Despite relatively high

mercury levels compared with dredger tailings fines and whole rocks, these samples were still within the typical 50–200 ng/g range for uncontaminated soils and sediments (Davis et al. 1997). Of the five locations where fine sediments were sampled, the lowest THg levels were found at the near control site, sampled above Merced Falls Dam. The THg value measured at this site (50 ng/g) was the same as pre-mining, natural background levels estimated for San Francisco Bay (Hornberger et al. 1999) and near average crustal abundance levels (67 ng/g) (Emsley 1998). Although this suggests a low probability of mercury contamination in the upper Merced watershed, more comprehensive sampling would be required to increase the confidence in these results.

MeHg ranged from 0.1 to 3.5 ng/g as dry weight (Figure 15b), with the lowest and highest concentrations and percent MeHg occurring at adjacent sites; 0.1 ng/g at the near control site, sampled above Merced Falls Dam, and 3.5 ng/g at the MRR site. Percent MeHg at these sites was 0.2% and 2.5%, respectively. Since levels of MeHg in sediments > 1 ng/g generally indicate favorable mercury methylating conditions (Gilmour et al. 1998, Heim et al. 2003), the settleable solids collected at the MRR Cuneo access site and within ponds 2 and 3 represented favorable environments for bioavailable mercury.

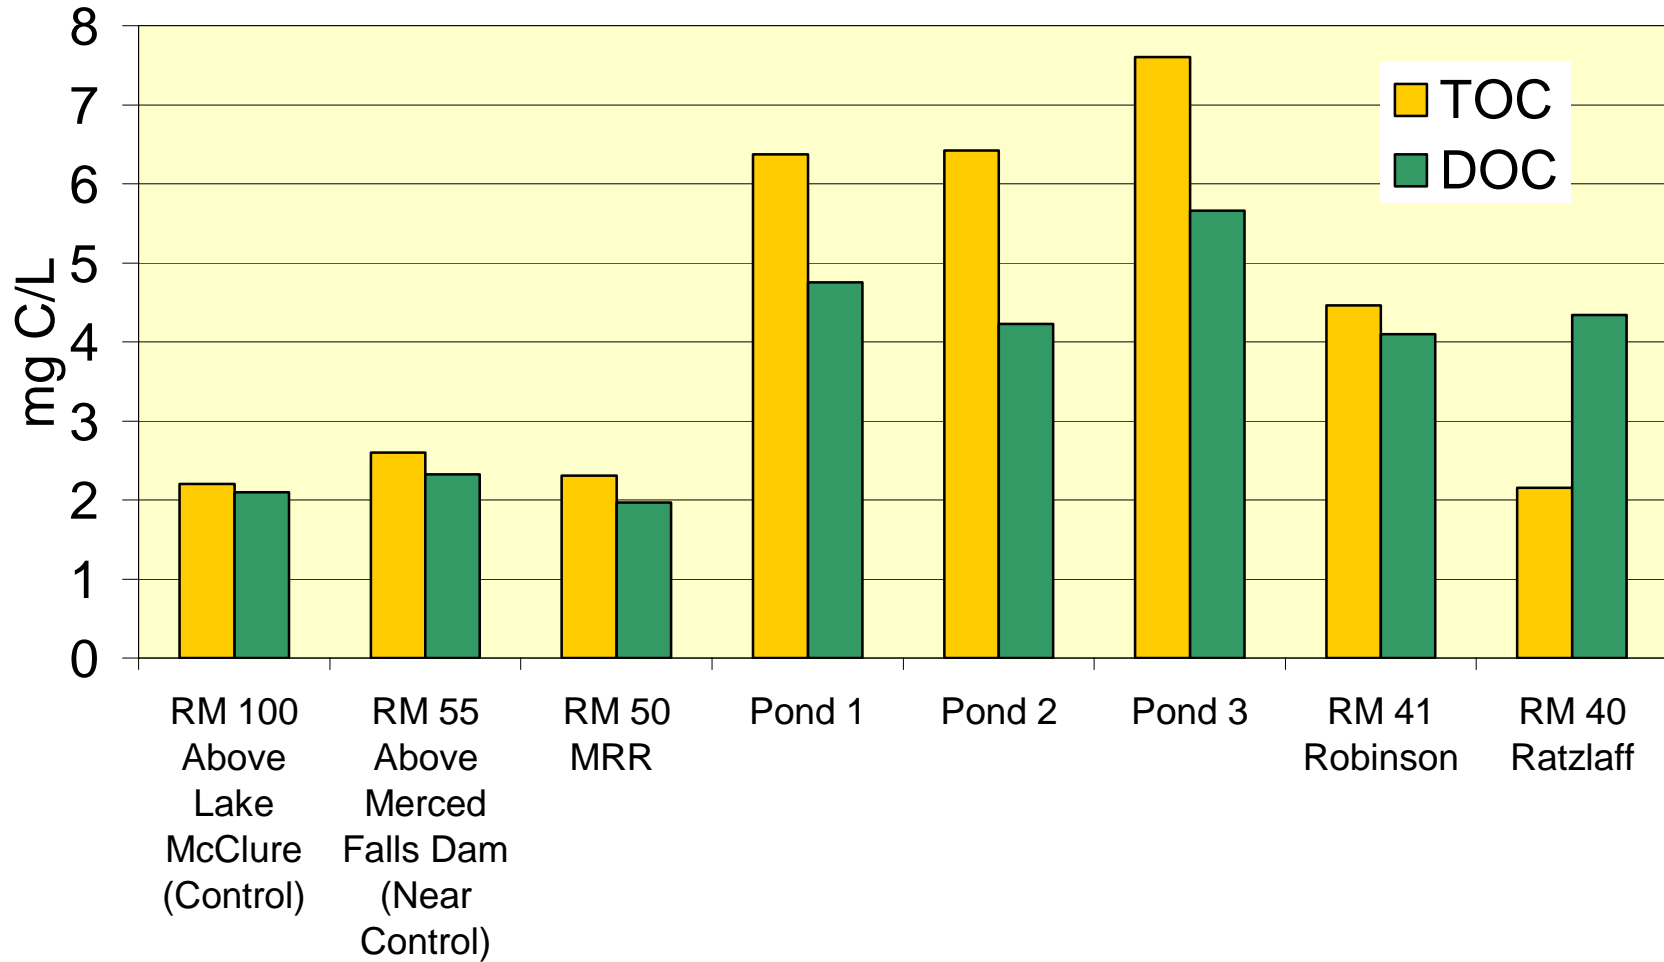
FIGURE 16

Total organic carbon (TOC) and dissolved organic carbon (DOC) in the water at Merced River sites. MDL=0.2 mg/l, n=1 for each.

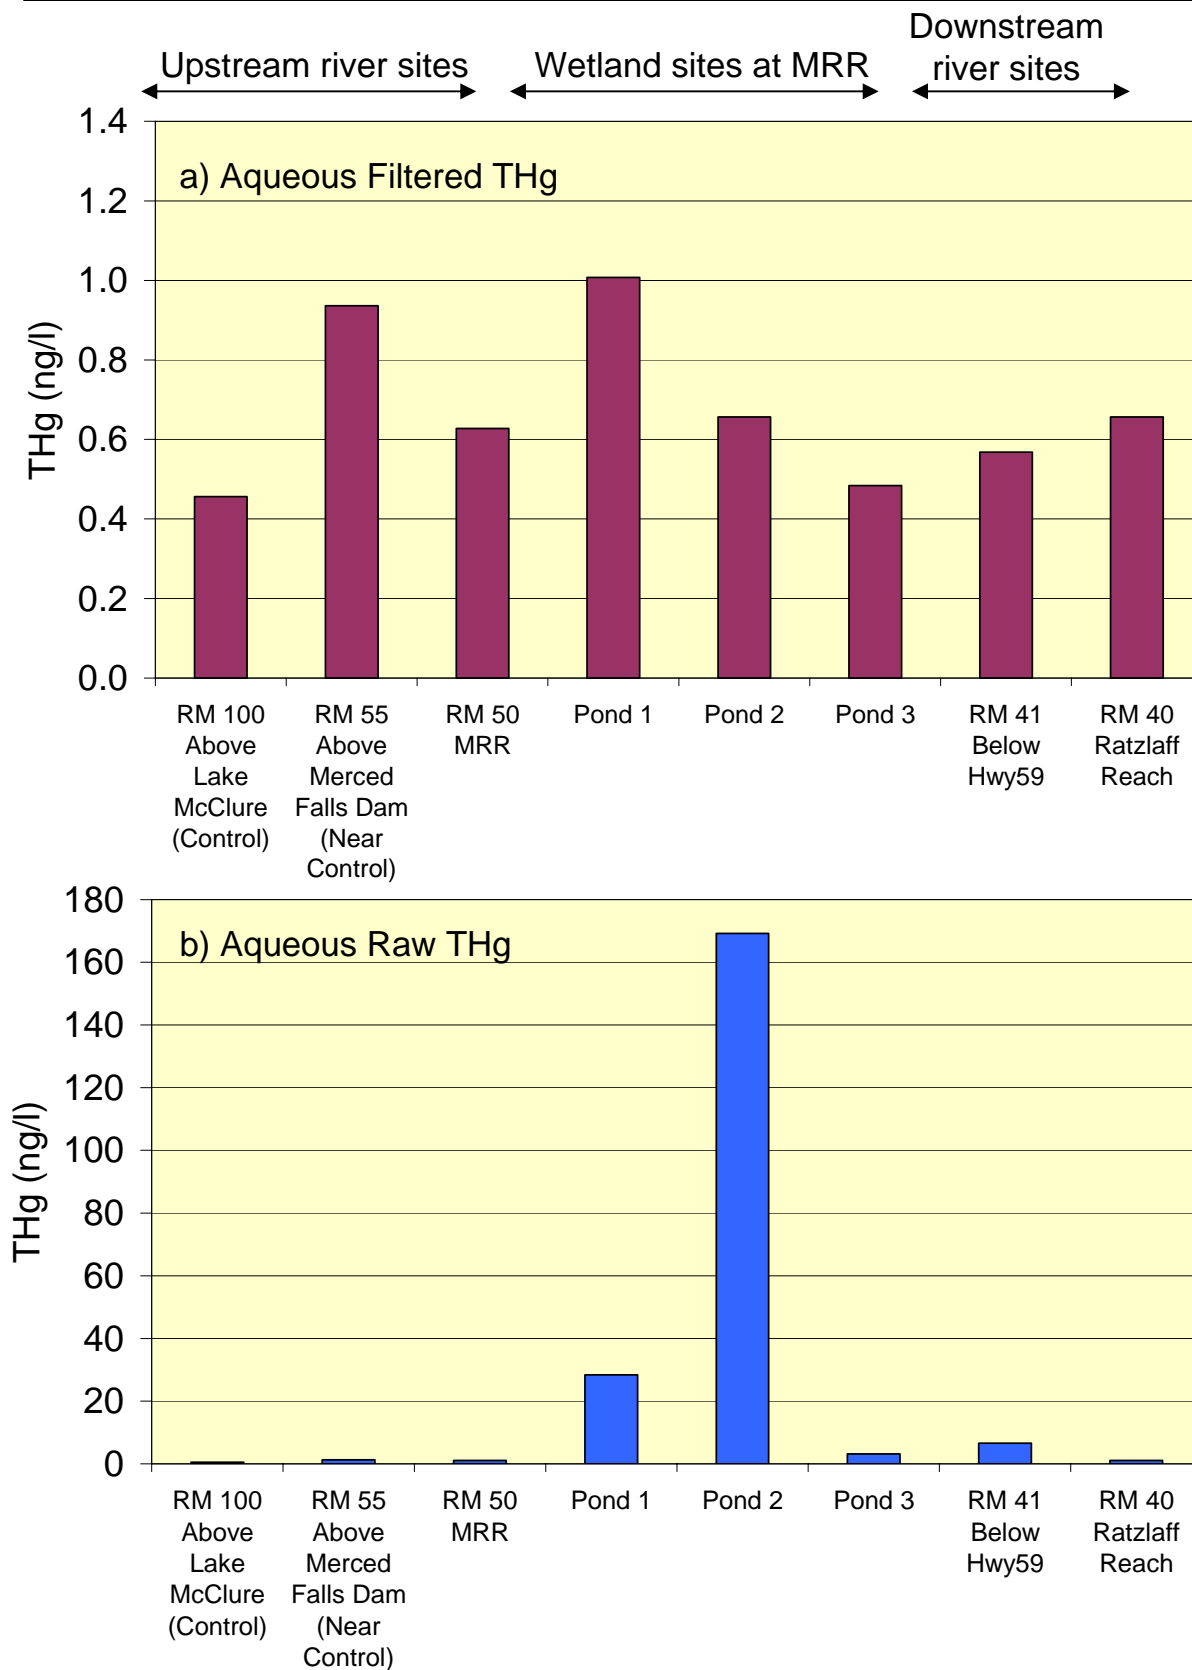
FIGURE 17

Aqueous total mercury at sites along the Merced River. Note the different scales on each graph. Estimated MDL = 0.02 ng/L, n=1 for each.

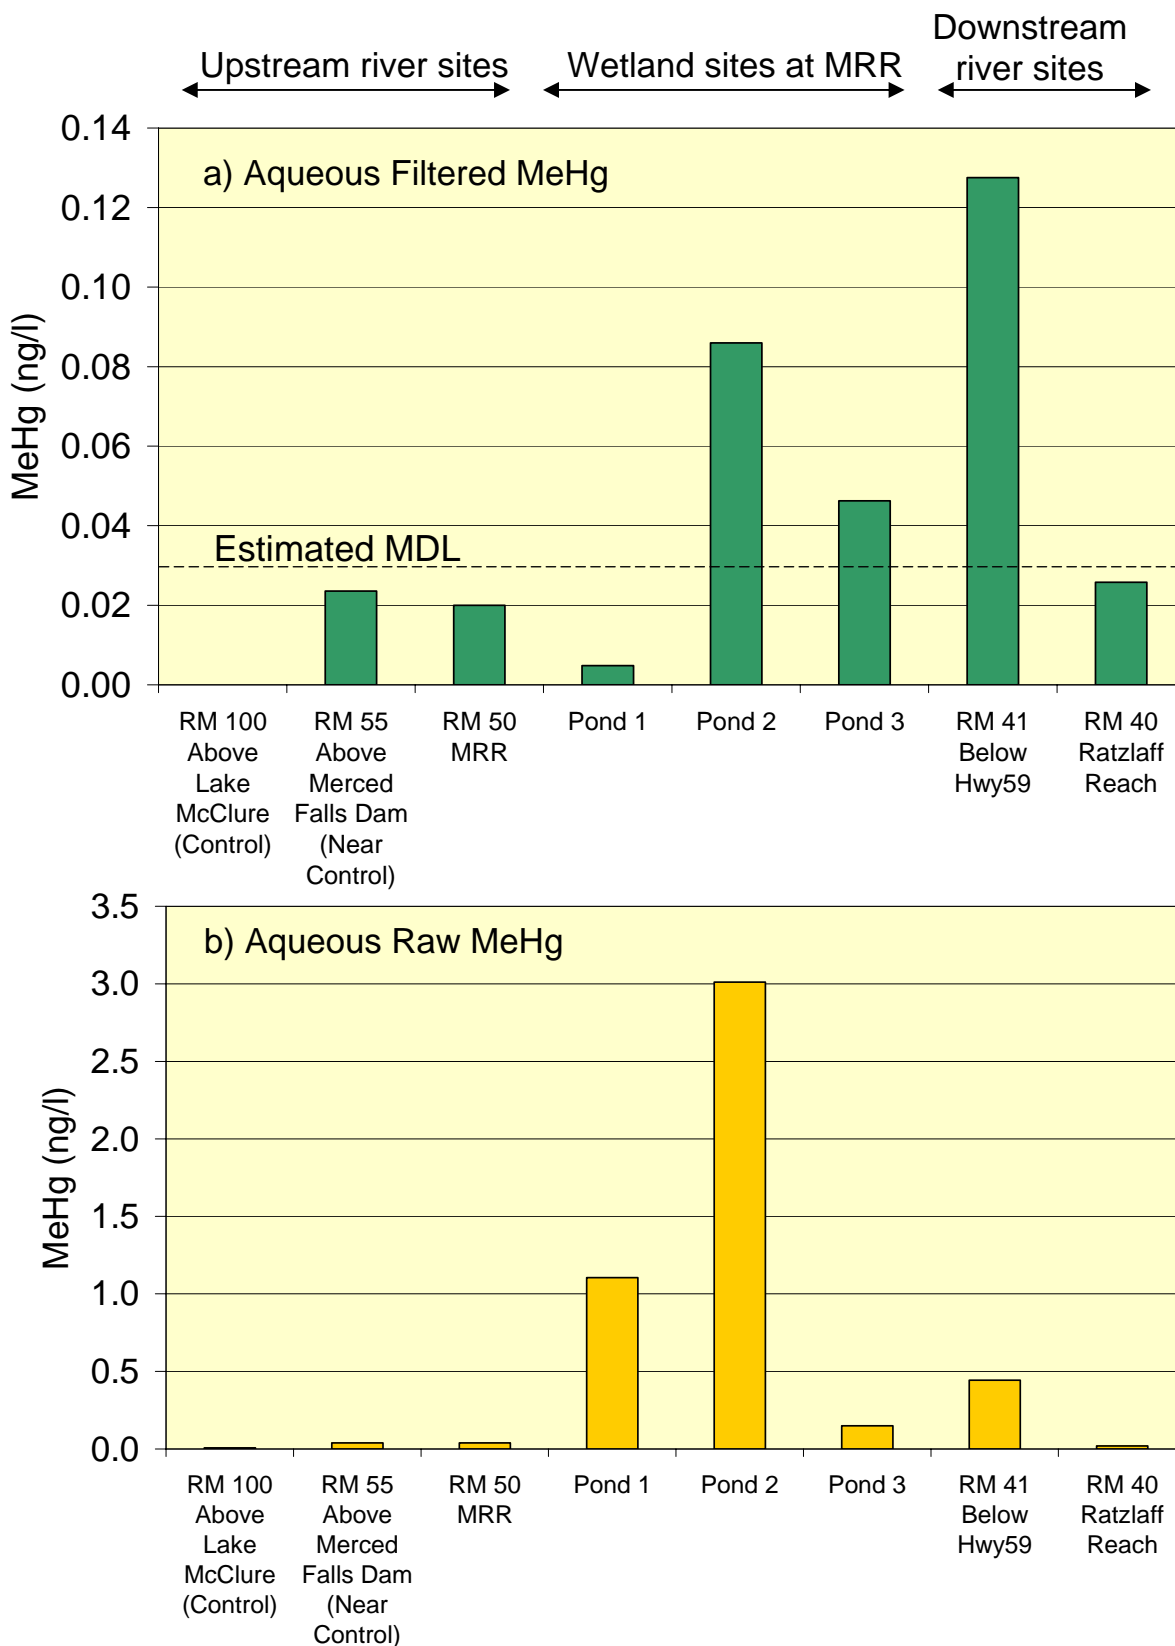
FIGURE 18

Aqueous methylmercury at sites along the Merced River. Note the different scales on each graph. Estimated MDL = 0.03 ng/L, n=1 for each

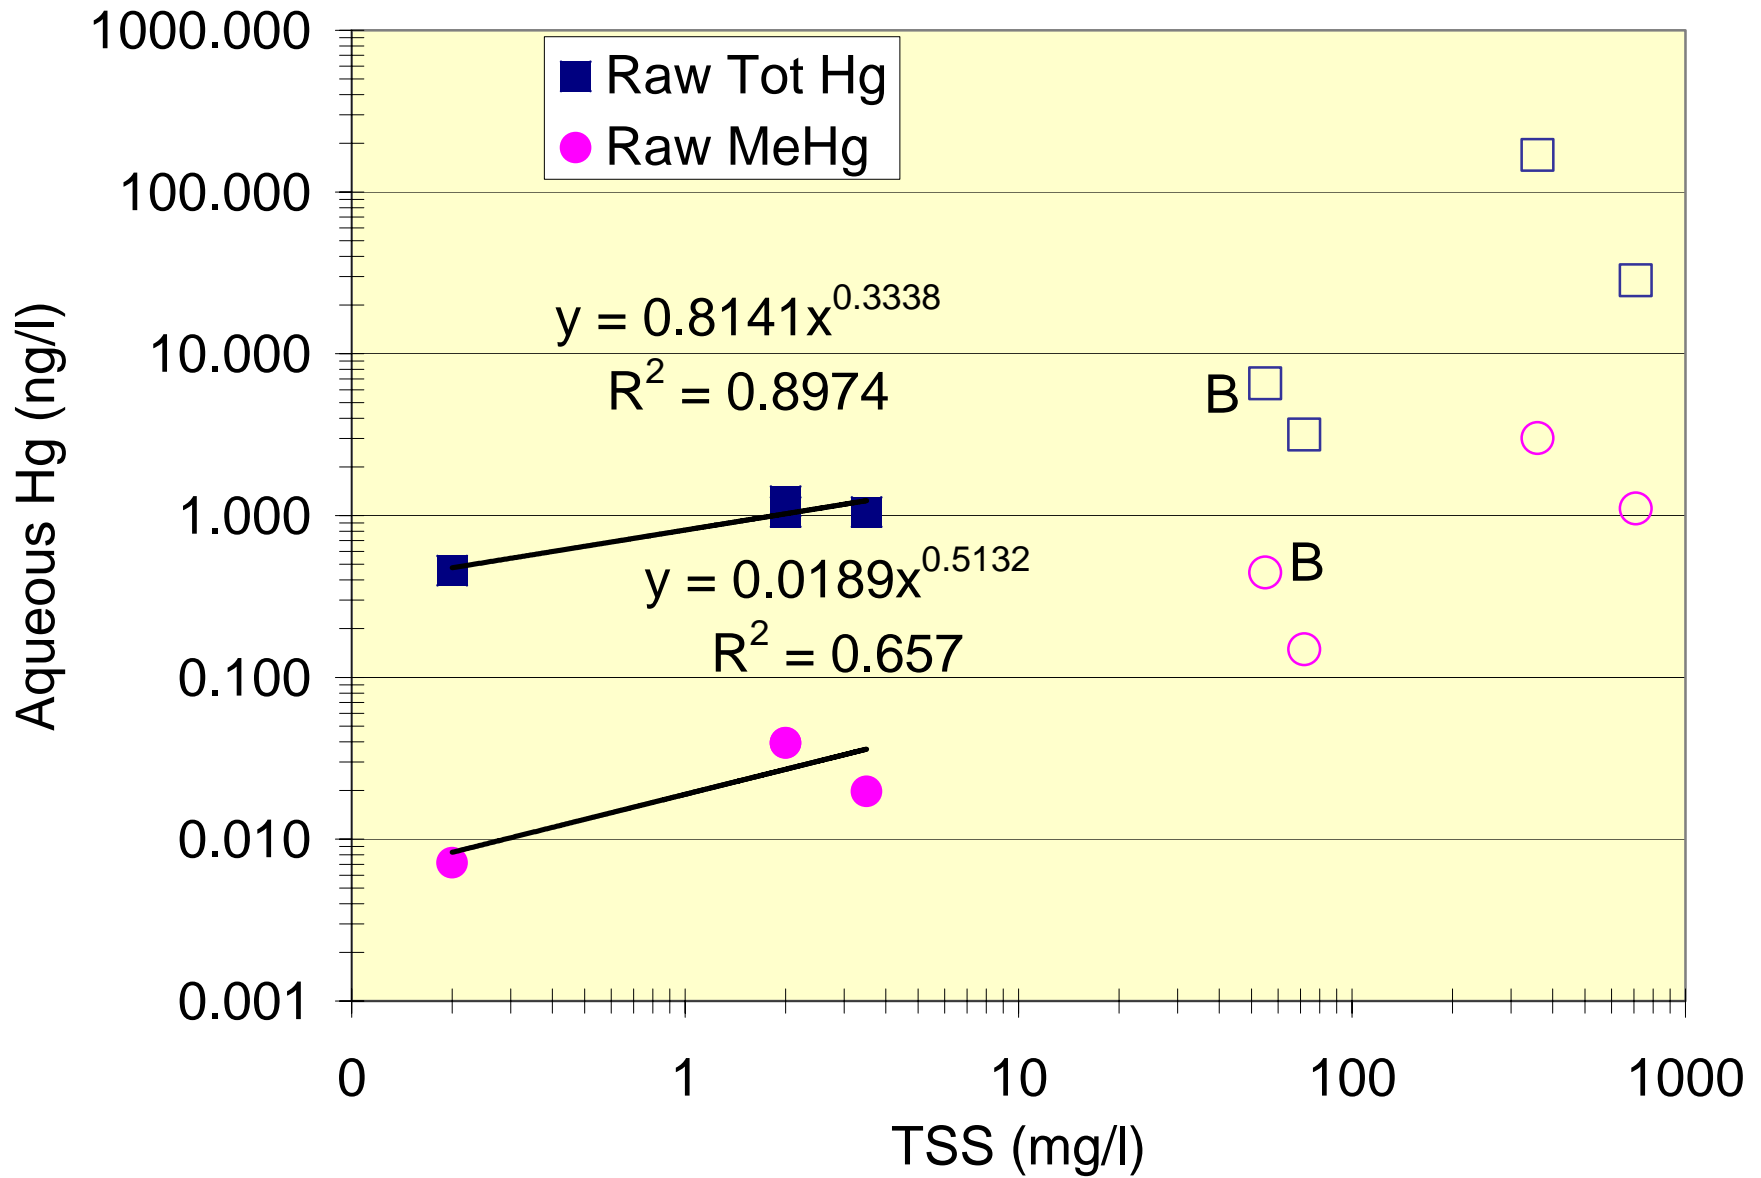
FIGURE 19

Power regression of aqueous total mercury and methylmercury by total suspended solids (TSS) in Merced River water. Filled symbols are Merced River channel sites and hollow symbols are from a backwater area at the Below Hwy59 site (noted with an B) and the Merced River Ranch ponds.

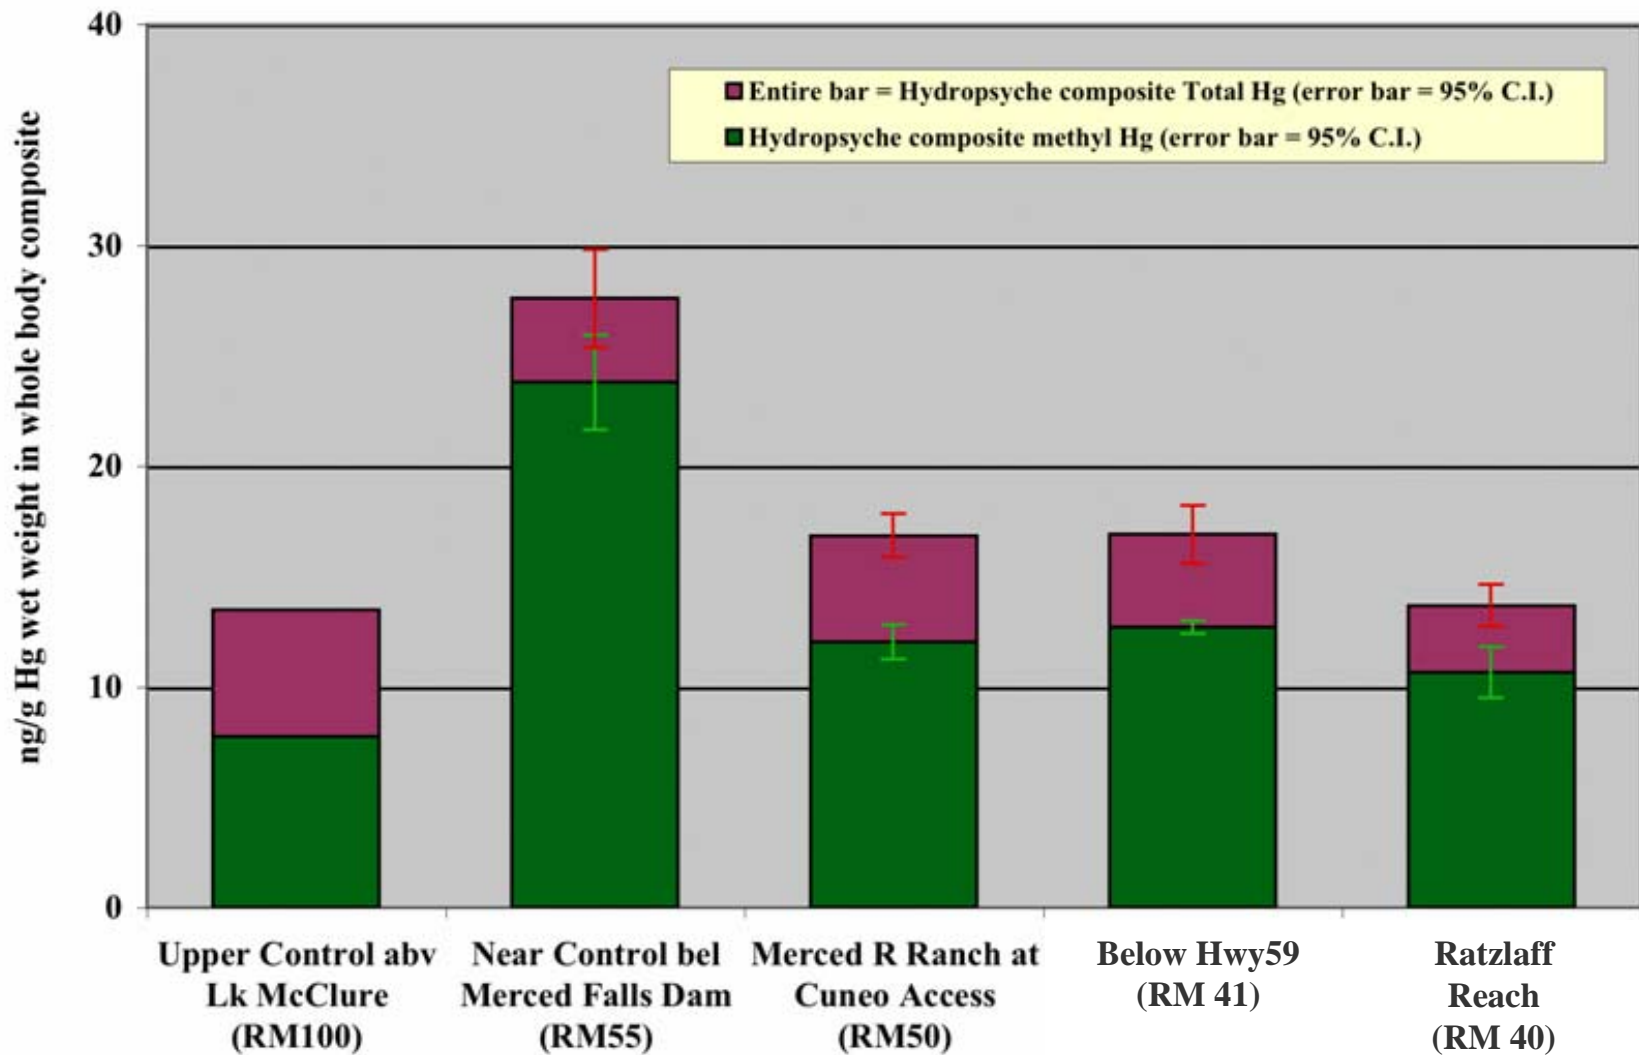
FIGURE 20

Mercury content of Hydropsychid caddisfly from Merced River sites. Mean MeHg and THg in replicate, multi-individual composites is shown with 95% confidence intervals (RM = river mile).

Caddisfly mercury concentrations (both MeHg and THg) exhibited a spatial trend similar to that described above for the MeHg:THg ratio. The lowest mean concentration, 8 ng/g MeHg, was seen at the upstream control site above Lake McClure. At the Merced Falls site below the reservoirs, caddisfly MeHg was elevated three fold, averaging 24 ng/g. This represented a “near control” for the downstream sites within and below the zone of dredger tailings. Mercury bioaccumulation was not found to increase downstream of Merced Falls as the river moved through the dredger tailings material. Instead, caddisfly MeHg dropped by approximately 50%, to concentrations of 11–13 ng/g. This relative decline was strongly significant statistically. Concentrations were similar among the sites located in the middle of the tailings zone and immediately downstream of it (12–13 ng/g). A small but statistically significant additional decline was seen moving downstream between the Below Hwy59 site, located below the tailings zone, and the Ratzlaff Reach site, located at the base of the river restoration project (13 ± 0.3 ng/g vs. 11 ± 1 ng/g).
