Merced River Corridor Restoration Plan Phase IV: Dredger Tailings Reach

Technical Memorandum #5 **Mercury Assessment of the Merced River Ranch**

Prepared for
CALFED ERP
Sacramento, California
Recipient Agreement No. ERP-02-P12-D

October 2004

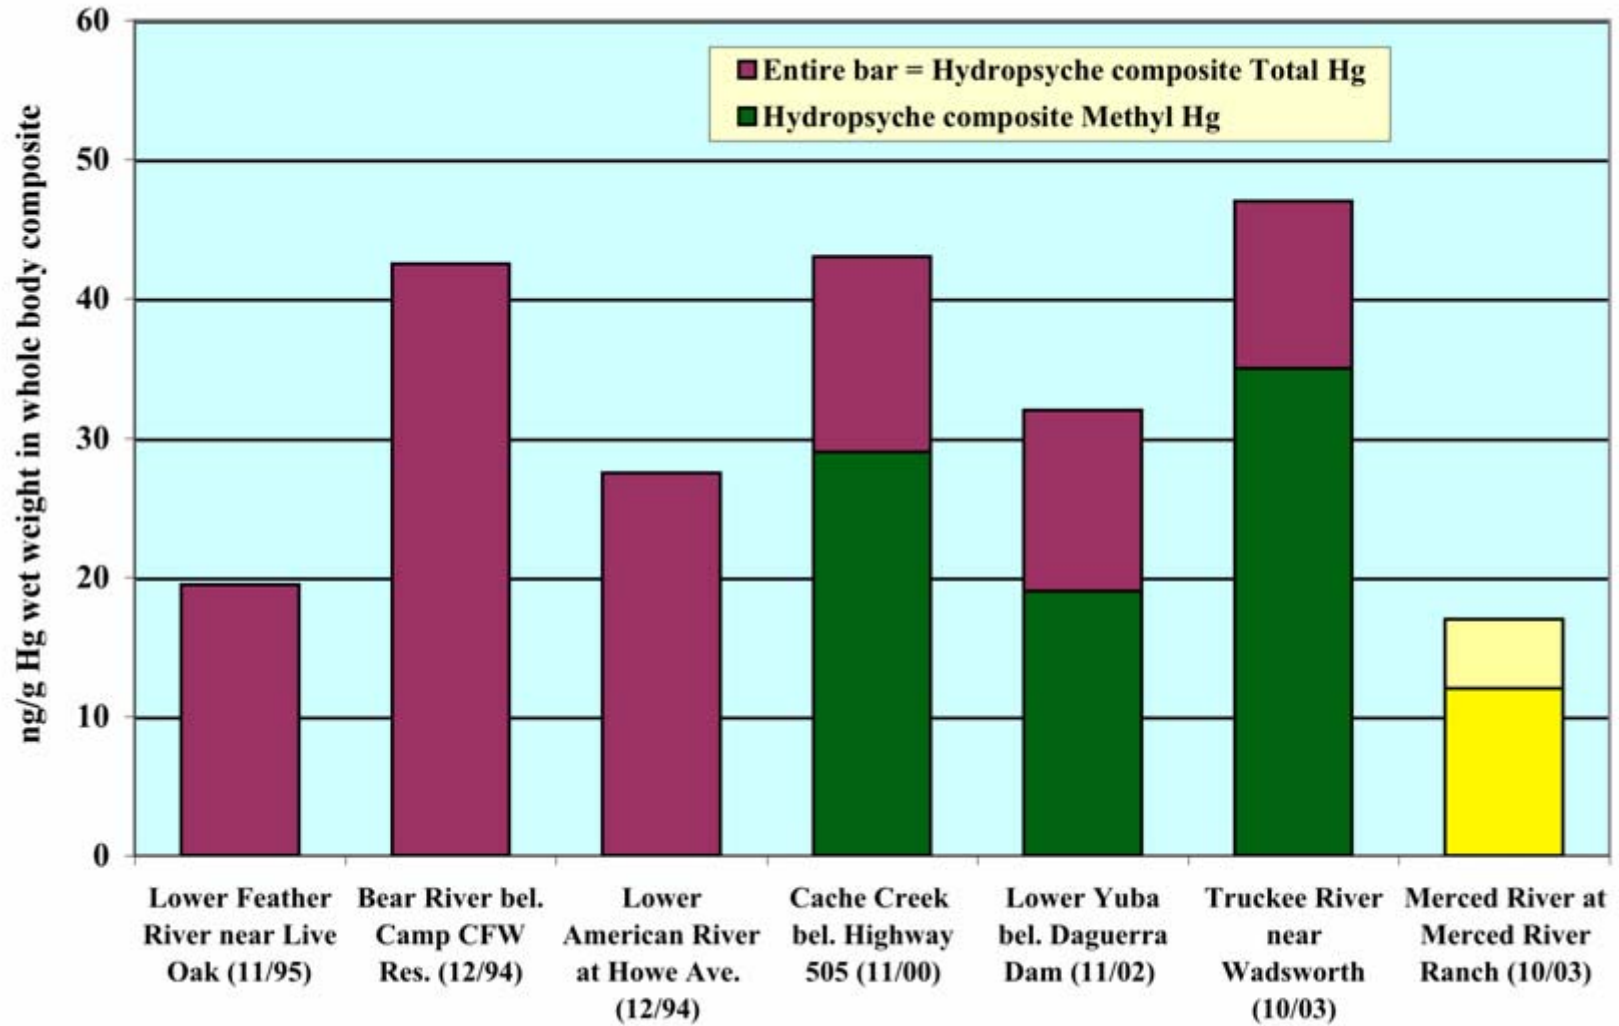
FIGURE 21

Comparative Hydropsychid caddisfly mercury content from other regional rivers. Mean THg and, as available, MeHg were collected as multi-individual composite samples.

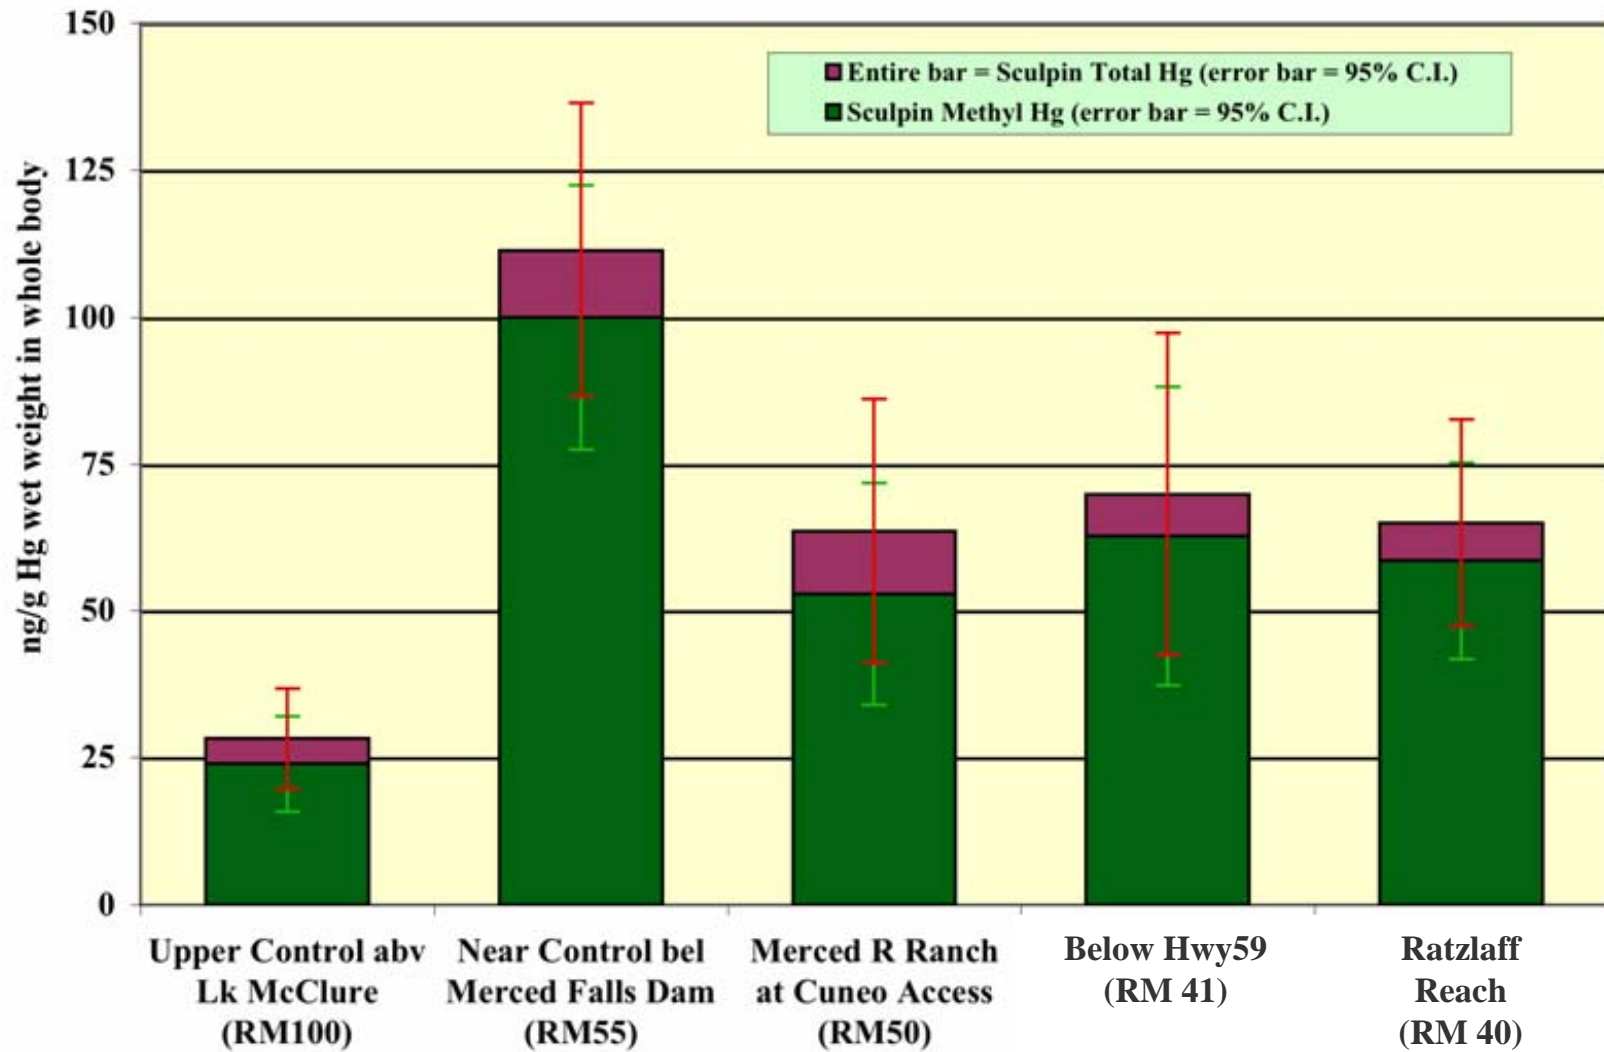
FIGURE 24

Mercury content of prickly sculpin (*Cottus asper*) from Merced River sites. Mean MeHg and THg in replicate, individually analyzed fish is shown with 95% confidence intervals. (RM = river mile)

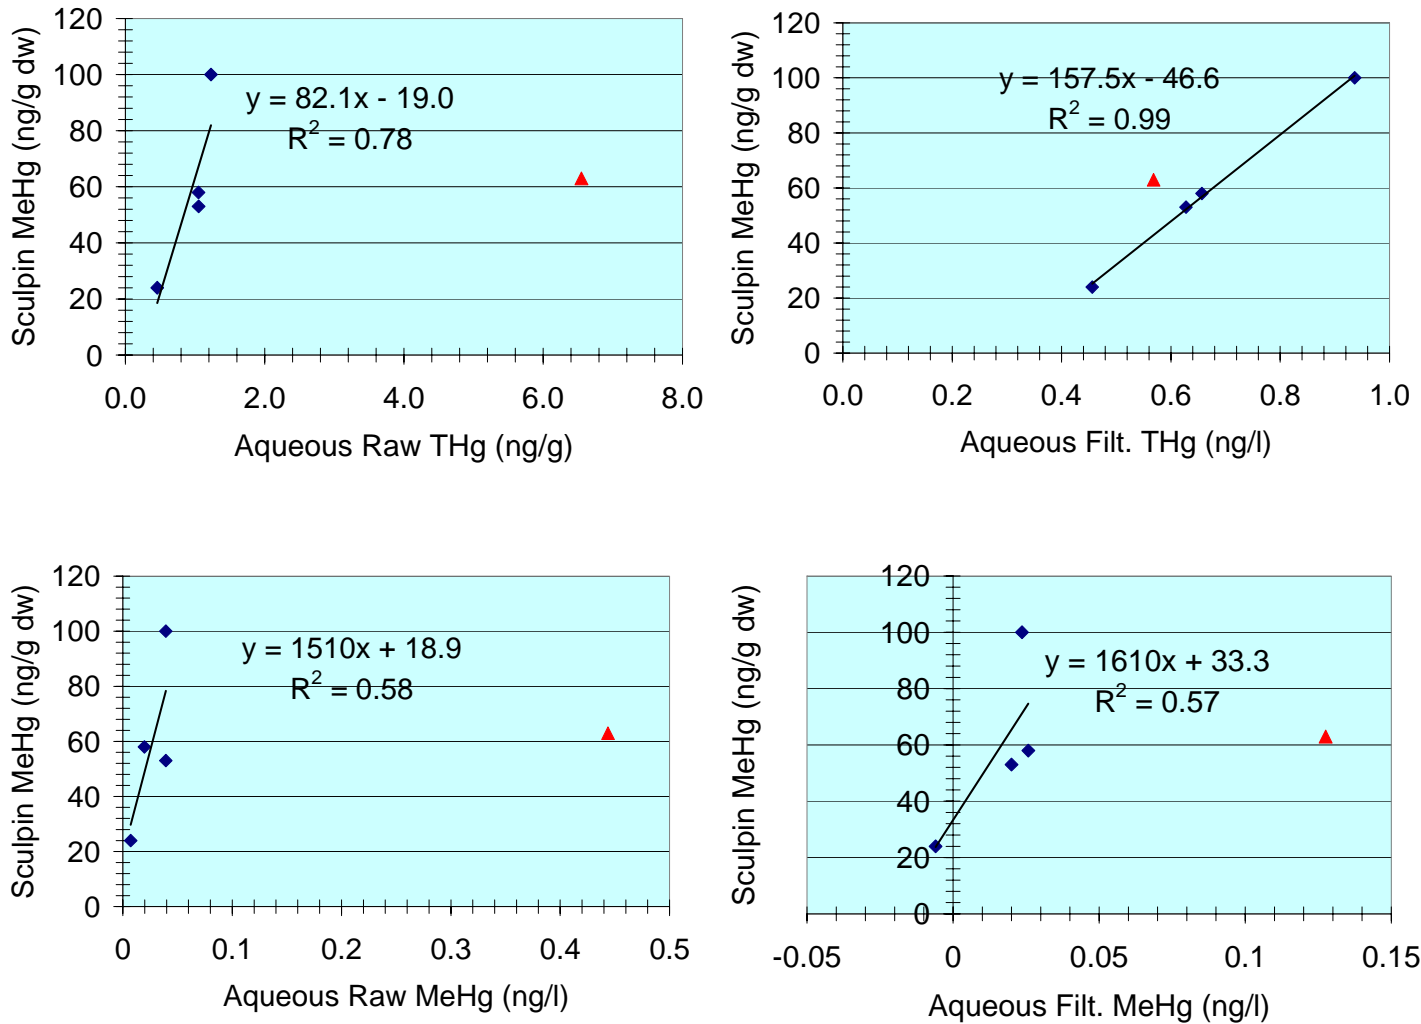
FIGURE 25

Linear regression of aqueous mercury fractions vs. methylmercury in prickly sculpin (*Cottus asper*) at Merced River sites. The red triangle represents the Below Hwy59 site (RM 41), and since it is an outlier in 3 of the 4 cases shown it is not included in any of the regressions.

to those found with the caddisflies. Again, the Below Hwy59 site behaved as an outlier in three of four comparisons and, despite the low sample size and one-time water sampling event, a significant correlation was apparent between sculpin MeHg and aqueous THg, as either the raw ($r^2=0.78$) or filtered ($r^2=0.99$) fractions. The correlation was less significant for aqueous raw MeHg ($r^2=0.58$) and aqueous filtered MeHg ($r^2=0.57$).

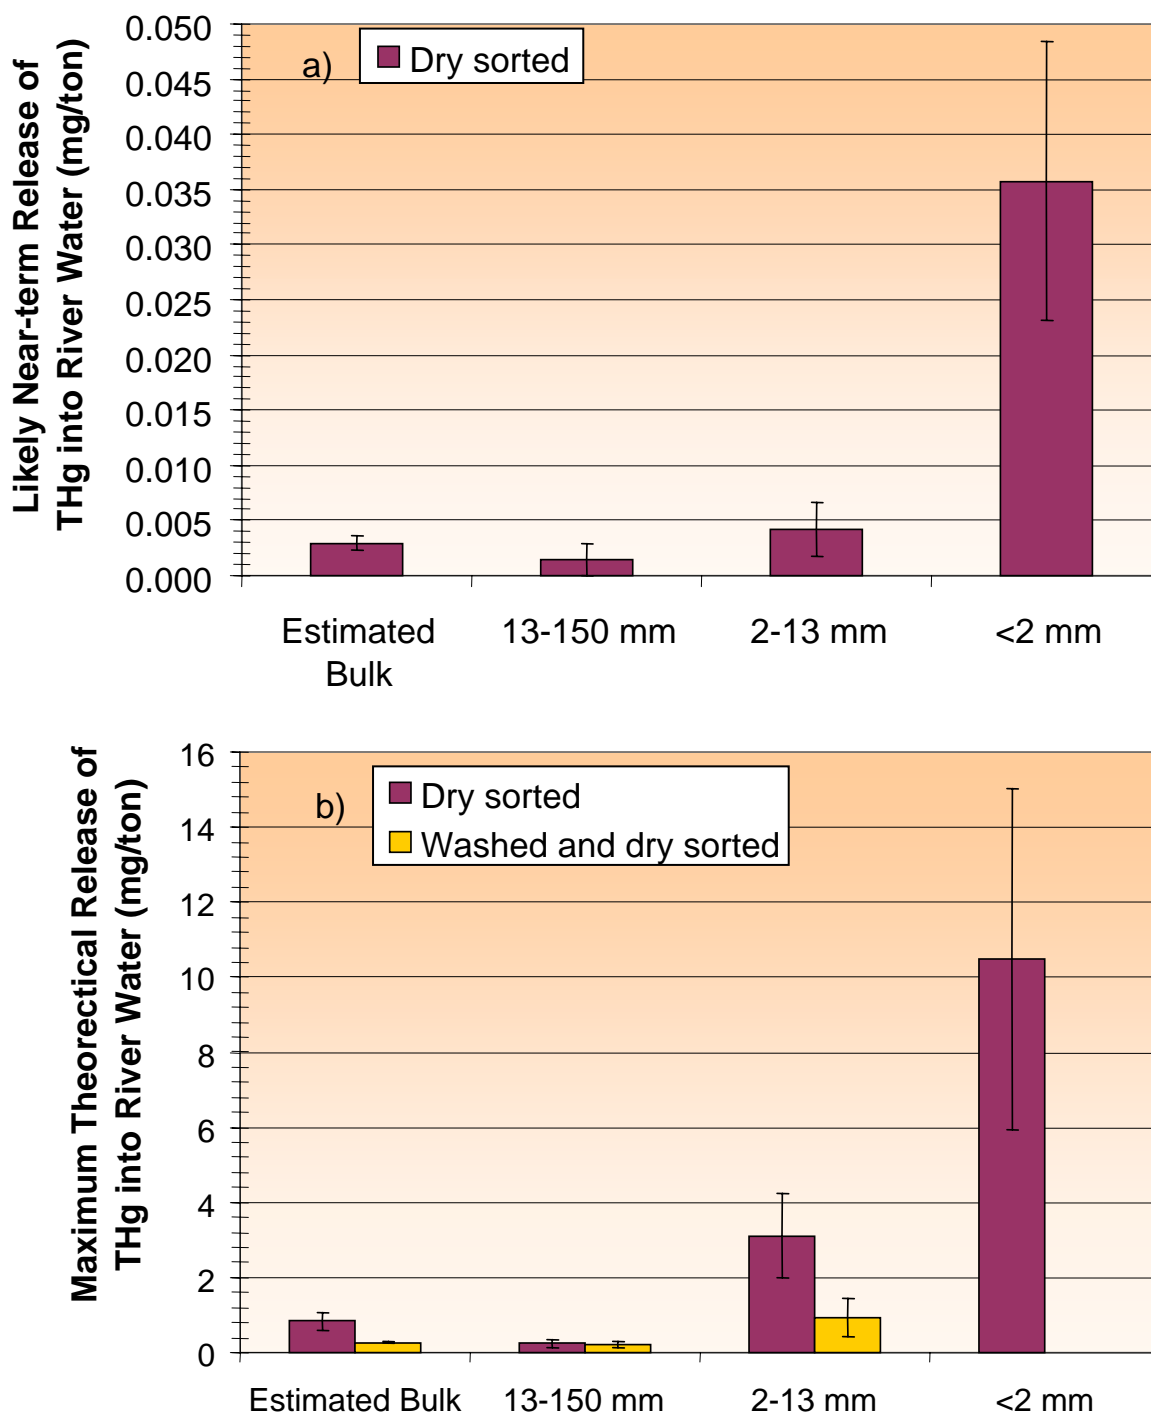
FIGURE 26

Effects of processing on mercury released from Merced River Ranch dredger tailings. Results are expressed as mg per ton of dredger tailings. (a) THg liberated from dredger tailings washed with synthetic river water, without any processing (Estimated Bulk) or processed by dry sorting (remaining size fractions). (b) A comparison of washed vs. unwashed for the maximum theoretical mercury that could be leached from the dredger tailings over a long period of time. Mercury in bulk dredger tailings was estimated by weighting mercury measured in individual size fractions of known mass distribution (URS 2004).
